# How We Diagnosed and Fixed the 2023 Voyager 1 Anomaly from 15 Billion Miles Away

David Cummings  
Jet Propulsion Laboratory  
California Institute of Technology  
25-March-2025.

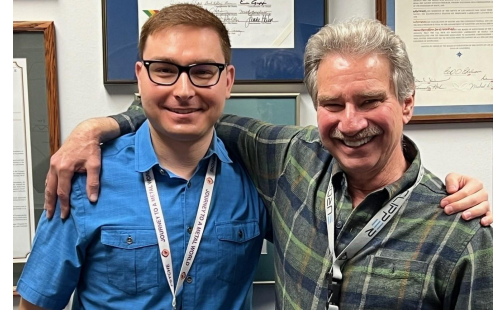
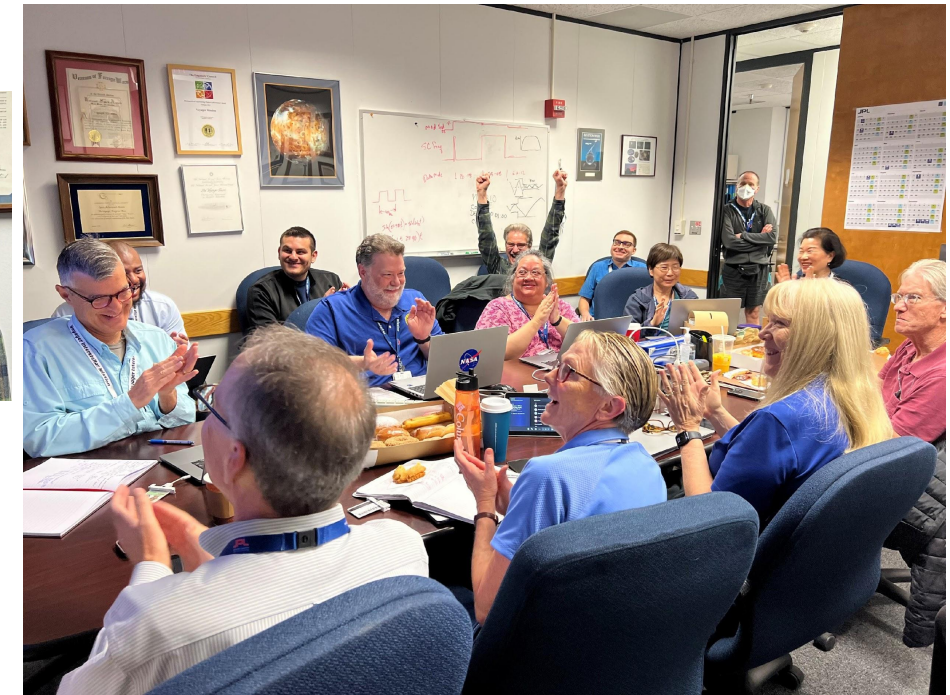
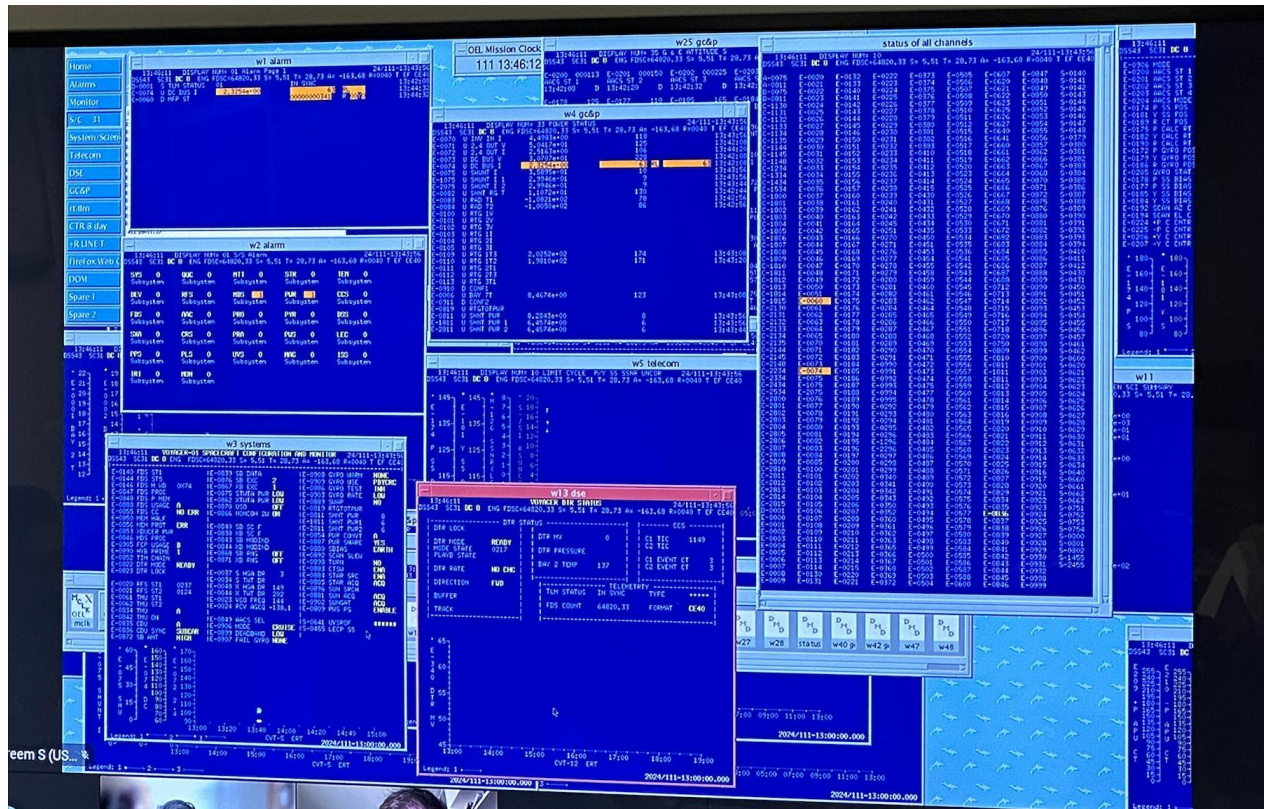
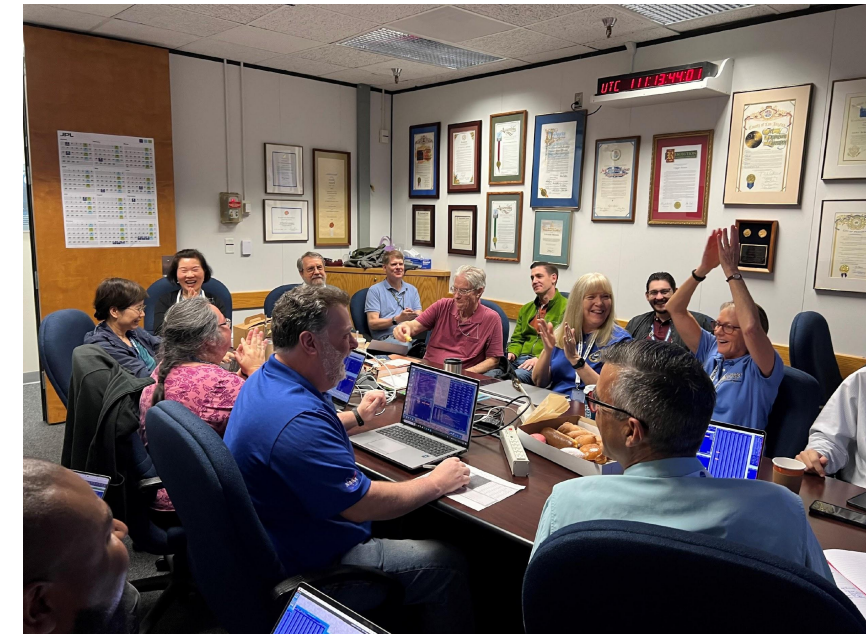
- Received telemetry from Voyager 1 for the first time in five months!

- Patch 1: Relocate corrupted code referenced by EL-40
- Patch 2: Fix up all EL-40 references to corrupted code
