ESCORT MEXICO

Original classic Fords: This straightforward rebuild turned into an extensive restoration, because when it's the oldest surviving Special Build Order AVO Escort Mexico, you have to get it perfect.

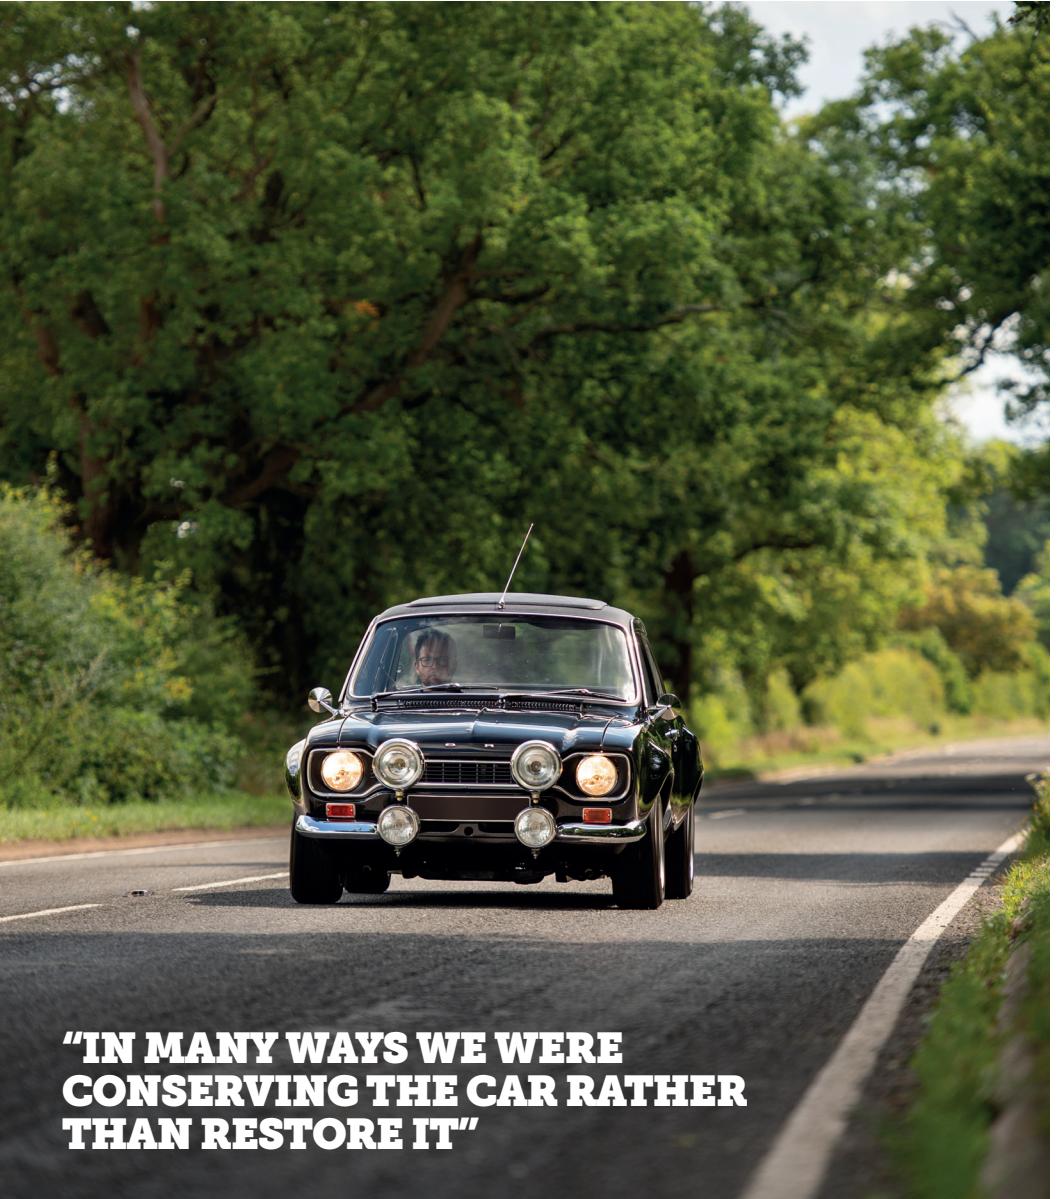
"The rear wings were the most alarming aspect, they'd been replaced in the past and there were clouds of filler. Although original, the arches were tacked on over standard size wheelarches so the tyres rubbed. Normally there would be an extension from the wing to the arches but these were essentially only held on by sealant."

The door panels were wrinkled and creased from theft damage and had been 'repaired' with filler. Replacement door panels were carefully fitted, with all mechanisms replaced. "The new left-hand wing wasn't correctly aligning with the door and the rear wing, I then realised the A-pillar was bent toward the centre of the car — probably as the result of a roll — and the scuttle panel was curved in the

wrong direction. We dug out 4 kg of lead — it was over half an inch thick in places — realigned everything and then seam-welded the joins. In the process we leaded the seams and did away with the inherent rust traps in the flitch panels and bulkhead. It still looks standard because we carefully etched the join line into the lead."

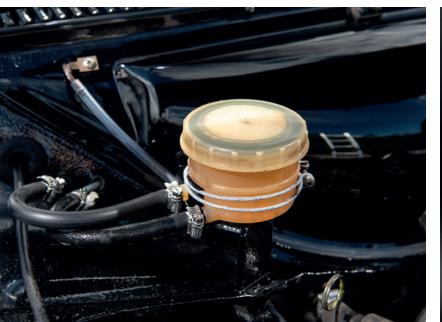
Majestic Motors have done a superb job in making sure this Mexico doesn't look over-restored.

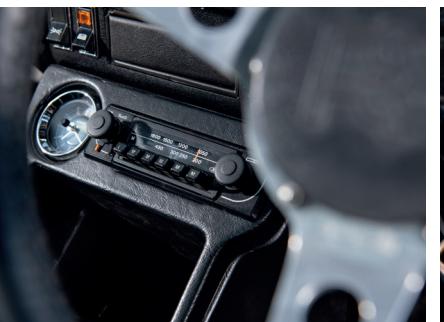
The Mexico's hard-to-find centre console was missing so a replacement had to be tracked down.

"Mark previously had all the seats reupholstered, I sourced a new centre console and we fitted a new carpet set. New doorcards and kick panels were bought from East Kent Trim Supplies but we restored the rear seat panels because they had the optional armrests. The original walnut wood trim had been replaced by cheap plastic versions, but I managed to find a

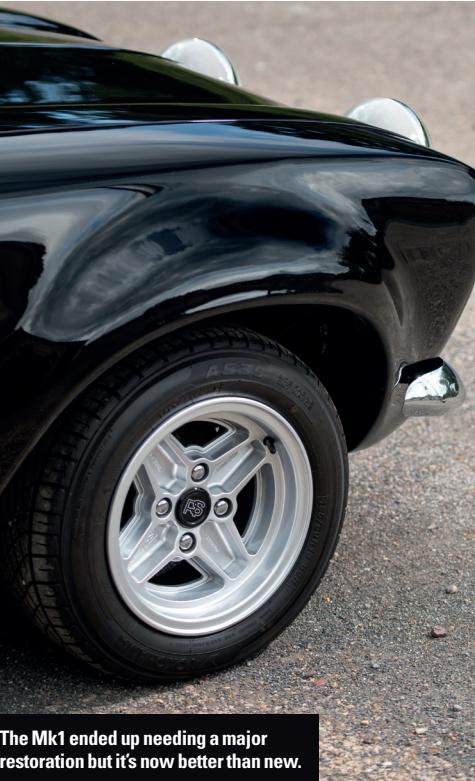
The Mk1 ended up needing a major restoration but it's now better than new.

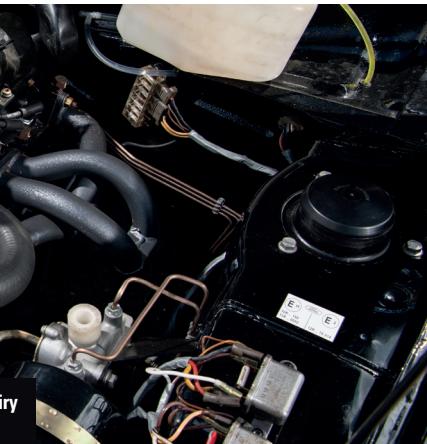
Ben has a specific process for painting metal components. "We dip parts then carefully shotblast them. Even gentle shotblasting takes some metal away so we mainly use it to provide a key for the paint coats that follow. We'll then E-Coat the part, Electrophoretic Painting, that removes any remaining grease and oil and it puts paint into the tiniest crevices, such as the join between two welded panels. Then we powdercoat it, which gives it an attractive, smooth finish. Powder coating is purely cosmetic, it won't protect against corrosion and it doesn't like being applied on sharp edges. You shouldn't ever powdercoat the area under a critical fastening; the powder coat contains plastic and it relaxes, so if you torque up a bolt over a powder coated surface chances are a week later it will be loose."
