SCExAO PSF Vibration report post HiCIAO upgrade - observing run 14-15th April 2014

The rebuilt HiCIAO:

HiCIAO's affects on the PSF of SCExAO:

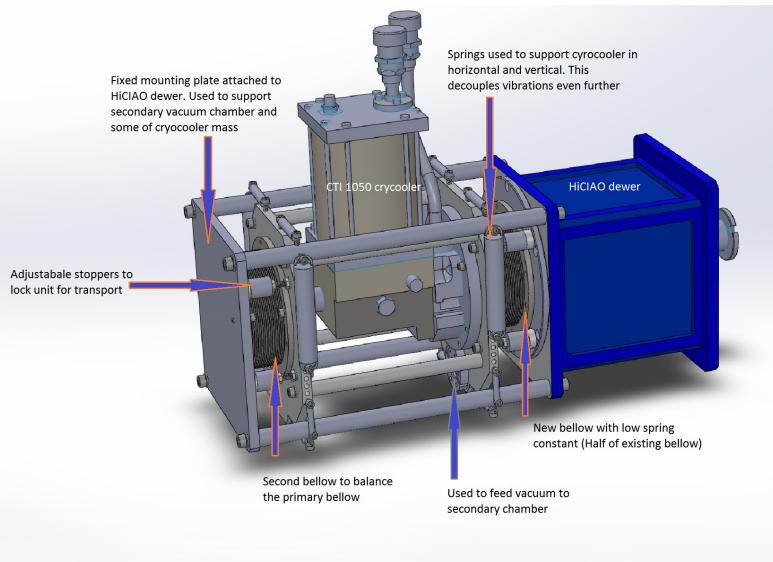
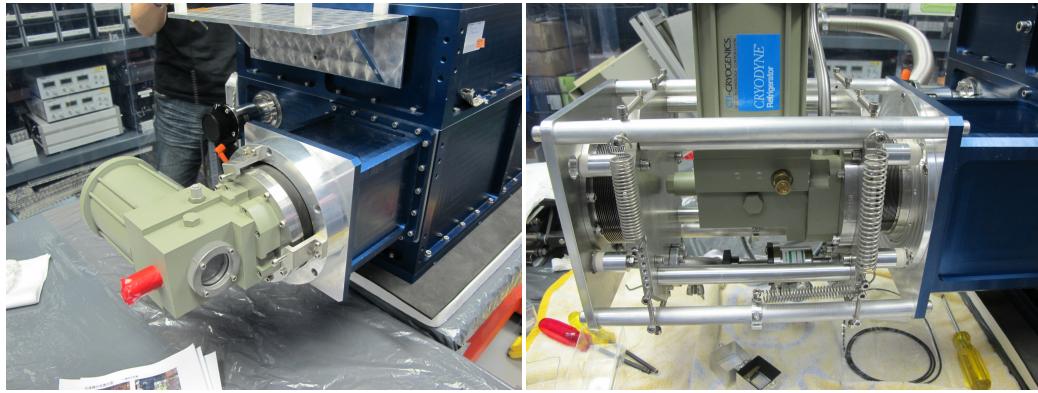
The left figure is the pre-rebuild HiCIAO. The black neoprene ring can be seen keeping the pump from colliding with the dewer. The right figure shows the post rebuild HiCIAO. The secondary vacuum chamber/bellow can be seen to the left. Also a host of springs as described above. You will also notice that the cryo-pump was rotated to be oriented in the vertical post rebuild as it was easier to balance the mass when the torque due the cryo-pump being on its side was eliminated.

The concept we adopted was to use a secondary vacuum chamber on the opposite side of the cryo-pump which pulls the pump in the opposite direction to that which the primary chamber pulls. If you get the surface area of the two chambers matched just right the forces cancel and the pump simply floats between the two bellows. In this case each pulse from the pump is damped by the soft springs of the bellows. No solid contact is made between the cryo-pump and the dewer in this way. To support the mass of the pump we added mechanical springs in both the vertical and horizontal directions. This way the cryo-pump is only coupled to the body of the dewer via either a spring or a bellow. The figure below shows some of the features of what I just described. There were several minor hiccups but the build was completed in 3 days.

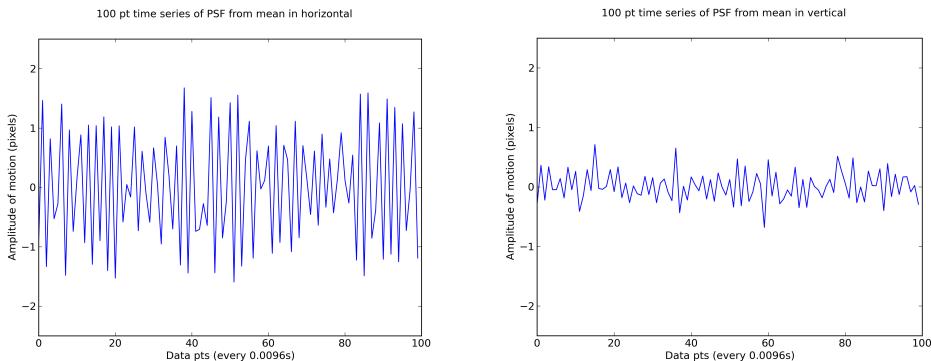
Pre-rebuild:

Clearly the horizontal axis has a greater amplitude of oscillation and is periodic. $\sigma_{horiz}=0.94$ pixels, $\sigma_{vert}=0.24$ pixels. This is more evident in the amplitude spectra below.

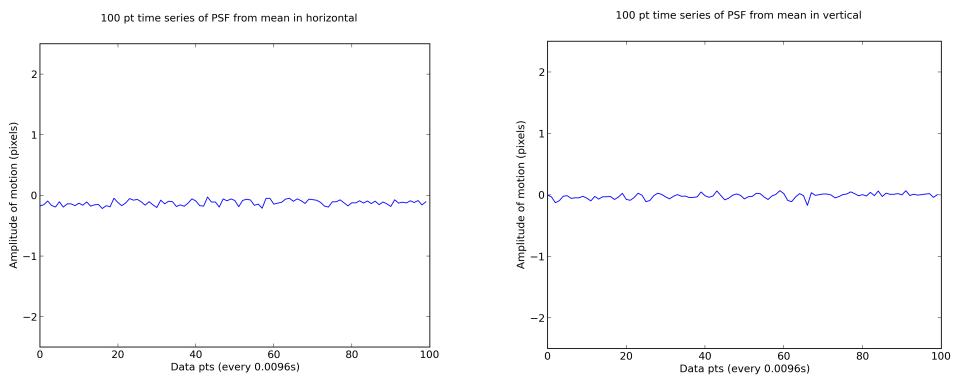
Post-rebuild:

Post rebuild the time series has a much smaller amplitude and there is no obvious structure. $\sigma_{horiz}=0.06$ pixels, $\sigma_{vert}=0.08$ pixels. The standard deviation in the horizontal plane is a factor of $\sim 16x$ improved and $\sim 3x$ in the vertical.

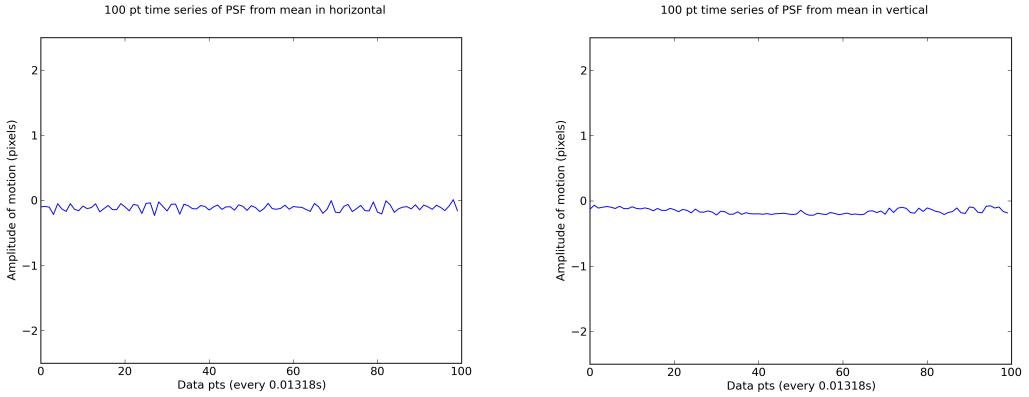
Cryo-pump off (reference):

It's clear that the time series amplitude is very similar in appearance to the post rebuild case. Indeed, $\sigma_{horiz}=0.09$ pixels and $\sigma_{vert}=0.11$ pixels agree very well with the post-rebuild values provided above. So now the stability of the PSF is within the limits of uncertainty of measuring its position (0.1 pixels). Also, the residual vibrations do not have a measurable affect on the PSF any longer. This is a significant reduction in the motion of the PSF. Wohhoooo!

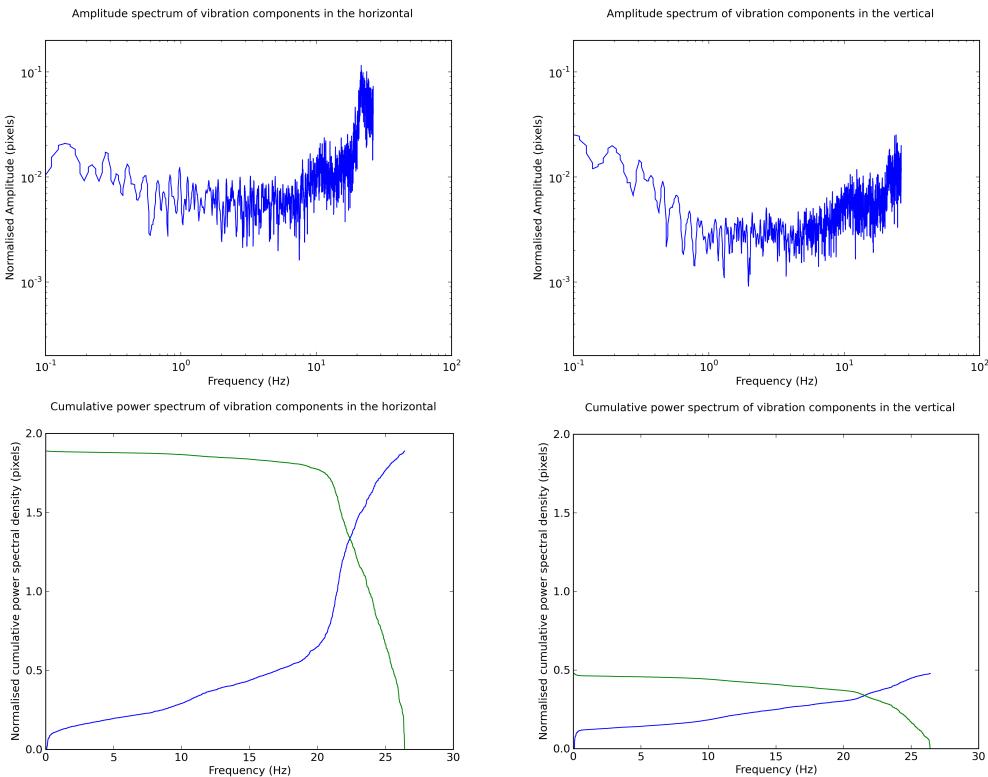
Pre-rebuild:

The cumulative power spectral density simply shows you, which frequencies are contributing to the oscillation. For the horizontal its the broad peak around 21-25 Hz while for the vertical there is no specific frequency. Note the 1 Hz peak, due to the cryo-pump, can not really be seen in either plot. I've checked and there was enough data for a 1 Hz oscillation to be seen, so these results indicate that it was not the dominant frequency of vibration in our system, but is certainly the excitation frequency.

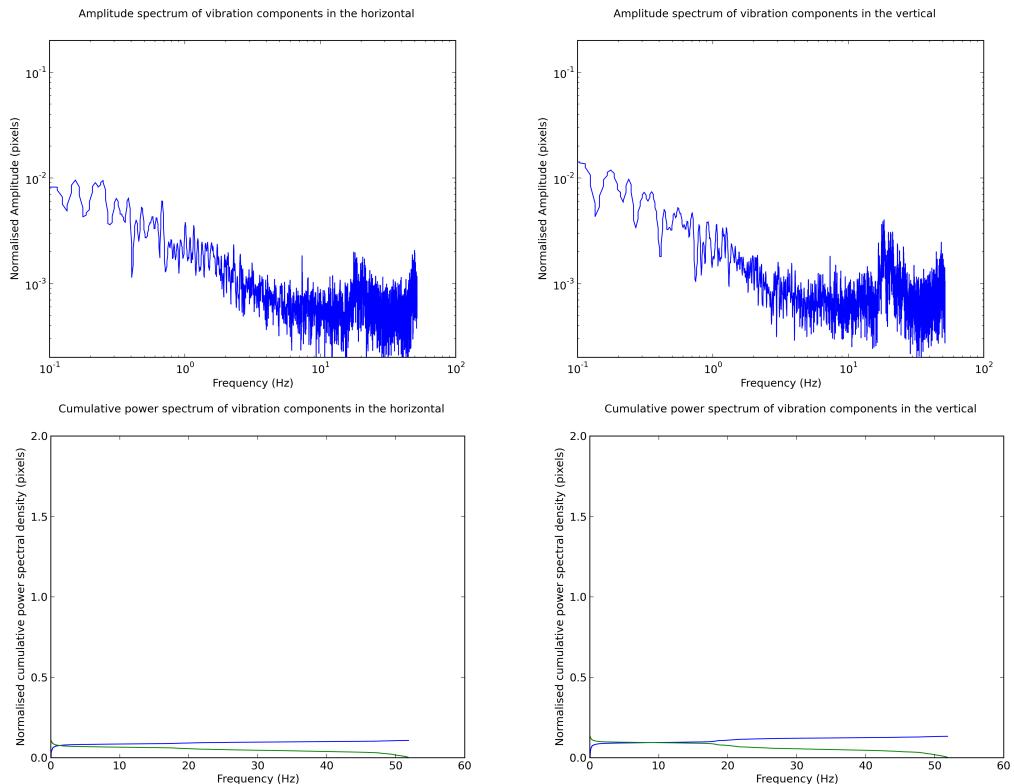
Post-rebuild:

It can be seen from the above figures that post-rebuild that the amplitude across the entire spectrum has reduced significantly. In addition the horizontal axis has almost no structure while the vertical has a small peak around 20 Hz. This confirms our suspicion that the time series also does not have any structure to it. The remainder of the tip/tilt error, which has a structure, may be corrected with clever LQG or Kalman filtering loops.

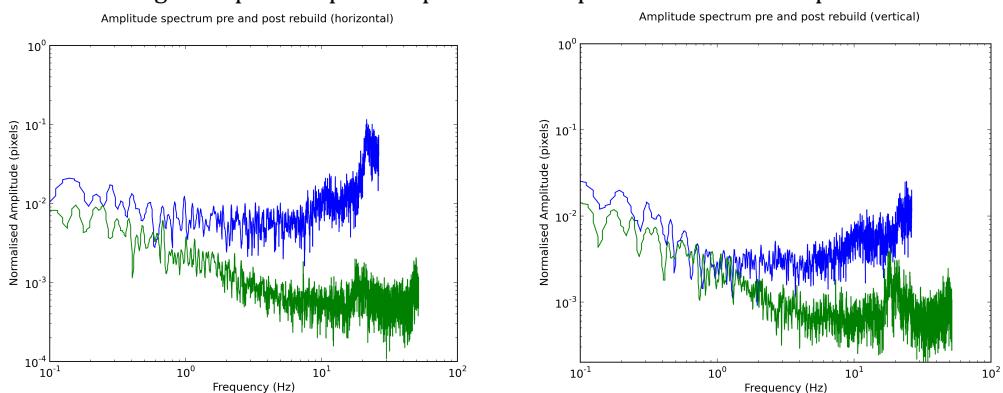
It is clear that there is little reduction in PSF motion at frequencies below ~ 1 Hz (almost none for the vertical). However, at 10 Hz, there is an order of magnitude improvement in the horizontal and almost the same in the vertical. The maximum improvement occurs at the 23 Hz peak which is attenuated by ~ 100 times in the horizontal direction!

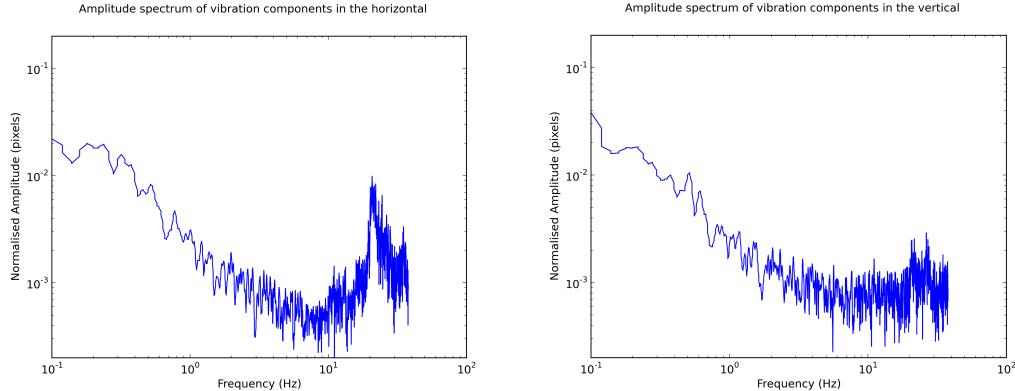
Cryo-pump off (reference):

The amplitude spectra almost had no features except the small bump around 23 Hz in the horizontal. This indicates that the majority of the tip/tilt jitter in the PSF was indeed due to the cryo-pump (in December) as suspected and also that the cryo-pump is not the only source of noise. As described in January when we initially analyzed the data, our understanding was that the cryo-pump, which operates at 1 Hz is only the excitation source, which creates a ring down affect in the mounts holding the DM in SCExAO. As the beam path from the DM to the camera is long, then even a very slight motion can cause a large excursion in the PSF position. In addition to the HiCIAO upgrade outlined above, we also changed the DM mounts and made use of stainless steel instead of aluminum plates as well as increasing the thickness from 5-10 mm to 12 mm all round. Some of the changes we made to the DM mounting can be seen in the CAD drawings below.

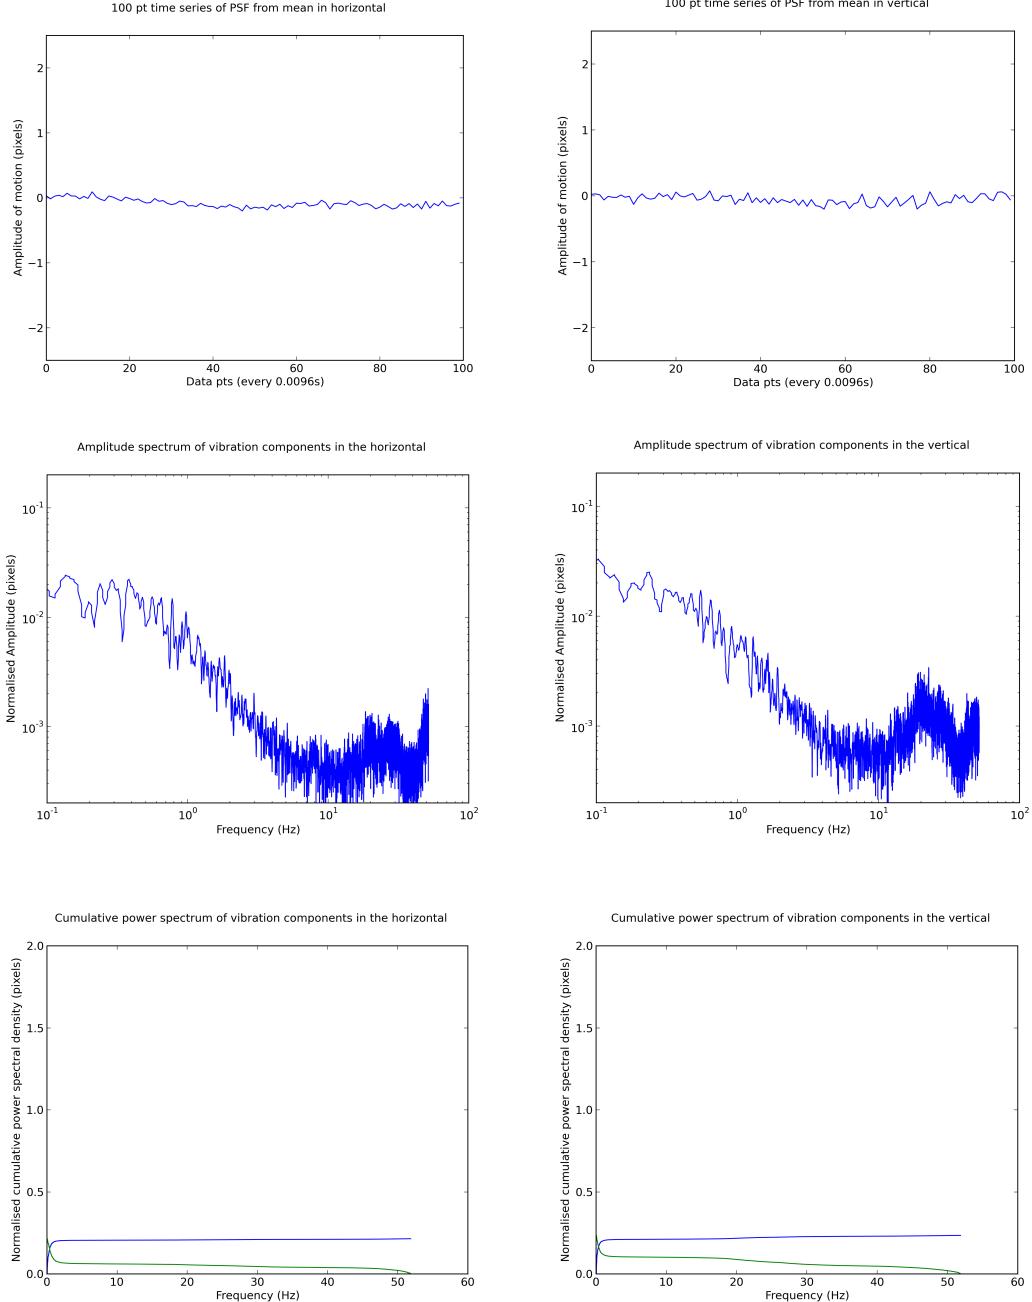
Finally, we now have a mains power mini-cooling fan extracting warm air from the bench in order to prevent turbulence. The fan sits off the Nasmyth-platform (near the staircase) and is connected via a very soft flexible duct to the covers of SCExAO. I measured the PSF motion for the case with the fan-on (post rebuild) and got $\sigma_{\text{horiz.}} = 0.11$ and $\sigma_{\text{vert.}} = 0.13$, which are consistent but slightly larger than with the fan-off case presented above ($\sigma_{\text{horiz.}} = 0.06$ and $\sigma_{\text{vert.}} = 0.08$). Here are the plots:
