Boost Driver Debugging

Using Schoki's (v1) driver assembled by TA

13 Mar 2018

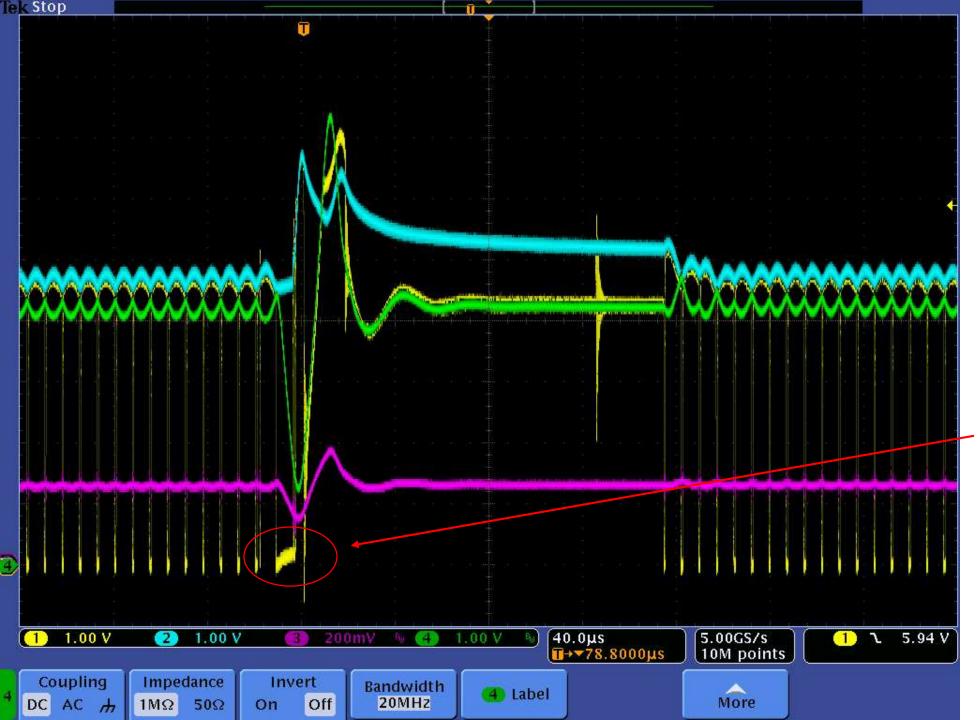
Original TA Driver No modifications

Zoom in from previous slide.

Note the green input voltage. When the lower switch in the MP3431 turns on for a long duration, Vin drops significantly, causing the MP3431 to turn off and restart.
