**Memo to:**  
Roland de Witte

## EMC BASELINE SURVEY AND GAP-ANALYSIS

**Project:** Simonshaven 380kV Uitbreiding (DP2-4)

**DNV Reference:** OPP-00436810-PSP 25-1757

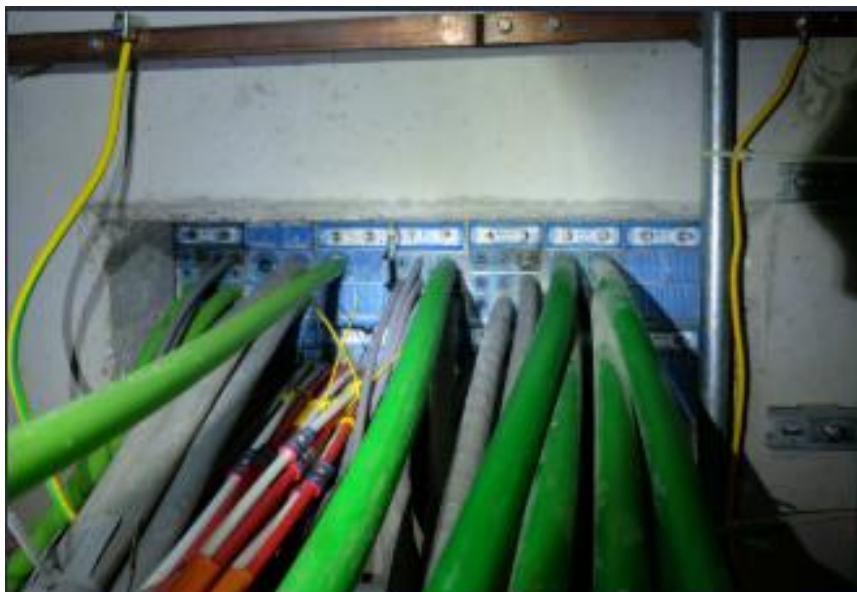
Photo reference SMH002

- **Inspection Scope:** Visual check of the Roxtec cable transit frames in the AC/DC and Telecom rooms. Verification of frame bonding to the main earth bar and correct termination of cable shields (360° bonding) within the modules, in accordance with *TenneT Detail 27*.
- **Observations:**
  - The physical condition of the Roxtec frames was found to be **Fair**
  - The bonding connection between the transit frame and the room's ring earth could not be visually observed (aardrail). It is possible that an electrical connection exists but can only be verified through measurement.
  - Regarding cable shields: It was not possible to verify shield termination visually. Recommendation that measurements should be performed to verify connection.
- **Photo Reference:** SMH001-SHM016

| <b>2. Roxtec Frame Bonding</b> | Visually confirmed Defect. Frames are oxidized and lack dedicated bonding straps (See Photo SMH002). | Confirmed Deviation visually. It should be confirmed through measurement. |

- Scope: Roxtec frames, Steel Door Frames, and Cabinet Gland Plates.
- Objective: Verify electrical continuity to the Main Earth Bar (MEB).
  - *Roxtec Frames*: Confirm if oxidation (Photo SMH002) has compromised the bond.
  - *Cabinets*: Confirm if the use of plastic connectors/glands has isolated the cable entry plates from the earthing system.

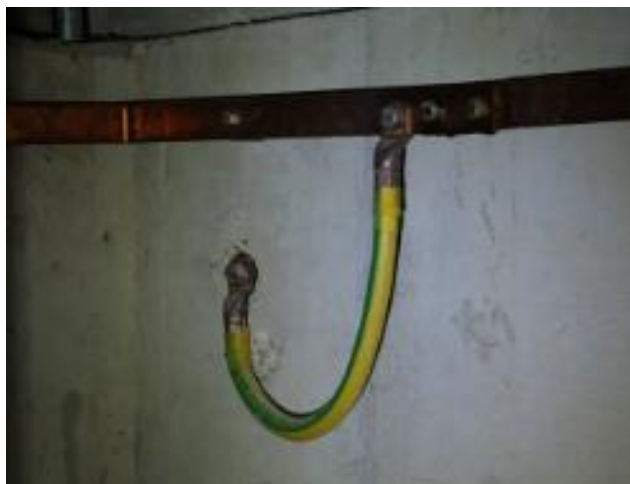
Photo reference SMH019, SMH011

- **Inspection Scope:** Verification of the Faraday cage concept (LPZ 2). Inspection of bonding points between the wall reinforcement (wapening/EMC-net) and the earthing system, and bonding of metal door frames.
- **Observations:**
  - Visible connections to the building reinforcement or EMC mesh were **Observed at regular intervals**
- **Photo Reference:** SMH019, SMH020

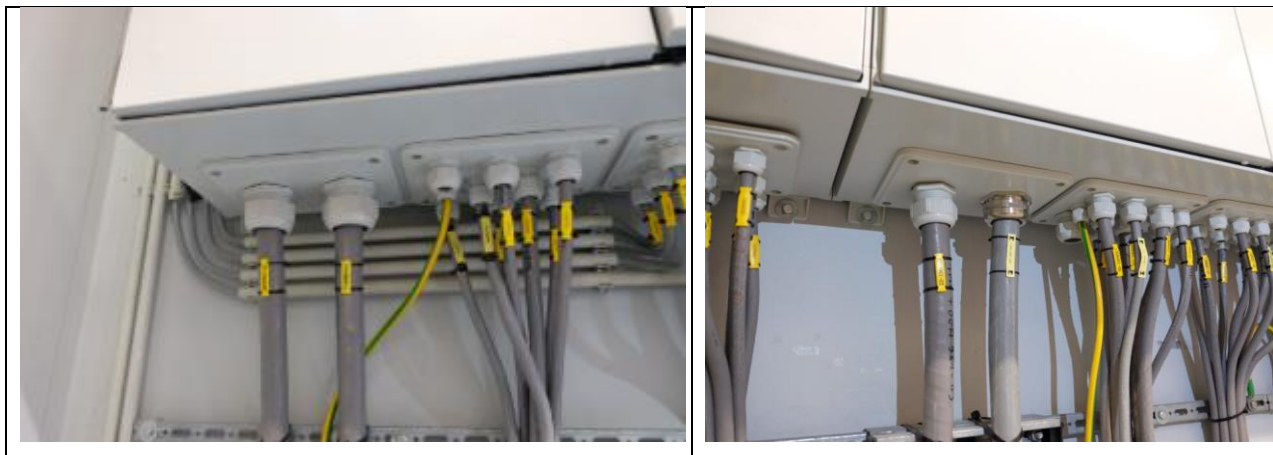
Photo reference SMH036, SMH038

- **Inspection Scope:** Check of protection relay cabinets and auxiliary power distribution boards.
- **Observations:**
  - Cable connections of the cabinets were found to be Inconsistent and included plastic connection lugs. It might be that for some of the cables (for example, fibre optics), the EMC compliant connection lugs are not required. The specific cable connections that do not comply therefore need specific identification to inventorize the non-conformances. For new modifications, conform to TenneT standards.

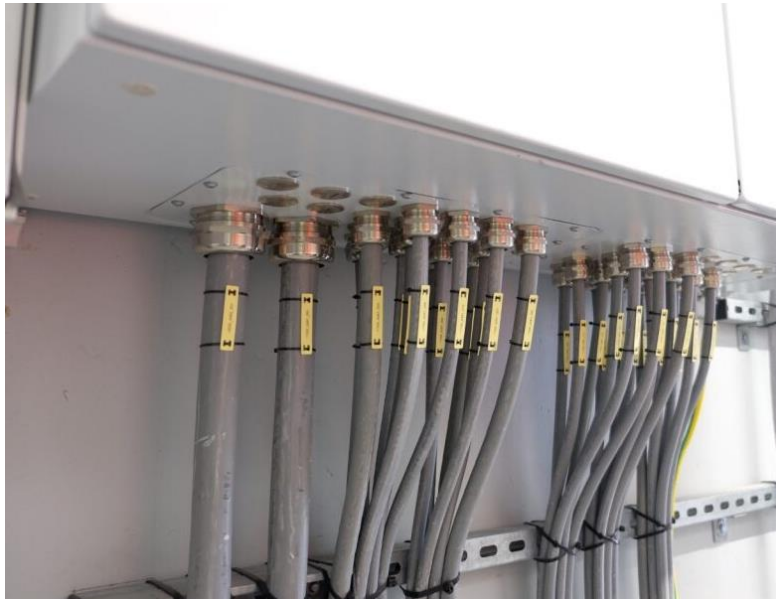
Photo reference SMH063 (Takhuisje 3)

In Takhuisje 3, a more consistent approach was followed as seen below in the metallic cable lugs:

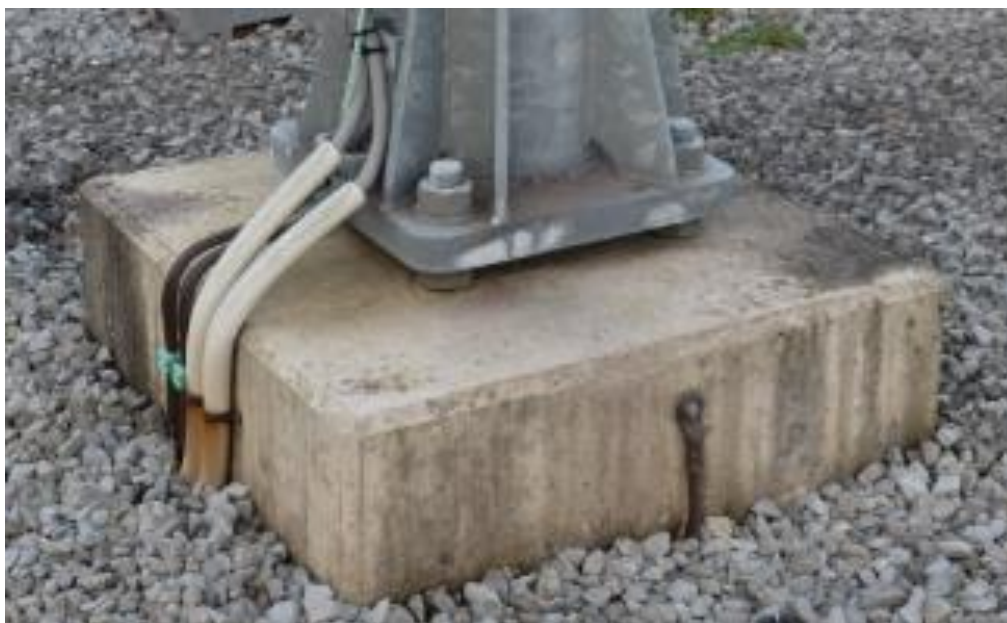
Photo reference SMH048

- **Inspection Scope:** Not all structures were inspected as this is an earthing and bonding scope of work and not EMC. However, Visual check of earthing connections of the lightning termination rod were captured (TenneT requirement: 2x connections for main structures).
- **Observations:**
  - Corrosion: Galvanic corrosion was observed at bonding points (See SMH045 in Section 7).
  - Poor Contact: Lugs were observed bolted directly to painted surfaces, creating high resistance (See SMH056 in Section 7).
  - Non-Compliant Connectors: Plastic connectors were observed on field equipment (See SMH051).

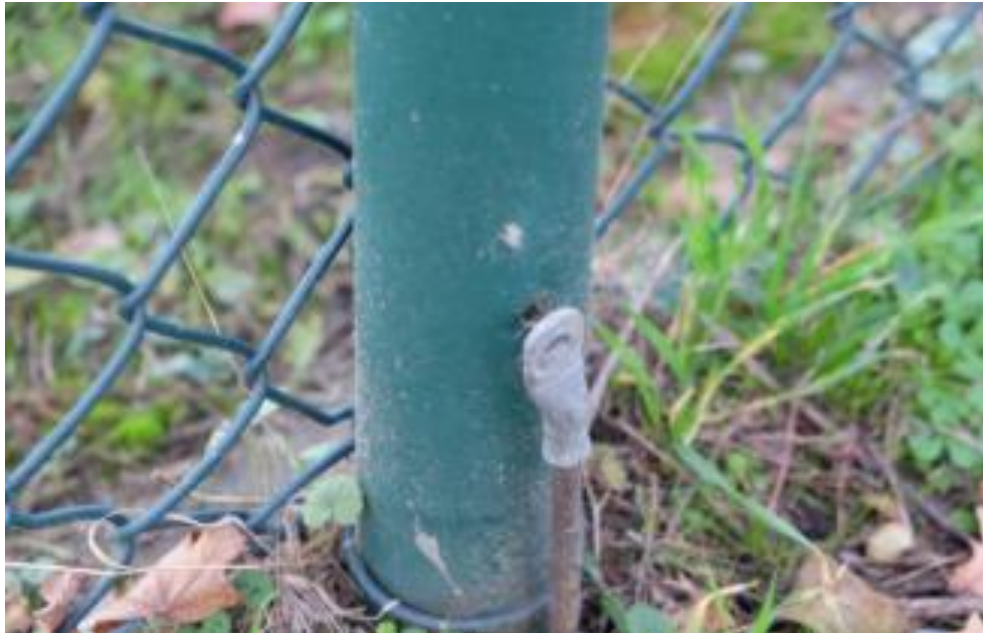
Photo reference SMH054

- **Inspection Scope:** Verification of earthing straps between fence panels and connection to the station earth grid to prevent touch voltage hazards.
- **Observations:**
  - Flexible earthing straps between fence panels are **Missing in some sections / Broken**.
  - Connection to the main earth grid was **Not visible in all locations**.
- **Photo Reference:** SMH052-SMH061.

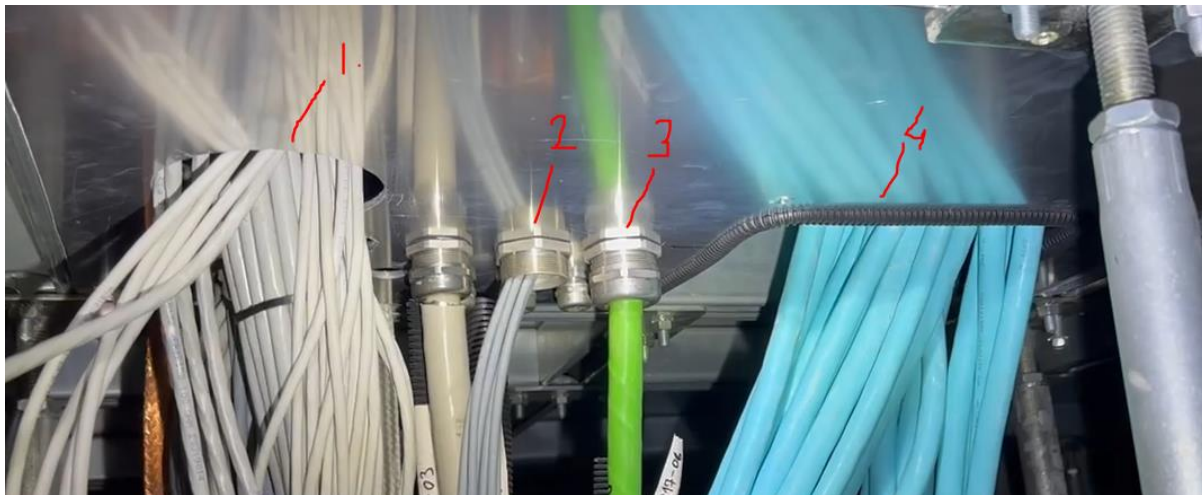
1. IMG\_6466 (1 to 4 – Possible cables with shields passing through base plate without shields being bonded to base plate or via EMC glands).

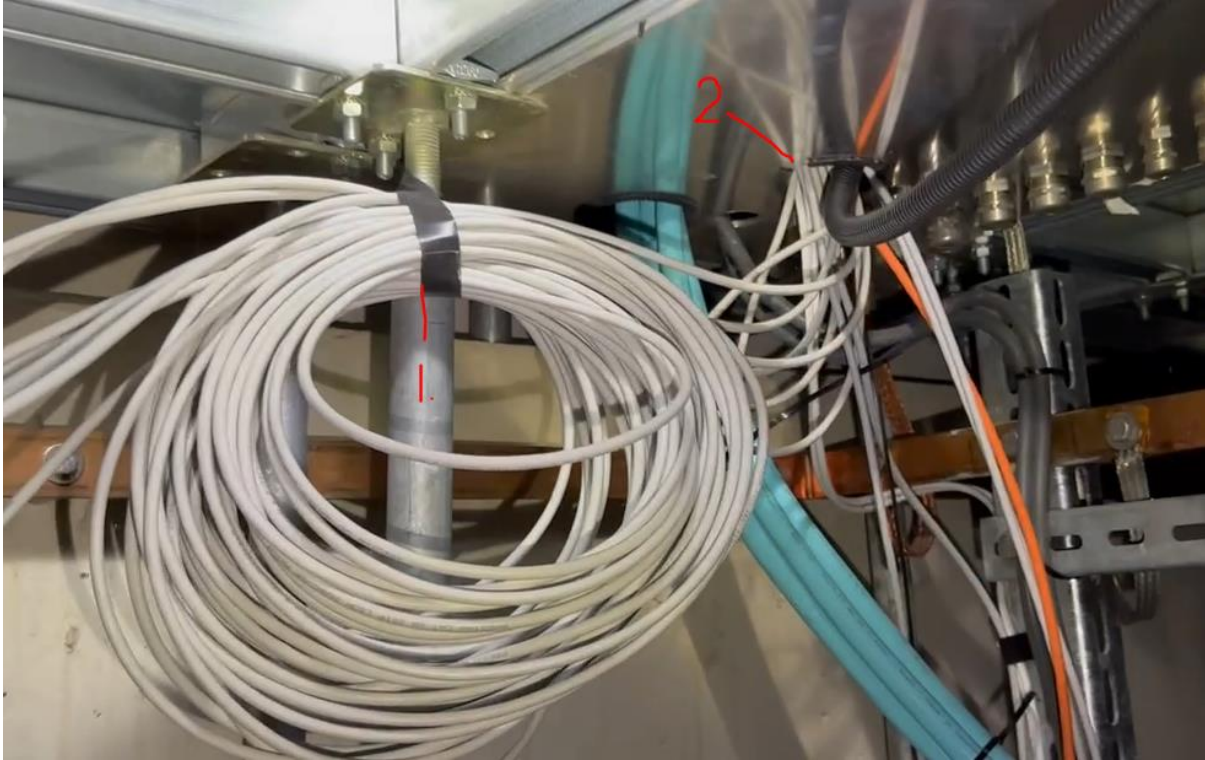
2. IMG\_6466 ((1) – Excess cable coiled – coiled cable with shield exposed to magnetic fields and passing through base plate without shield being bonded to plate or via EMC gland (2)).

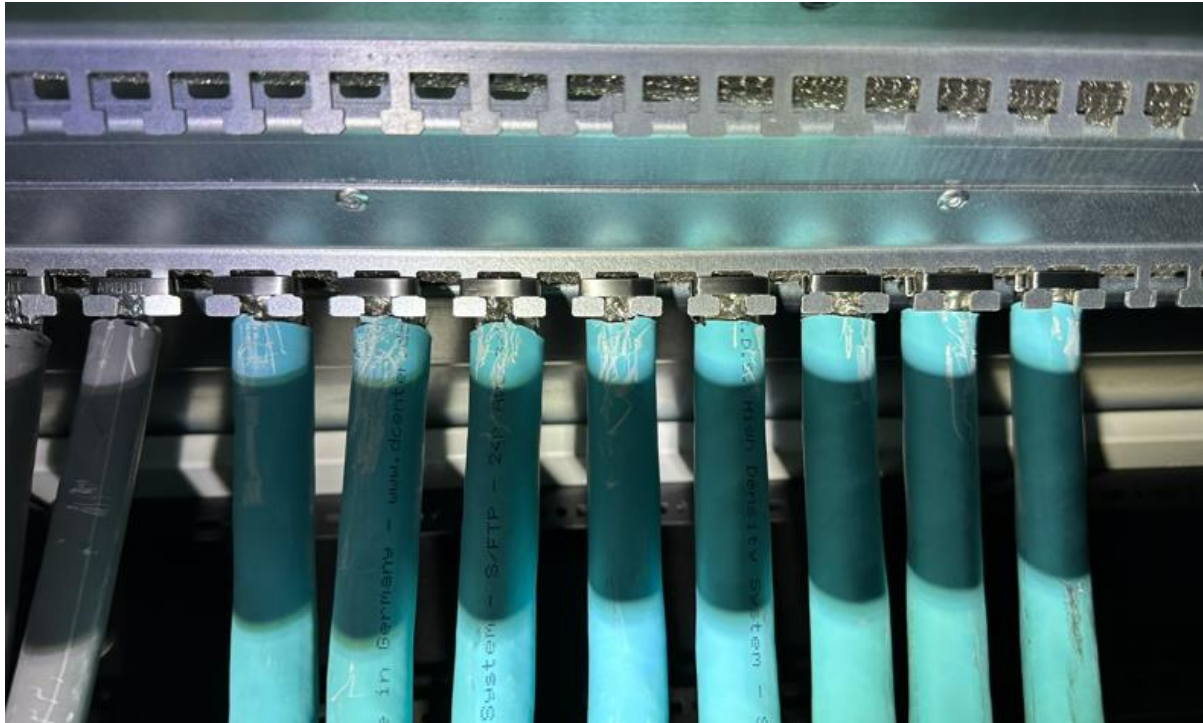
4. IMG\_6467 (Good example of cable shields being bonded to base plate).

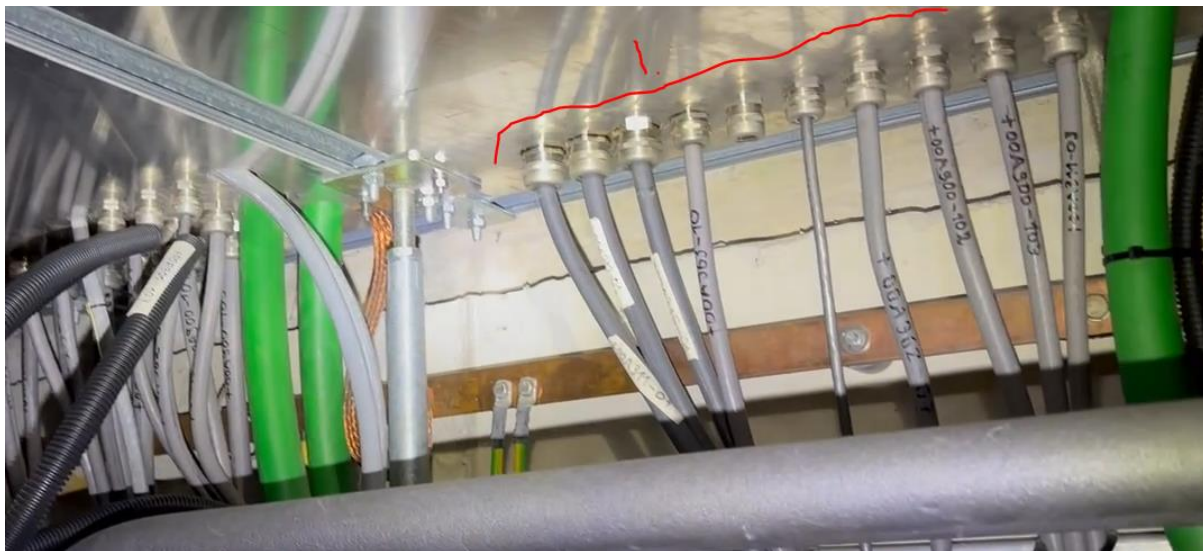
5. IMG\_6469 (1 – Possible cables with shields passing through base plate without shields being bonded to base plate via EMC glands).

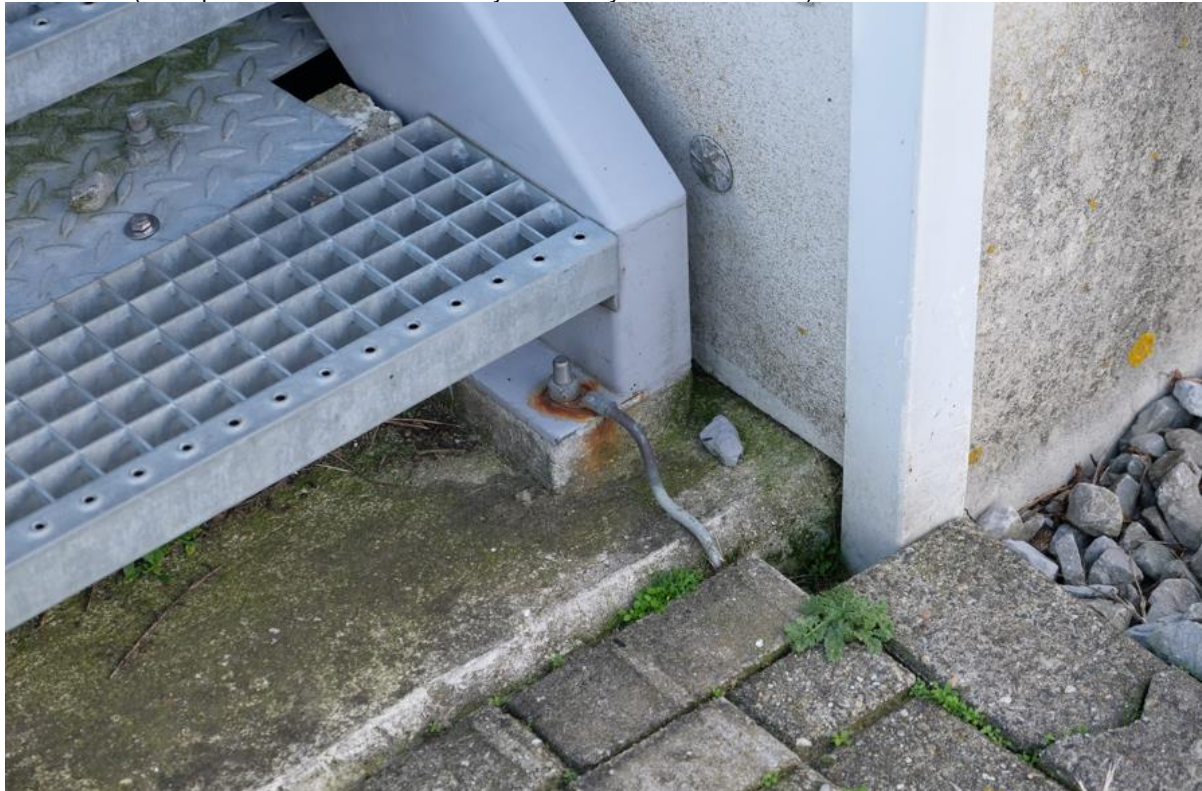
1. SMH045 (Example of corrosion – most likely caused by dissimilar metals).

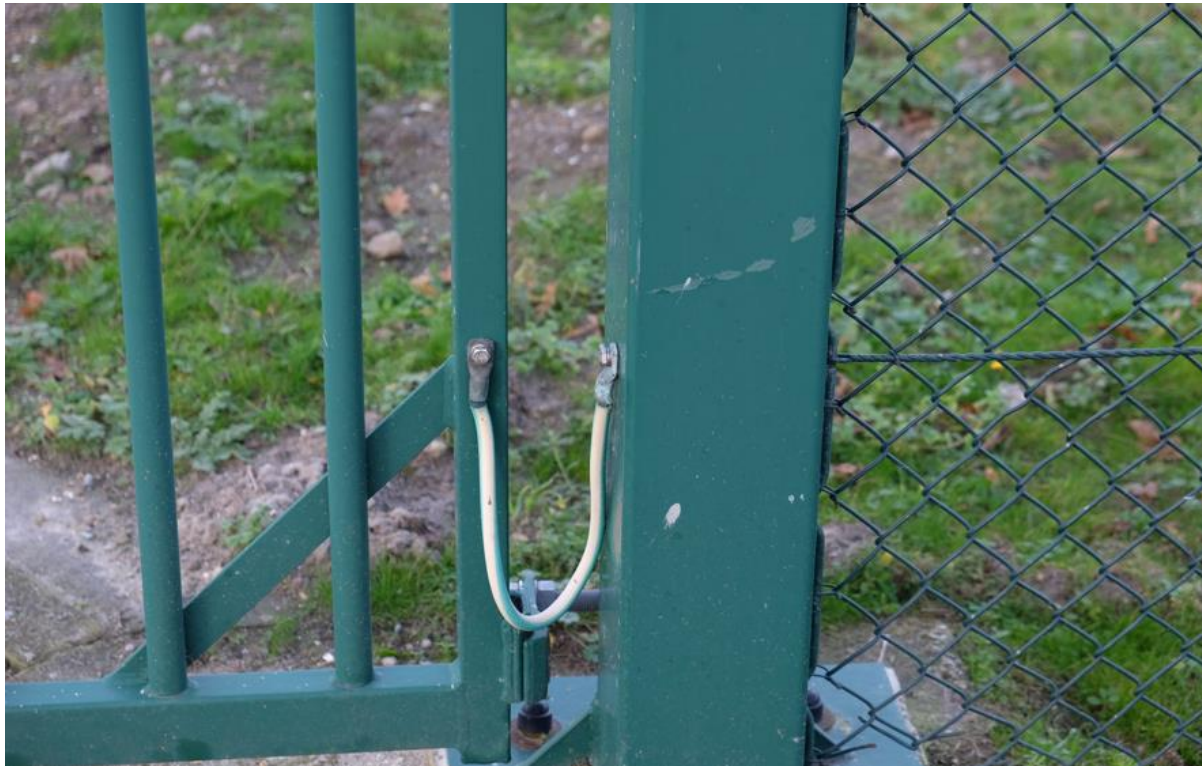
3. SMH056 (Poor electrical contact (lugs on paint and not metal)).

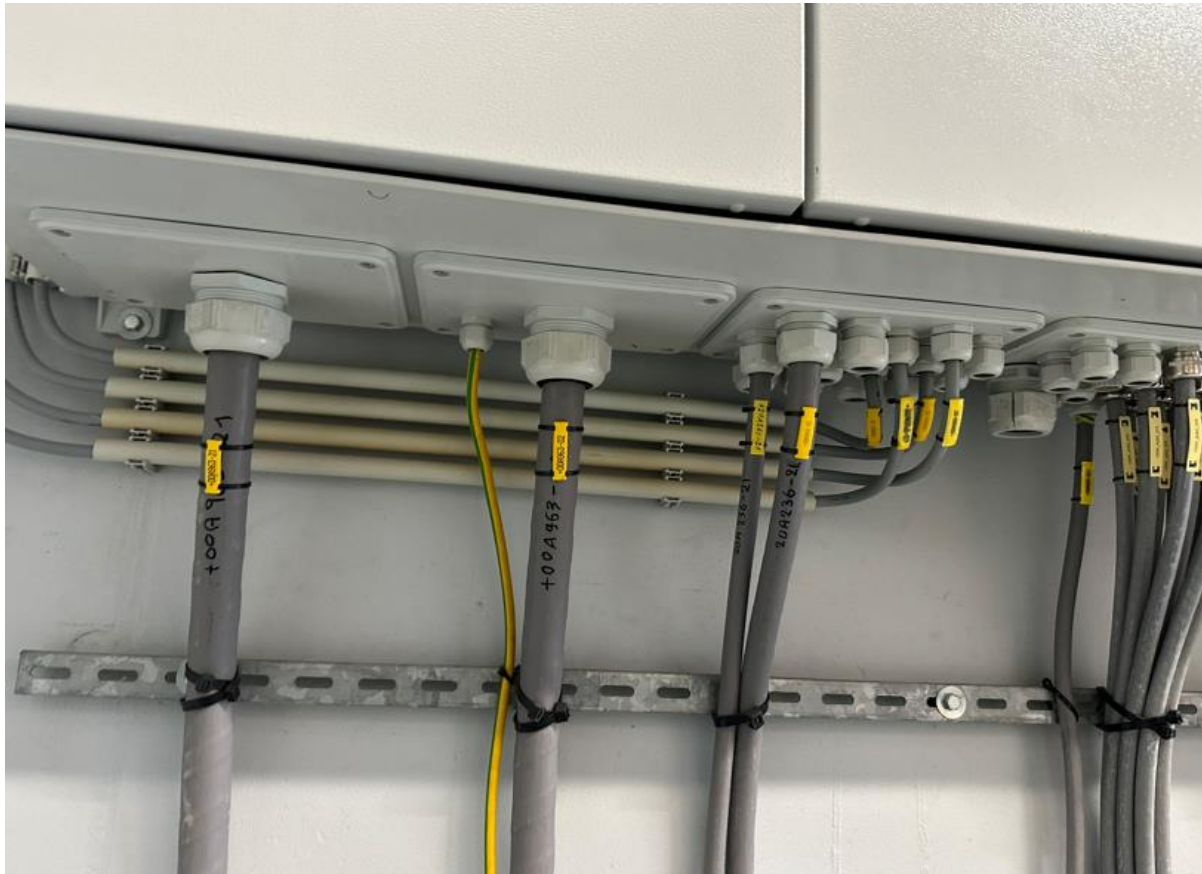
1. IMG\_6491 (Appears to be plastic connectors that are not EMC compliant).

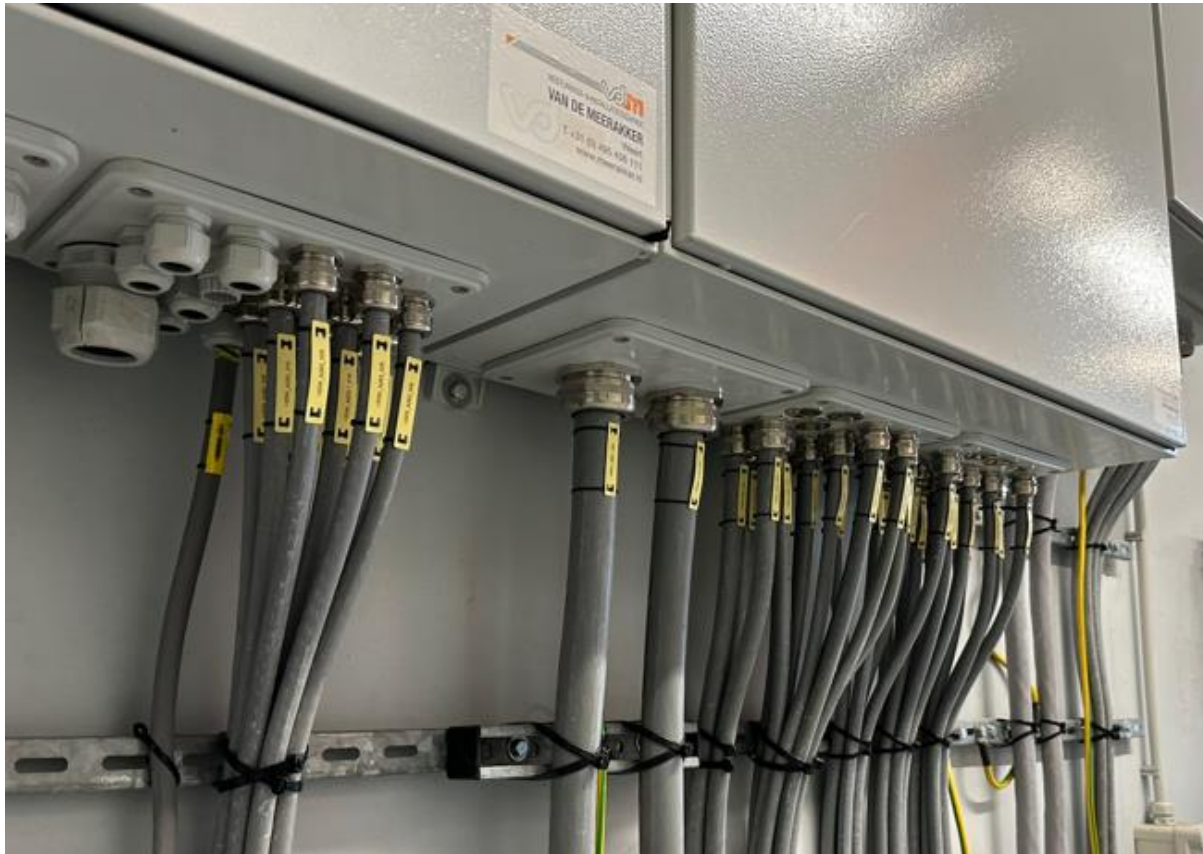
4. IMG\_6492 (Good example of use of EMC connectors – bonding of cable shields to enclosure to be confirmed by measurement).

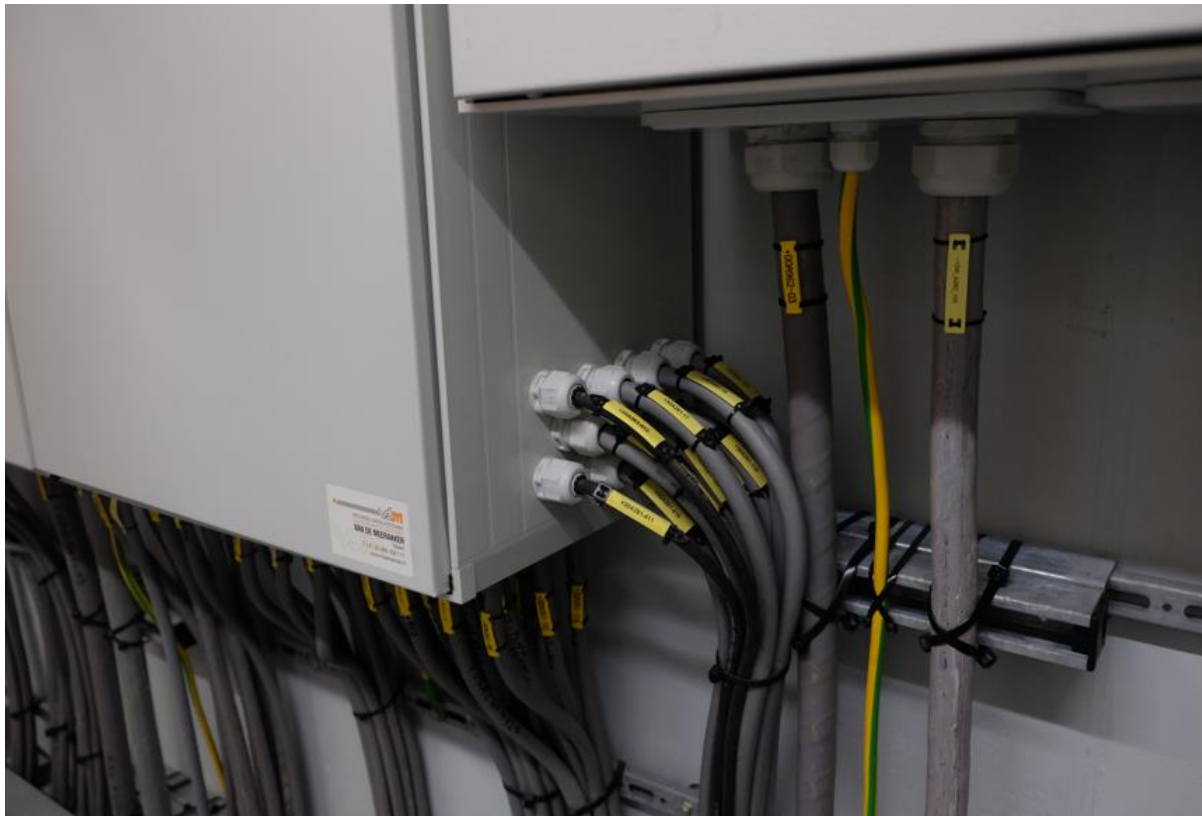
2. SMH042 (Appears to be plastic connectors that are not EMC compliant).

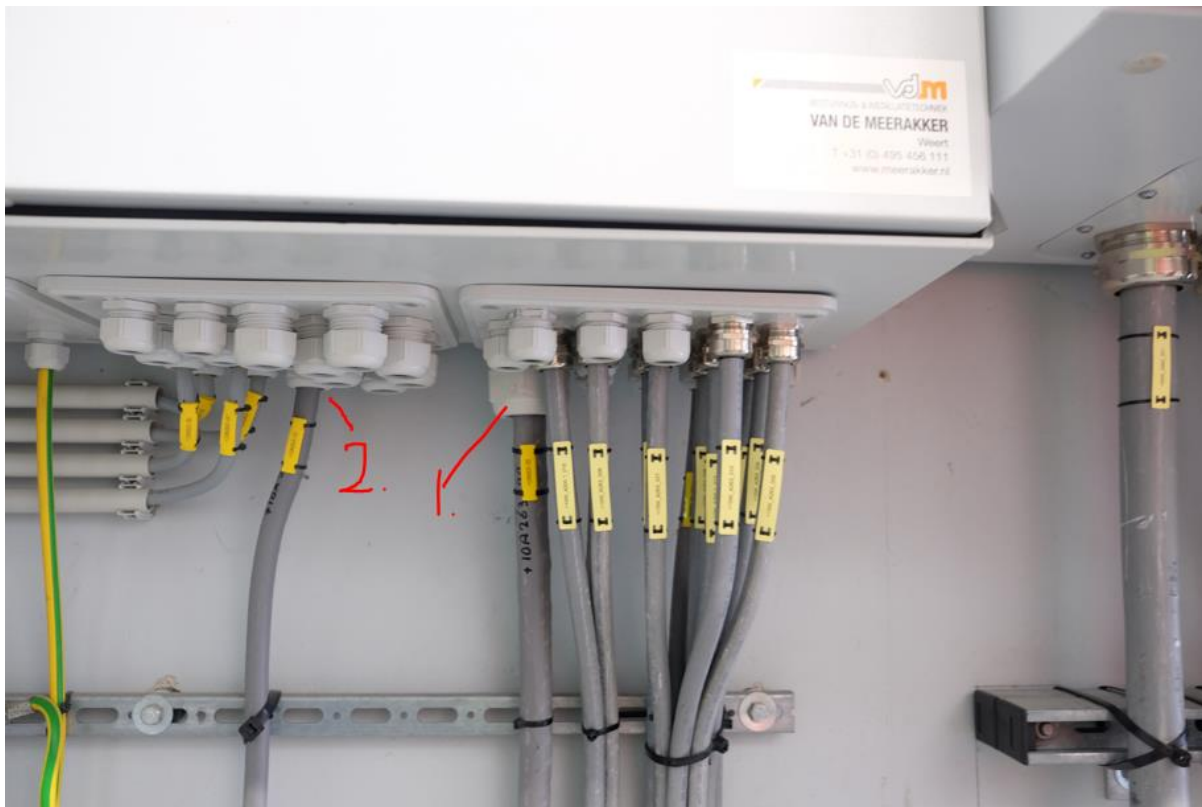
1. SMH064 ((1) and (2) appears to be plastic connectors that are not EMC compliant).
