## 1 RAPPORTAGE: NULINSPECTIE & EMC GAP-ANALYSE

**Project:** Simonshaven 380kV Uitbreiding (DP2-4)

**Client:** SC&M II V.O.F.

**DNV Reference:** OPP-00436810-PSP 25-1757

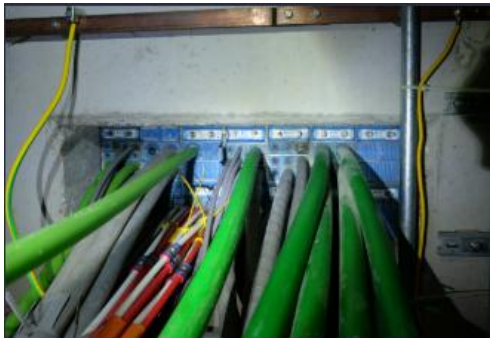
Photo reference SMH002

- **Inspection Scope:** Visual check of the Roxtec cable transit frames in the AC/DC and Telecom rooms. Verification of frame bonding to the main earth bar and correct termination of cable shields (360° bonding) within the modules, in accordance with *TenneT Detail 27*.
- **Observations:**
  - The physical condition of the Roxtec frames was found to be **Poor**.
  - The bonding connection between the transit frame and the room's ring earth (aardrail) was **Missing**.
  - Regarding cable shields: **It was not possible to verify shield termination visually**.
- **Photo Reference:** SMH001-SHM016

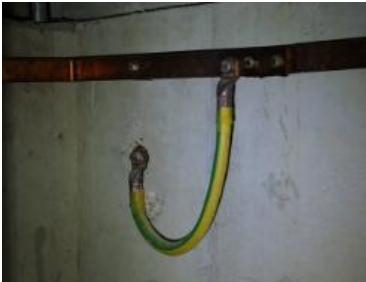
Photo reference **SMH019**

- **Inspection Scope:** Verification of the Faraday cage concept (LPZ 2). Inspection of bonding points between the wall reinforcement (wapening/EMC-net) and the earthing system, and bonding of metal door frames.
- **Observations:**
  - Visible connections to the building reinforcement or EMC mesh were **Observed at regular intervals**
  - Metal door frames **Are** bonded to the structure earth with short flexible straps (liitze).

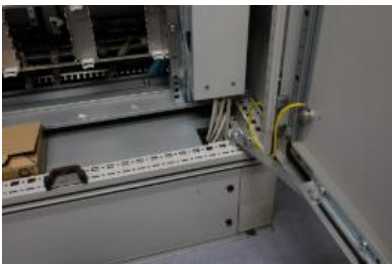
Photo reference SMH012

- **Inspection Scope:** Check of cabinet earthing and cable gland plates (wartelplaten) in the CDG server/telecom room.
- **Observations:**
  - Cabinets are earthed via Short flat copper litz wire and Long round yellow-green wire (Pigtail) – this is found to be inconsistent and not a good practice. For new modifications, conform to TenneT standards more strictly.
  - Cable entry into cabinets is via Conductive gland plates with EMC glands : It was not possible to visually confirm the consistent implementation of ~~conductive-EMC~~ glands. For new modifications, conform to TenneT standards ~~more strictly~~.
- **Photo Reference:** SMH011, SMH012

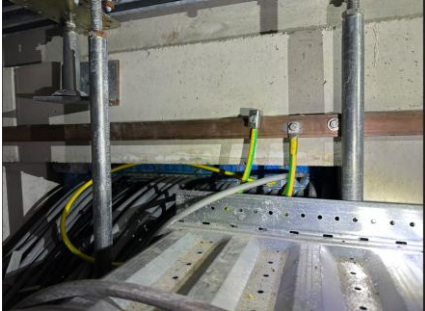
Photo reference IMG\_6485

- **Inspection Scope:** Covers were not lifted but presence of a Parallel Earthing Conductor (PEC) was visible and terminated inside the Takhuisjes.
- **Observations:**
  - **Location 1 (Near CDG):** A copper PEC ( $\geq 50\text{mm}^2$ ) **Was** visible terminating inside. No External PEC was identified.
  - **Location 2 (Near Tak 1):** A copper PEC **Was** visible inside all Tak-huisjes
- **Photo Reference:** IMG\_6485

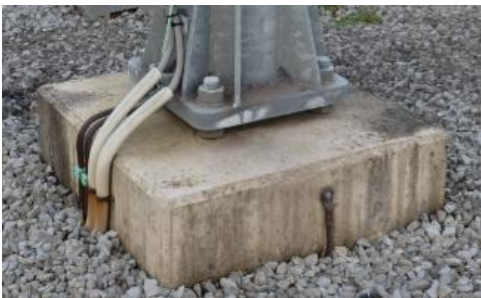
Photo reference SMH048

- **Inspection Scope:** Not all structures were inspected as this is an earthing and bonding scope of work and not EMC. However, Visual check of earthing connections of the lightning termination rod were captured (TenneT requirement: 2x connections for main structures).
- **Observations:**
  - The condition of the connections is **Good**
- **Photo Reference:** SMH048

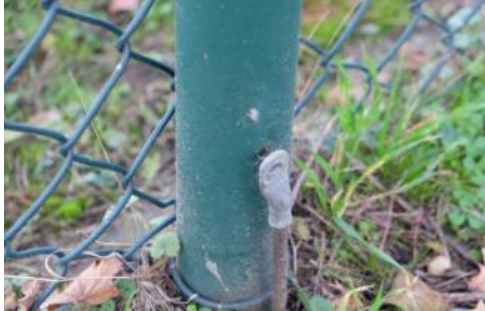
Photo reference SMH054

- **Inspection Scope:** Verification of earthing straps between fence panels and connection to the station earth grid to prevent touch voltage hazards.
- **Observations:**
  - Flexible earthing straps between fence panels are **Missing in some sections / Broken**.
  - Connection to the main earth grid was **Not visible in all locations**.
- **Photo Reference:** SMH052-SMH061
