## 1 RAPPORTAGE: NULINSPECTIE & EMC GAP-ANALYSE

**Project:** Simonshaven 380kV Uitbreiding (DP2-4)

**DNV Reference:** OPP-00436810-PSP 25-1757

**Date:** 15-1-2026

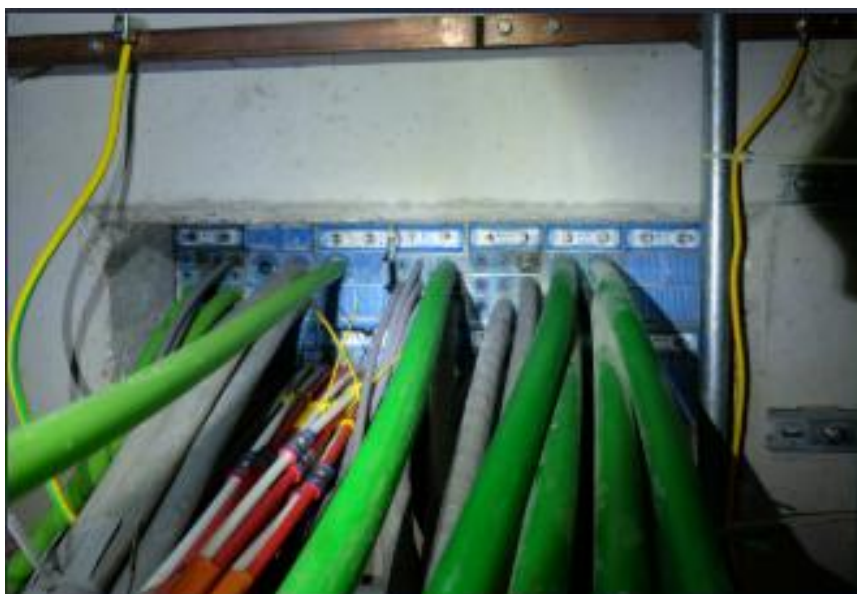
Photo reference SMH002

- **Inspection Scope:** Visual check of the Roxtec cable transit frames in the AC/DC and Telecom rooms. Verification of frame bonding to the main earth bar and correct termination of cable shields (360° bonding) within the modules, in accordance with *TenneT Detail 27*.
- **Observations:**
  - The physical condition of the Roxtec frames was found to be **Fair**
  - The bonding connection between the transit frame and the room's ring earth could not be visually observed (aardrail). It is possible that an electrical connection exists but can only be verified through measurement.
  - Regarding cable shields: It was not possible to verify shield termination visually. Recommendation that measurements should be performed to verify connection.
- **Photo Reference:** SMH001-SHM016

| Risk Item (from Sec 4.1) | Site Observation | Status |
|---|---|---|
| <b>2. Rextec Frame Bonding</b> | Visually confirmed Defect. Frames are oxidized and lack dedicated bonding straps (See Photo SMH002). | Confirmed Deviation visually. It should be confirmed through measurement. |

- Scope: Roxtec frames, Steel Door Frames, and Cabinet Gland Plates.
- Objective: Verify electrical continuity to the Main Earth Bar (MEB).
  - *Roxtec Frames*: Confirm if oxidation (Photo SMH002) has compromised the bond.
  - *Cabinets*: Confirm if the use of plastic connectors/glands has isolated the cable entry plates from the earthing system.

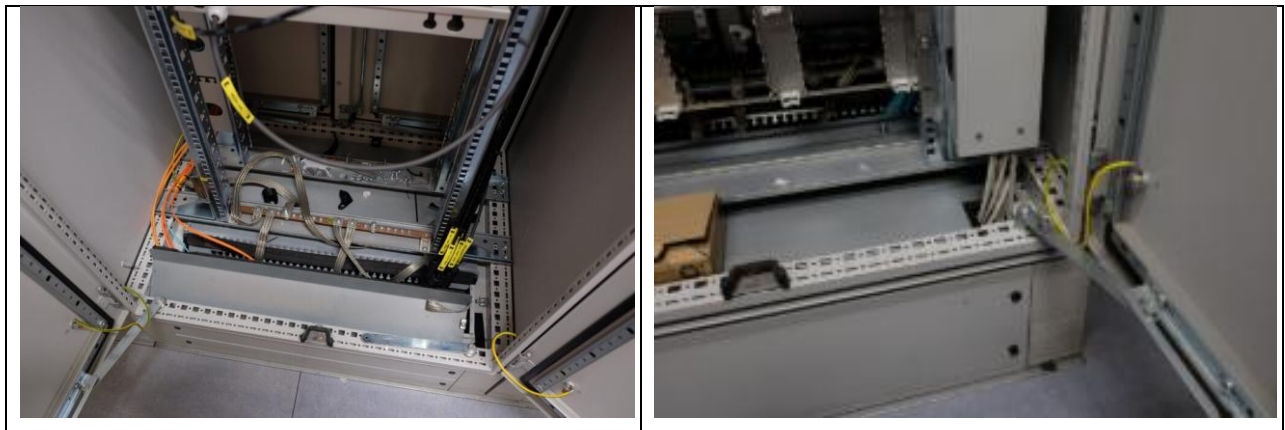
Photo reference SMH011, SMH012

- **Inspection Scope:** Check of cabinet earthing and cable gland plates (wartelplaten) in the CDG server/telecom room.
- **Observations:**
  - Cabinets are earthed via Short flat copper litze wire and long round yellow-green wire (Pigtail) – this is found to be inconsistent and not a good practice. For new modifications, conform to TenneT standards more strictly.
  - Cable entry into cabinets is via Conductive gland plates with EMC glands: It was not possible to visually confirm the consistent implementation of EMC glands. For new modifications, conform to TenneT standards.

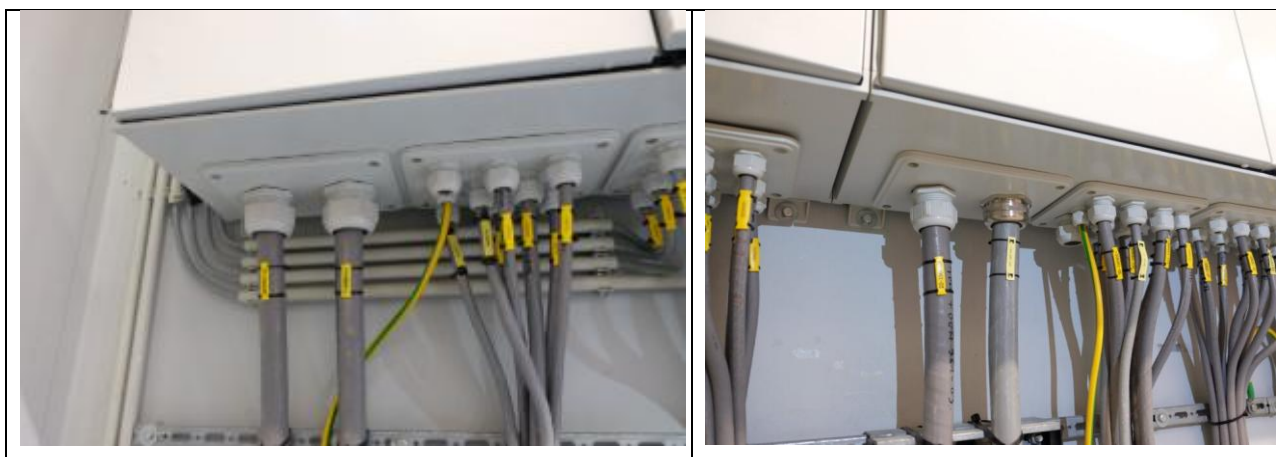
Photo reference SMH036, SMH038

- **Inspection Scope:** Check of protection relay cabinets and auxiliary power distribution boards.
- **Observations:**
  - Cable connections of the cabinets were found to be Inconsistent and included plastic connection lugs. For new modifications, conform to TenneT standards.

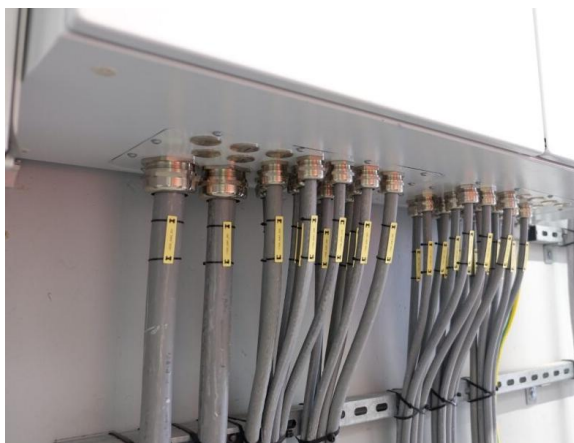
Photo reference SMH063 (Takhuisje 3)

In Takhuisje 3, a more consistent approach was followed as seen below in the metallic cable lugs:

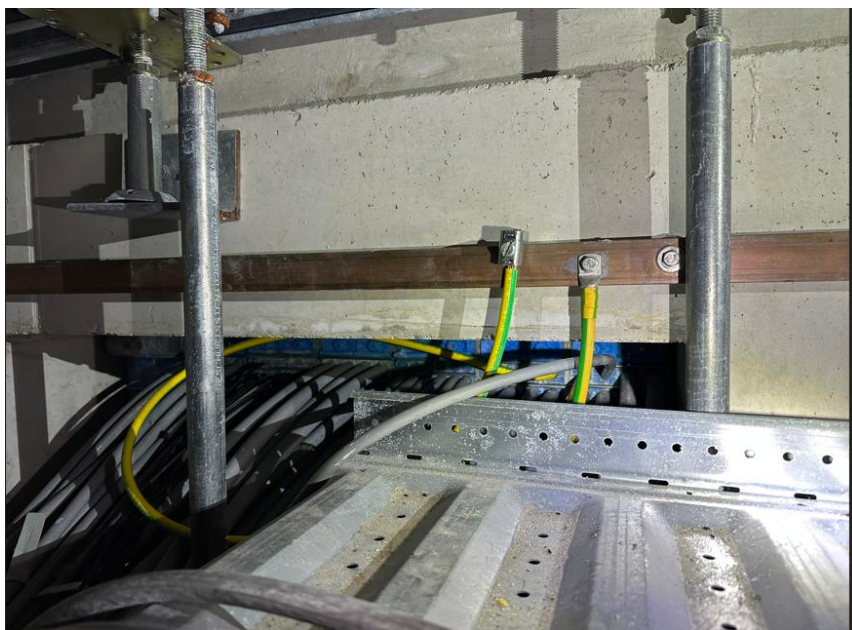
Photo reference IMG\_6485

- **Inspection Scope:** Covers were not lifted but presence of a Parallel Earthing Conductor (PEC) was visible and terminated inside the Takhuisjes.
- **Observations:**
  - **Location 1 (Near CDG):** A copper PEC ( $\geq 50\text{mm}^2$ ) was visible terminating inside. No External PEC was identified.
  - **Location 2 (Near Tak 1):** A copper PEC **Was** visible inside all Takhuisjes

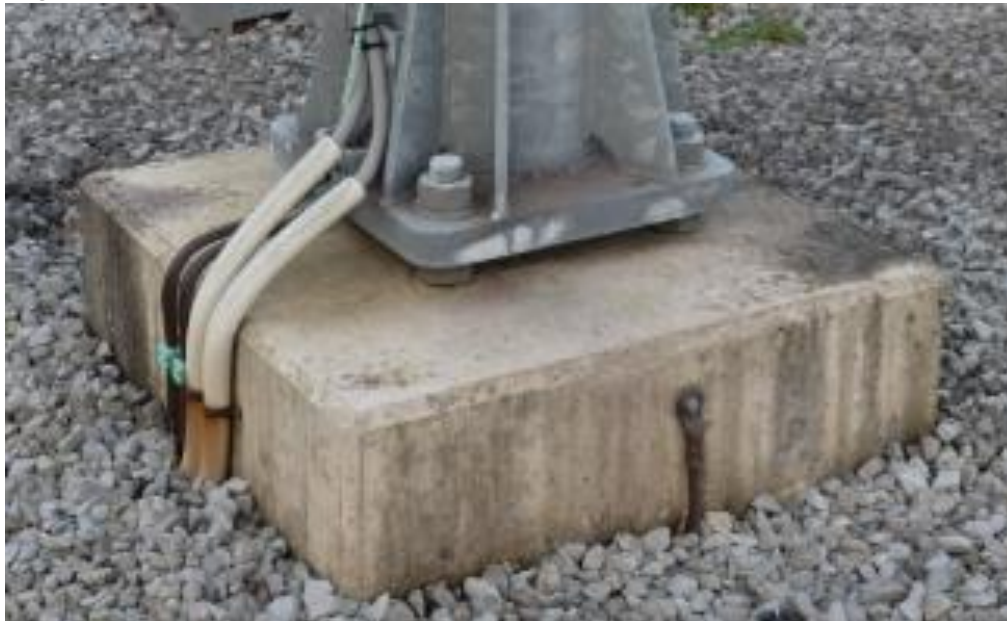
Photo reference SMH048

- **Inspection Scope:** Not all structures were inspected as this is an earthing and bonding scope of work and not EMC. However, Visual check of earthing connections of the lightning termination rod were captured (TenneT requirement: 2x connections for main structures).
- **Observations:**
  - Corrosion: Galvanic corrosion was observed at bonding points (See SMH045 in Section 7).
  - Poor Contact: Lugs were observed bolted directly to painted surfaces, creating high resistance (See SMH056 in Section 7).
  - Non-Compliant Connectors: Plastic connectors were observed on field equipment (See SMH051).

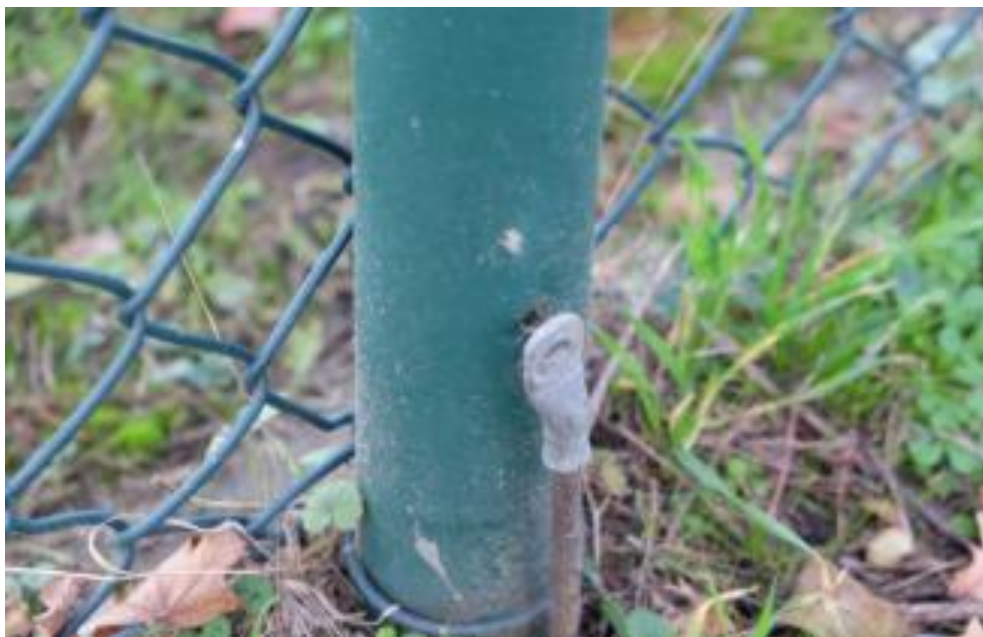
Photo reference SMH054

- **Inspection Scope:** Verification of earthing straps between fence panels and connection to the station earth grid to prevent touch voltage hazards.
- **Observations:**
  - Flexible earthing straps between fence panels are **Missing in some sections / Broken**.
  - Connection to the main earth grid was **Not visible in all locations**.
- **Photo Reference:** SMH052-SMH061

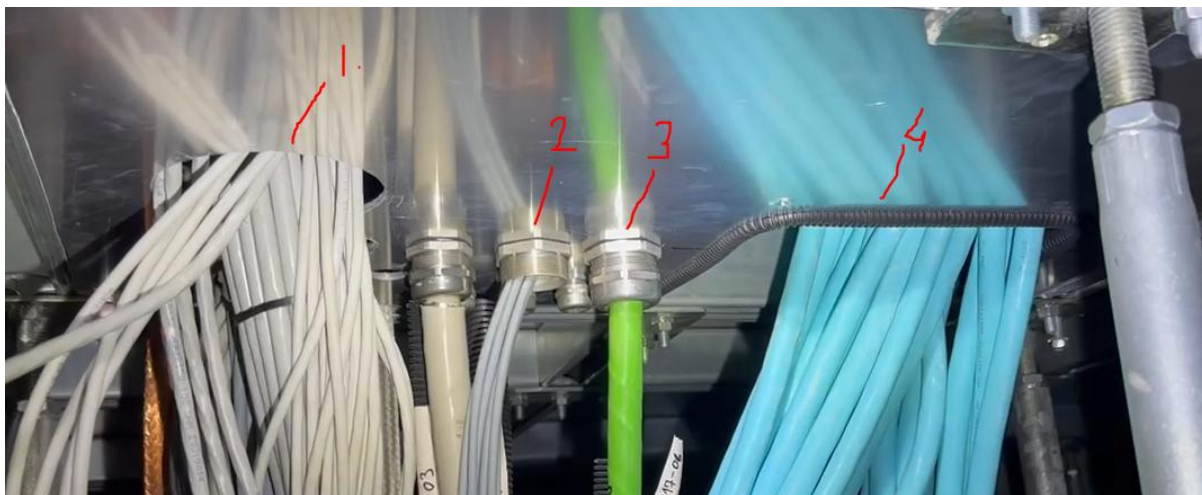
1. IMG\_6466 (1 to 4 – Possible cables with shields passing through base plate without shields being bonded to base plate or via EMC glands).

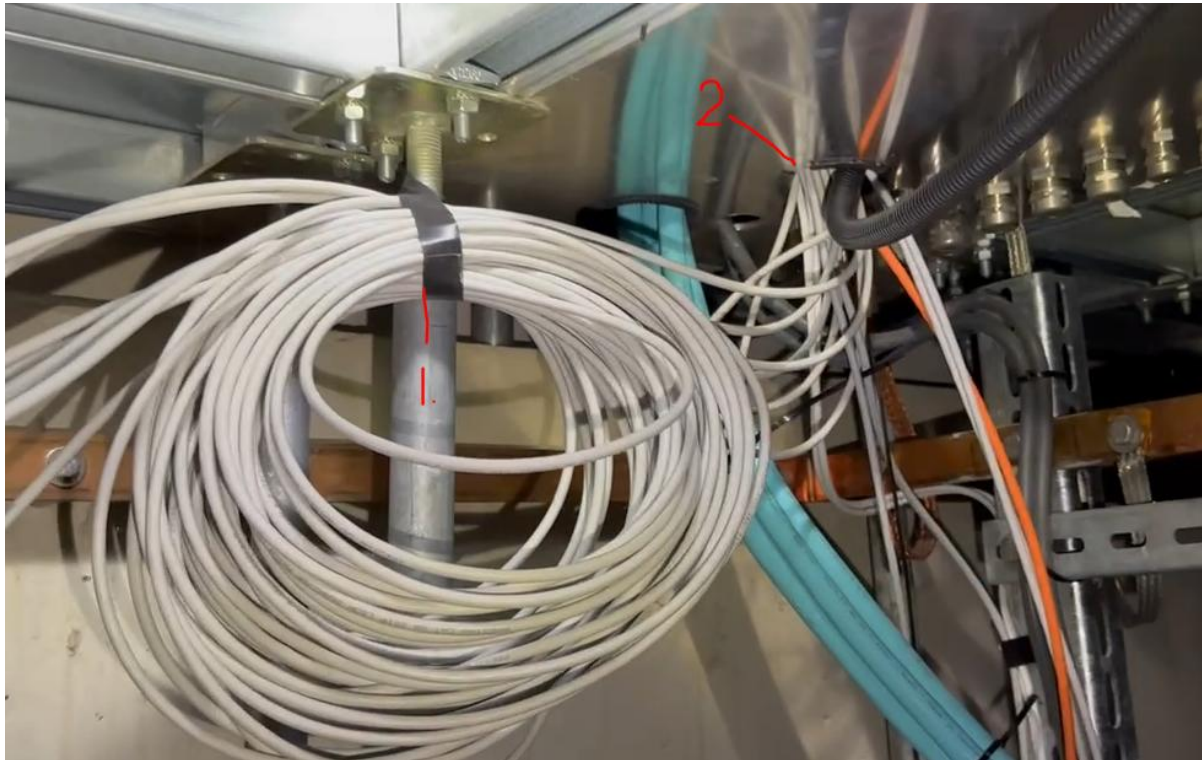
2. IMG\_6466 ((1) – Excess cable coiled – coiled cable with shield exposed to magnetic fields and passing through base plate without shield being bonded to plate or via EMC gland (2)).

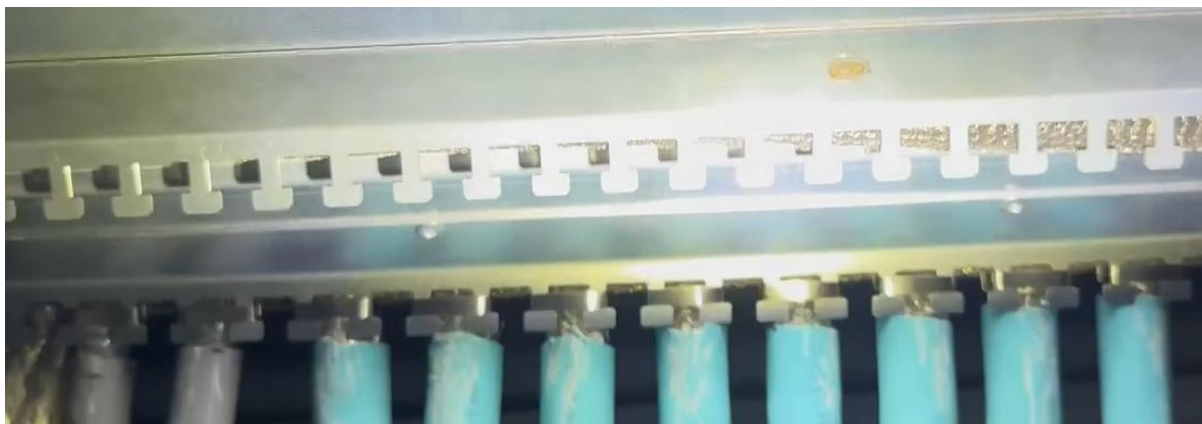
3. IMG\_6466 (Good example of cable shields being bonded to base plate).

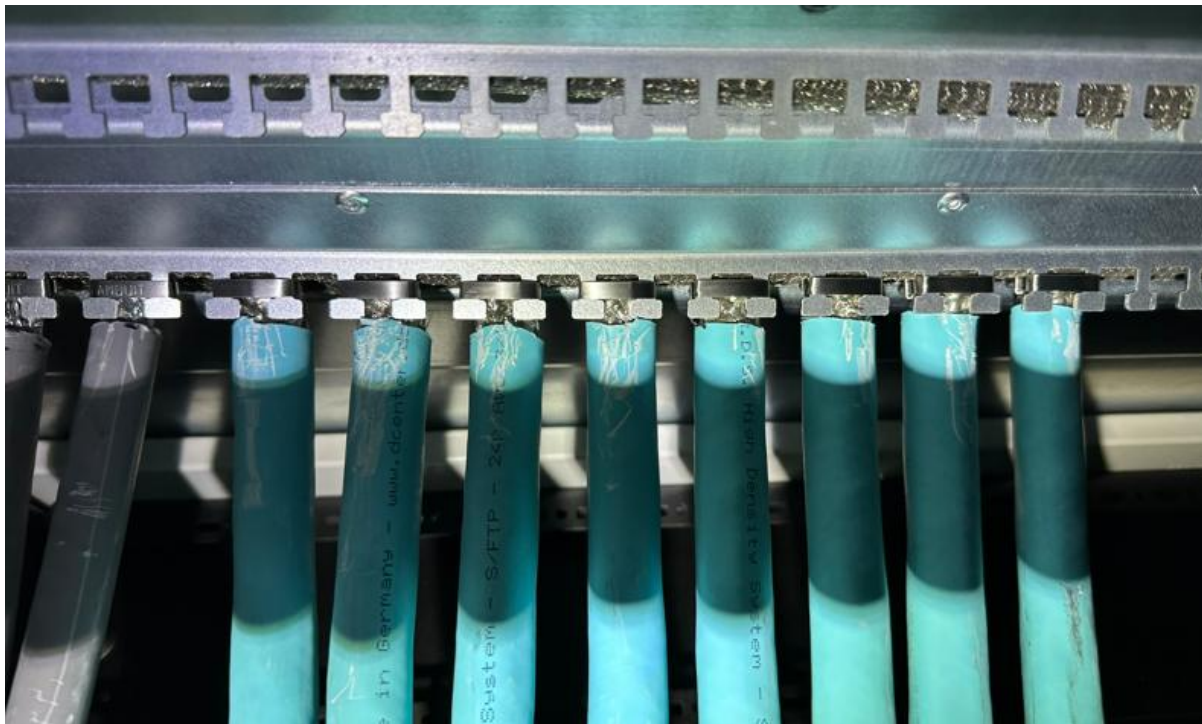
4. IMG\_6467 (Good example of cable shields being bonded to base plate).

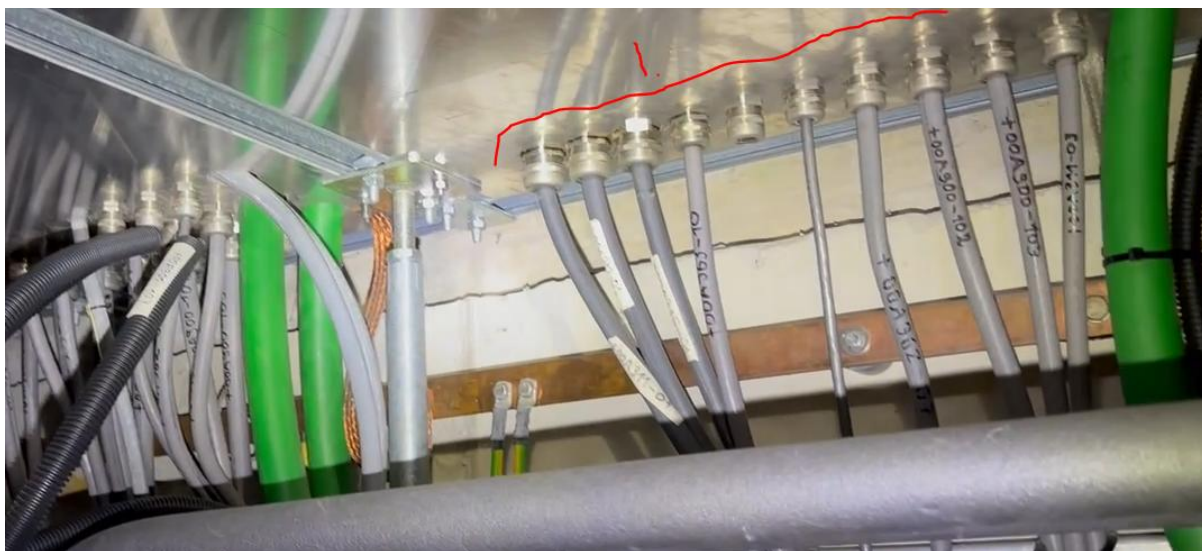
5. IMG\_6469 (1 – Possible cables with shields passing through base plate without shields being bonded to base plate via EMC glands).

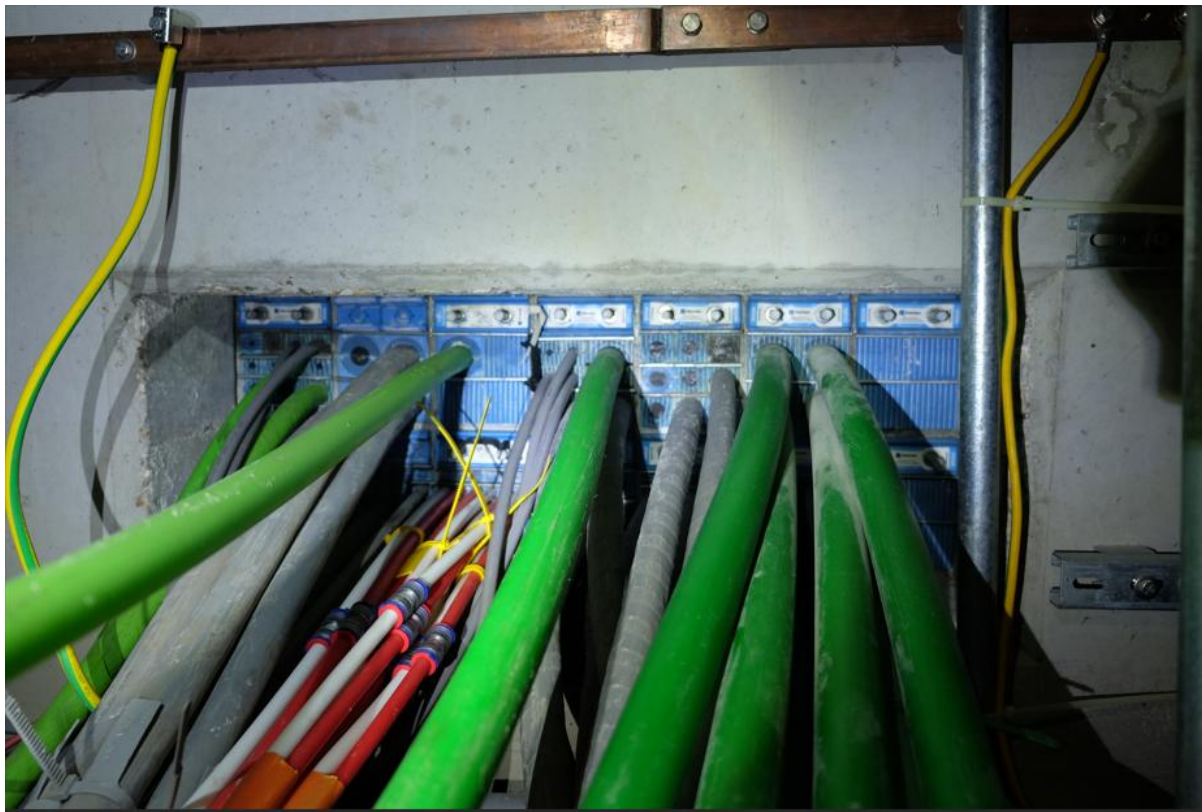
6. SMH002 (Is Roxtec metal frame bonded to earth – as discussed).

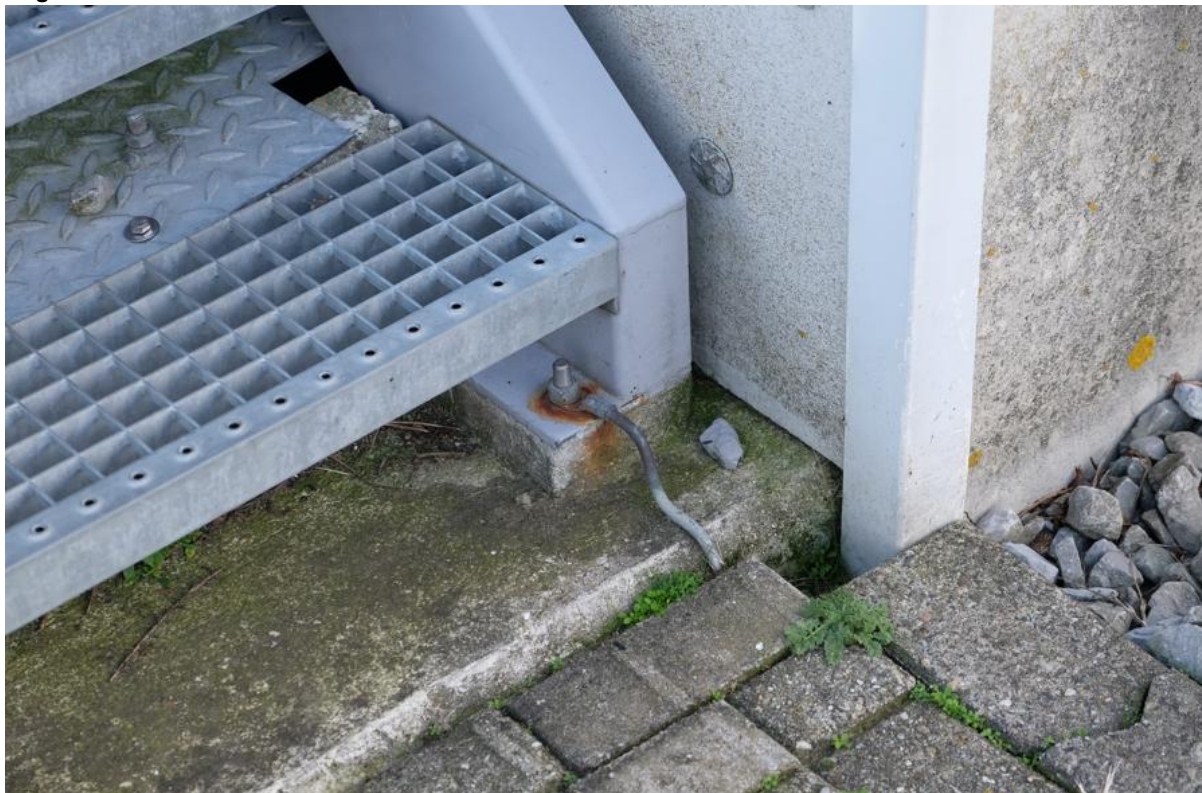
1. SMH045 (Example of corrosion – most likely caused by dissimilar metals).

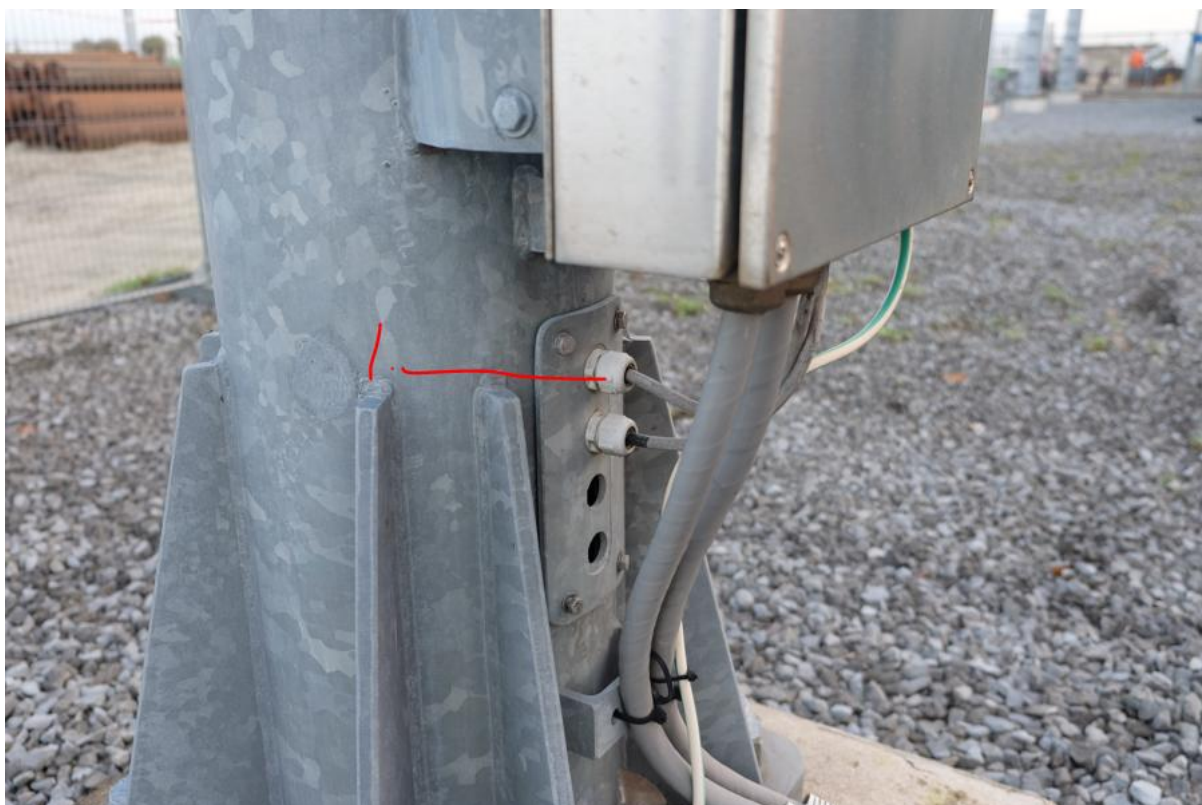
2. SMH051 (Appears to be plastic connectors that are not EMC compliant).

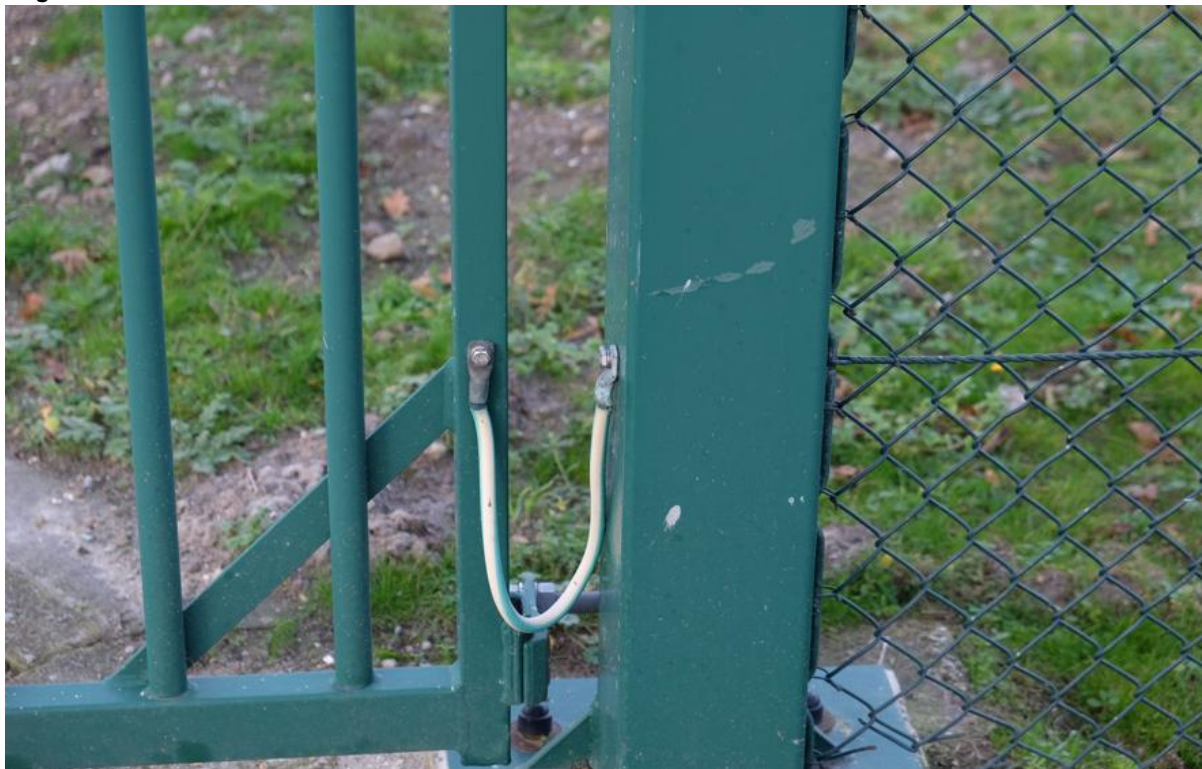
3. SMH056 (Poor electrical contact (lugs on paint and not metal)).

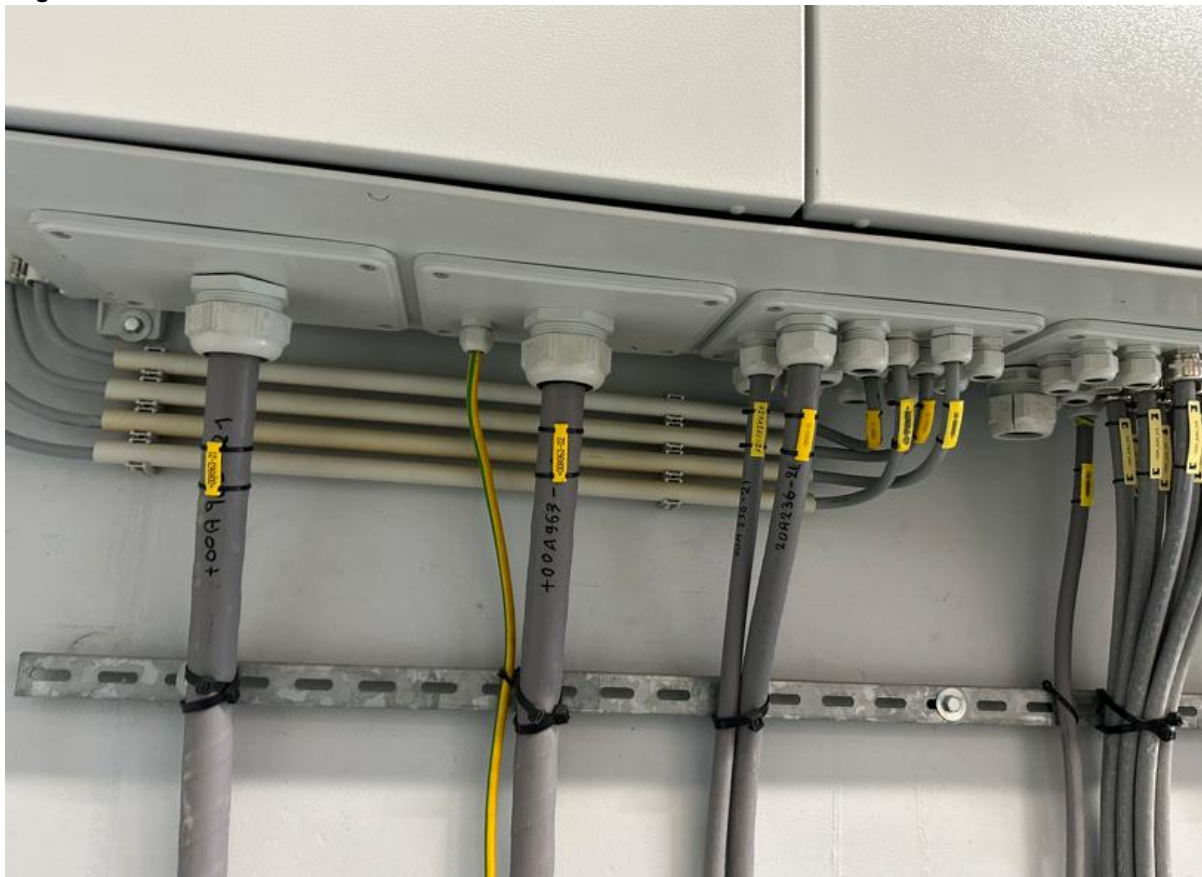
1. IMG\_6491 (Appears to be plastic connectors that are not EMC compliant).

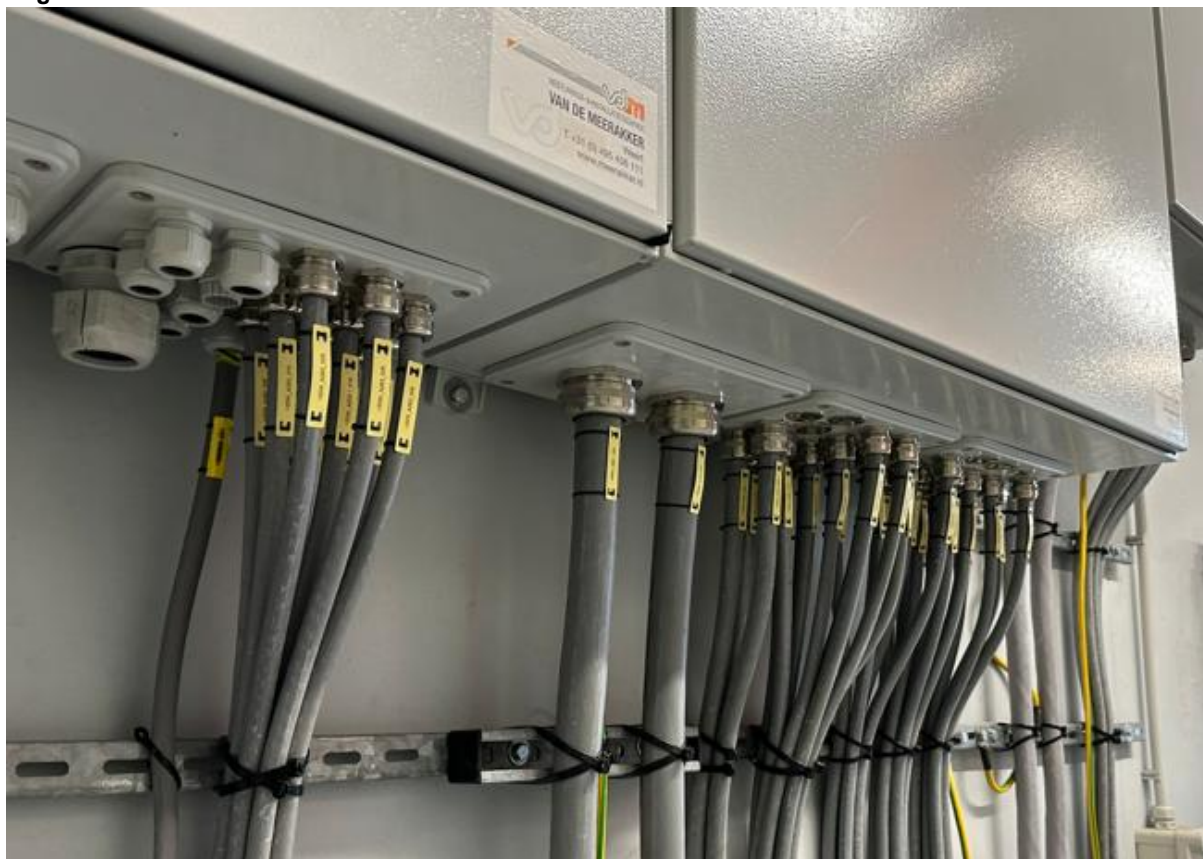
4. IMG\_6492 (Good example of use of EMC connectors – bonding of cable shields to enclosure to be confirmed by measurement).

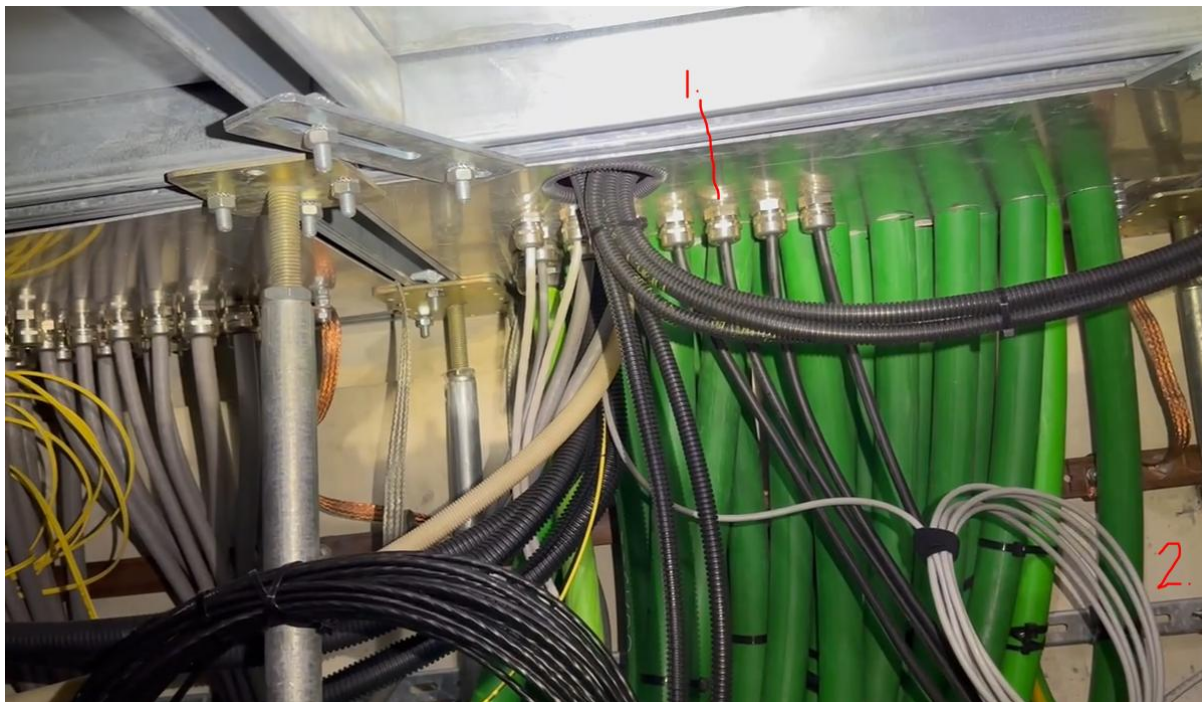
1. IMG\_6470 ((1) – Possible cables with shields passing through base plate without shields being bonded to base plate or via EMC glands). (2) – Excess cable coiled – coiled cable with shield exposed to magnetic fields and passing through base plate without shield being bonded to plate or via EMC gland).

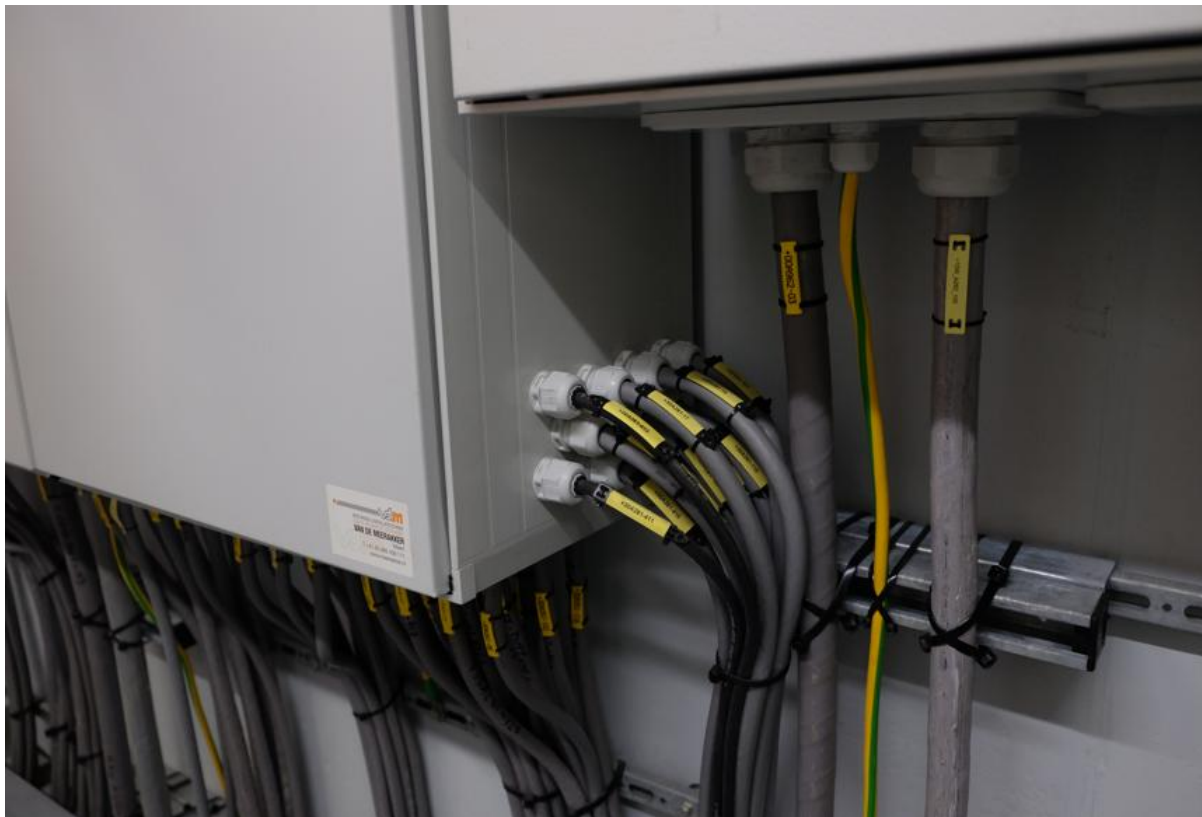
2. SMH042 (Appears to be plastic connectors that are not EMC compliant).

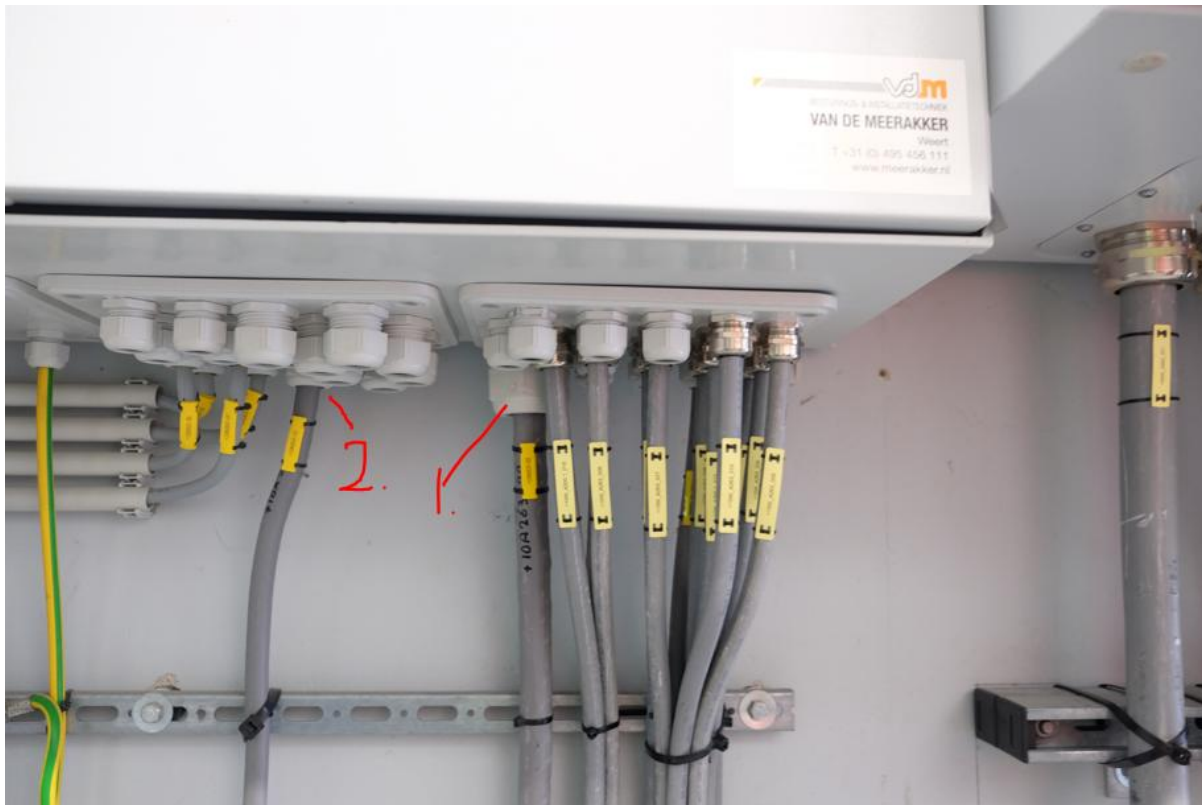
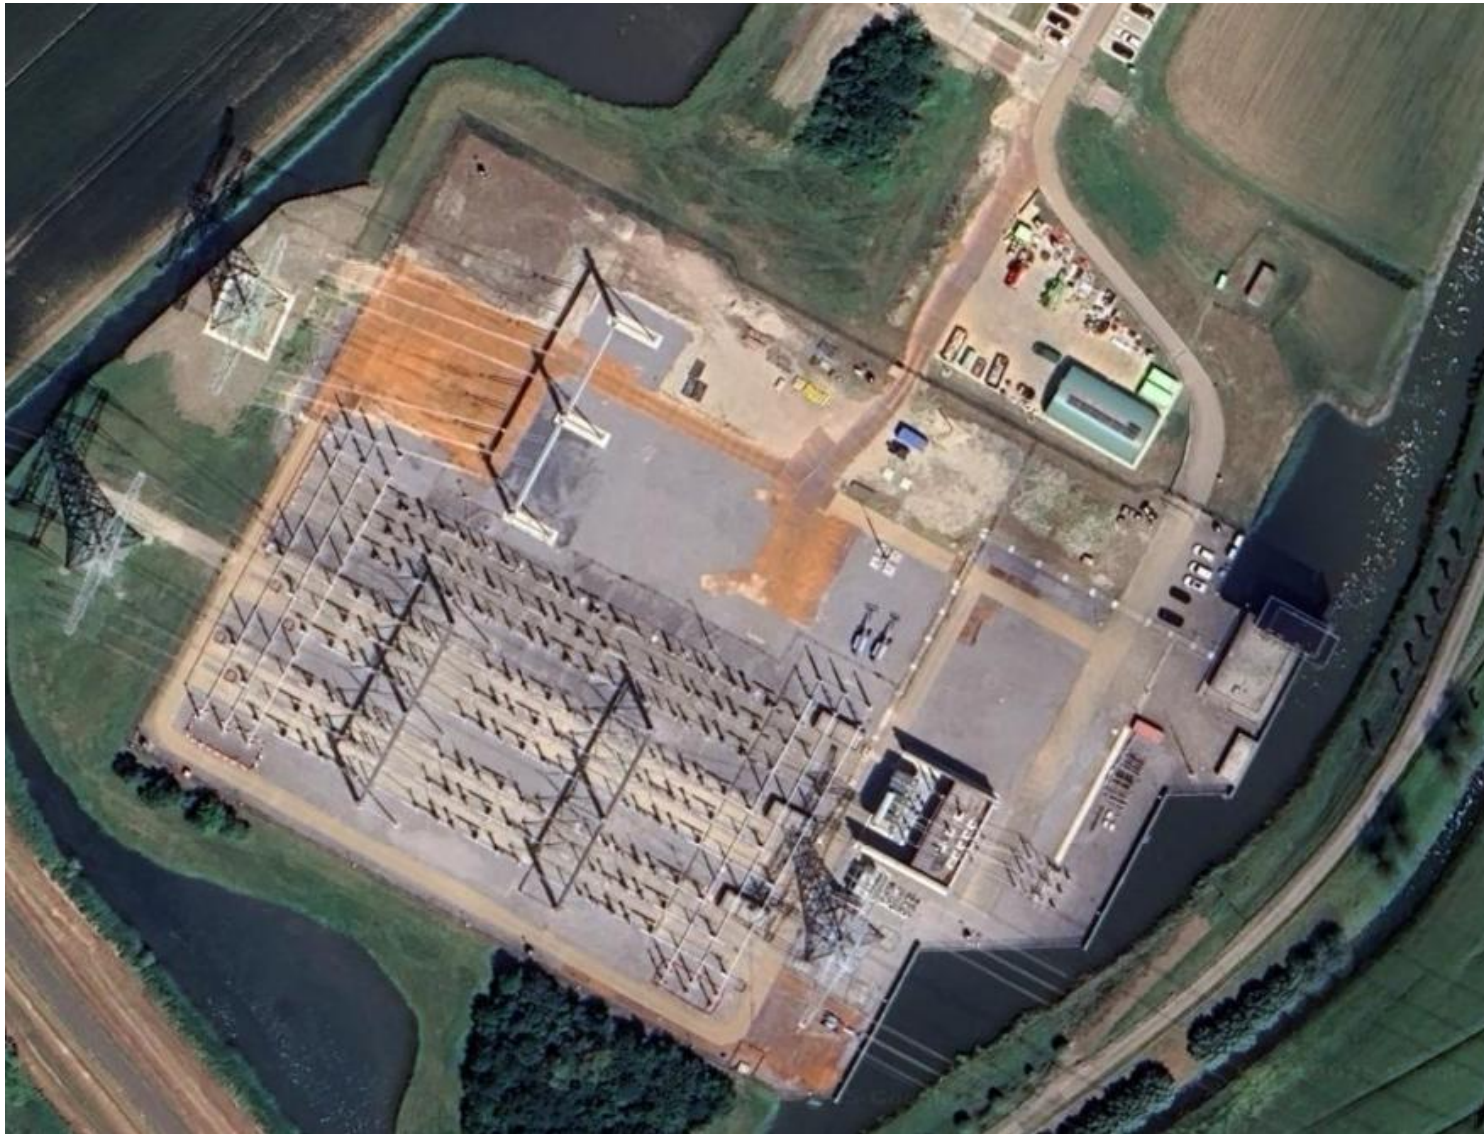
1. SMH064 ((1) and (2) appears to be plastic connectors that are not EMC compliant).

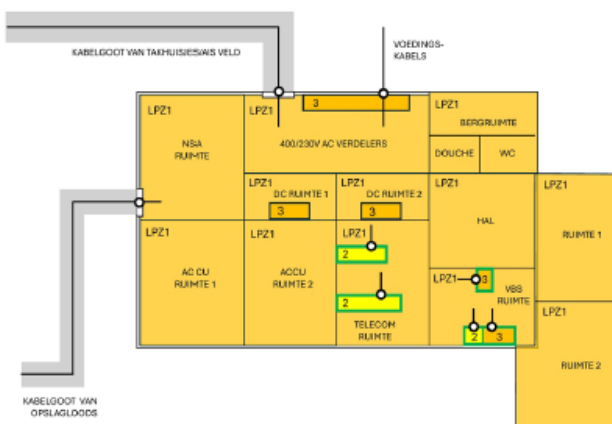
EM zonering CDG conform zoals uitgevoerd

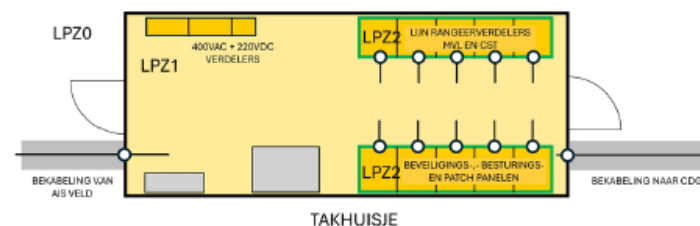
EM zonering takhuisje conform zoals uitgevoerd
