## APPENDIX A: SITE INSPECTION CHECKLIST (NULINSPECTIE)

**Project:** Simonshaven DP2-4 (Nulinspectie)

**Date** 10 December 2025

**Inspector:** DNV – PJ Schutte

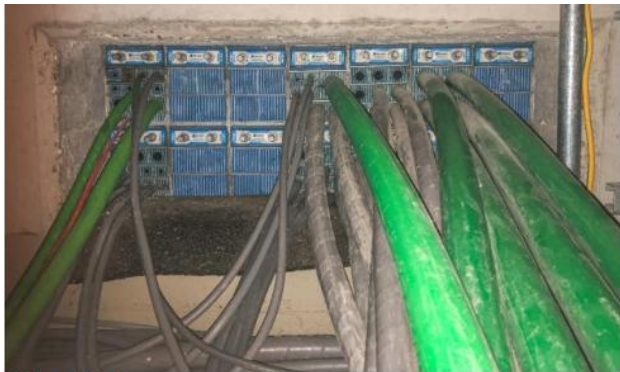
| A1 – AC ruimte | A2 Telecomruimte |

**Text:** *"Het EMC invoerraam in de AC ruimte lijkt niet consistent te zijn toegepast. Er zijn geen aardverbindingen vanaf het frame... zichtbaar."* (The EMC frame in the AC room... no earth connections visible from the frame).

| ID | Item | What to Look For (The Defect) | Reference Photo (Paste from PDF 1) | Status (OK/NOK) |
|---|---|---|---|---|
| A1 | Roxtec Frames (AC Room) | <b>Defect:</b> "Inconsistent application." No visible earth wire from the metal frame to the earth bar. <b>Check:</b> Is the frame bonded? | <b>Paste Photo PH2-7231</b> (Page 33)Shows blue blocks, check frame edge for earth wire. | |

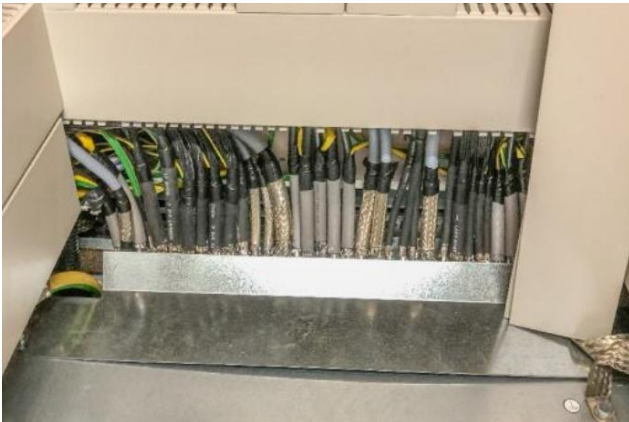
| A3 – Telecomruimte | A4 – VBS ruimte |

**Text:** *"...is de kast geaard d.m.v. VD50mm2 via de kastinvoer/brievenbus (PH32-7272)."* (Cabinet earthed via round wire [VD50mm2]...).

| ID | Item | What to Look For (The Defect) | Reference Photo (Paste from PDF 1) | Status (OK/NOK) |
|---|---|---|---|---|
| A3 | Cabinet Earthing (VBS/Telecom) | <b>Defect:</b> Use of long, round green/yellow wires ("Pigtails") instead of short, flat braids (Litze). <b>Check:</b> Has this been retrofitted to flat braid? | <b>Paste Photo PH32-7272</b> (Page 40)Shows long green/yellow wire on right side. | |

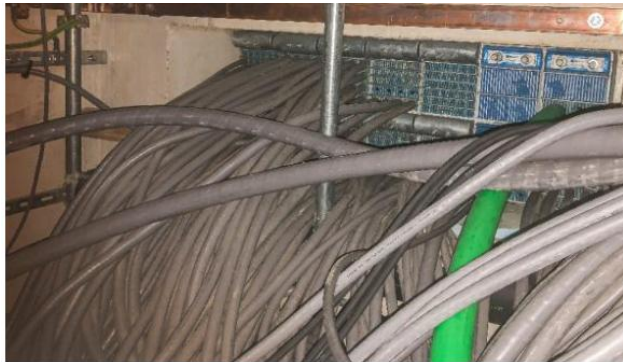
| <p>B3 takhuisje 3</p> | |

**Text:** *"Aan de veldzijde is bij takhuisje 3 geen PEC gevonden."* (At field side bay house 3, no PEC found).

| <b>B3</b> | <b>Floor Entry Takhuisje 3(PEC)</b> | <b>Defect:</b> PEC (Parallel Earth Conductor) status is not found. <b>Check:</b> Look at the floor entry. Do you see a thick copper wire (PEC) coming from the outside trench and connecting to the earth bar?<br>Check cable trenches | <b>Paste Photo PH45-7291</b> (Page 42)Shows the floor entry point. | |

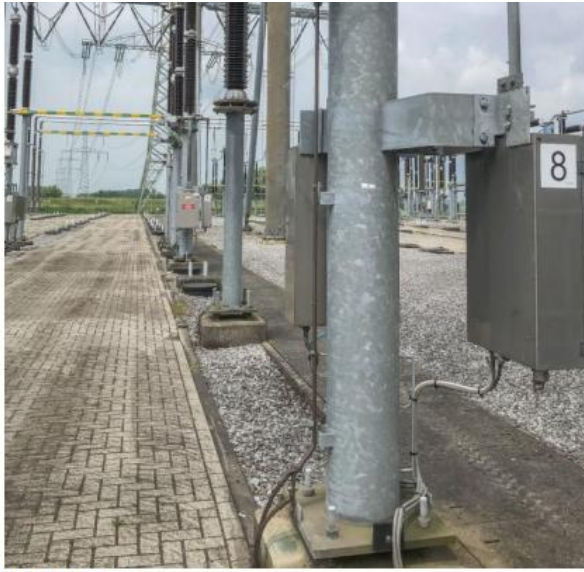
PH49-7300

| ID | Item | What to Look For (The Defect) | Reference Photo (Paste from PDF 1) | Status (OK/NOK) |
|---|---|---|---|---|
| <b>C2</b> | <b>Portal Earthing</b> | <b>Check:</b> Verify steel portals have 2x diagonal earth connections. | <b>Paste Photo PH49-7300</b> (Page 43)Shows portal leg earthing. | |

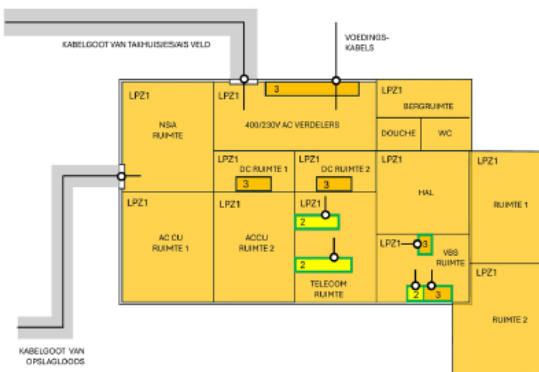
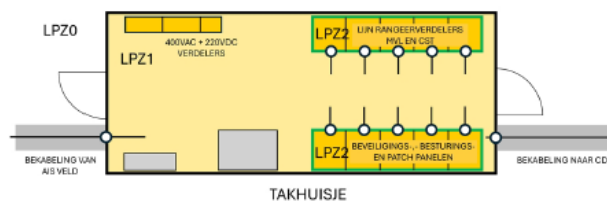
Figuur A.2 EM en LPZ zone indeling CDG en takhuisjes

EM zonering CDG conform zoals uitgevoerd

EM zonering takhuisje conform zoals uitgevoerd
