**PROJECT:** EU303 SIMONSHAVEN 380 kV SUBSTATION (SMH380) EXPANSION (DP2-4)

**ITEM:** Task 2 – Comments on Photos from Nulinspectie

**Prepared by:** Pieter H Pretorius

**Date:** 22 Jan 2026

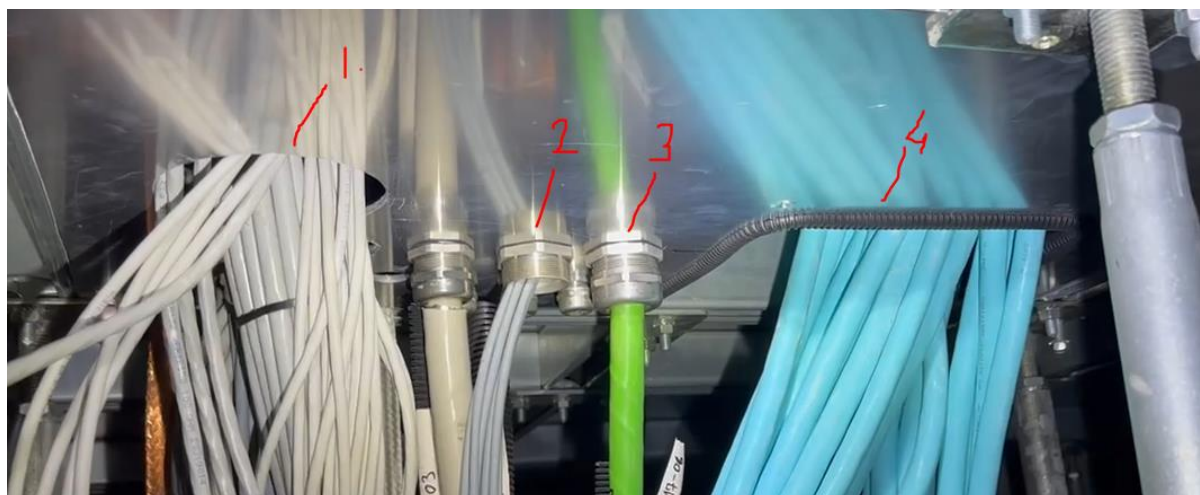
1. IMG\_6466 (1 to 4 – Possible cables with shields passing through base plate without shields being bonded to base plate or via EMC glands).

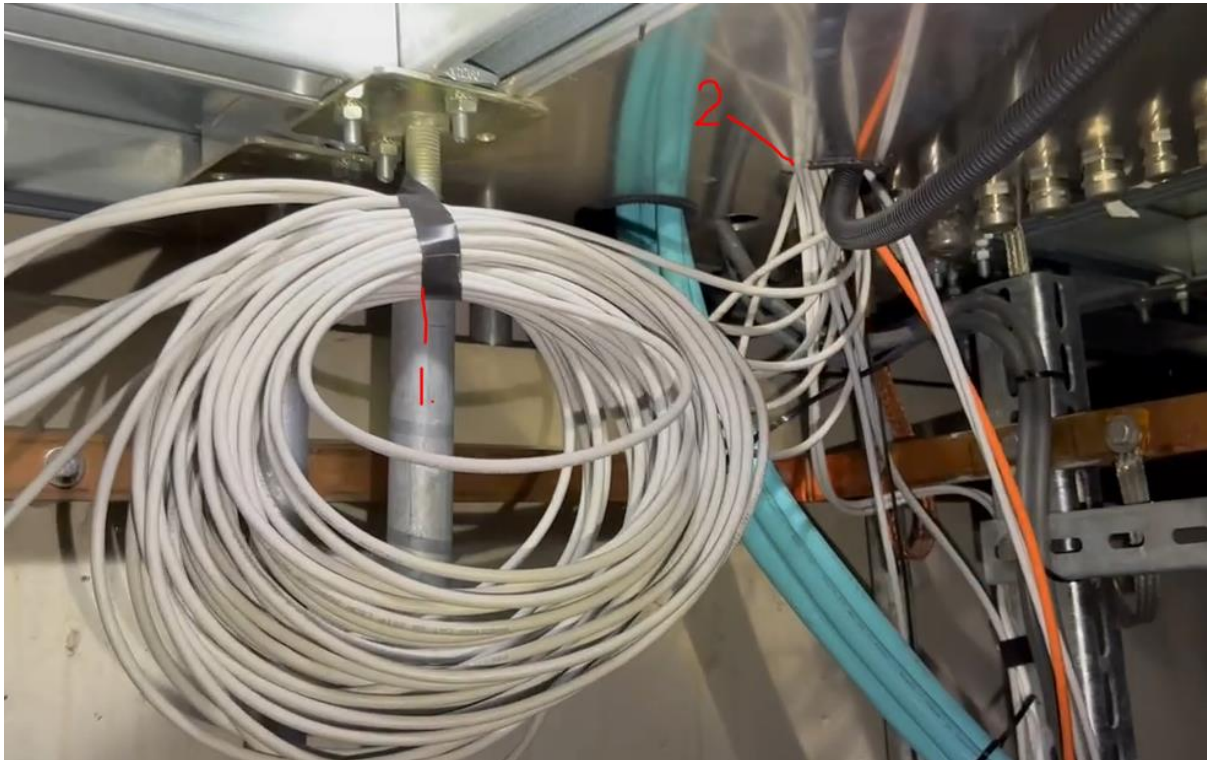
2. IMG\_6466 ((1) – Excess cable coiled – coiled cable with shield exposed to magnetic fields and passing through base plate without shield being bonded to plate or via EMC gland (2)).

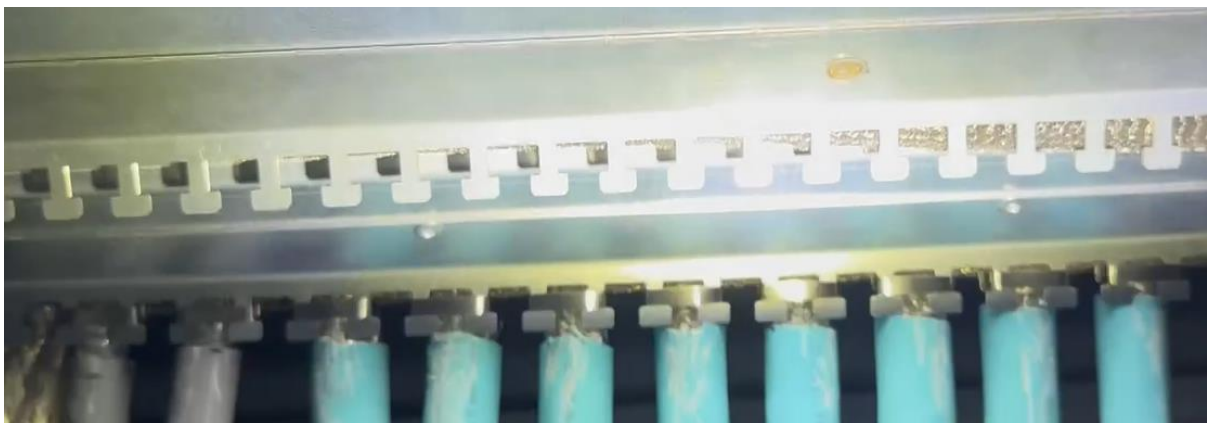
3. IMG\_6466 (Good example of cable shields being bonded to base plate).

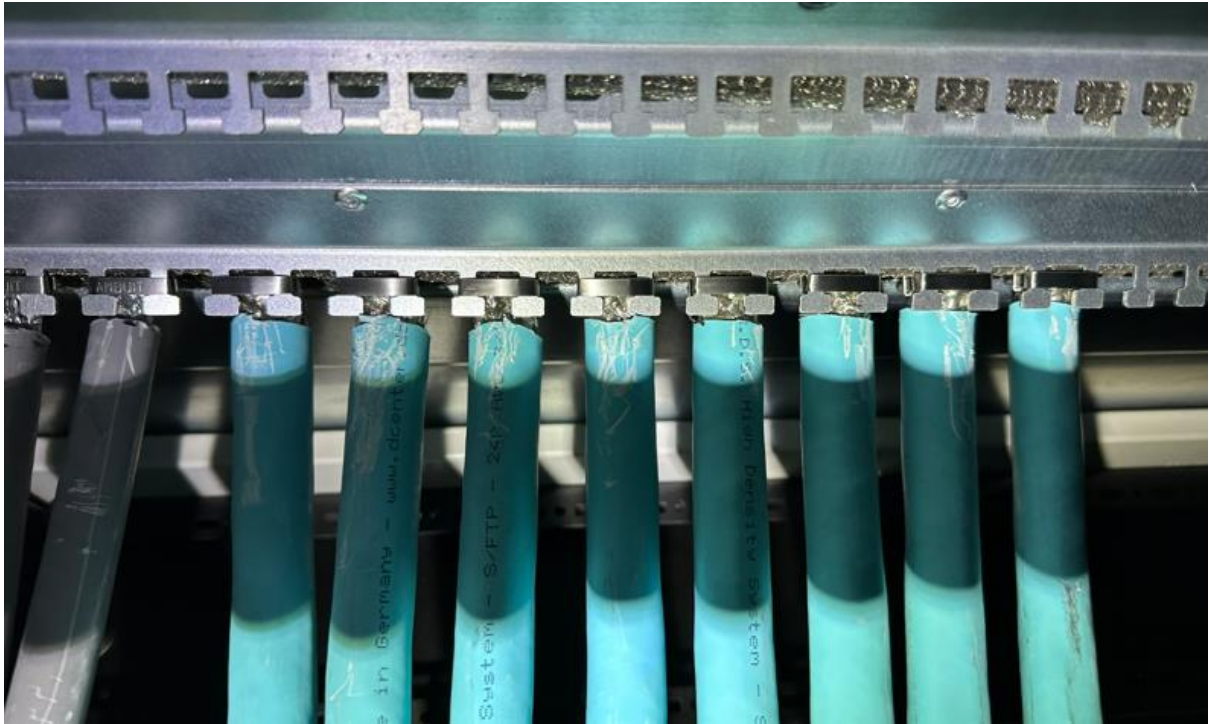
4. IMG\_6467 (Good example of cable shields being bonded to base plate).

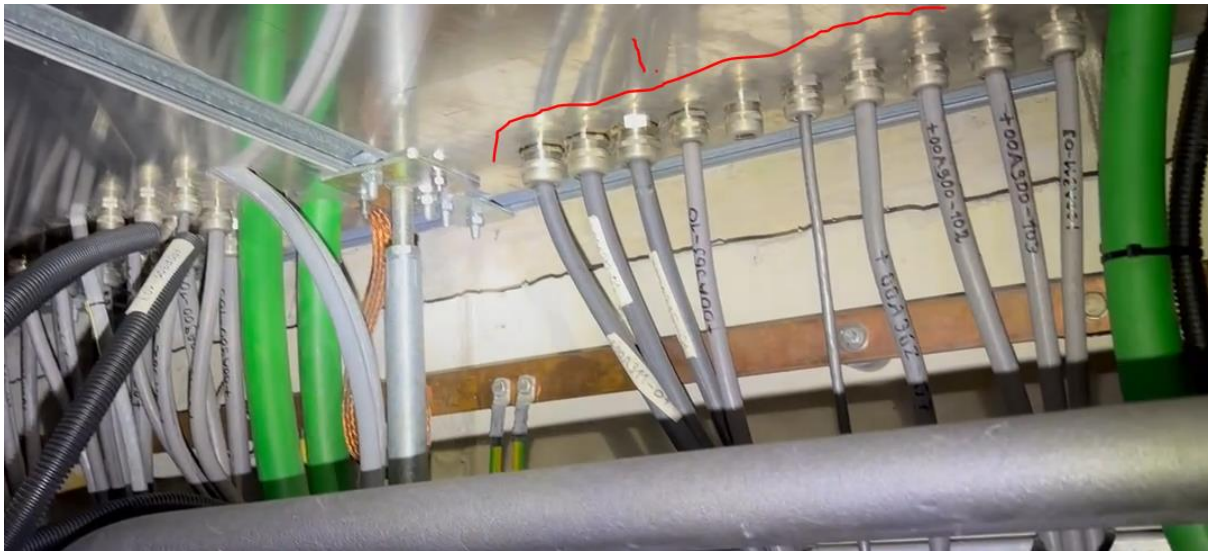
5. IMG\_6469 (1 – Possible cables with shields passing through base plate without shields being bonded to base plate via EMC glands).

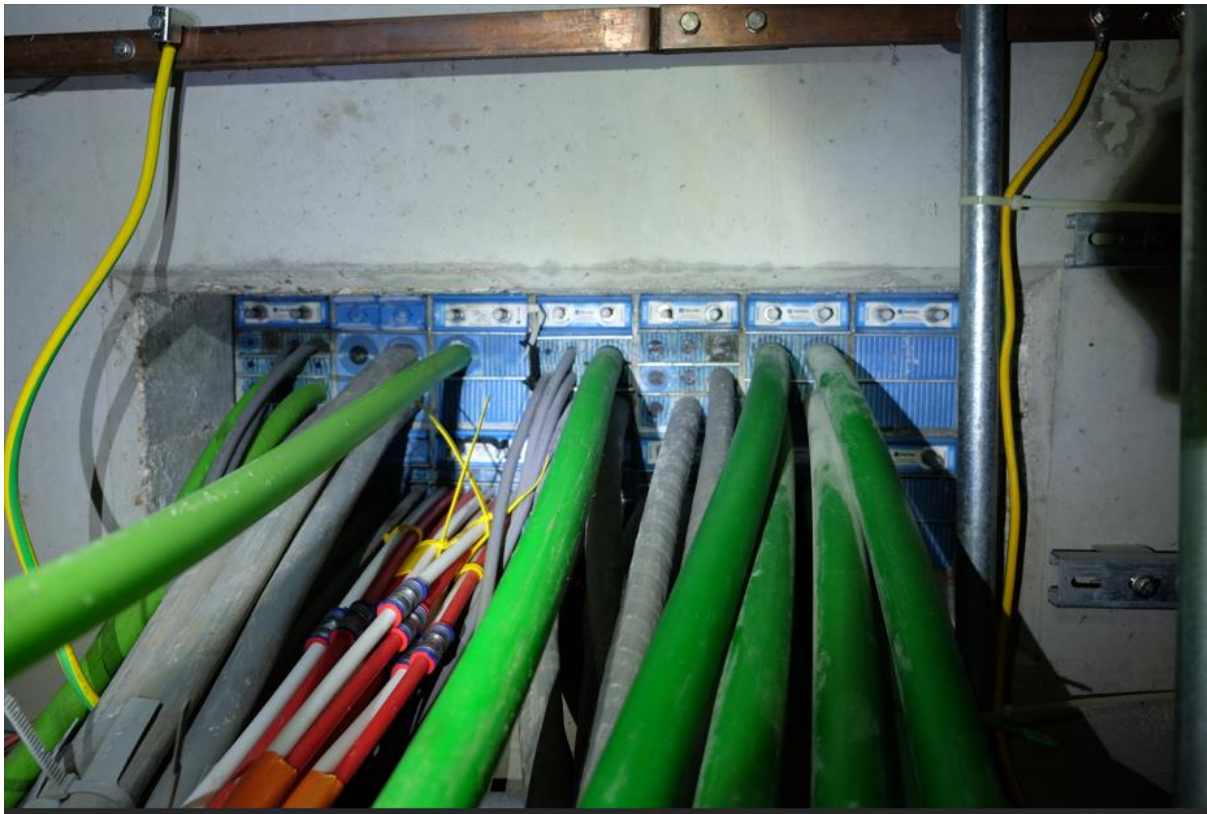
6. SMH002 (Is Roxtec metal frame bonded to earth – as discussed).

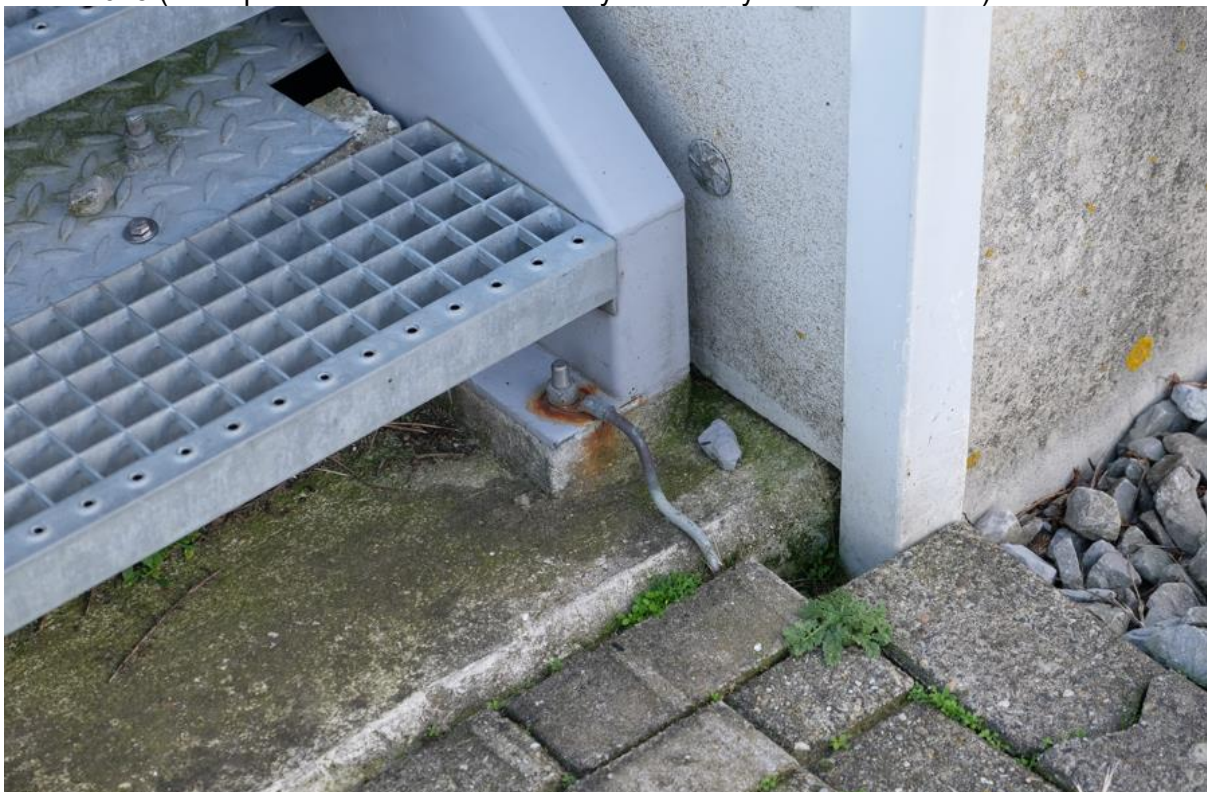
1. SMH045 (Example of corrosion – most likely caused by dissimilar metals).

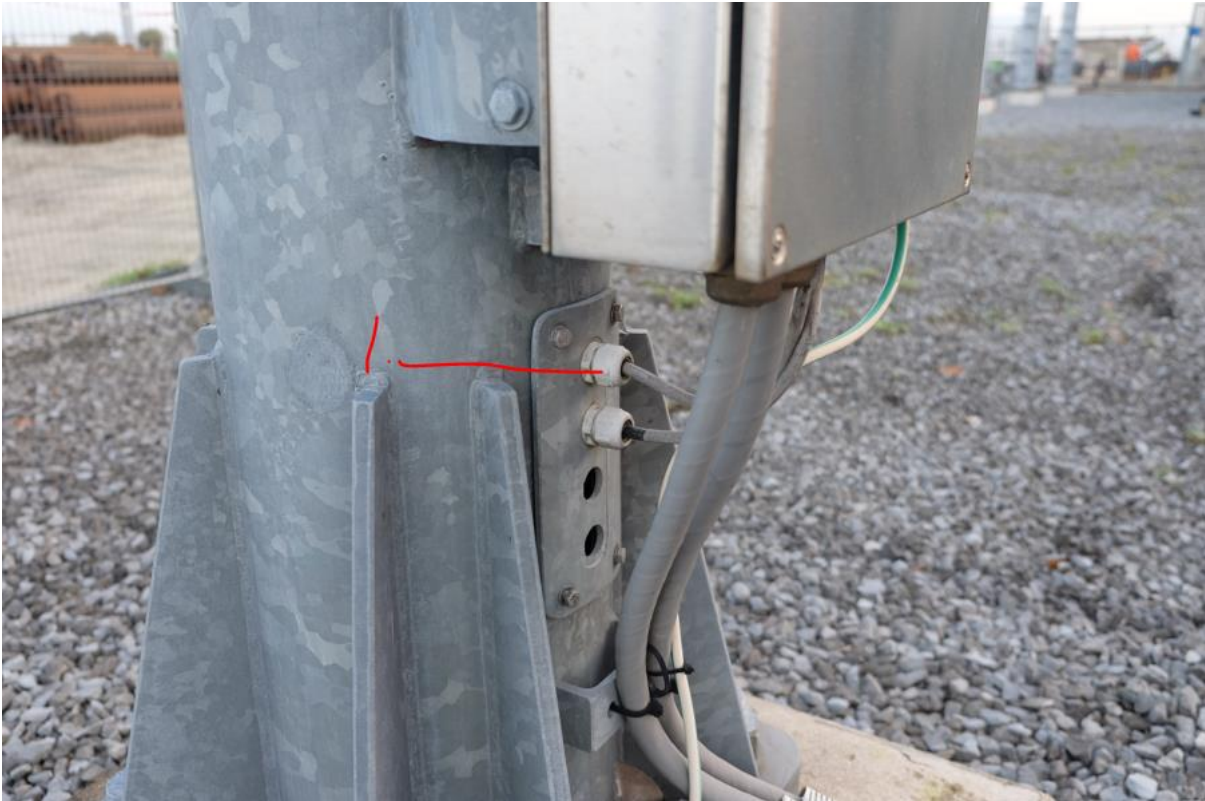
2. SMH051 (Appears to be plastic connectors that are not EMC compliant).

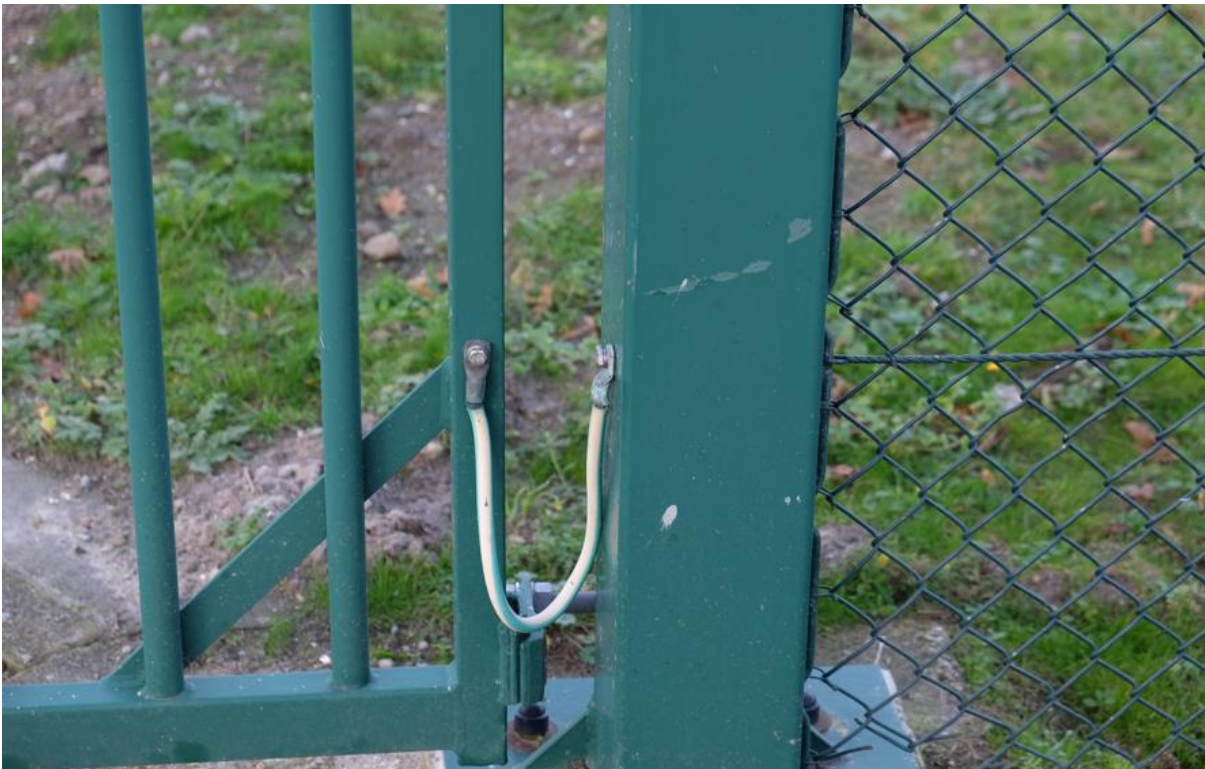
3. SMH056 (Poor electrical contact (lugs on paint and not metal)).

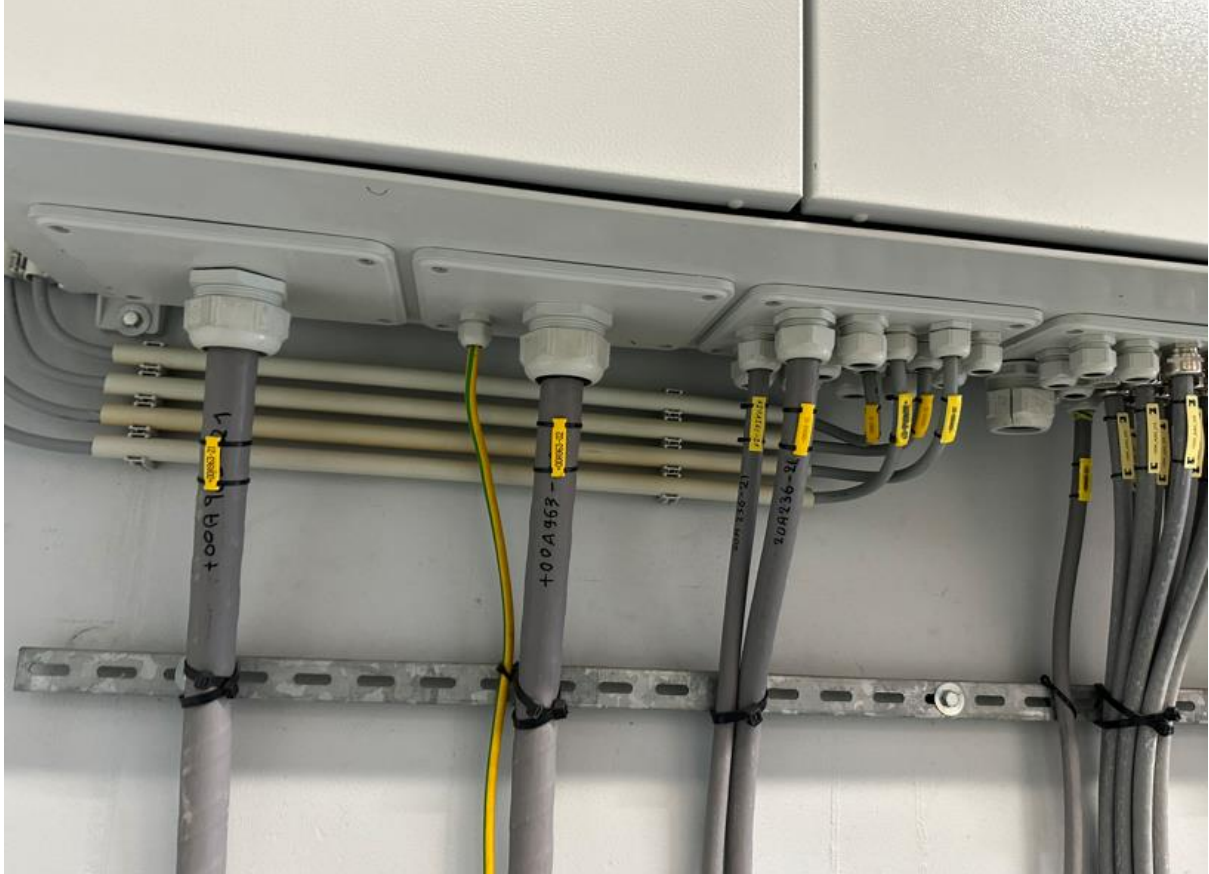
1. IMG\_6491 (Appears to be plastic connectors that are not EMC compliant).

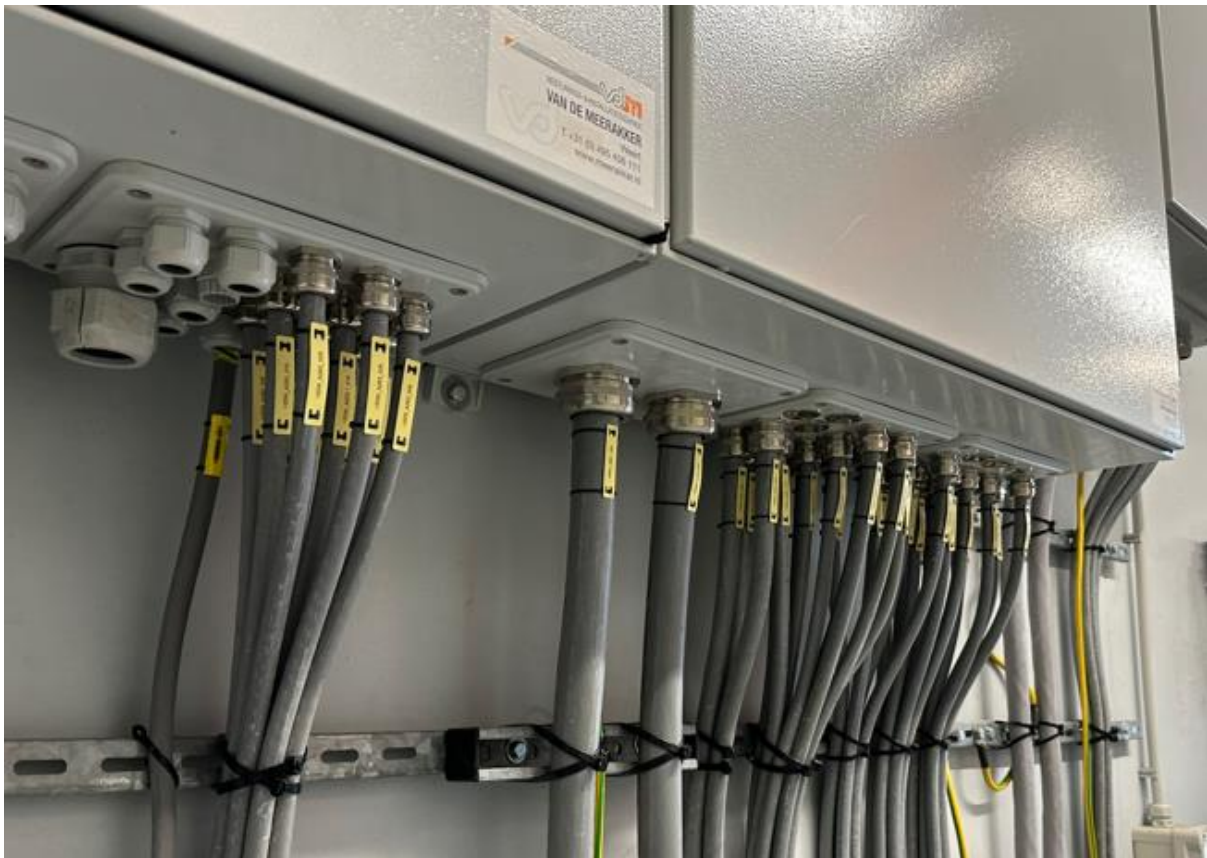
4. IMG\_6492 (Good example of use of EMC connectors – bonding of cable shields to enclosure to be confirmed by measurement).

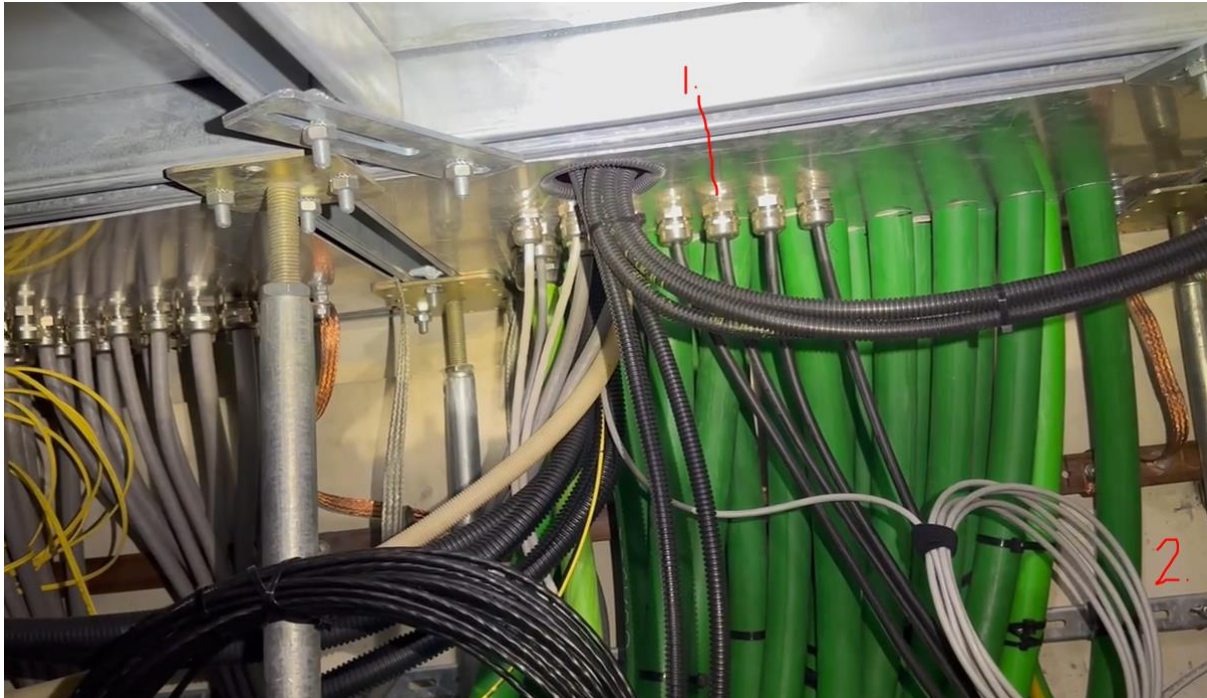
1. IMG\_6470 ((1) – Possible cables with shields passing through base plate without shields being bonded to base plate or via EMC glands). (2) – Excess cable coiled – coiled cable with shield exposed to magnetic fields and passing through base plate without shield being bonded to plate or via EMC gland).

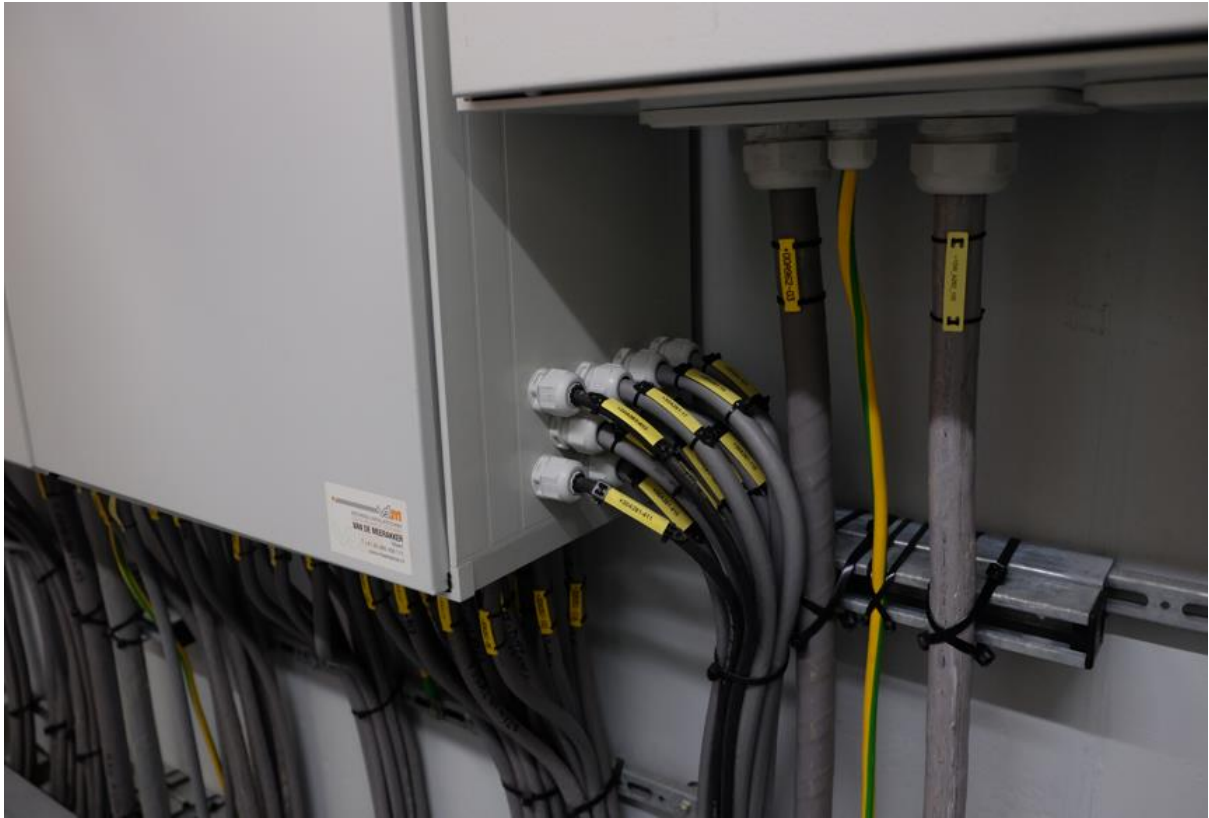
2. SMH042 (Appears to be plastic connectors that are not EMC compliant).

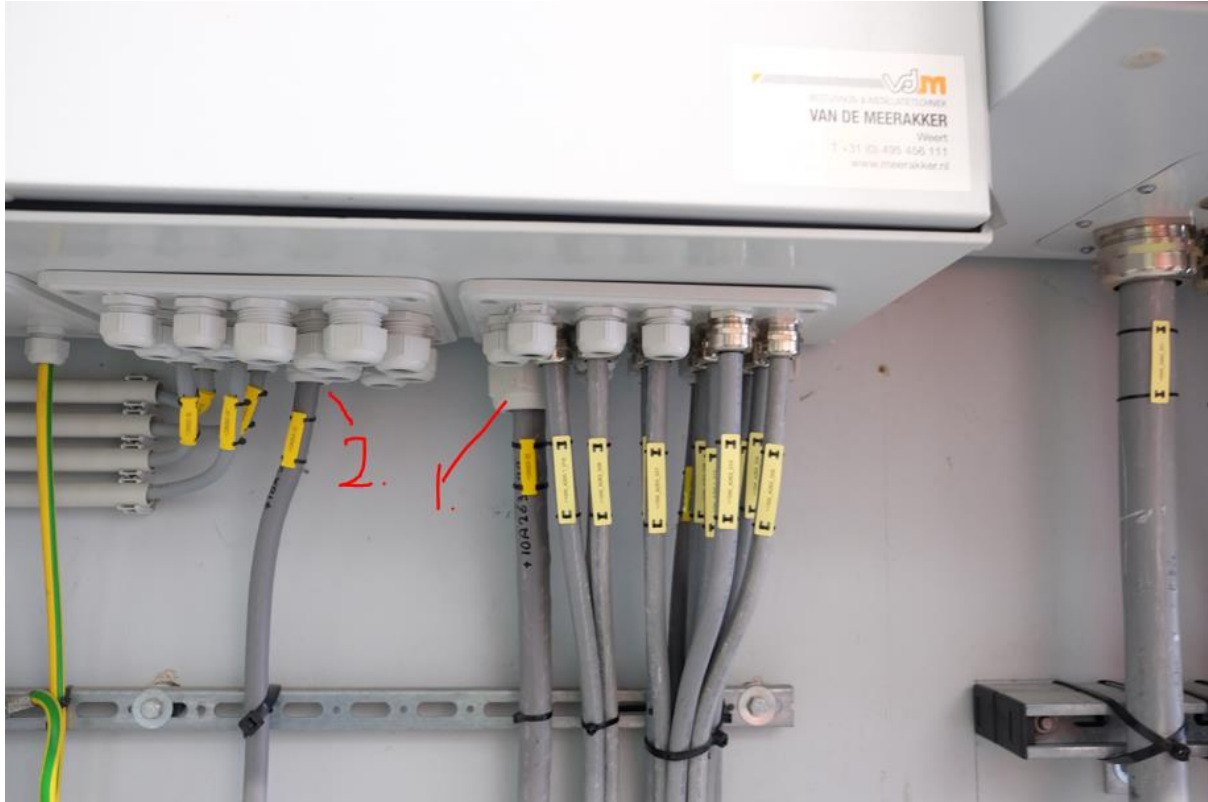
1. SMH064 ((1) and (2) appears to be plastic connectors that are not EMC compliant).
