## Data Report

Report type	Photolithography assessment 0.5-50um lines			
Report author	Rowan Temple			
Date created	2025-01-17			
Date finalised	2025-01-18			
Sample ID	abcd1234			
Device ID	bcde2345			
Fabrication by	Joe			
Date of fabrication	2025-01-01			
Date of measurement	2025-01-02

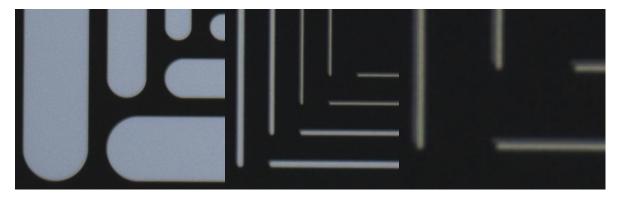
Figure 2: Detailed image portions

These results all look consistent with a basic visual inspection of the bars (see figure 2). In the image we see clear smearing of the bars, particularly in the "North West" direction. This could be caused by energy leakage (maybe from in-film scattering) under the mask during the exposure process. This is consistent with the largest bars having a greater 3.3 um smearing due to the larger energy dump in these areas. The finest bars which receive fewer photons have leaked less but it has a proportionately larger impact on the desired pattern. Another possible explanation is the direction of deposition if there is overhanging resist at the edges. More information about the patterning process is needed to make a firm conclusion.
