# Your Inspection Report

4956 Waterside Circle  
Carmel, IN 46033

RE: Report No. 37111  
4956 Waterside Circle  
Carmel, IN  
46033

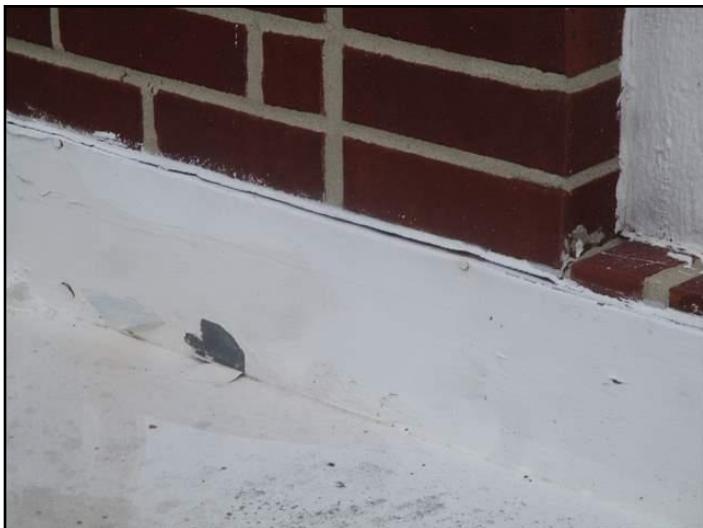
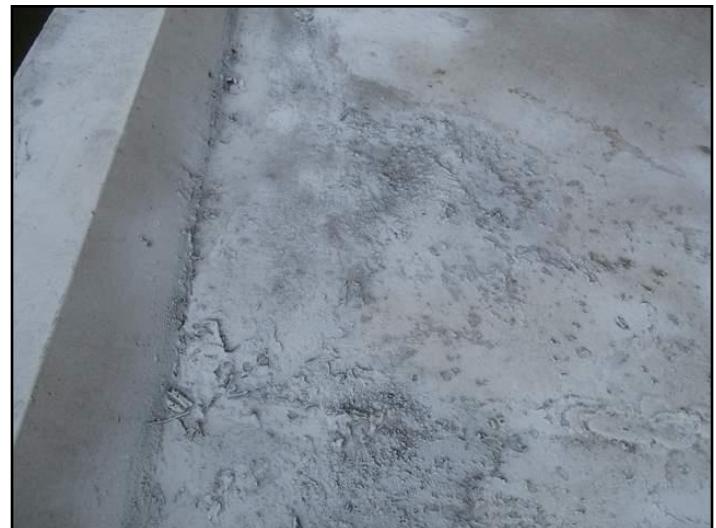
- 1. Condition:** • Peeling paint is present on flat roof. Sanding and painting are recommended. Flashing at house also needs sealing.

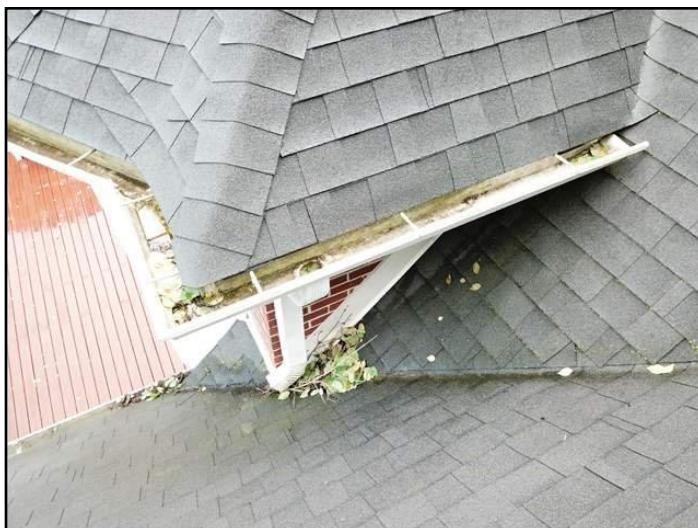
- 2. Condition:** • Valley in NE area of roof traps leaves. This may be susceptible to ice damming and potential leaks. Raising downspout may help reduce risk.

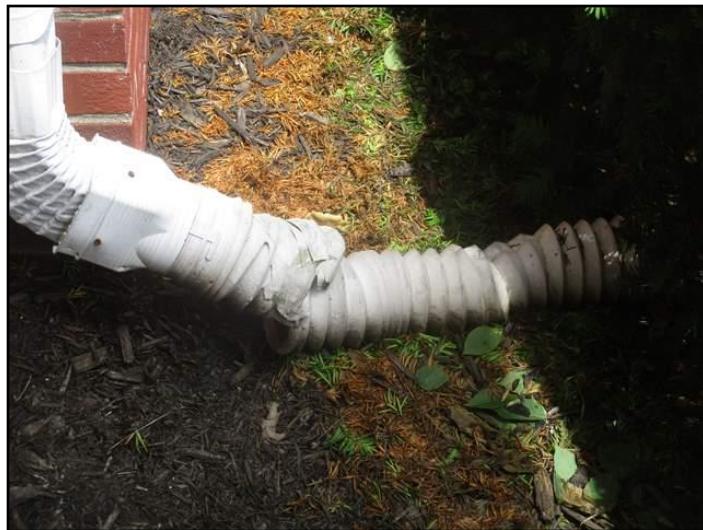
- 4. Condition:** • Underground drain tile at NE corner has separated .

**Task:** Repair

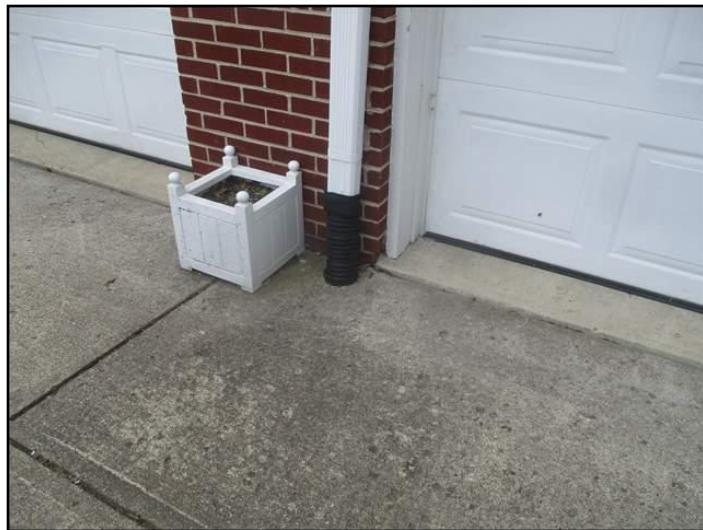
7. Condition: • -Drainage needs improving from downspouts.

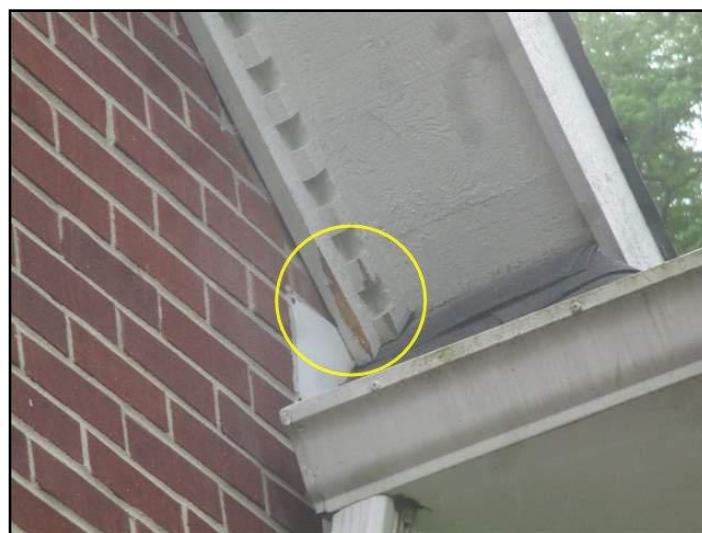
- 9. Condition:** • Recaulking is needed on exterior.

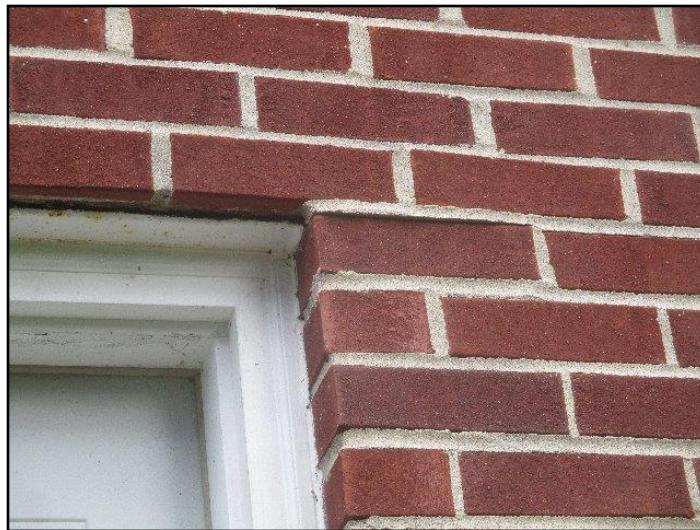
- 11. Condition:** • Recent repairs were noted to brick above garage door.

**Task:** Monitor

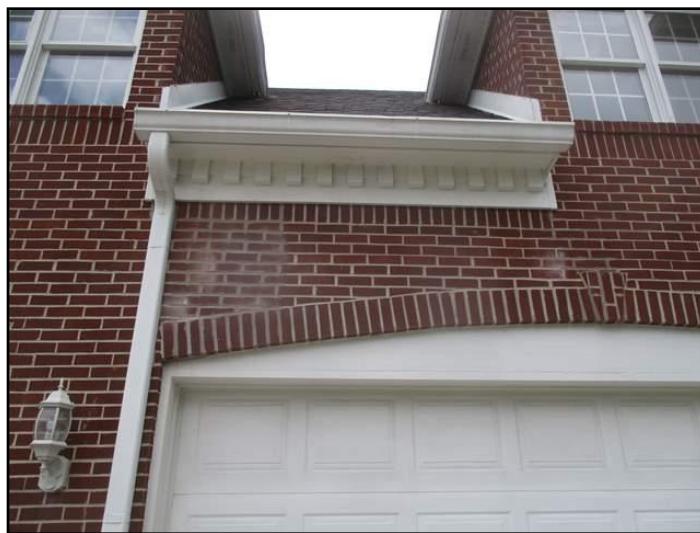
- 12. Condition:** • -Weep holes were not visible in the masonry walls. Weep holes were required when the home was constructed.

**Task:** Correct

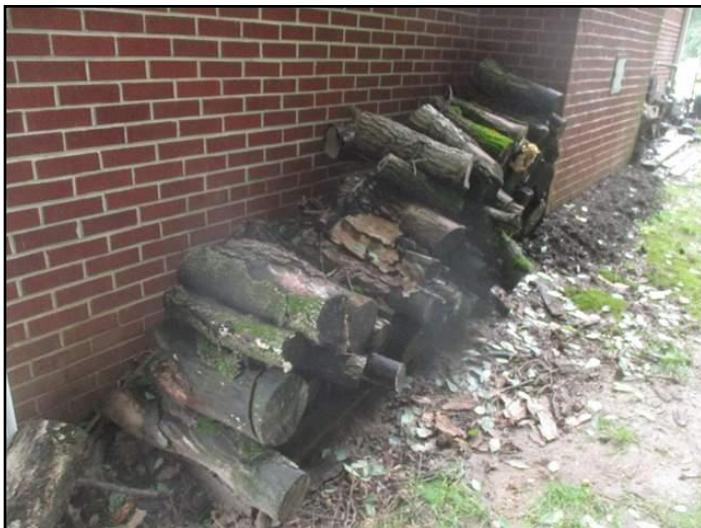
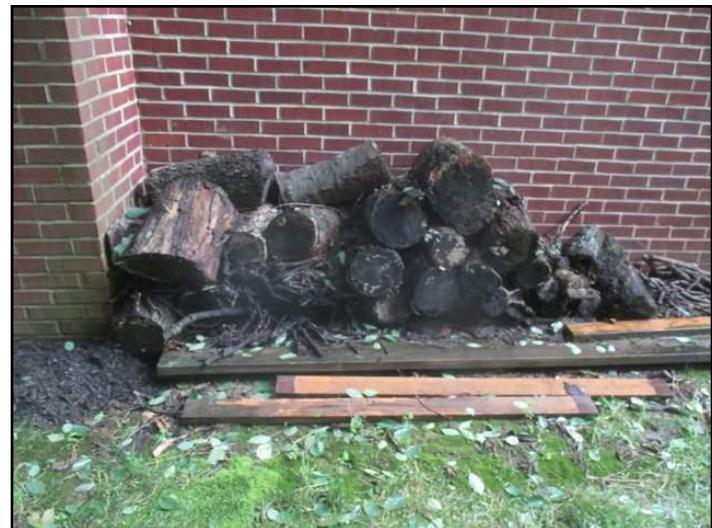
**Condition:** • Firewood is stored next to house. Recommend this be moved away from house and off ground.

**16. Condition:** • Firewood is stored next to house. Recommend this be moved away from house and off ground.

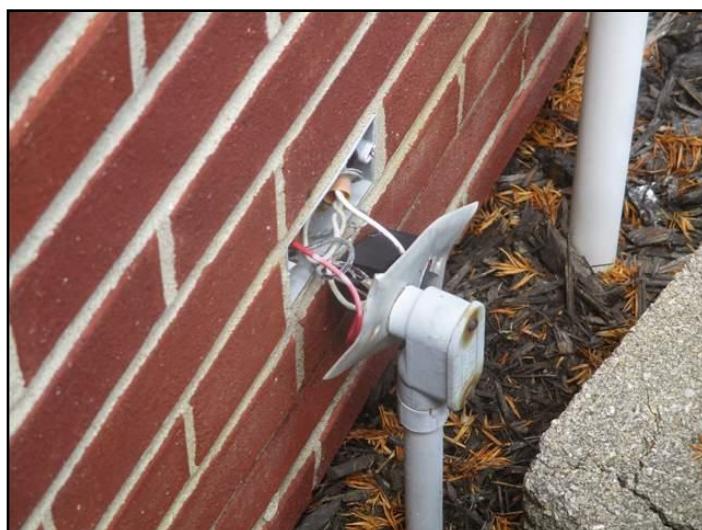
**Condition:** • Wiring for yard light is loose at house wall. Light did not turn on.

**23. Condition:** • Wiring for yard light is loose at house wall. Light did not turn on.

**Task:** Repair

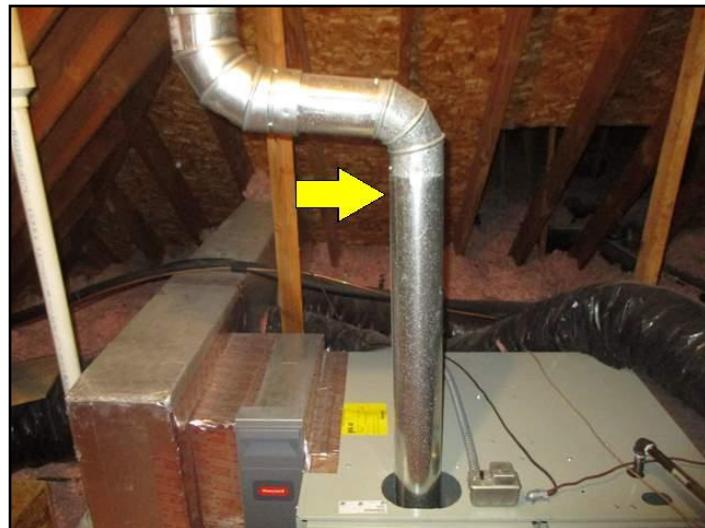
**26. Condition:** • -The furnace vent pipe does not meet the minimum combustible clearance requirement. A one inch clearance for double walled vent (B-vent) and six inch clearance for single wall vent is required.

Location: Framing and decking in attic

Task: Repair

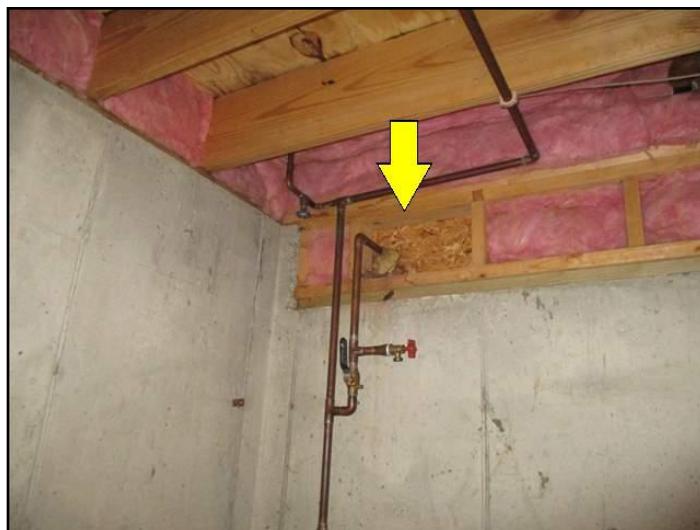
**31. Condition:** • A missing bat of insulation was noted in basement storage room.

**Task:** Replace

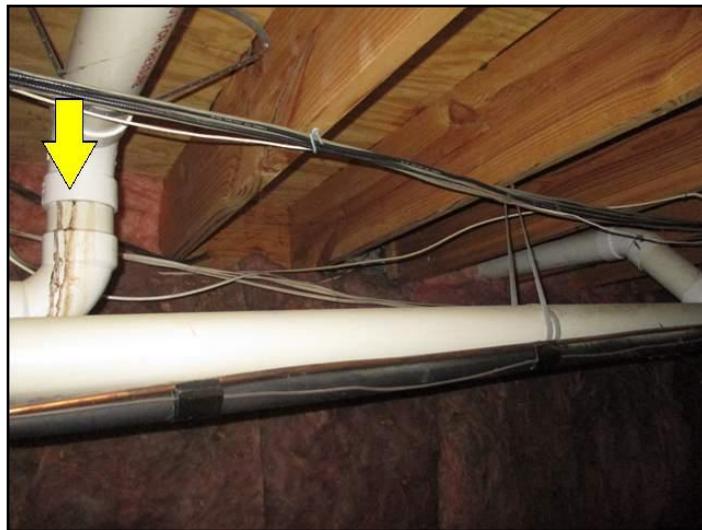
34. • Signs of a condensate leak were noted on radon pipe in crawl space.

**Task:** Repair

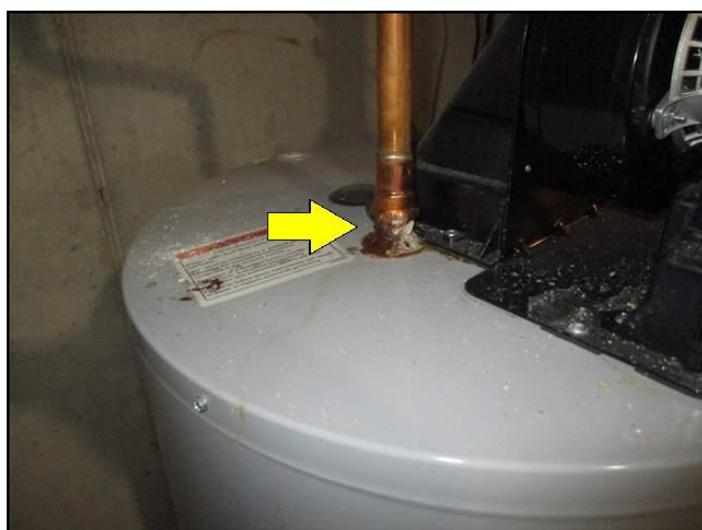
**35. Condition:** • Leakage was noted on hot connection above water heater.

**Task:** Repair

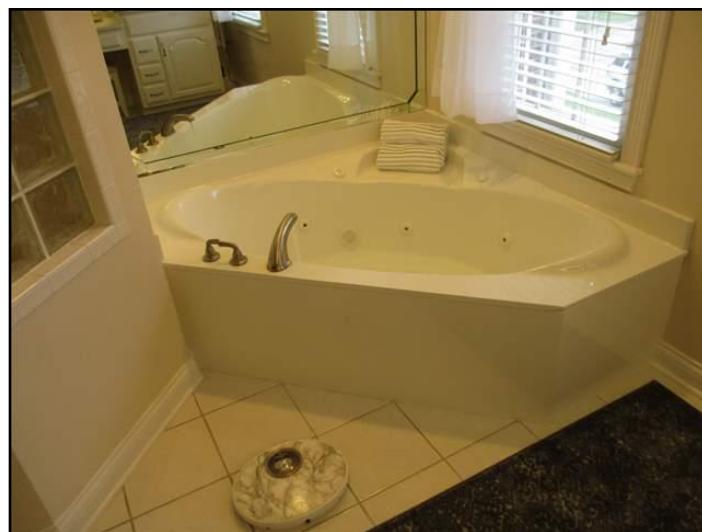
- 38. Condition:** • -There is no access for whirlpool tub pump. One is required.

**Task:** Correct

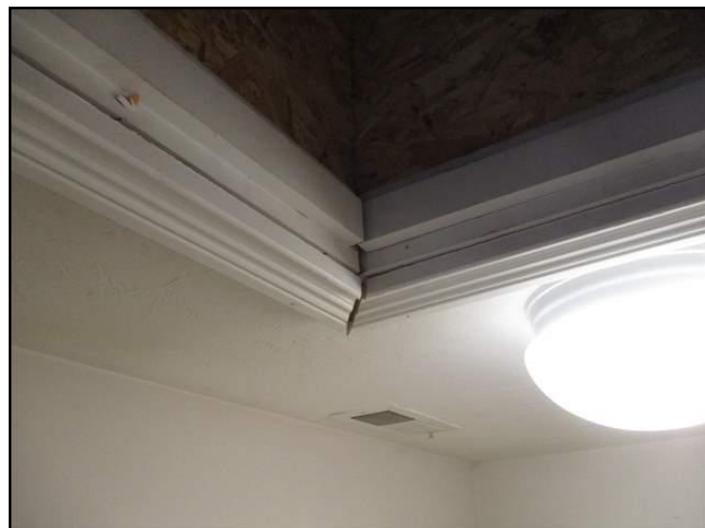
**40.** • Loose framing was noted around upper attic entrance.

**Task:** Repair

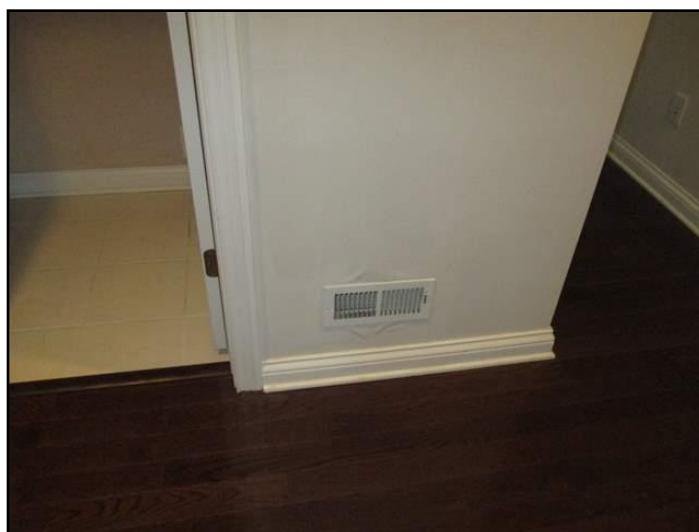
- 43. Condition:** • Water damage was noted on wall in hall to garage. This area tested dry at time of inspection.

**Task:** Repair

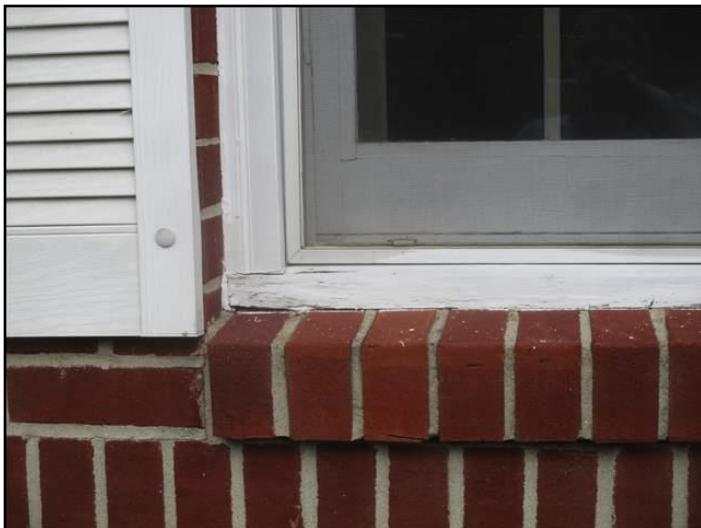
Sitting room

- 44. Condition:** • Rot was noted in the following windows: Garage, back stairs, laundry, living room, sitting room and entry

**Task:** Repair or replace

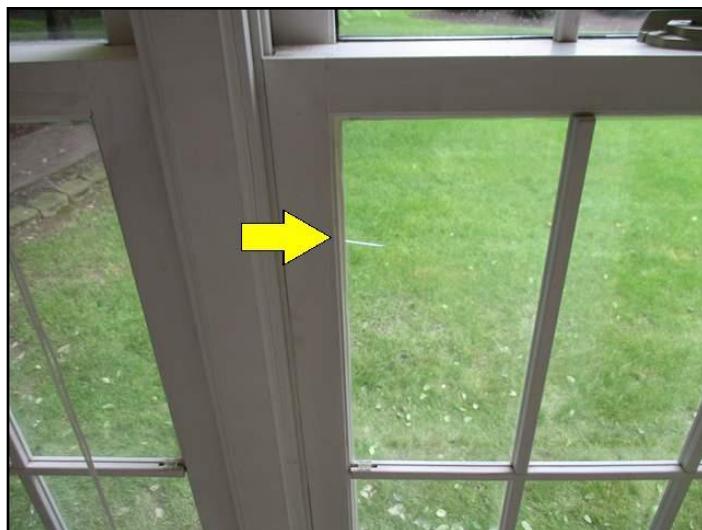
49. Condition: • A cracked window was noted in family room.

Task: Replace glass unit

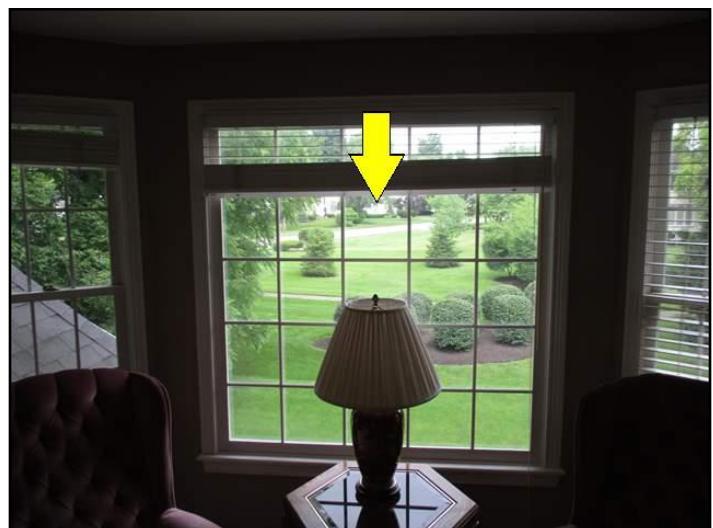
51. Condition: • -The following windows have broken thermal seals.

Location: Lower 2 in north section of family room windows, upper left in center section in family room, lower right in den, lower left in LR, 3 in entry, 3 in garage, center in master bedroom, SE bedroom closet, upper right in south bedroom, and MBR closet

Task: Replace glass units

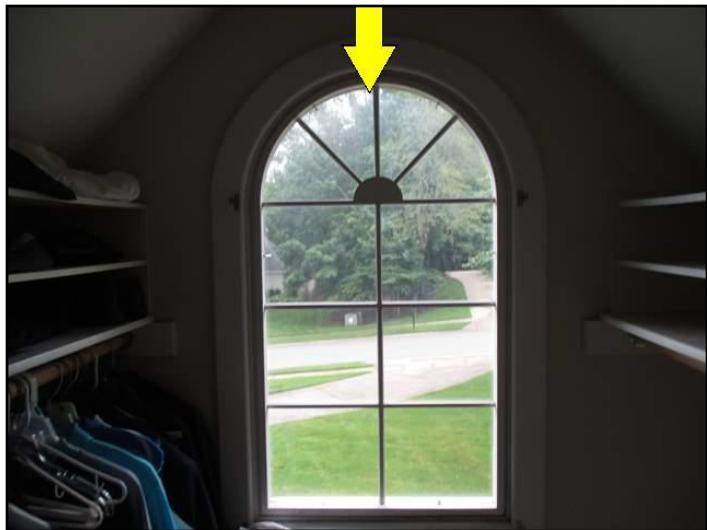
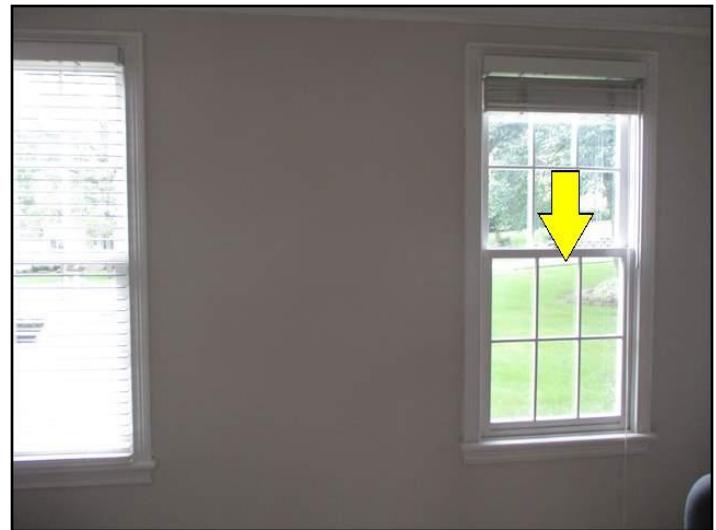
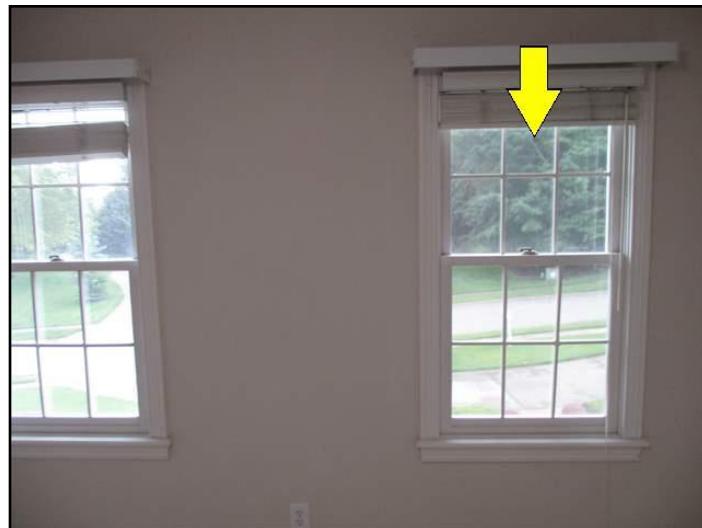
**52. Condition:** • -Tempered glass is not installed and should be.

Task: Replace glass

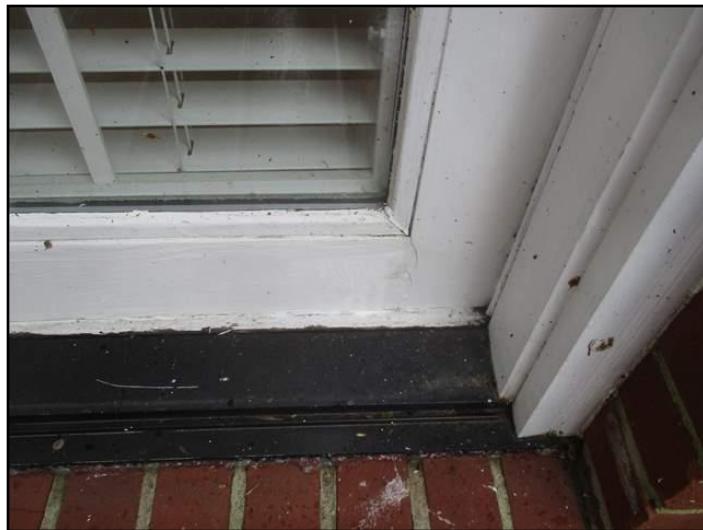
**Location:** Master bedroom

**58. Condition:** • The door binds on the jamb and is difficult to close.

**Task:** Repair

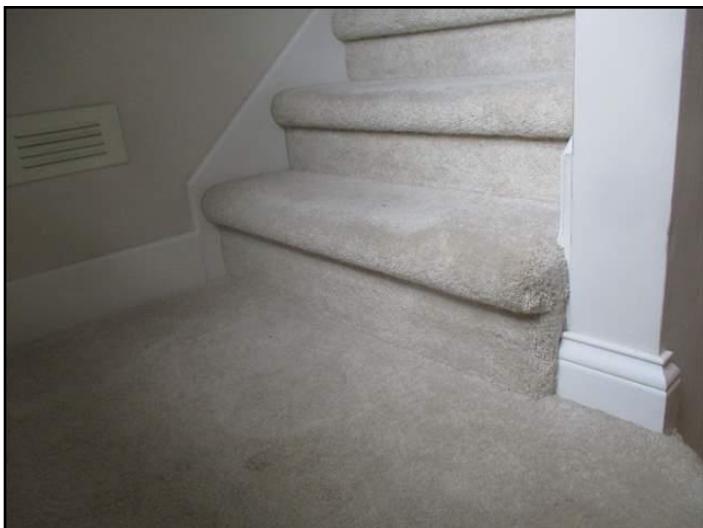
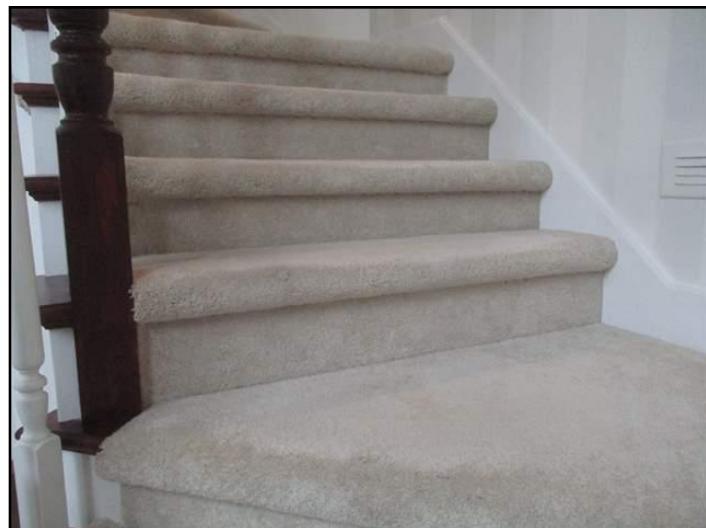
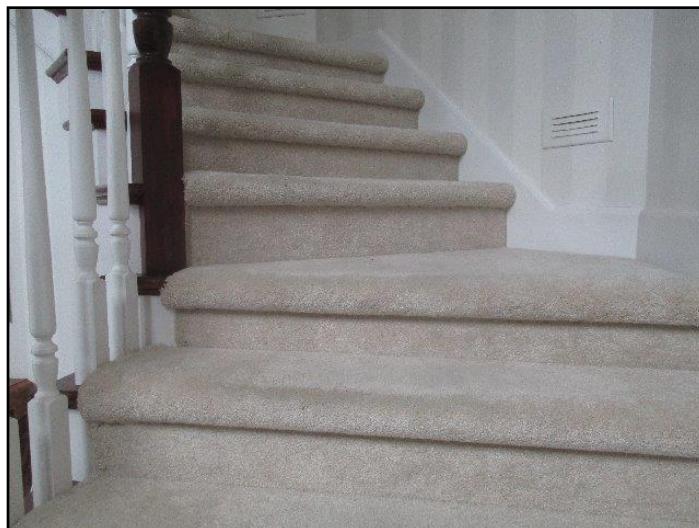
Both sets of stairs to second floor.

**62. Condition:** • -Risers on stairs vary more than 3/8".
