Fire Risk Appraisal of the External Walls Report (FRAEW)

Building Name: 20:20 House

Address: Skinner Lane, Leeds, LS7 1BE

Date: 07/10/2022

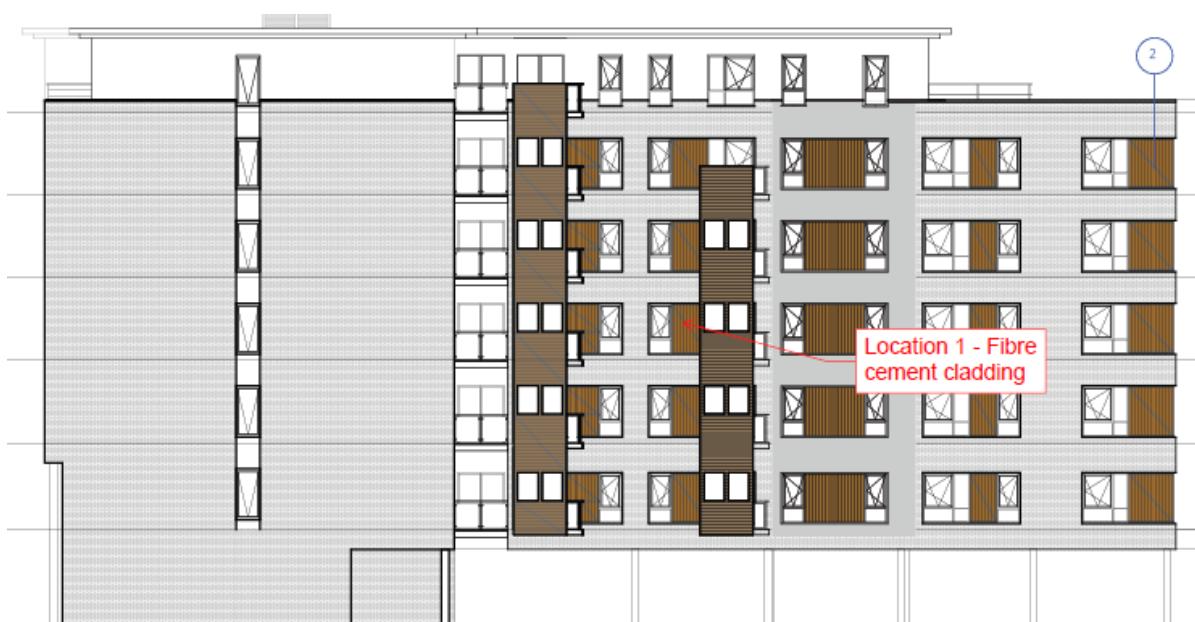
Figure 6 - Location of survey points for invasive survey on the building West elevation

Inspection Point	Photo Reference
<p>Location 1: 3rd floor West elevation</p> <p>The build-up of this system was found to be:</p> <ul style="list-style-type: none"> - James Hardie VL fibre cement cladding panel - Galvanised steel support rails - Rockwool insulation - Wraptite VCL breather membrane - Bitumen covered blockwork with concrete mortar <p>Workmanship was found to be of a good standard.</p> <p>Cavity fire barriers have been installed correctly.</p>

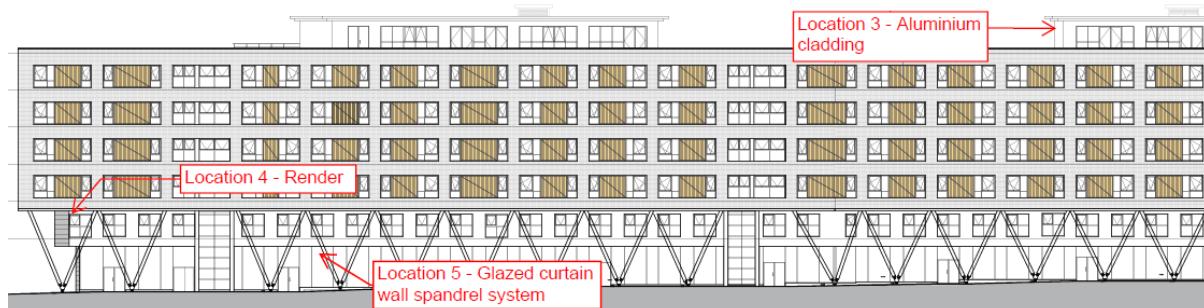
Figure 8 – Location of survey points for invasive survey on the building North elevation

Inspection Point	Photo Reference
<p>Location 4: 1st floor North elevation</p> <p>The build-up of this system was found to be:</p> <ul style="list-style-type: none"> - Unknown silicone or acrylic based render topcoat - Blockwork with concrete mortar <p>Workmanship was found to be of a good standard.</p>

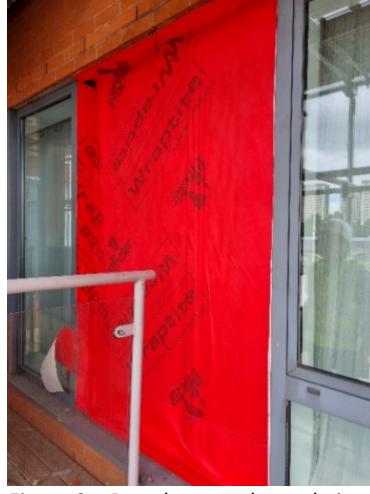
<p>Figure 9 – Breather membrane being installed</p>

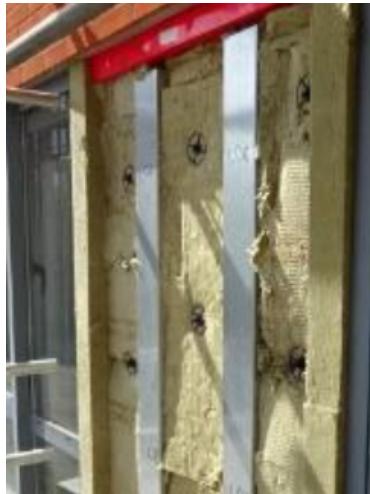
<p>Figure 10 – Mineral wool insulation and cavity barriers being installed</p>

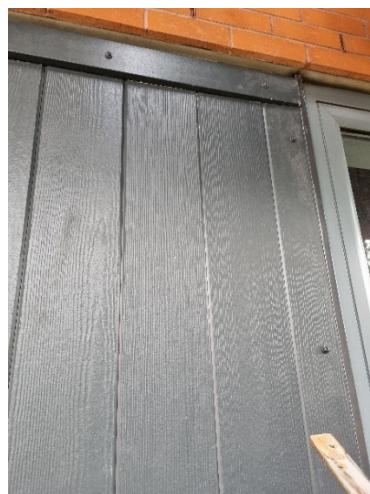
<p>Figure 11 – Fibre cement cladding outer face</p>

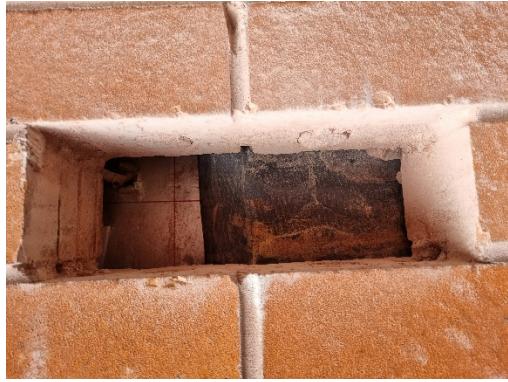
Inspection Point	Photo Reference
<p>Location 2: 1st floor East elevation</p> <p>The build-up of this system was found to be:</p> <ul style="list-style-type: none"> - Brickwork with concrete mortar - Cavity - Celotex foil faced PIR insulation - Bitumen covered blockwork with concrete mortar <p>Cavity fire barriers were located horizontally at compartment floor level, but were found to be poorly installed with gaps present in some areas.</p> <p>Cavity closers were located around window openings</p> <p>No cavity fire barriers were located around extraction ducting penetrations</p>

<p data-bbox="801 640 1110 662"><i>Figure 12 – Brickwork removed</i></p>

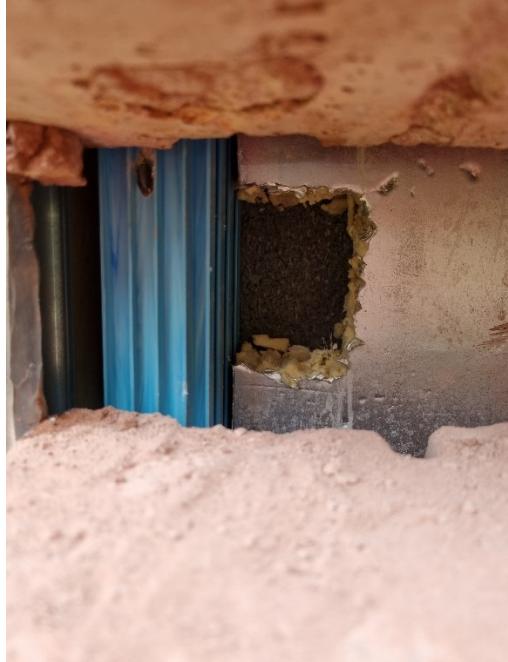
<p data-bbox="801 1358 1380 1381"><i>Figure 13 – Celotex insulation located in front of blockwork</i></p>

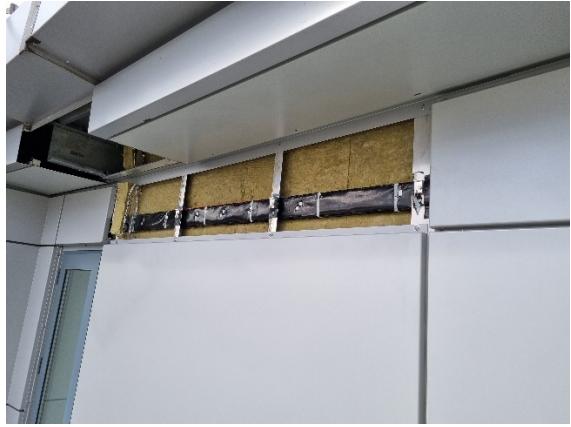
Inspection Point	Photo Reference
<p>Location 3: 6th floor East elevation</p> <p>The build-up of this system was found to be:</p> <ul style="list-style-type: none"> - Genius Prime aluminium rainscreen panel - Aluminium support rails (helping hand brackets) - Cavity - 50mm Rockwool duo slab insulation - Steel frame system - Siniat Weather Defence sheathing board <p>Siderise cavity fire barriers are correctly installed horizontally and vertically in most areas, however cavity fire barriers could not be located adjacent to all window/door openings</p> <p>Cavity fire barriers were located around extraction ducting penetrations.</p>

<p>Figure 14 – Aluminium panel removed to reveal mineral wool insulation and cavity barrier</p>

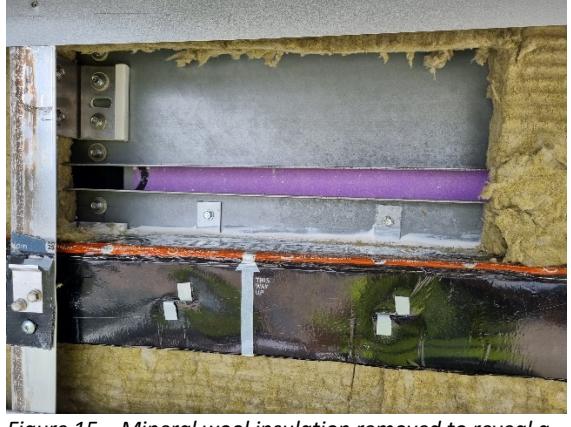
<p>Figure 15 – Mineral wool insulation removed to reveal a steel frame system and Siniat Weather Defence board</p>

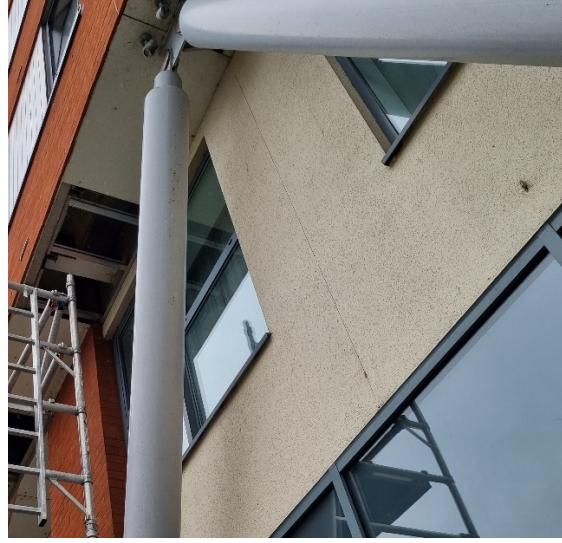
<p>Figure 16 – Render coated outer wall</p>

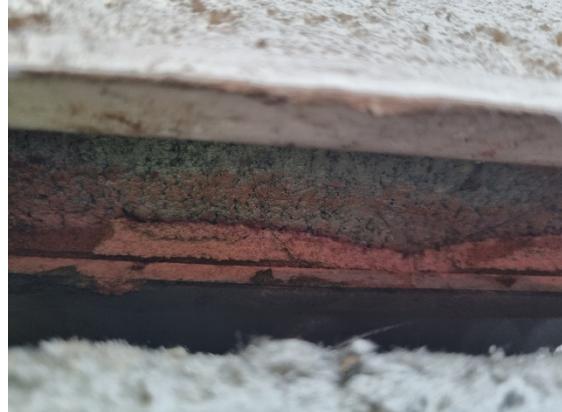
<p>Figure 17 – Blockwork positioned behind the render coating</p>

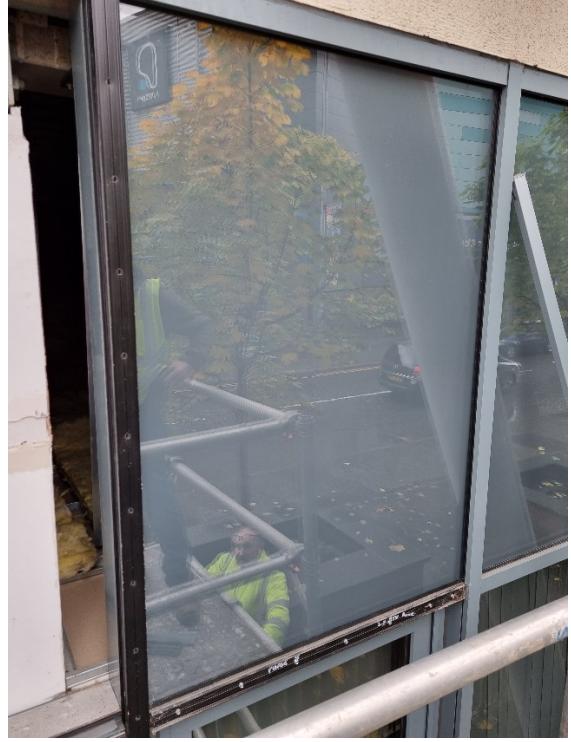
Inspection Point	Photo Reference
<p>Location 5: Ground floor North elevation</p> <p>The build-up of this system was found to be:</p> <ul style="list-style-type: none"> - Double glazed unit with rubber gasket seal and coloured blackout film to rear of unit - Aluminium curtain wall support frame - Open void on ground floor level units only - Mineral wool insulation on upper floor units - Concrete compartment floor on upper floor units - Fire batt to false ceiling void on upper floor units <p>Workmanship was found to be of a good standard.</p>

<p>Figure 18 – Glazed spandrel unit</p>

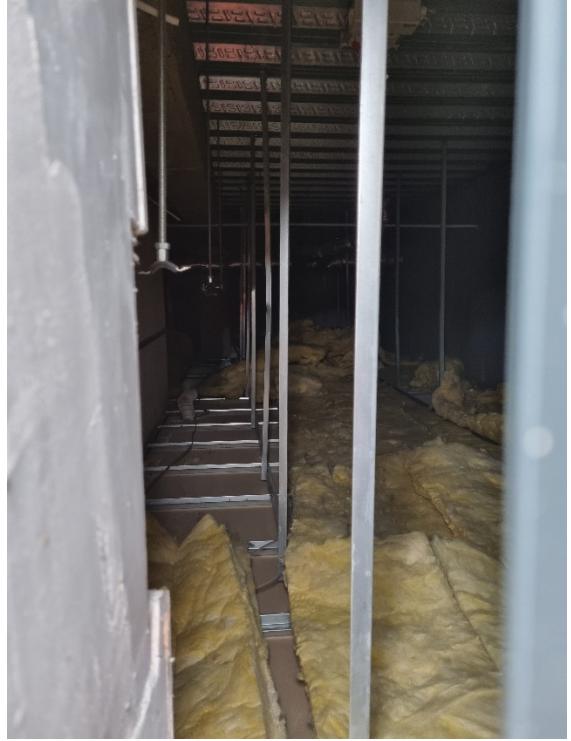
<p>Figure 19 – Open void on the ground floor units</p>

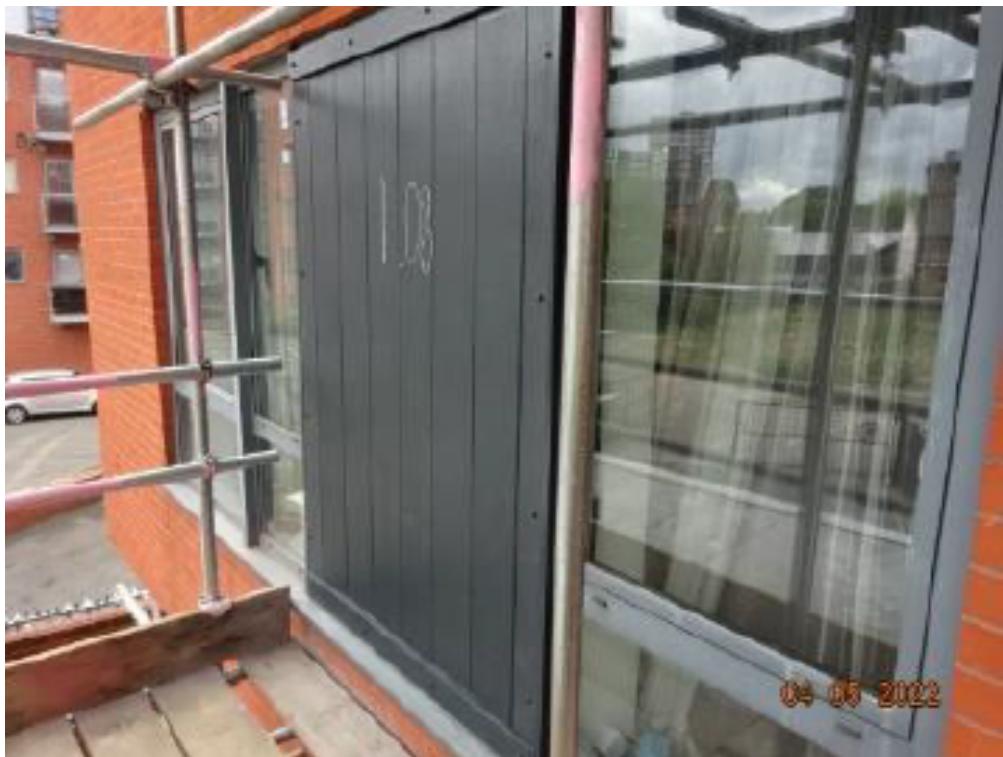
Figure 20 - wall type 1

Material / System	Primary / Secondary	Fire performance	Compliance with ADB at the time of construction	Compliance with ADB 2019
James Hardie VL fibre cement cladding panel	Primary	A2-s1, d0	Yes	Yes
Galvanised steel support rails	Primary	A1	Yes	Yes
Rockwool insulation	Primary	A1	Yes	Yes
Wraptite VCL breather membrane	Primary	B-s1, d0	Yes	Yes
Bitumen covered blockwork with concrete mortar	Primary	Assumed Class A1	Yes	Yes

Cavity fire barriers bordering the cladding system are of the correct type and are correctly installed as per the manufacturers recommendations.

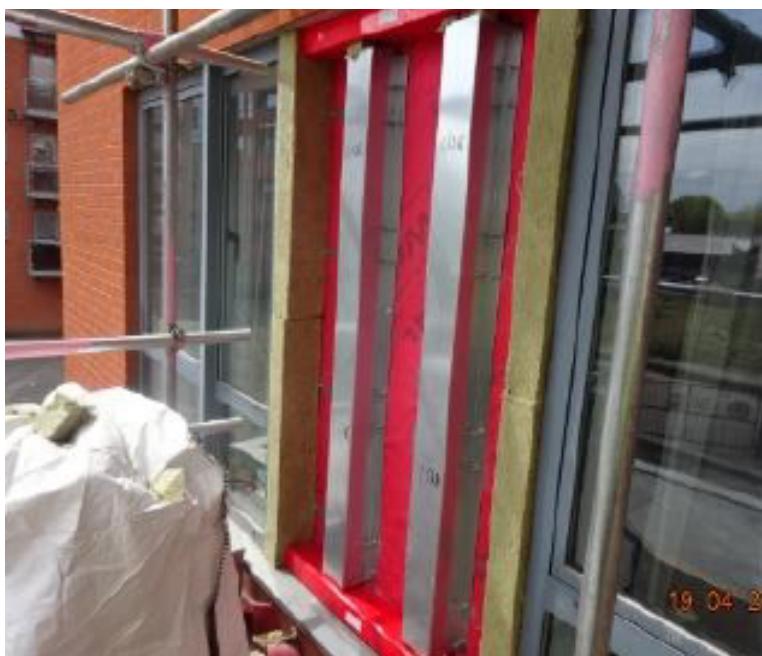
Tenmat 'closed state' cavity fire barriers are installed vertically at either side of the window frame in the system and are mechanically secured in place with good compression to the inside face of the outer cladding panel. Tenmat 'open state' cavity fire barriers are installed horizontally at the top and bottom of the cladding system. Where they adjoin the 'closed state' cavity fire barriers, the 'closed state' cavity fire barriers take priority. The 'open state' cavity fire barriers are mechanically fixed in place and are used to separate the fibre cement cladding system from the brickwork system.

Figure 21 - Example of cavity barriers

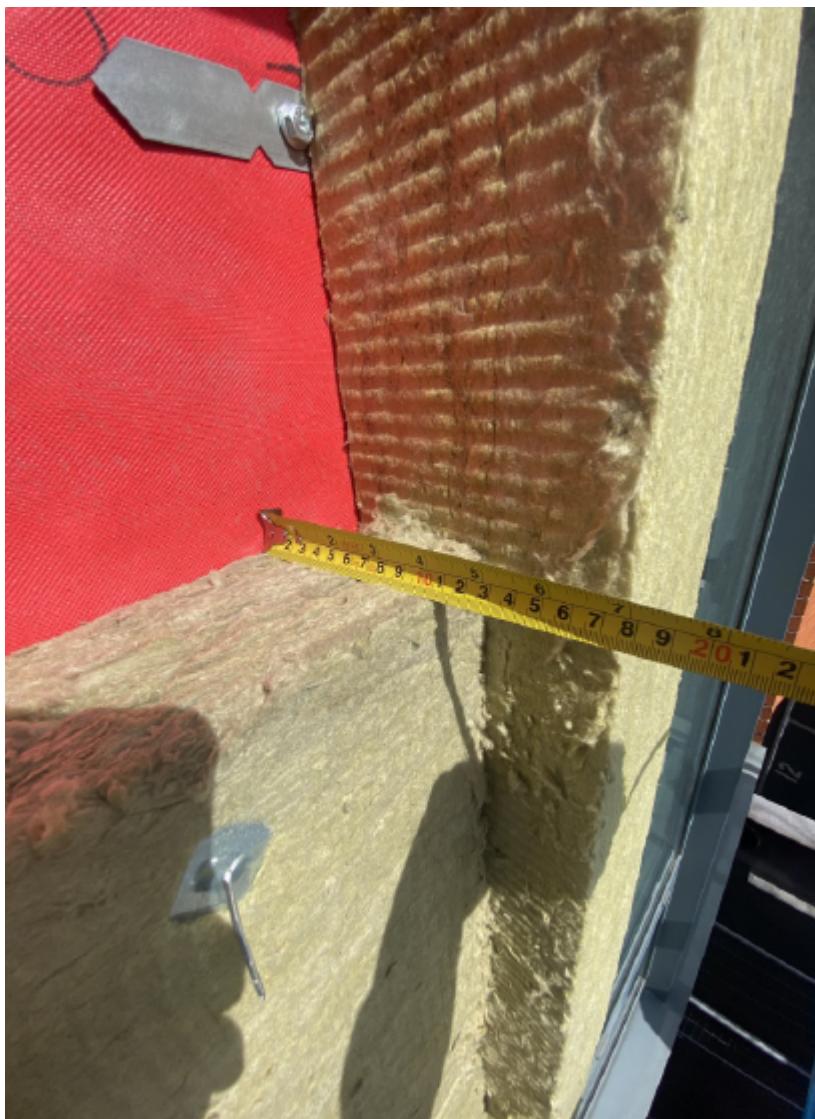
There are no penetrations in the fibre cement cladding system other than windows and balcony doors. Where windows and balcony doors are present in the system Tenmat 'closed state' cavity fire barriers are installed vertically at either side of the window/door frame.

Figure 22 - Example of cavity barrier adjacent to window opening in the system

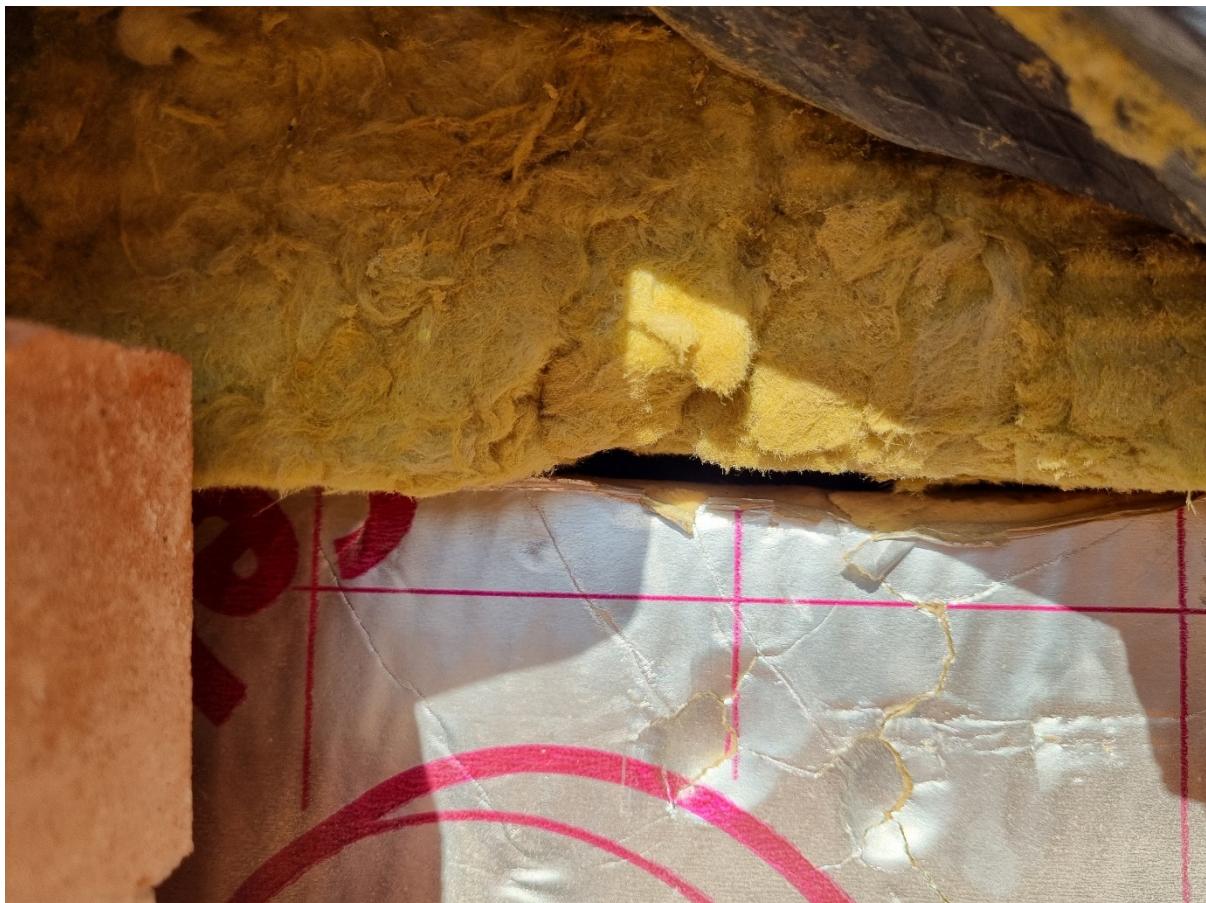
Cavity fire barriers could not be located vertically on compartment wall lines during intrusive investigations in the brickwork system.

As the brickwork system comprises of an inner and outer skin of solid masonry more than 75mm thick between a cavity, there is no requirement to provide cavity fire barriers horizontally at compartment floor level or vertically on compartment wall lines. It should however be ensured that all openings such as windows and balcony doors are closed with a cavity closer and the system is closed at the top.

Figure 24 - Example of horizontal cavity barrier in the brickwork system

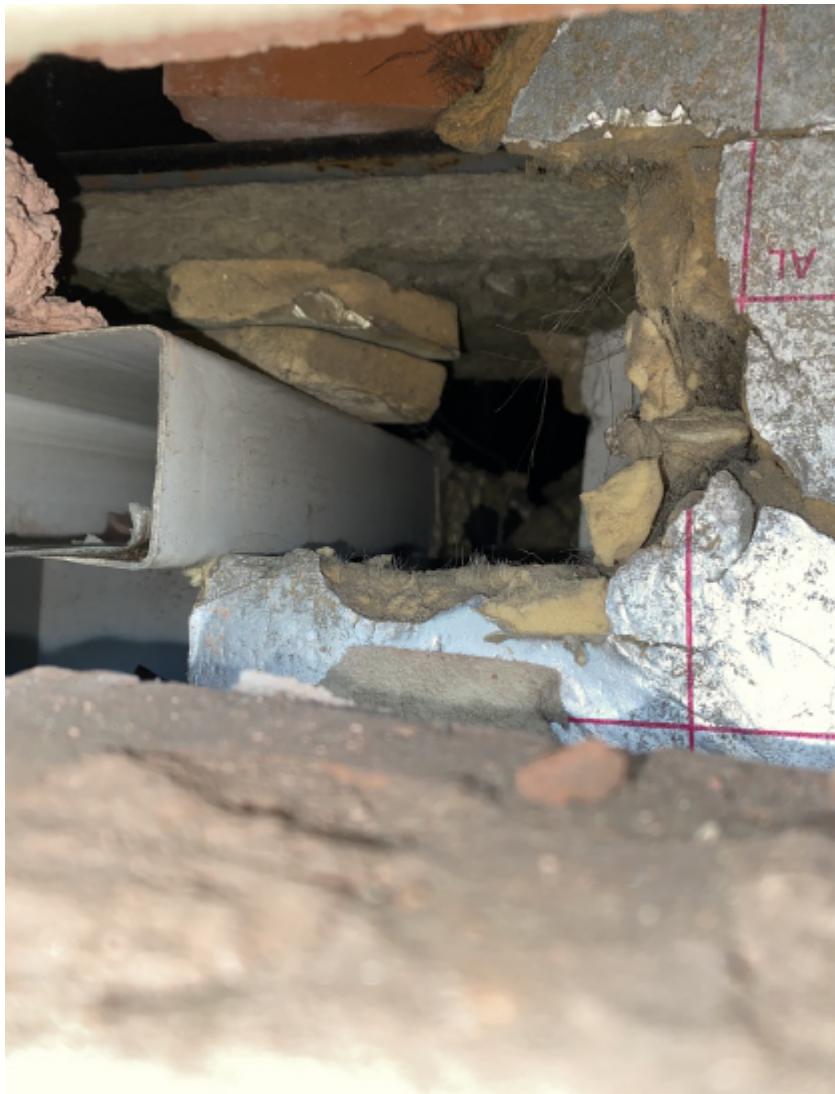
There are window and balcony door openings in the brickwork system along with plastic extraction ducting penetrations. All window and balcony door openings in the brickwork system were found to have been fitted with cavity closers during intrusive investigations. No cavity fire barrier was located around the plastic extraction ducting in the system during intrusive investigations.

Figure 25 - Example of plastic extraction ducting penetration

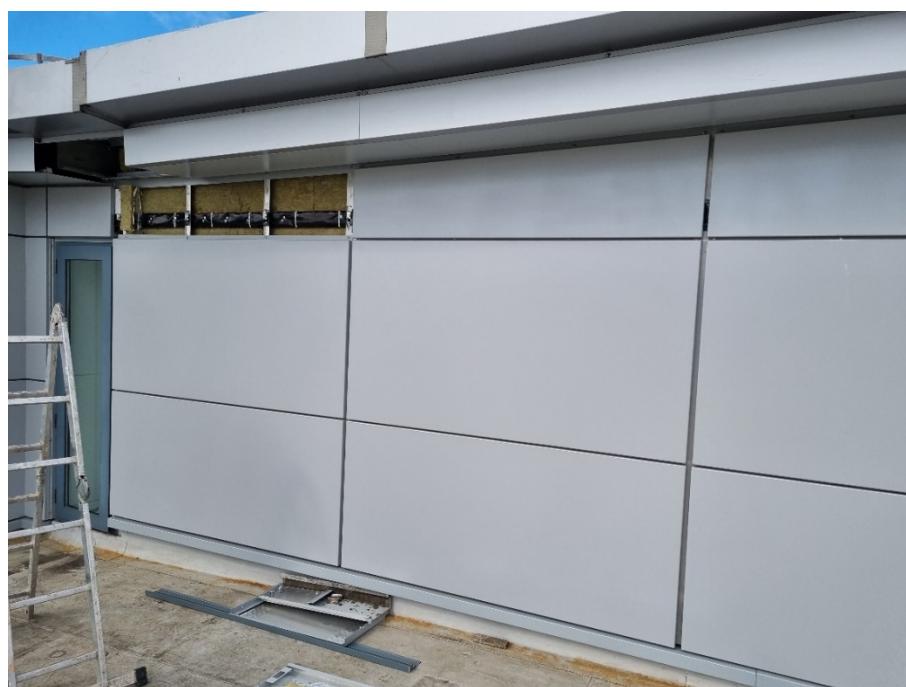
Figure 26 - Wall type 3

Material / System	Primary / Secondary	Fire performance	Compliance with ADB at the time of construction	Compliance with ADB 2019
Genius Prime aluminium rainscreen panel	Primary	A2-s1, d0	Yes	Yes
Aluminium support rails	Primary	A1	Yes	Yes
Rockwool Duo slab insulation	Primary	A1	Yes	Yes
Steel frame system	Primary	A1	Yes	Yes
Siniat Weather Defence sheathing board	Primary	A1	Yes	Yes

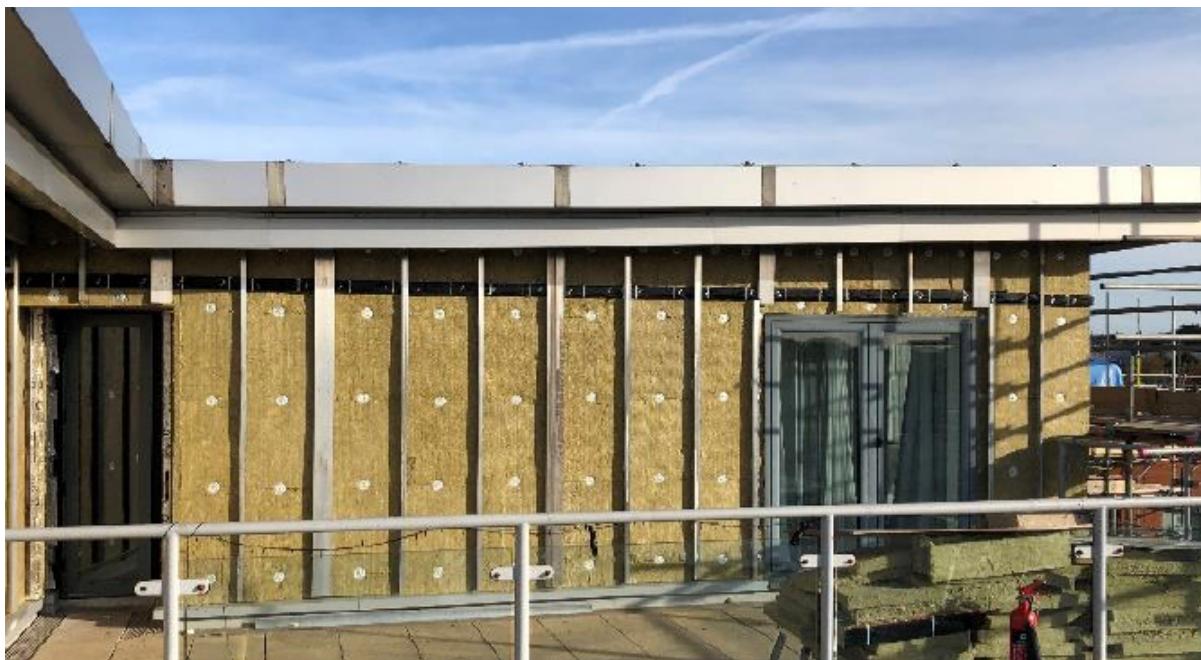
Siderise 'closed state' cavity fire barriers are installed vertically on compartment wall lines in the aluminium cladding system. The cavity fire barriers are mechanically secured in place with good compression to the inside face of the outer cladding panel. It was noted that the vertical cavity fire barrier had been cut in some areas due to the design of the cladding panels, thus creating a small gap in some locations where fire and smoke may bypass the barrier.

Siderise 'open state' cavity fire barriers are installed above door and window openings on the 6th floor to separate the aluminium cladding system from the roof. These cavity fire barriers are correctly installed and run continuously through the system. Due to the design of the cladding panels, Siderise cavity fire barriers are also fixed to the inside face of the aluminium cladding panels where the horizontal 'open state' cavity barriers are positioned. Where the 'open state' barriers adjoin the 'closed state' barriers, the 'closed state' barriers take precedence.

Cavity fire barriers were not located to the side of all window and door openings in the aluminium cladding system.

Figure 27 - Example of cavity barriers in the aluminium cladding system

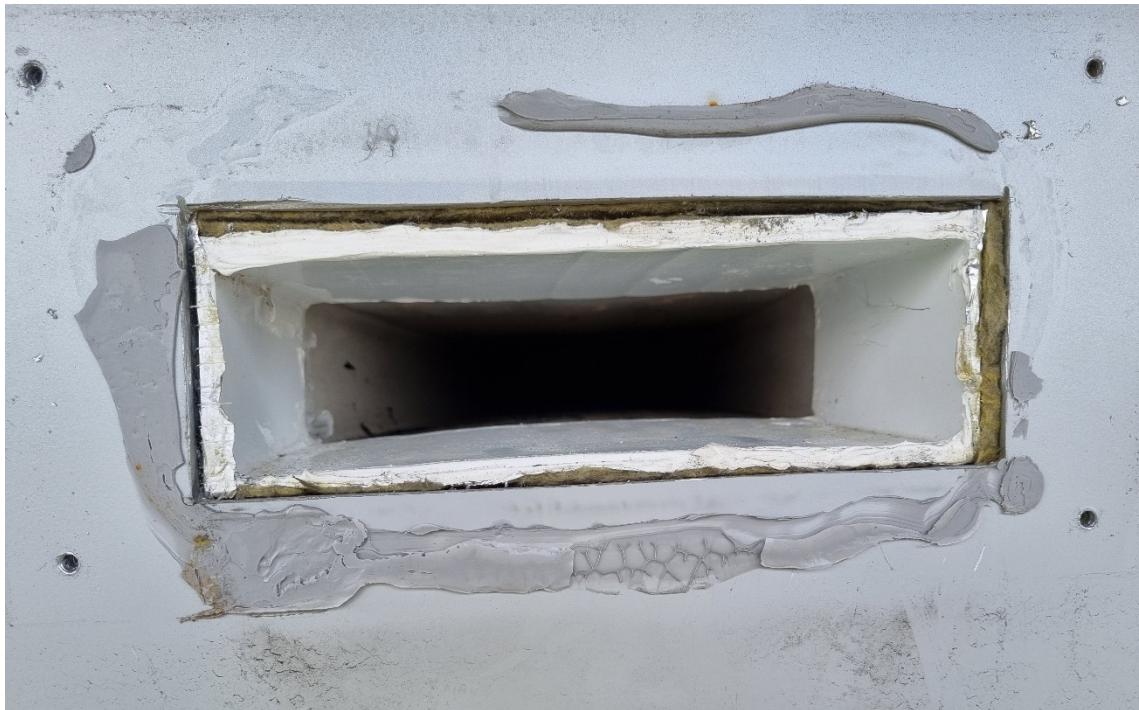
All plastic extraction ducting penetrations in the aluminium cladding system were found to have been installed with a form of cavity fire barrier during intrusive investigations.

Figure 28 - Example of cavity fire barriers around plastic ducting penetrations

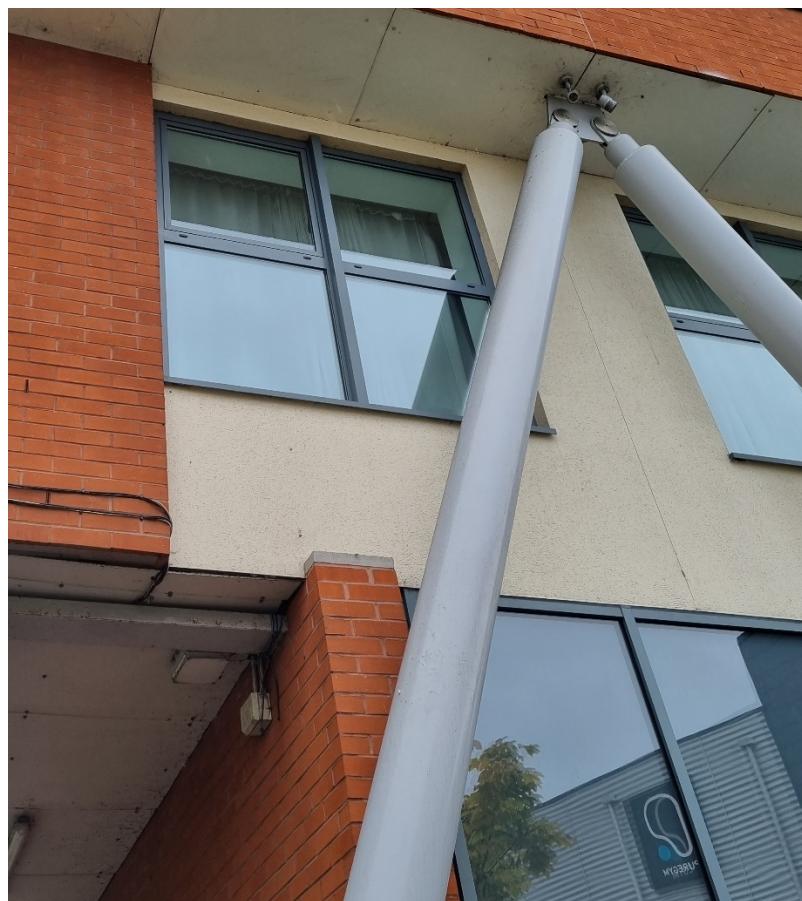
Figure 29 - Wall type 4

Material / System	Primary / Secondary	Fire performance	Compliance with ADB at the time of construction	Compliance with ADB 2019
Unknown silicone or acrylic based render topcoat	Primary	Assumed A2-s1, d0	Yes	Yes
Blockwork with concrete mortar	Primary	A1	Yes	Yes

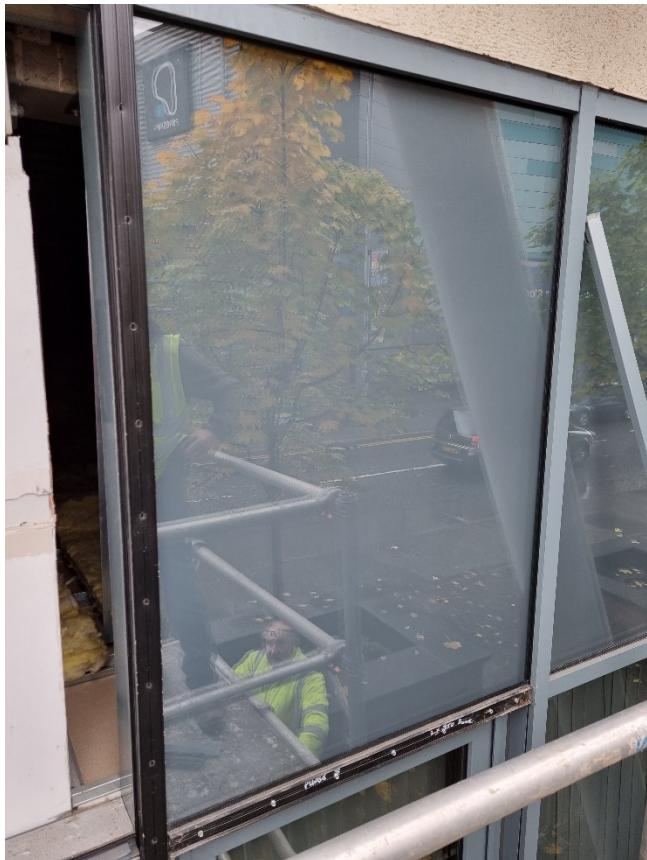
Figure 30 - Wall type 5

Material / System	Primary / Secondary	Fire performance	Compliance with ADB at the time of construction	Compliance with ADB 2019
Double glazed unit with rubber gasket seal and coloured blackout film to rear of unit	Primary	Assumed A1	Yes	Yes
Aluminium curtain wall support frame	Primary	A1	Yes	Yes
Mineral wool insulation on upper floors	Primary	A1	Yes	Yes
Concrete compartment floor on upper floors	Primary	A1	Yes	Yes
Fire batt to false ceiling void on upper floors	Primary	A1	Yes	Yes
