Health Safety & Fire Risk Assessment

One Cromwell Square Limited
Undertaken at
Saxon House
Cromwell Square
Ipswich
IP1 1TS

Report reference No: HSF30592/0052/040222/2

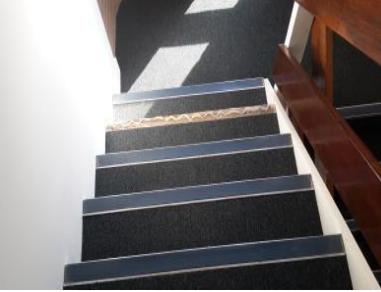
| 3.5 Action Plan - Health, Safety & Fire Risk/Hazards Risk/Hazard | | | | |
|---|---|---|---|---|
| Gd to 1st floor both stairwells | | | | |

| 3.5 Action Plan - Health, Safety & Fire Risk/Hazards Risk/Hazard | | | | |
|---|---|---|---|---|
| Anti-slip strips/nosings on stairs are missing. Potential trip/fall hazard. | | | | |

| 3.5 Action Plan - Health, Safety & Fire Risk/Hazards Risk/Hazard | | | | |
|---|---|---|---|---|
| Employ a qualified, competent and 3rd party accredited contractor to carry out the necessary remedial actions to the anti-slip strips/nosings. Monitor the anti-slip strips/nosings for condition, damage & security as part of the building maintenance schedule. | | | | |

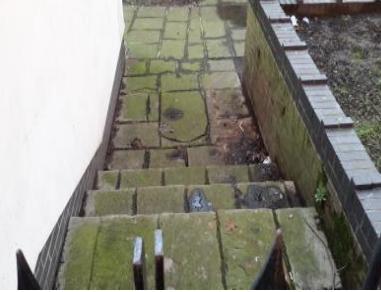
| 3.5 Action Plan - Health, Safety & Fire Risk/Hazards Risk/Hazard | | | | |
|---|---|---|---|---|
| No handrail fitted to steps. Potential fall hazard. | | | | |

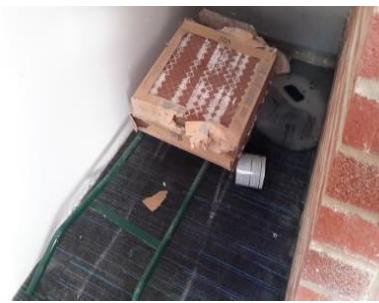
Combustible items stored.

Potential fire hazard.

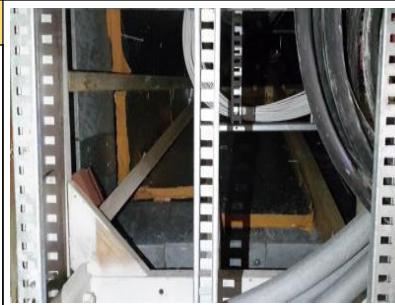
No fire breaks installed in the riser shafts between each floor.

Potential for smoke, heat and fire to spread throughout the property.

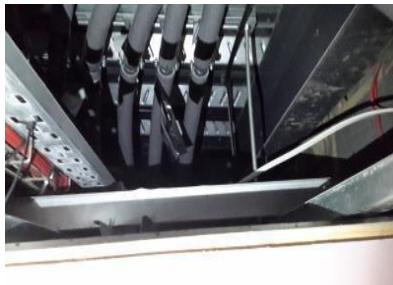
| 3.5 Action Plan - Health, Safety & Fire Risk/Hazards Risk/Hazard | | | | |
|---|---|---|---|---|
| Breach in compartmentation with insufficient fire stopping installed. Potential for fire, heat and smoke to spread through the property. | | | | |

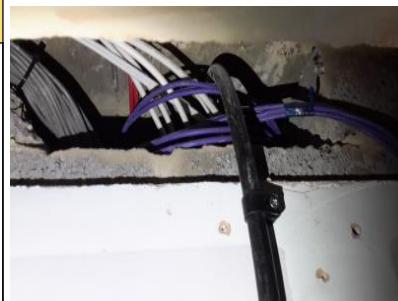
Breach in compartmentation with insufficient fire stopping installed in the CCTV cupboard and unknown boarding at the rear car park exit.

Potential for fire, heat and smoke to spread through the property.

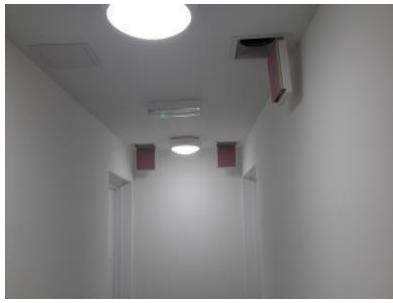
| 3.5 Action Plan - Health, Safety & Fire Risk/Hazards Risk/Hazard | | | | | | |
|---|---|---|---|---|--|--|
| <p>Fire door hatches are being left open.</p> <p>Potential for smoke, heat and fire to spread throughout premises.</p> | | | | | | |

| 3.5 Action Plan - Health, Safety & Fire Risk/Hazards Risk/Hazard | | | | | | |
|---|---|---|---|---|--|--|
| <p>Lock hatches.</p> <p>Ensure fire doors hatches are kept closed at all times. Tenants/contractors must be informed (in writing) of this requirement. Maintain fire doors operative and in good repair.</p> | | | | | | |

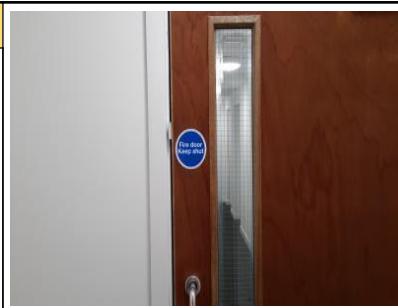
The gap between the fire door leaf and the frame is excessive.

Potential for fire and smoke to spread through property.

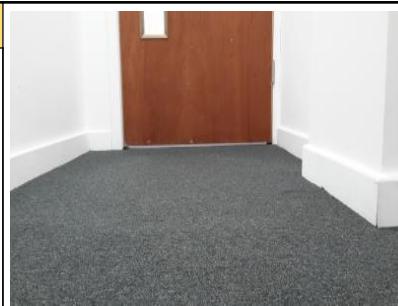
The threshold gap to the bottom of the door is excessive, ie, larger than 8mm.

Potential for fire and smoke to spread through property.

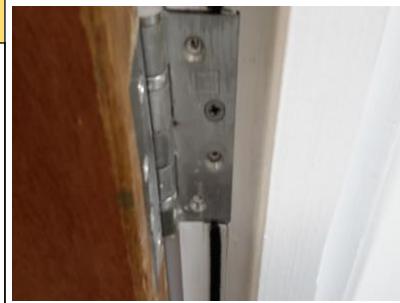
Fire door may not perform correctly, missing screws from hinges.

Potential for fire and smoke to spread through property

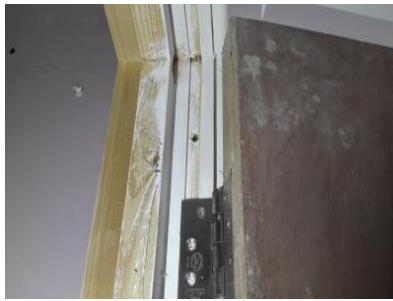
| 3.5 Action Plan - Health, Safety & Fire Risk/Hazards Risk/Hazard | | | | |
|---|---|---|---|---|
| Ground floor CCTV cupboard | | | | |

| 3.5 Action Plan - Health, Safety & Fire Risk/Hazards Risk/Hazard | | | | |
|---|---|---|---|---|
| Cold smoke seal/intumescent strip missing. Potential for fire & smoke to spread through property. | | | | |

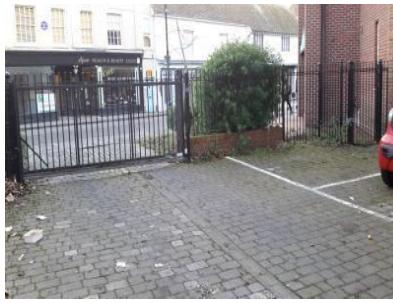
| 3.5 Action Plan - Health, Safety & Fire Risk/Hazards Risk/Hazard | | | | |
|---|---|---|---|---|
| Fire exit gate padlocked and gate requires a code. Potential to hinder evacuation of building in the event of an emergency. | | | | |

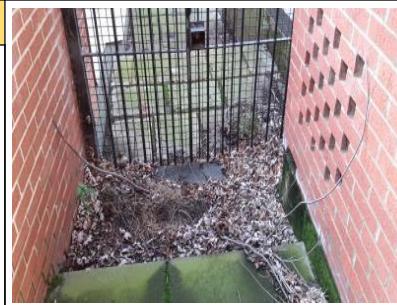
Final Fire Exit gate. External side of fire exit gate obstructed by debris.

Potential to hinder evacuation of building in the event of an emergency.

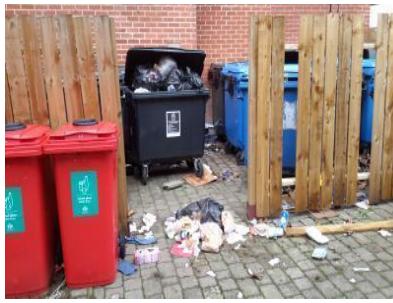
| 3.5 Action Plan - Health, Safety & Fire Risk/Hazards Risk/Hazard | | | | |
|---|---|---|---|---|
| Car park area | | | | |

| 3.5 Action Plan - Health, Safety & Fire Risk/Hazards Risk/Hazard | | | | |
|---|---|---|---|---|
| Refuse / rubbish container stored too close to building and overflowing containers. Potential for fire to spread into the building. | | | | |

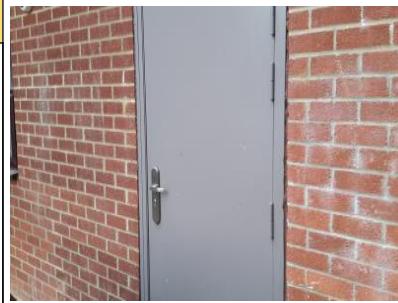
The advisor was unable to gain access to this area, locked door.

Potential for hazards to exist undetected, remain unmanaged and subsequently, cause injury and/or present a fire hazard.

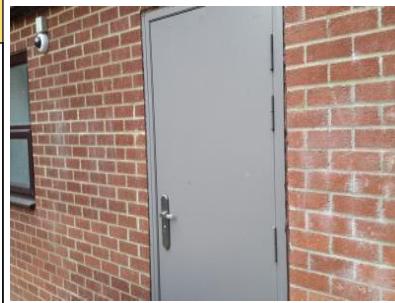
No electrical hazard information/voltage signage displayed on the electrical intake cupboard doors.

Potential electric shock.

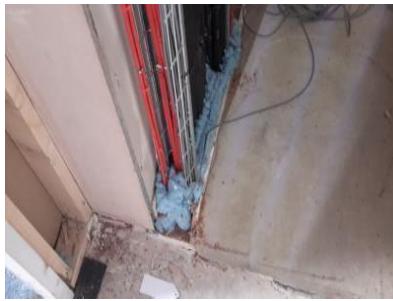
| 3.6 Action Plan - Health, Safety & Fire Risk/Hazards Risk/Hazard | | | | |
|---|---|---|---|---|
| Excessive amount of intumescent foam has been used to fire stop gaps. Foam should only be used for gaps less than 40mm or those stipulated in the manufacturer data sheet. Potential for fire and smoke to spread through the property | | | | |

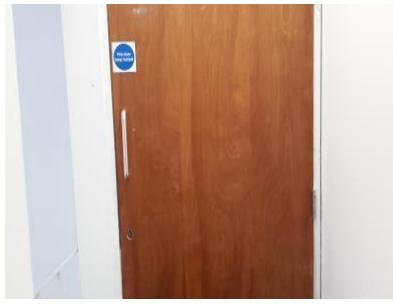
| 3.6 Action Plan - Health, Safety & Fire Risk/Hazards Risk/Hazard | | | | |
|---|---|---|---|---|
| Riser cupboards throughout | | | | |

| 3.6 Action Plan - Health, Safety & Fire Risk/Hazards Risk/Hazard | | | | |
|---|---|---|---|---|
| Riser cupboard door not locked. Potential for fire and smoke to spread through property. | | | | |

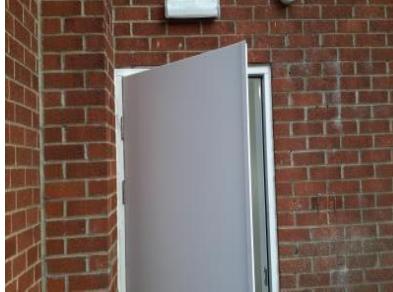
| 3.6 Action Plan - Health, Safety & Fire Risk/Hazards Risk/Hazard | | | | |
|---|---|---|---|---|
| Side exit point | | | | |

| 3.6 Action Plan - Health, Safety & Fire Risk/Hazards Risk/Hazard | | | | |
|---|---|---|---|---|
| External side of final fire exit door does not display "Fire Exit Keep Clear" signage. Potential to hinder evacuation of building in the event of an emergency. | | | | |

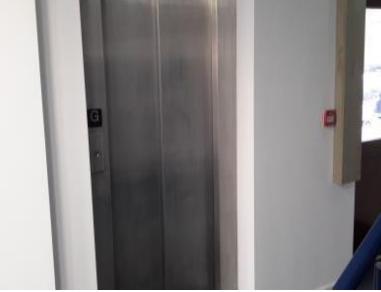
| 3.6 Action Plan - Health, Safety & Fire Risk/Hazards Risk/Hazard | | | | |
|---|---|---|---|---|
| Lift entry points | | | | |

| 3.6 Action Plan - Health, Safety & Fire Risk/Hazards Risk/Hazard | | | | |
|---|---|---|---|---|
| No notices displayed stating "Do Not Use Lift in Event of Fire". Potential for persons to become trapped in the lift car if the power failed, or potential for the lift car to take persons to the floor affected by fire. | | | | |

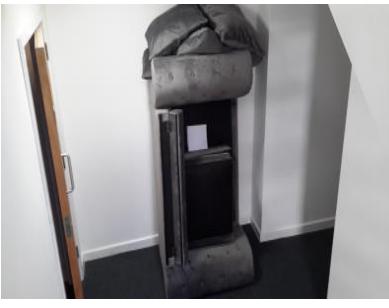
| Hazard Description |
|---|
| Storage on escape route. If storage is allowed to accumulate, it could result in blocked escape routes. Potential to hinder evacuation of building in the event of an emergency. |

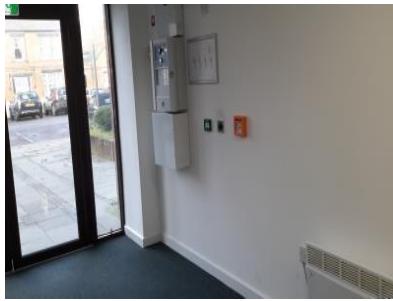
| 3.6 Action Plan - Health, Safety & Fire Risk/Hazards Risk/Hazard | | | | |
|---|---|---|---|---|
| No "No Smoking" signs displayed. Potential fire hazard, and/or health hazards associated with secondhand smoke. | | | | |
