FIRE SAFETY REPORT

Premises	
Premise's name	2020 House
Address	Skinner Lane Leeds LS7 1BB

Report Details	
Date of report	18 th November 2021
Amendment date	N/A
Requested by	John Marsden - Castles
Produced by	Richard Coggon BSc (Hons) MIFireE

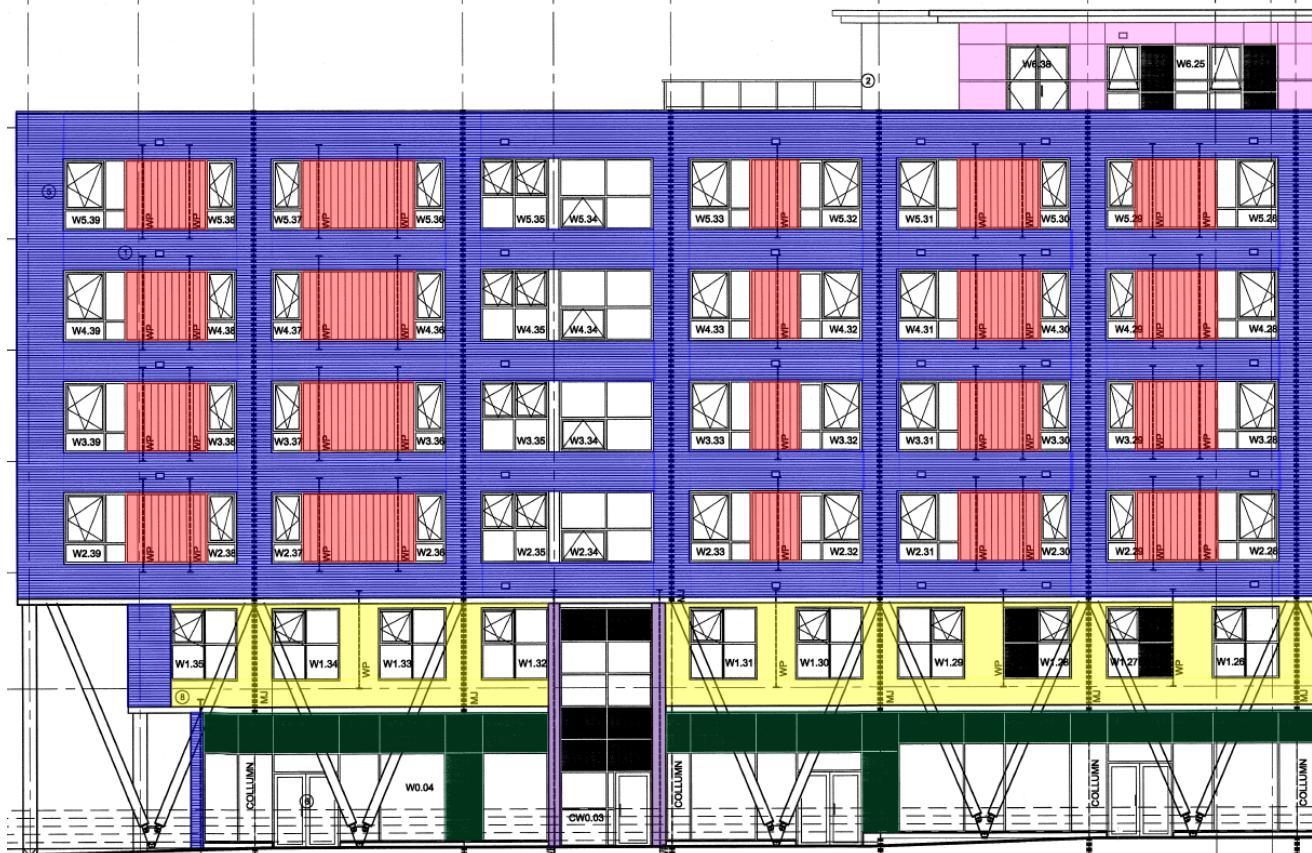
Figure 1: 2020 House North elevation external wall construction

Construction	Brickwork	Timber/HPL cladding	Render cladding	Grey aluminium cladding	Glazing spandrel panels	6 th floor cladding
Colour	Blue	Red	Yellow	Purple	Green	Pink

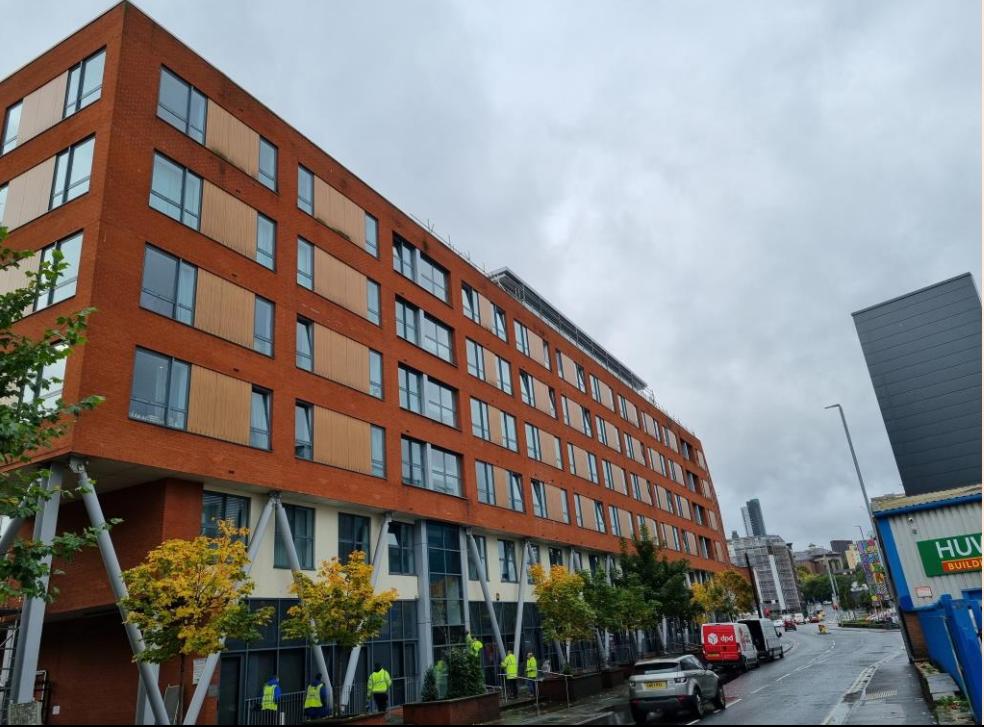
Description	Photograph 1
North elevation of the building

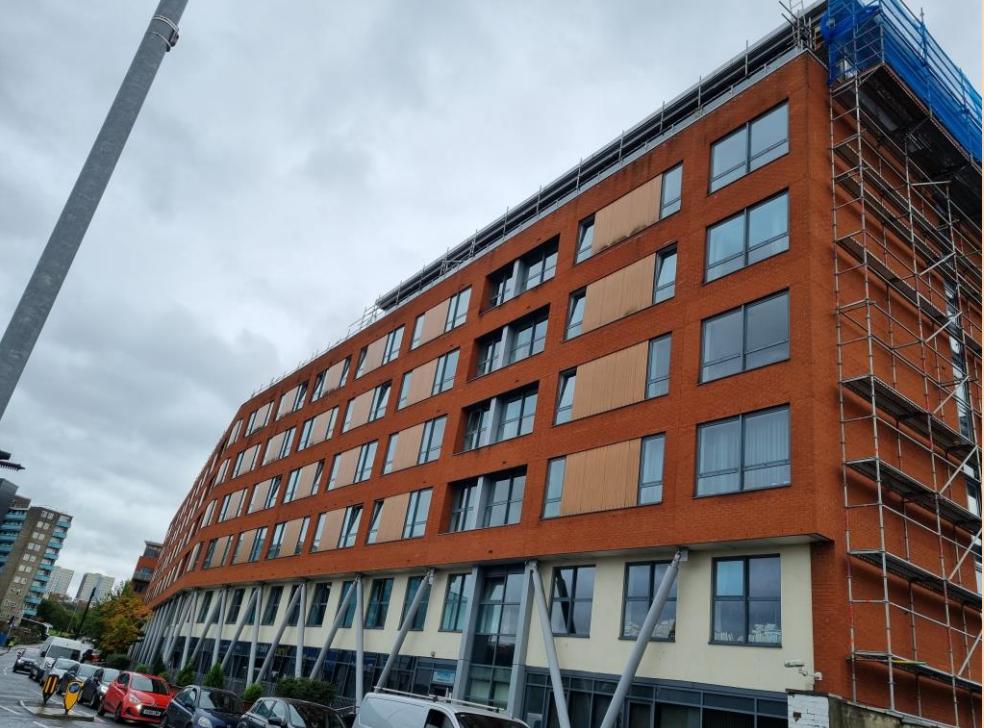
Description	Photograph 2
North elevation of the building

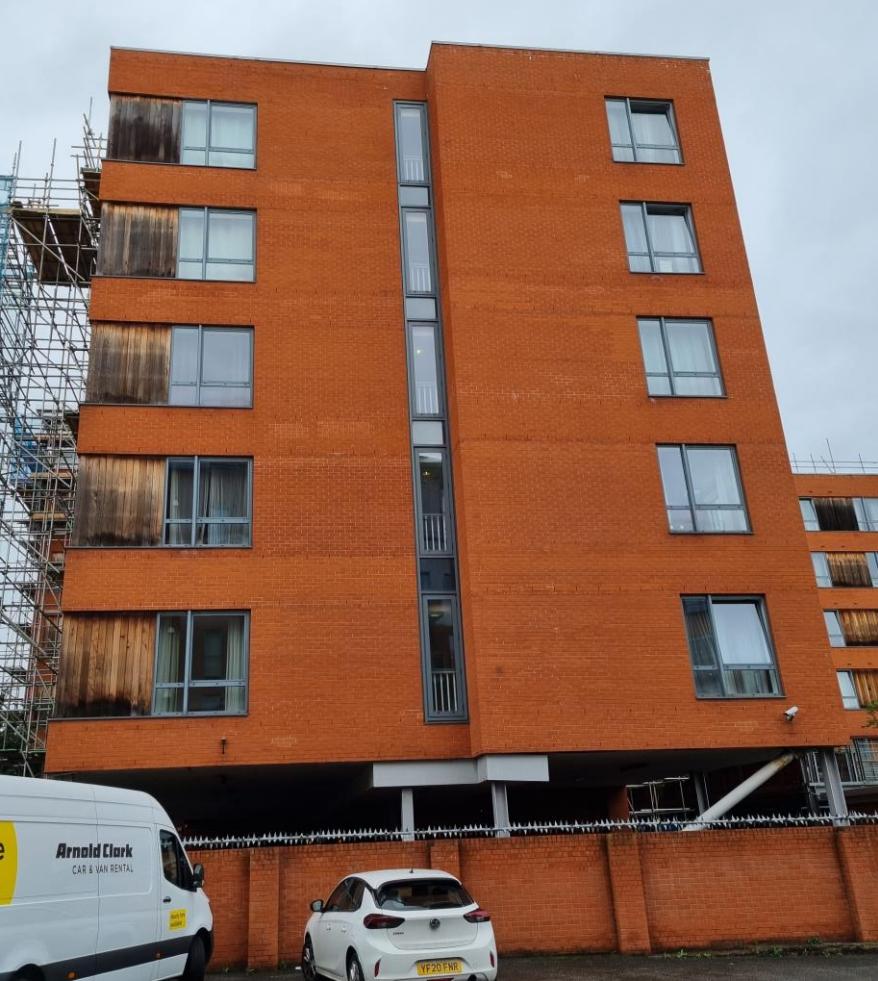
Description	Photograph 7
South elevation of the building rear leg

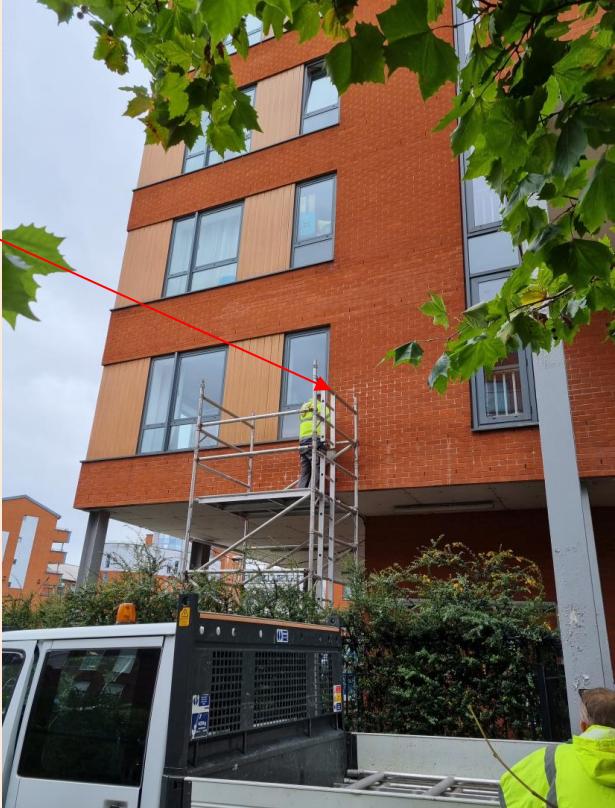
Description	Photograph 9
An intrusive investigation took place in the building East elevation at 1 st floor in the brickwork system close to the corner apartment window

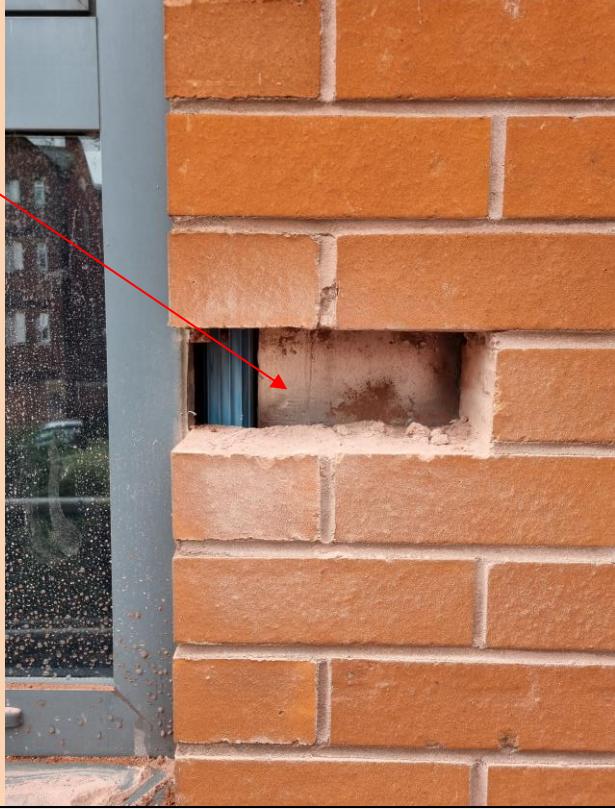
A brick was removed from the system near the corner apartment window

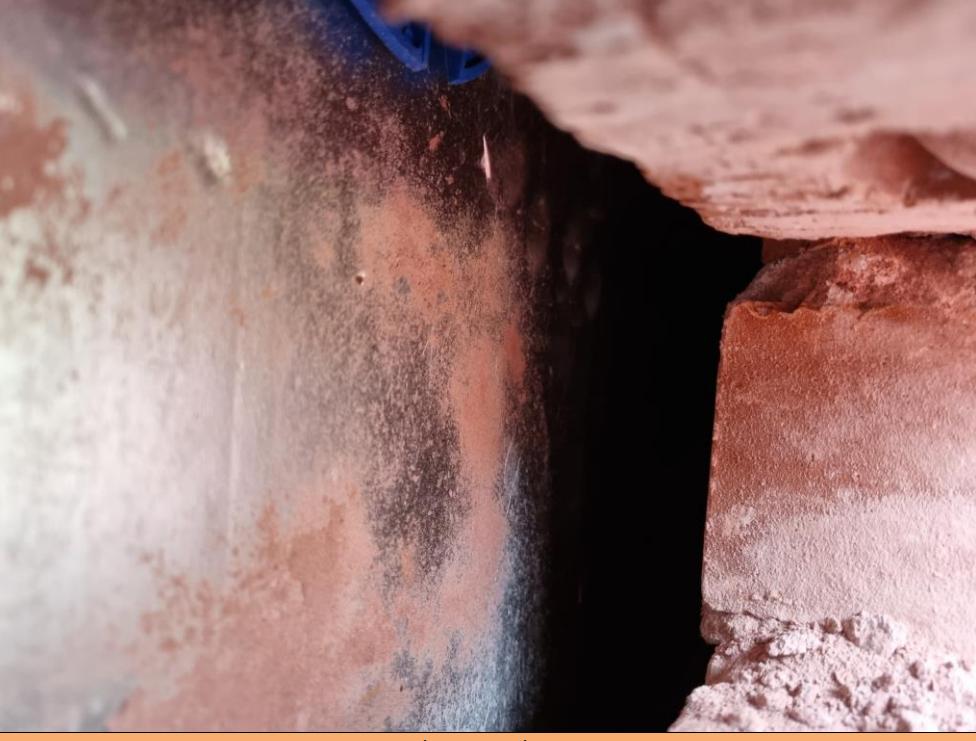
Description	Photograph 11
The brickwork system was found to contain a cavity and foil faced insulation

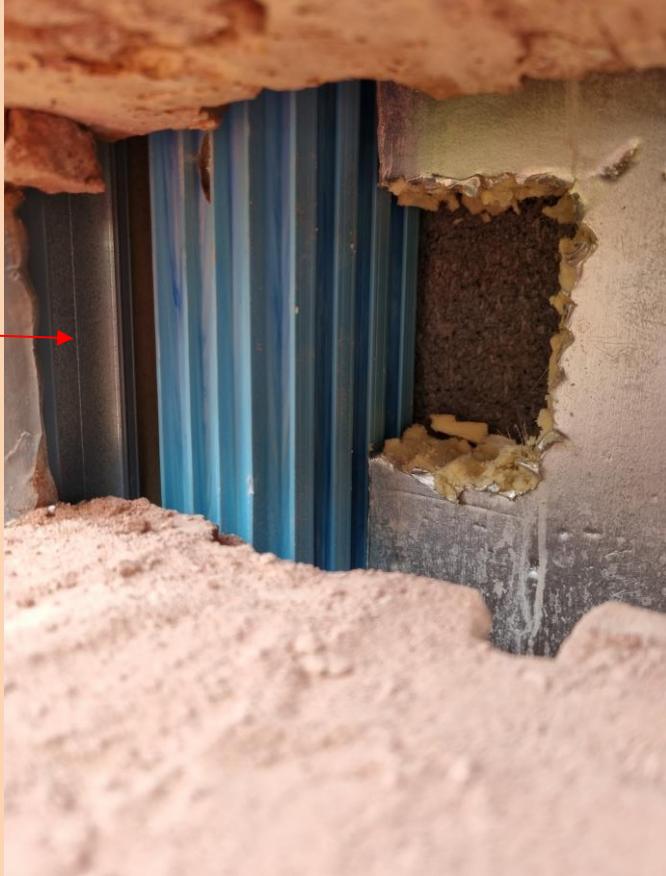
Description	Photograph 12
<p>The foil faced insulation was found to be of a foam PIR type with a blockwork internal leaf at the rear of the system</p> <p>No cavity closer was located around the apartment window opening</p>

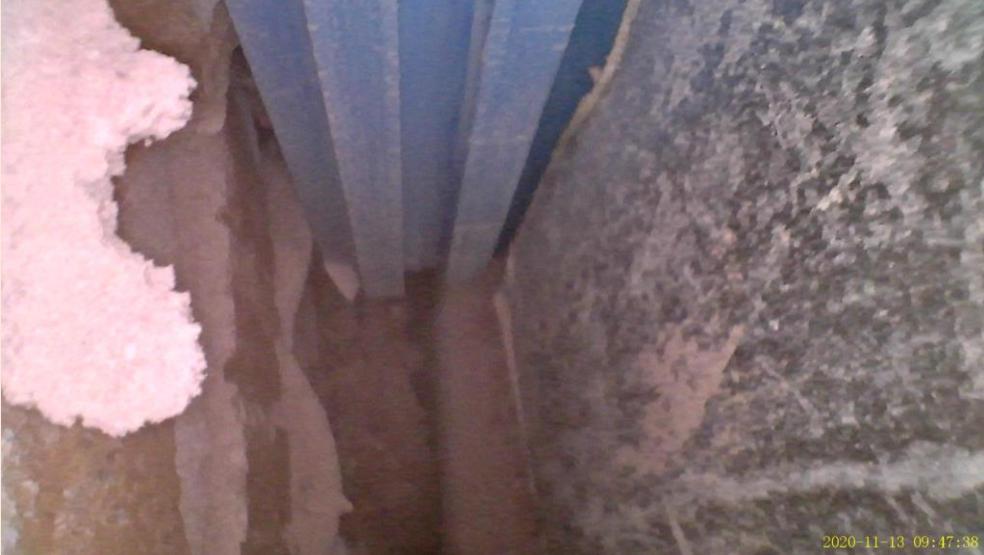
Description	Photograph 13
A borescope was used within the brickwork system and no cavity closer could be located around the window opening

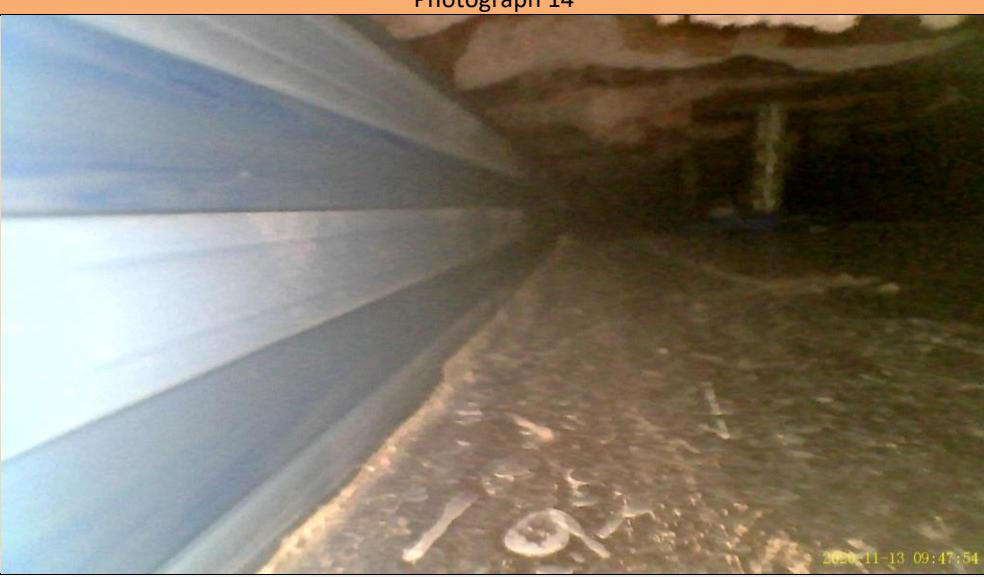
<p>2020-11-13 09:47:38</p>
Description	Photograph 14
A borescope was used within the brickwork system and no cavity fire barriers vertically or horizontally could be located

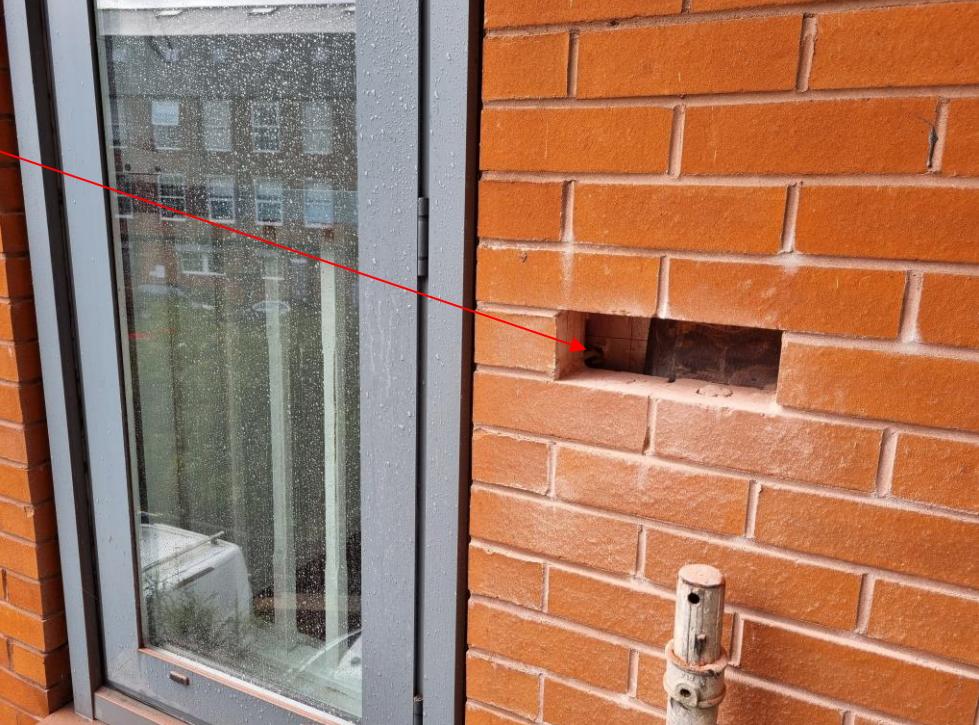
Description	Photograph 15
An intrusive investigation took place in the building East elevation at 1 st floor in the brickwork system close to the common corridor window

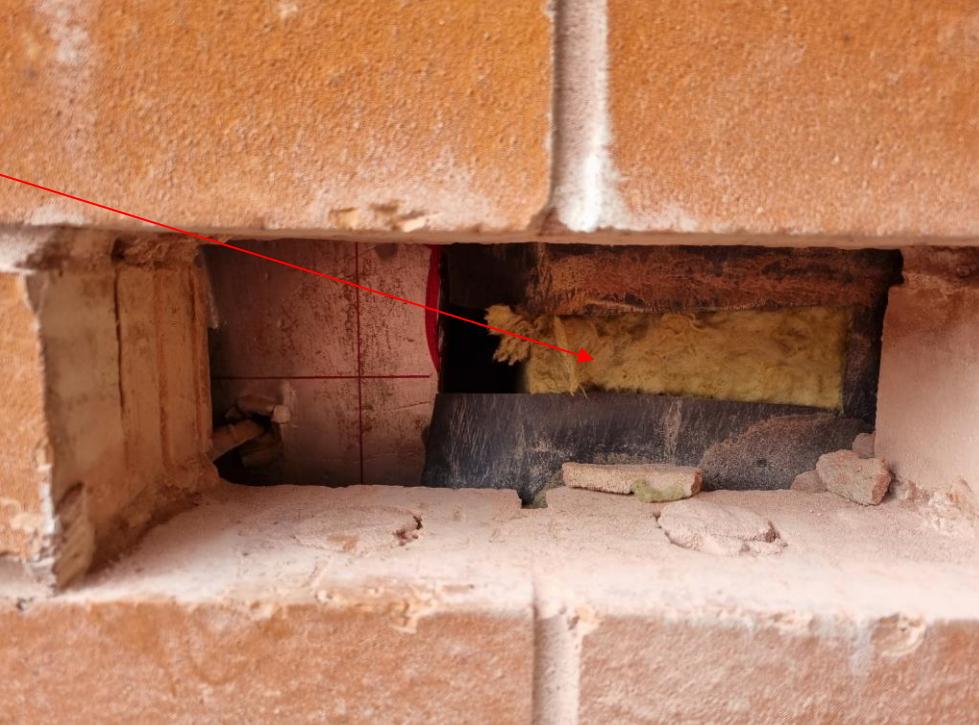
Description	Photograph 16
A brick was removed from the system Mineral wool insulation was located within the system to provide protection to the structural steel work

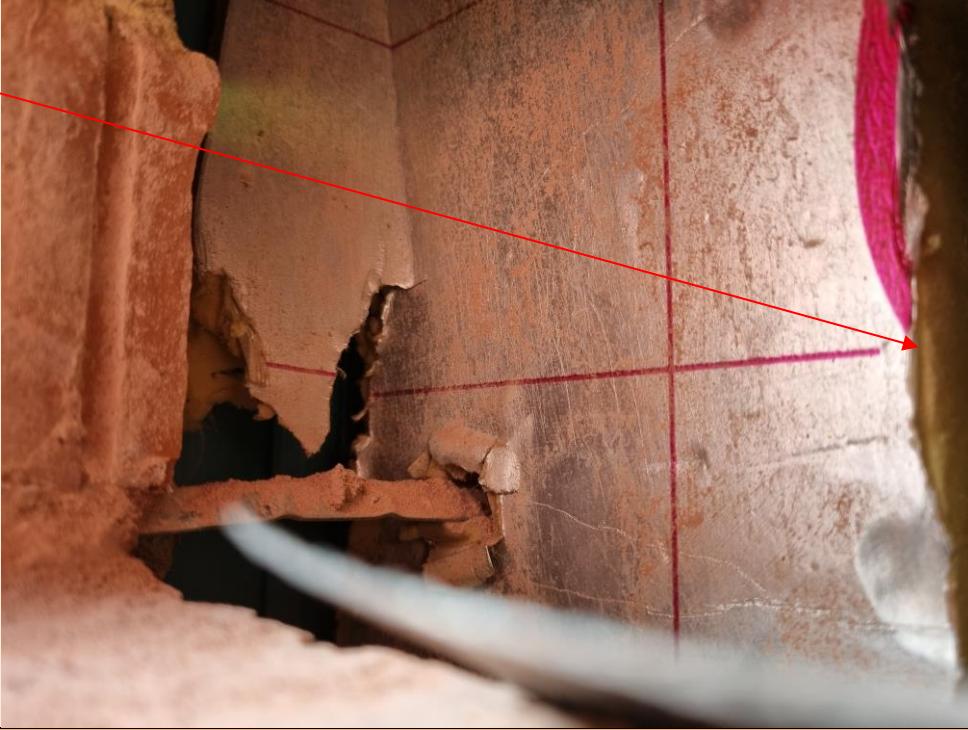
Description	Photograph 17
The brickwork system was found to contain a cavity and foil faced insulation

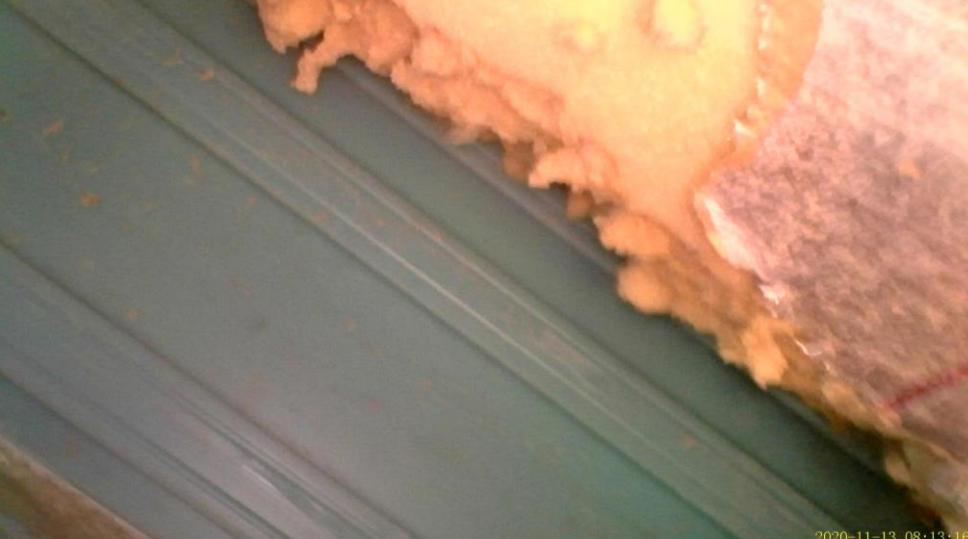
A borescope was used within the brickwork system and no cavity closer could be located around the window opening

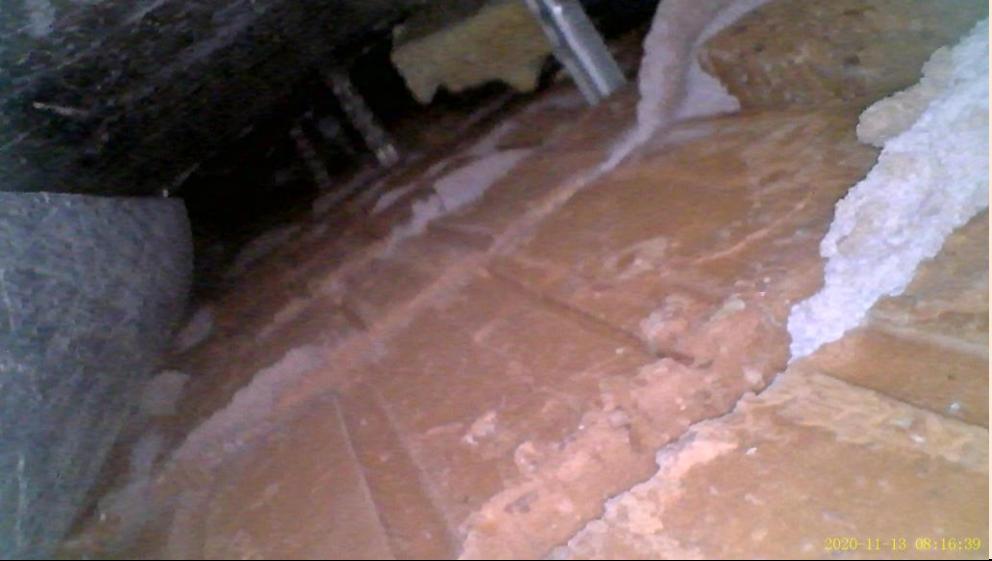
<p>Description</p> <p>A borescope was used within the brickwork system and no cavity fire barriers vertically or horizontally could be located</p>	<p>Photograph 19</p>

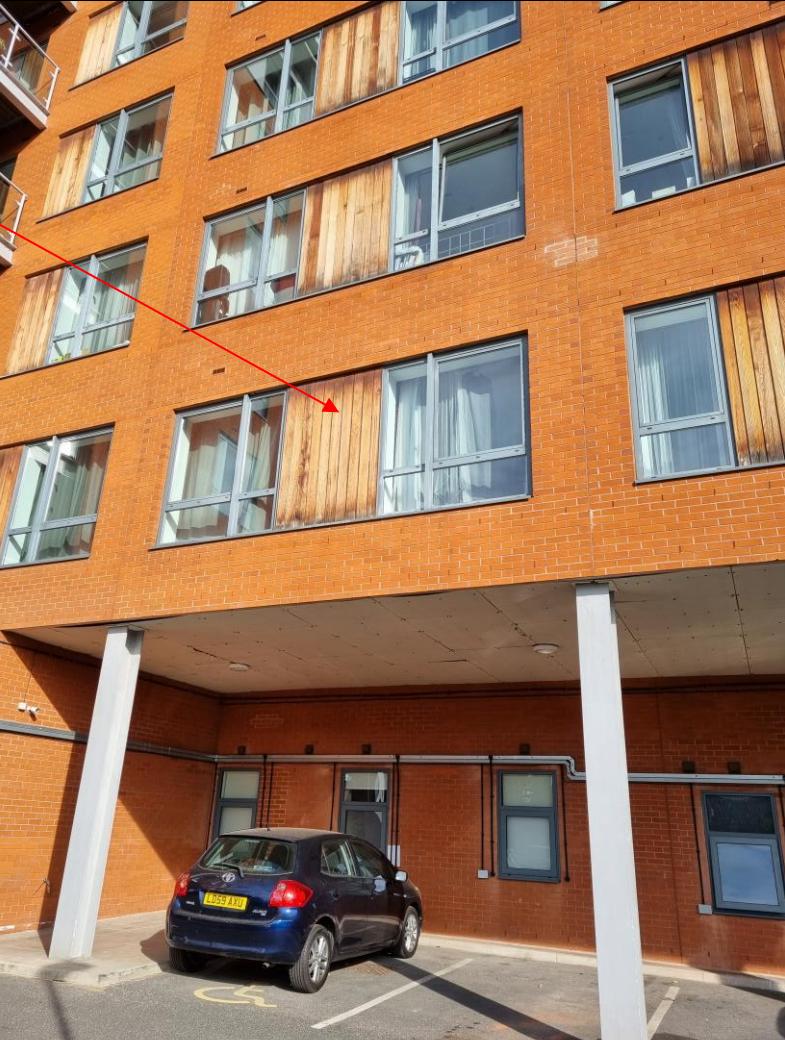
<p>Timber cladding panels are fitted in some areas of the building.</p> <p>Timber has a European fire classification of D and is combustible.</p> <p>This is supported by Photograph 20, 21 and 22 in Section 7.</p>	<p>The timber cladding panels on the building external façade should be removed and replaced with an external wall surface material that achieves class A2-s1, d0 or better.</p> <p>Any insulation product or filler material within the system should be class A2-s1, d0 or better.</p>

<p>2020-11-13 08:16:39</p>
<p>Description</p> <p>An intrusive investigation was carried out on the timber cladding system on the building South elevation at 1st floor</p>	<p>Photograph 20</p>

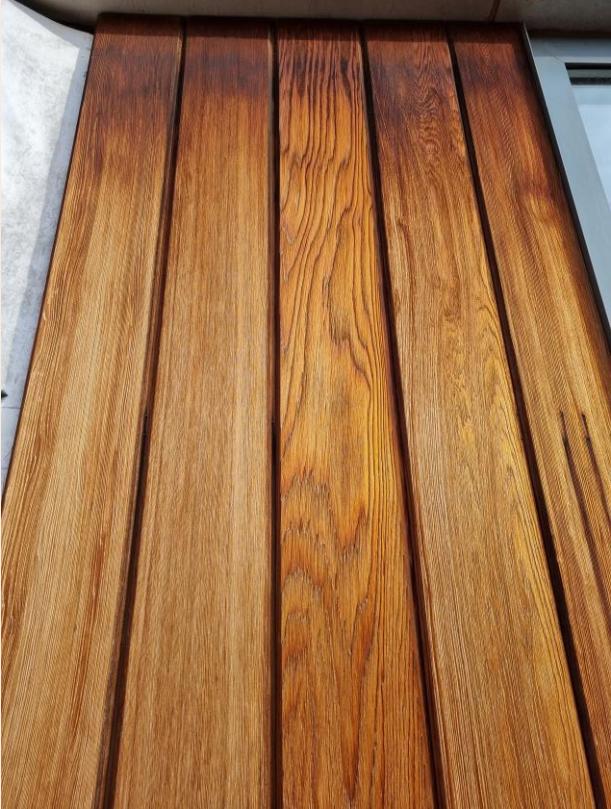
Description	Photograph 21
The timber cladding panels were removed from the system

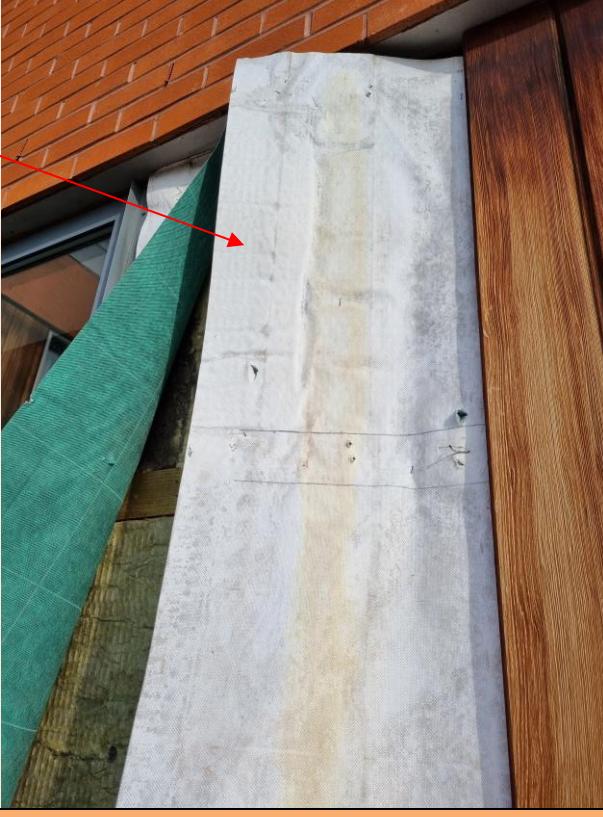
Description A breather membrane was revealed behind the timber cladding panels	<p style="text-align: center;">Photograph 23</p>

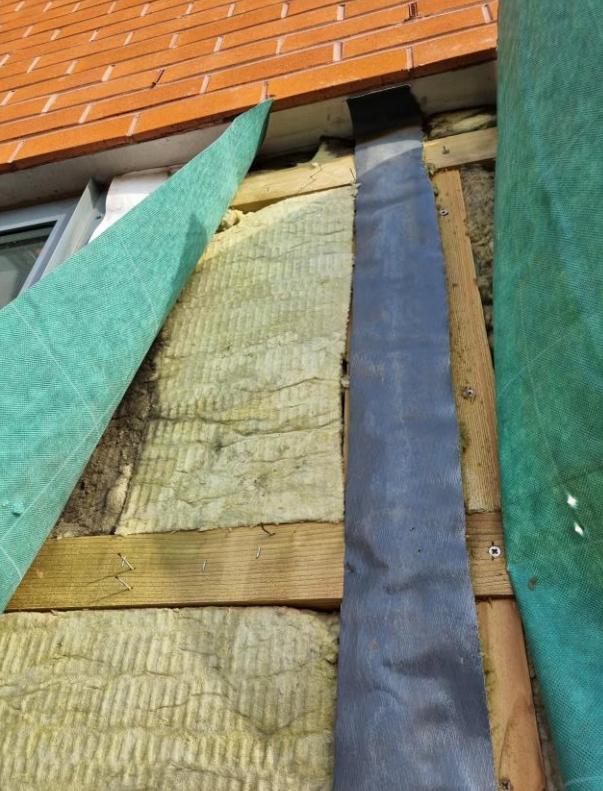
<p>Soft wood timber battens are present within the timber and Trespa Meteon high pressure laminate cladding systems.</p> <p>Timber has a European fire classification of D and is combustible.</p> <p>This is supported by Photograph 24, 25, 32 and 33 in Section 7.</p>	<p>The soft wood timber battens should be removed from within the timber and Trespa Meteon high pressure laminate cladding systems and replaced with a product that achieves class A2-s1, d0 or better.</p> <p>An example replacement would be steel or aluminium support rails.</p>

Description Beyond the breather membrane were horizontal and vertical soft wood timber battens with full fill mineral wool insulation in between	<p style="text-align: center;">Photograph 24</p>

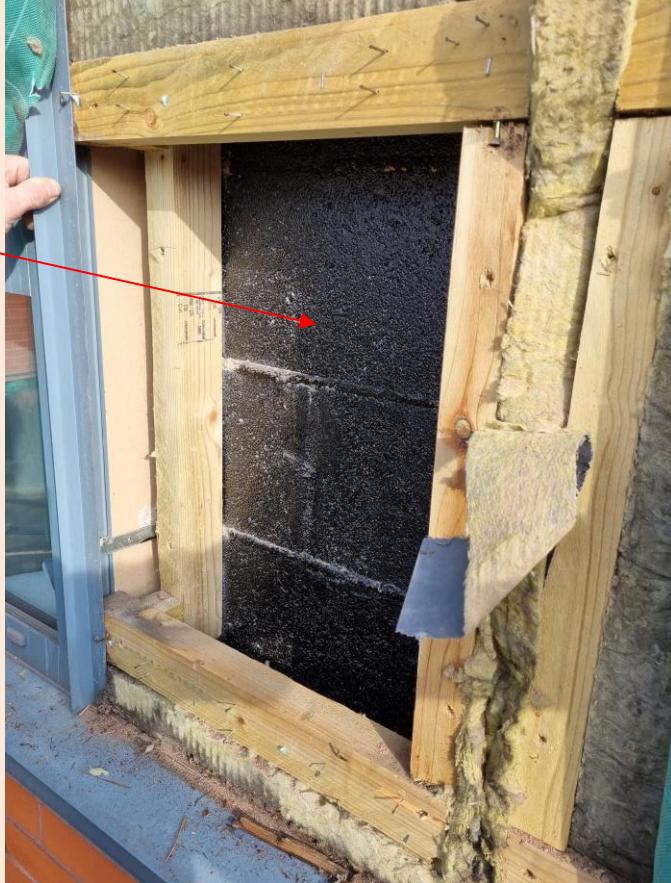
Description	Photograph 25
<p>Inner leaf blockwork was located at the rear of the system</p> <p>The blockwork had been painted with a bituminous coating</p>

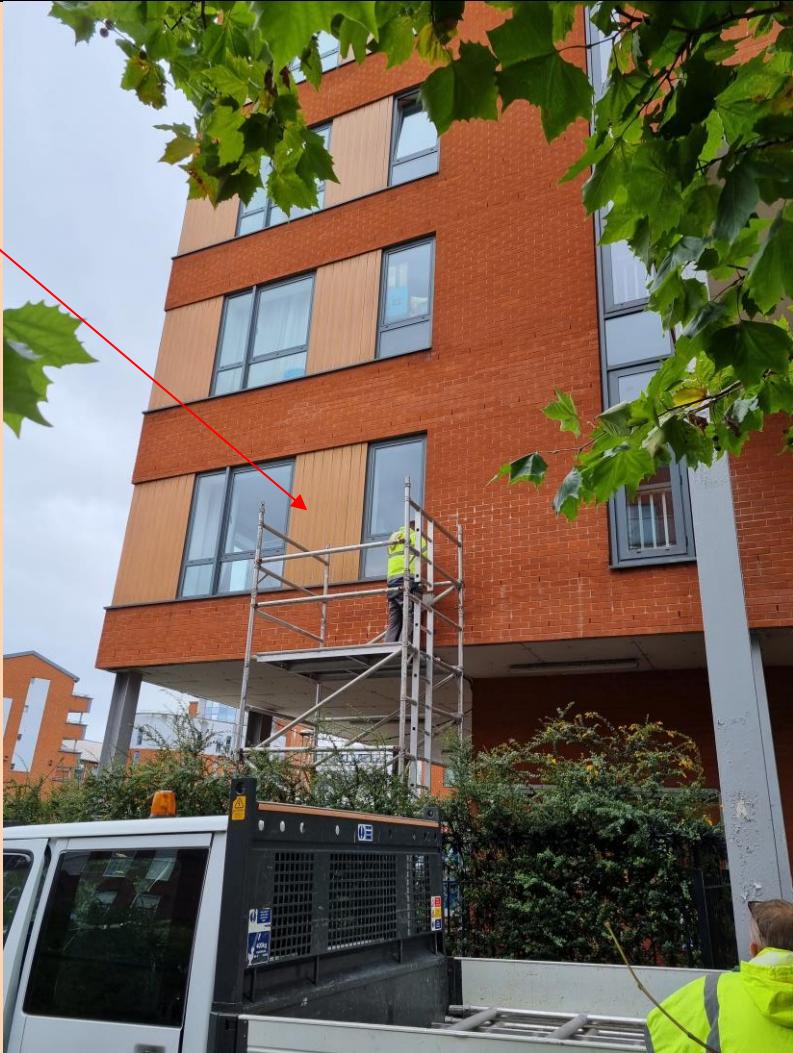
Significant Hazard	Additional Control Measures
<p>Trespa Meteon high pressure cladding panels are fitted in some areas of the building.</p> <p>Trespa Meteon has a European fire classification of D-s2, d0 and is combustible.</p> <p>This is supported by Photograph 28, 29, 30 and 31 in Section 7.</p>	<p>The Trespa Meteon high pressure laminate cladding panels on the building external façade should be removed and replaced with an external wall surface material that achieves class A2-s1, d0 or better.</p> <p>Any insulation product or filler material within the system should be class A2-s1, d0 or better.</p>
<p>An unknown breather membrane is present as part of both the timber and Trespa Meteon high pressure laminate cladding systems.</p> <p>This is supported by Photograph 23, 24 and 32 in Section 7.</p>	<p>The breather membrane positioned within the timber and Trespa Meteon high pressure laminate cladding systems should be replaced with one that achieves European fire class B-s3, d0 or better.</p>

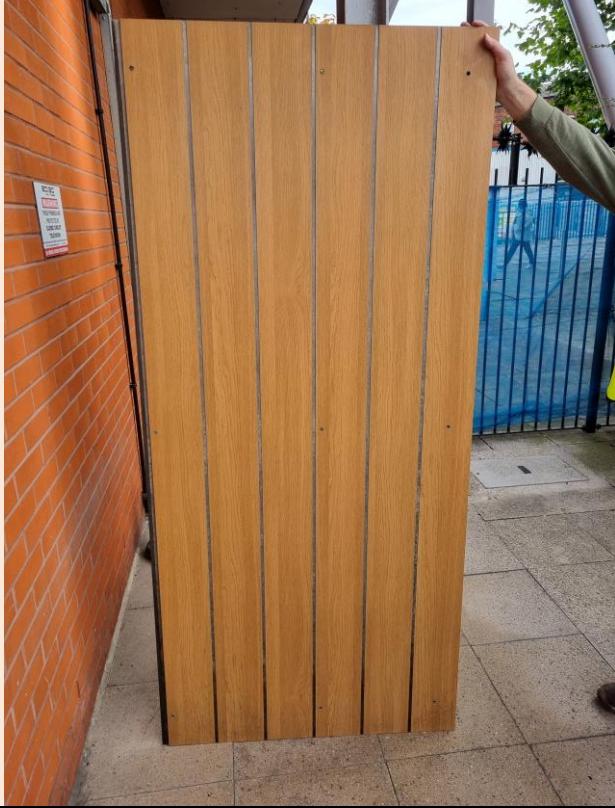
Description	Photograph 29
A timber effect high pressure laminate cladding panel was removed

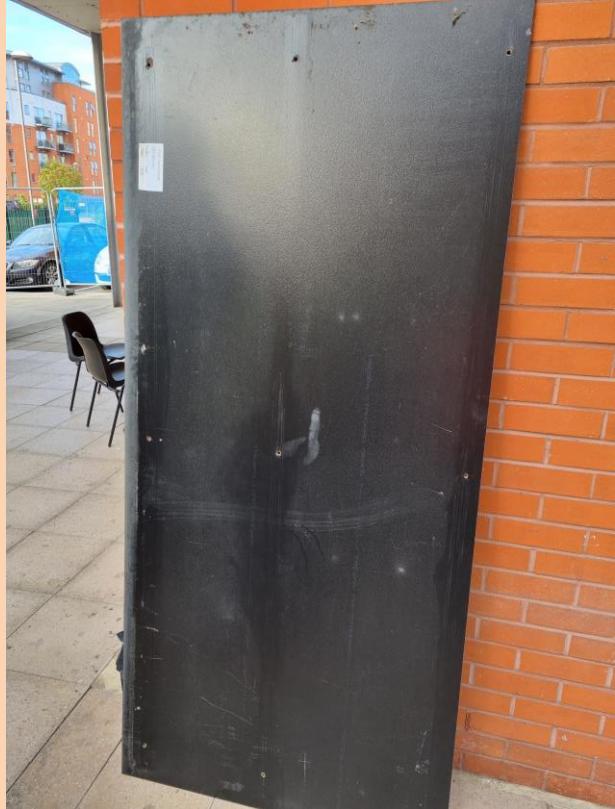
Description	Photograph 30
The high pressure laminate cladding panel was found to be a Trespa Meteon panel

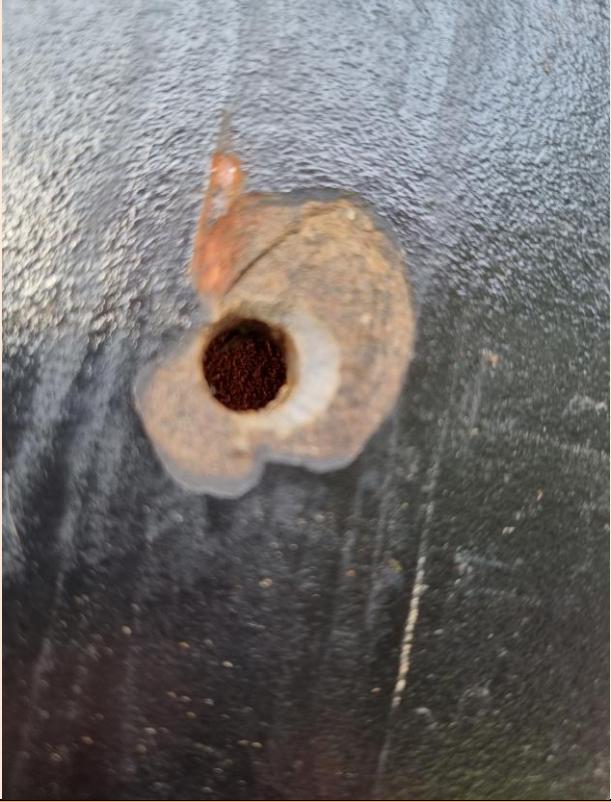
Description	Photograph 31
The high pressure laminate cladding panel was found to be a Trespa Meteon panel

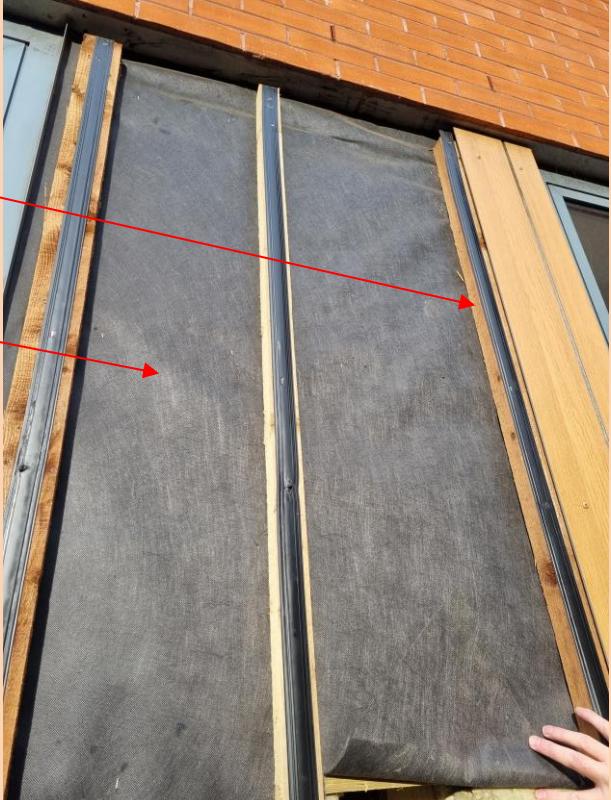
Description	Photograph 32
<p>A small cavity was located behind the high pressure laminate cladding panel with soft wood timber battens positioned vertically</p> <p>A breather membrane was located beyond the soft wood timber battens</p>

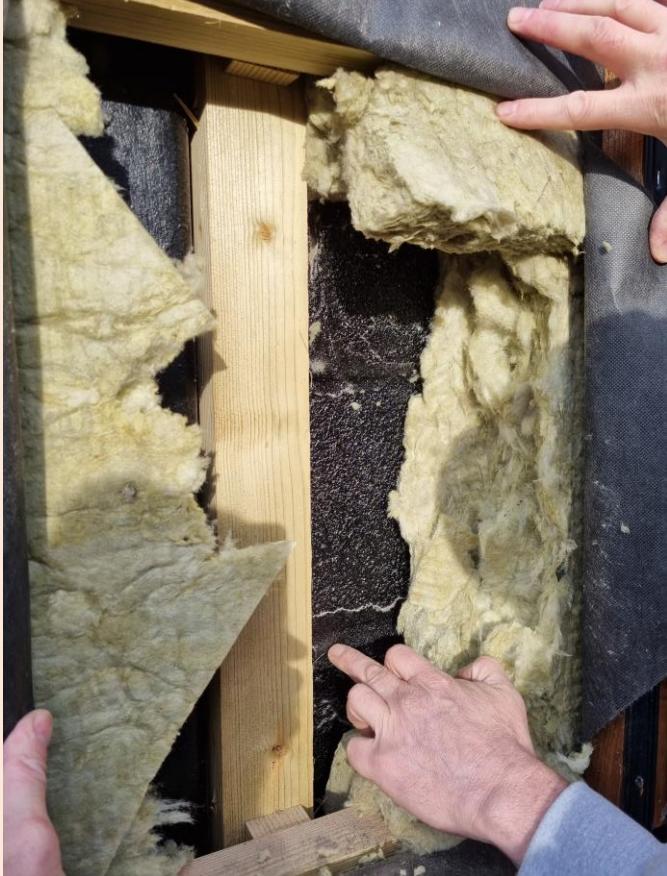
Description	Photograph 33
The breather membrane was cut away to reveal horizontal and vertical soft wood timber battens with full fill mineral wool insulation in between

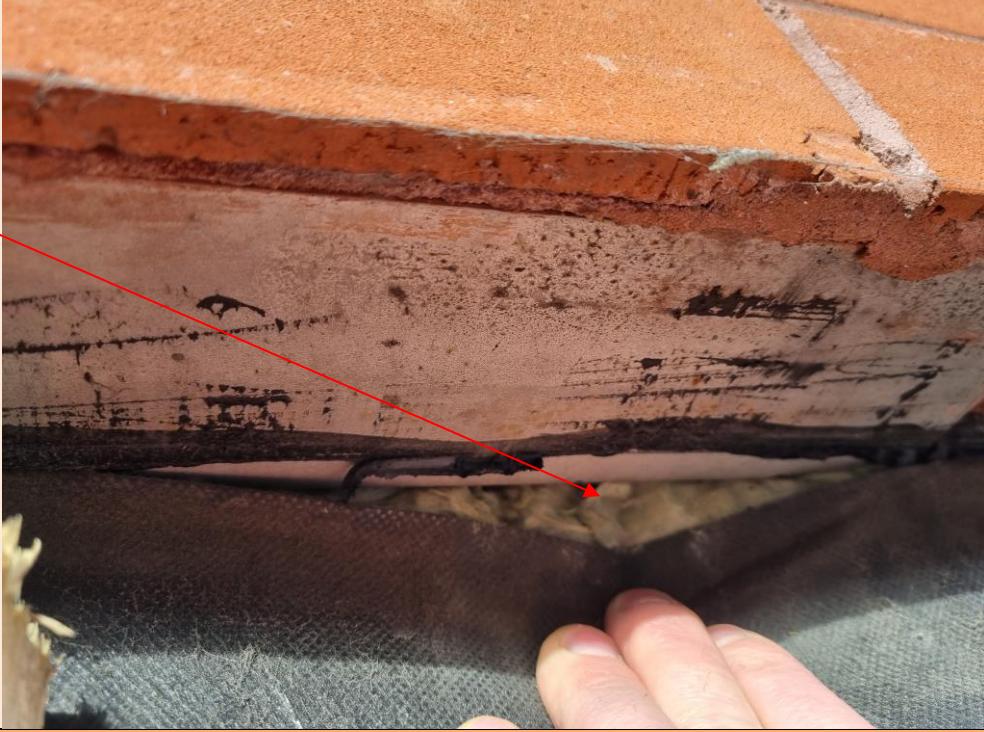
Description	Photograph 35
Mineral wool insulation was located above the high pressure laminate cladding system into the cavity of the brickwork system above

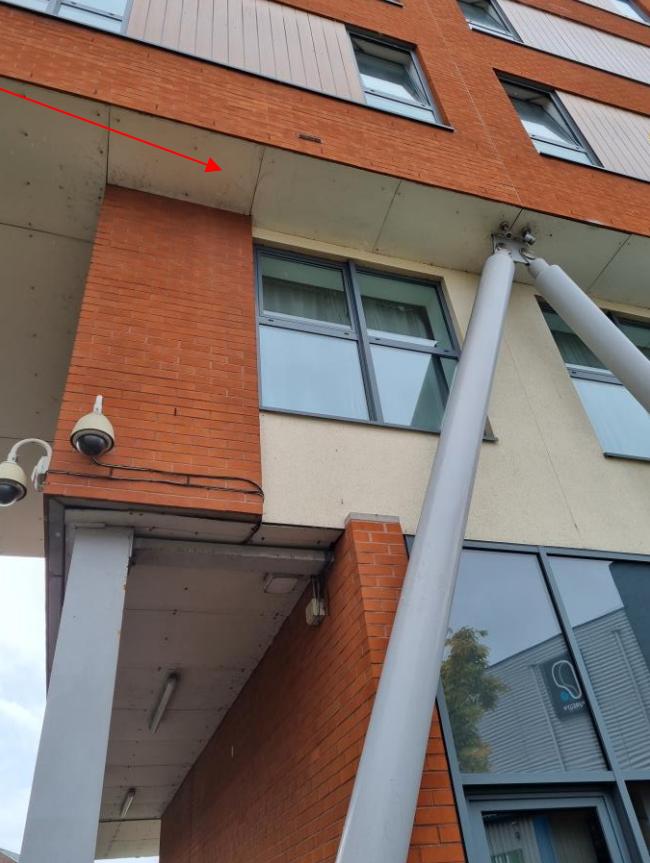
Description	Photograph 36
Soffit cladding panels are provided on the upper floor levels of the building These panels are positioned close to the building external wall façade and in some instances window openings

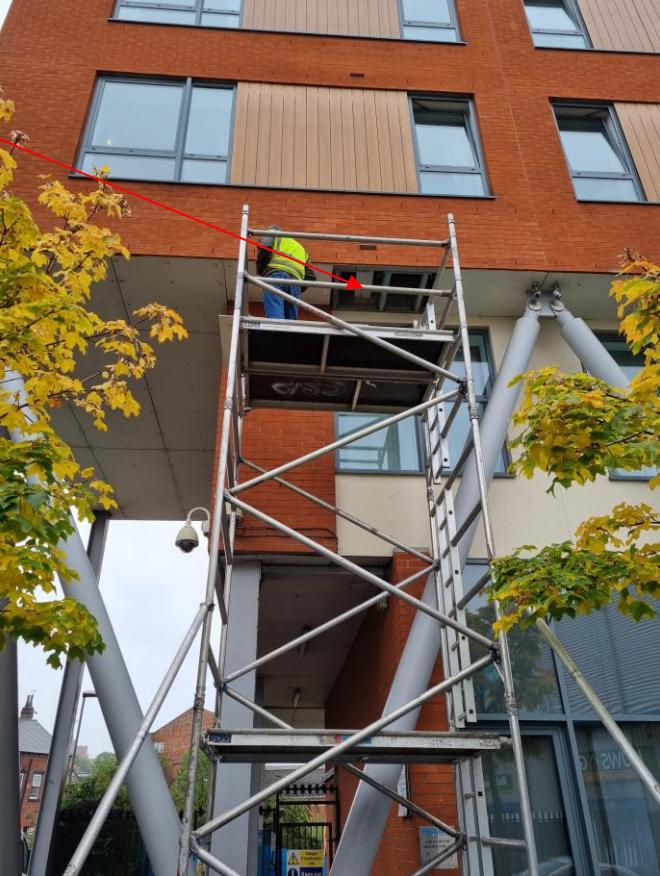
<p>Description</p> <p>An intrusive investigation was completed in the soffit of the building North elevation below the 2nd floor</p>	<p>Photograph 37</p>

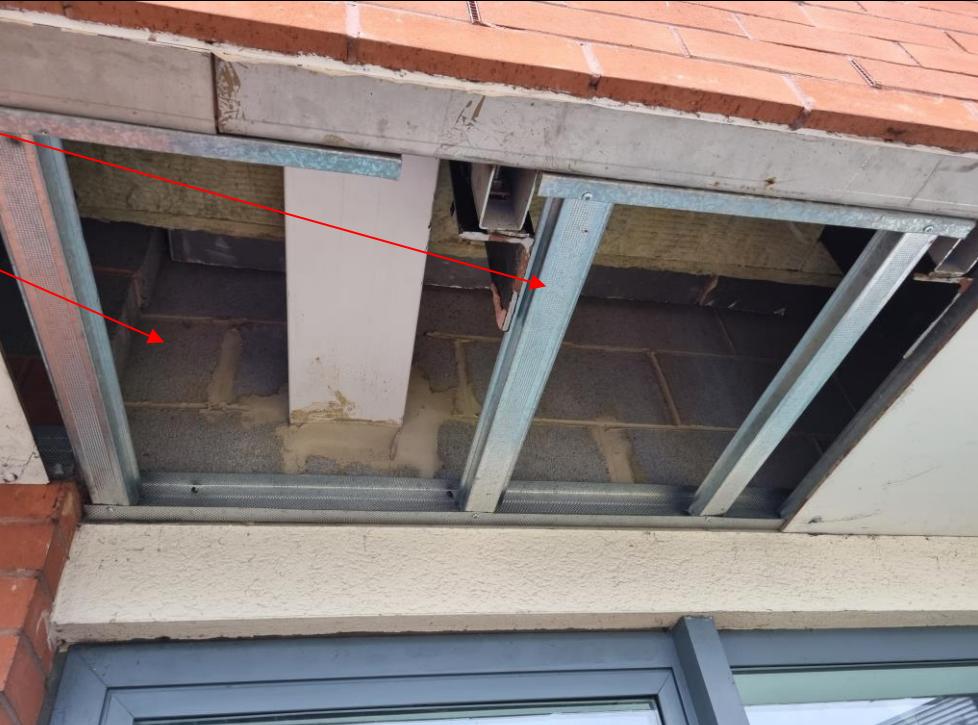
A cavity was found to be present in the soffit cladding systems during intrusive investigations. No cavity fire barriers could be located within the soffit cladding systems.

<p>Description</p> <p>A soffit cladding panel was removed to reveal an aluminium support structure and a large void above</p> <p>A blockwork internal wall was visible in the soffit void</p>	<p>Photograph 38</p>

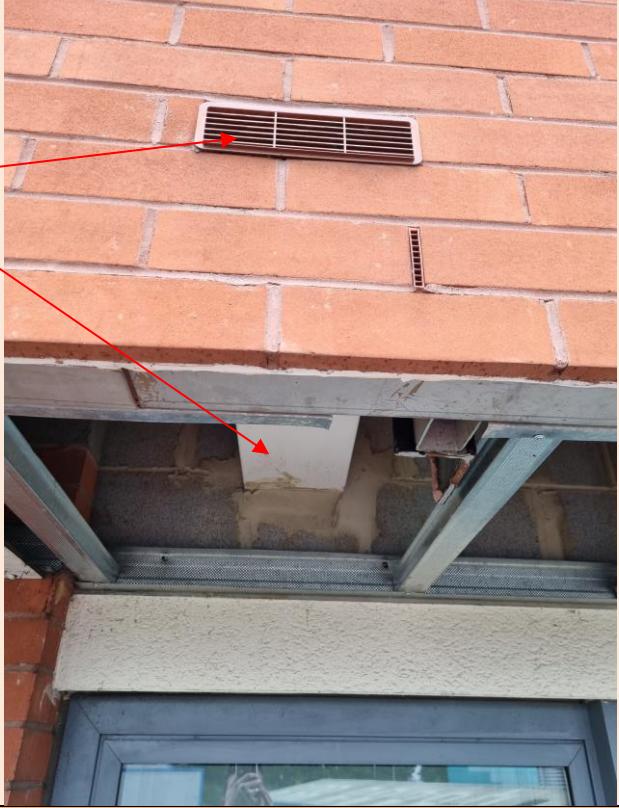
Description	Photograph 39
A uPVC extract duct from the 1 st floor apartment below was located in the soffit void

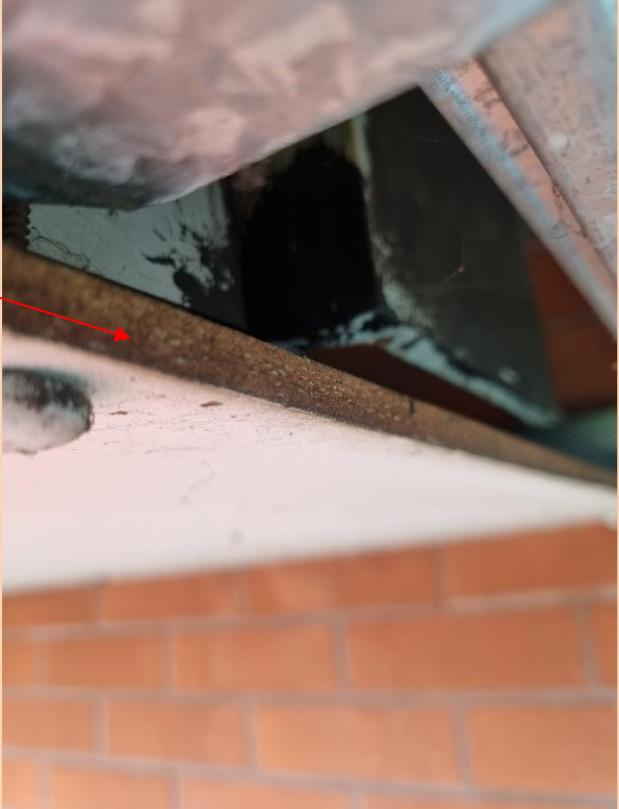
<p>Unknown white faced cladding panels are fitted to the soffit bordering the building below the 2nd floor on the North and East elevation.</p> <p>The cladding panels may be timber based but this is unconfirmed.</p> <p>This is supported by Photograph 36, 40 and 41 in Section 7.</p>	<p>The unknown white faced soffit cladding panels bordering the building below the 2nd floor on the North and East elevations should be removed from the building and replaced with a surface material that achieves class A2-s1, d0 or better.</p>

The soffit cladding panel material is unknown in this location and could possibly be a form of timber

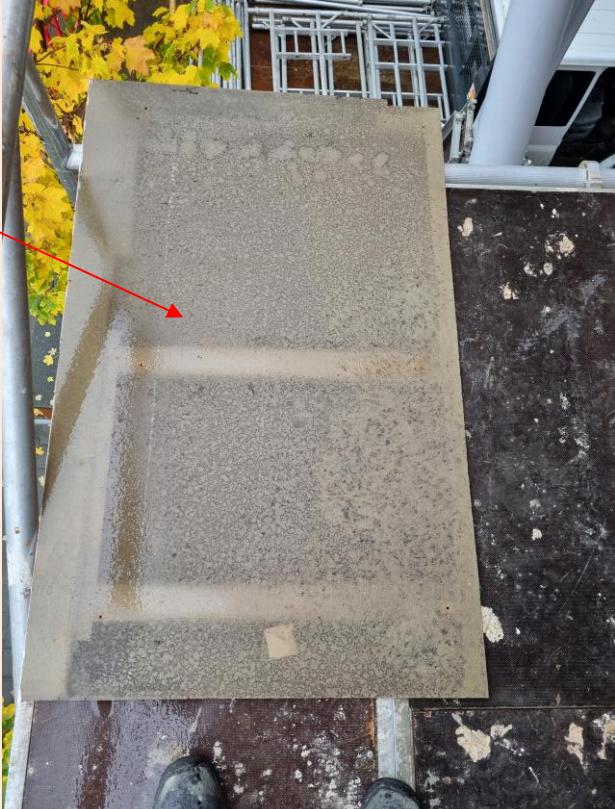
Description	Photograph 41
The soffit cladding panel material is unknown in this location and could possibly be a form of timber
