FIRE SAFETY REPORT

Premises	
Premise's name	2020 House
Address	Skinner Lane Leeds LS7 1BB

Report Details	
Date of report	18 th November 2021
Amendment date	N/A
Requested by	John Marsden - Castles
Produced by	Richard Coggon BSc (Hons) MIFireE

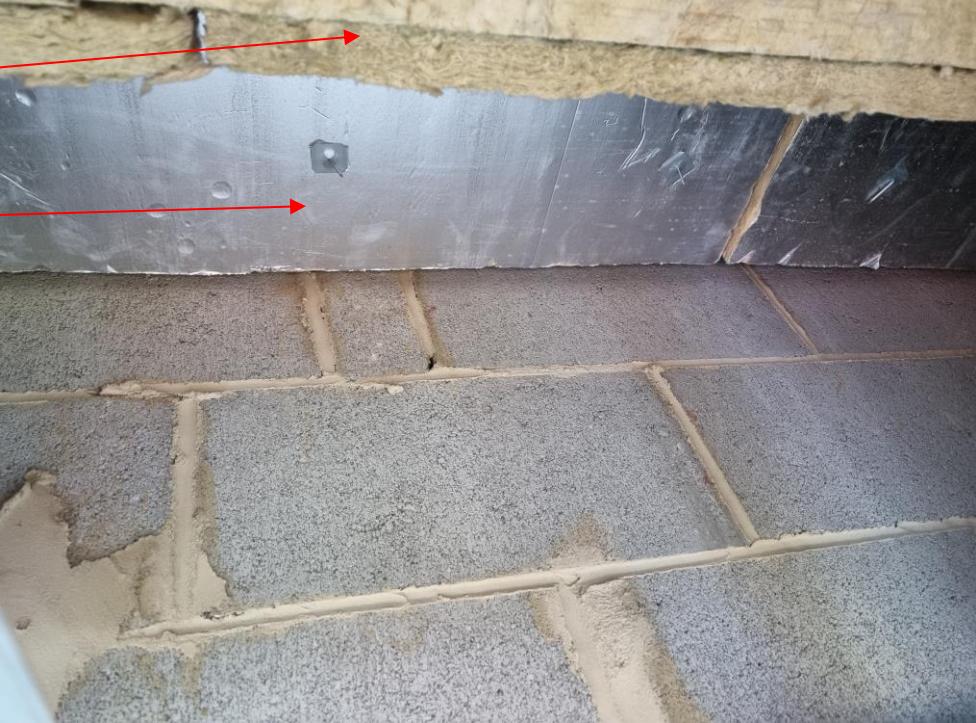
Description	Photograph 43
<p>Mineral wool insulation was found to be provided in some areas of the soffit void</p> <p>Foil faced PIR insulation was located at the top of the soffit void and beyond this insulation was steel floor tray with the concrete floor slab of the 2nd floor above</p>

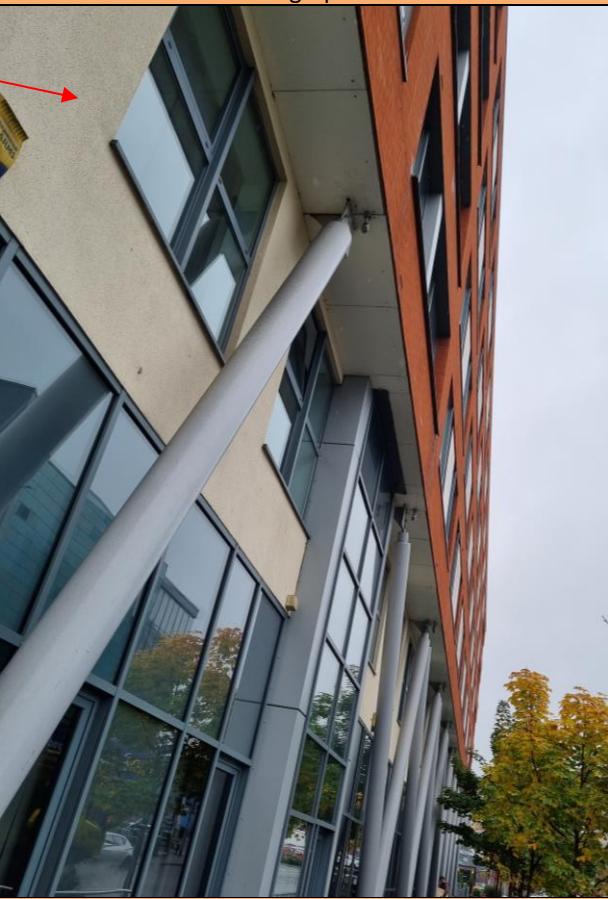
<p>Description</p> <p>A render cladding system is provided on the North elevation of the building and runs the length of the elevation on the 1st floor</p>	<p>Photograph 45</p>

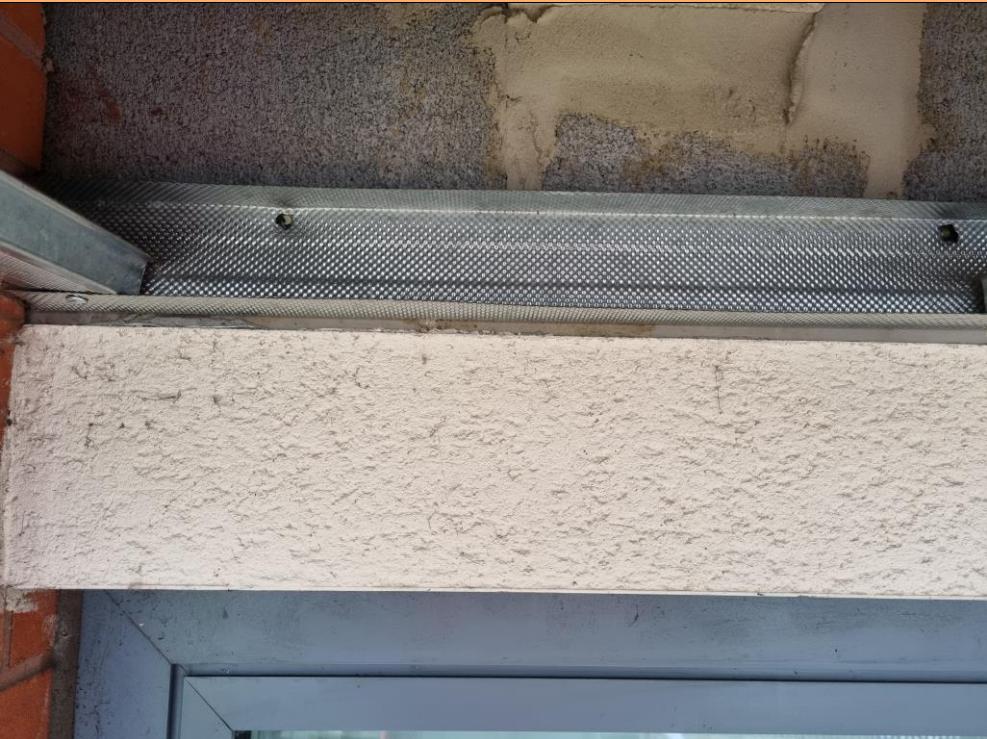
<p>Description</p> <p>A core sample was taken in the render cladding system and it was found that the render had been applied direct to the building internal leaf blockwork</p>	<p>Photograph 46</p>

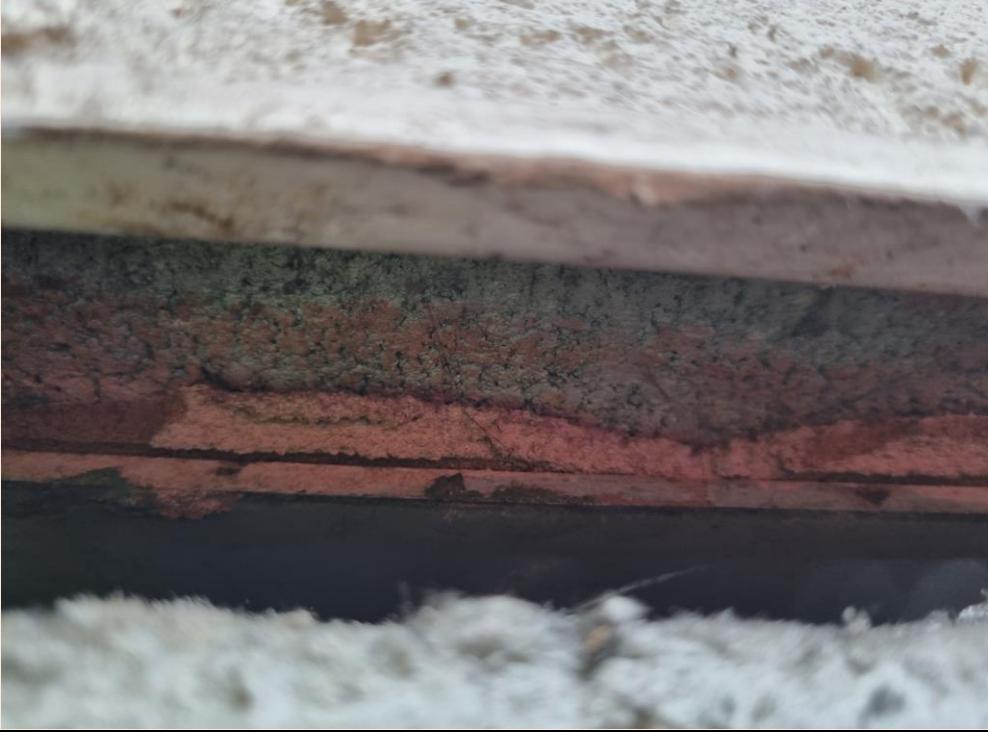
Description	Photograph 47
The render had been applied direct to the building internal leaf blockwork

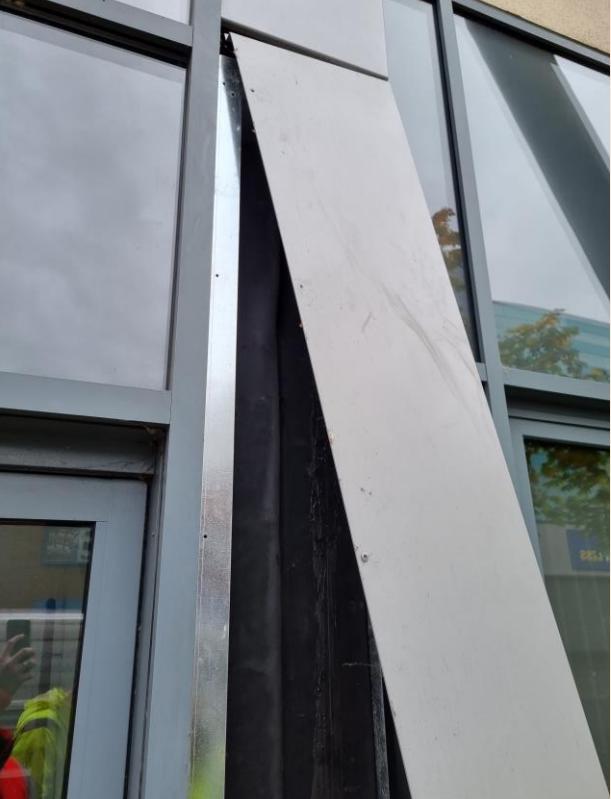
Description	Photograph 49
The cladding panel was removed and was found to be aluminium fixed to an aluminium support structure

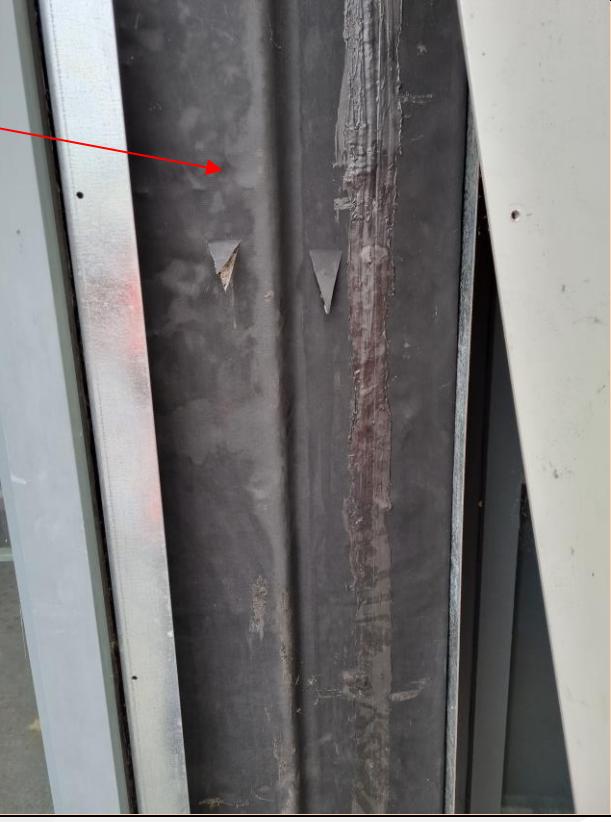
Significant Hazard	Additional Control Measures
<p>An EPDM rubber membrane is provided within the aluminium curtain wall cladding system on the building North elevation.</p> <p>The EPDM rubber membrane is combustible.</p> <p>This is supported by Photograph 50 in Section 7.</p>	<p>No further action required.</p> <p>Although the EPDM rubber membrane is combustible it will remain in situ within the aluminium curtain wall cladding system, this is acceptable when it is considered that:</p> <ul style="list-style-type: none"> ❖ The EPDM rubber membrane is present within a small area of aluminium cladding, which is only present as part of the entrance foyer of each building block on the North elevation; ❖ The cladding system only extends up to the 1st floor of the building; ❖ The system is not positioned close to any ignition sources.

Description	Photograph 50
Beyond the aluminium cladding panel was a EPDM type rubber material with a concrete and steel structure beyond this

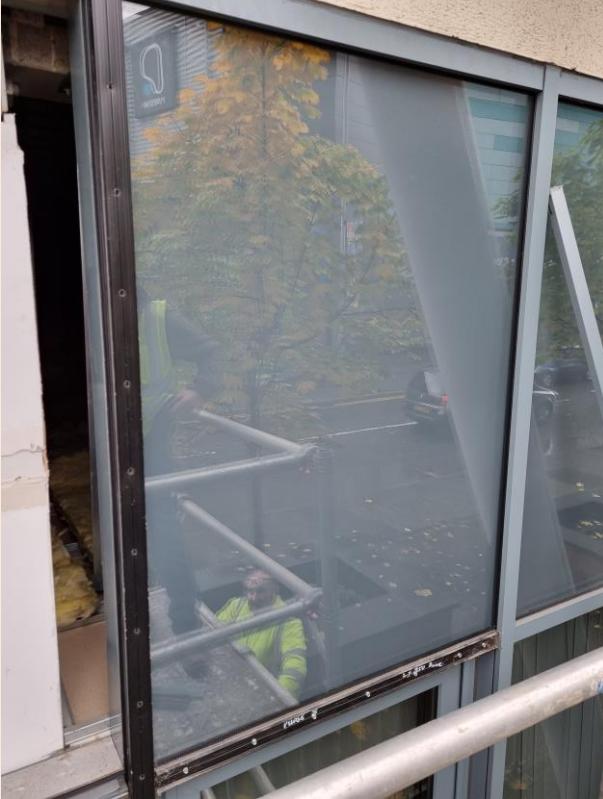
Description	Photograph 51
An intrusive investigation was completed within the glazed spandrel panel system on the building North elevation above the ground floor apartments

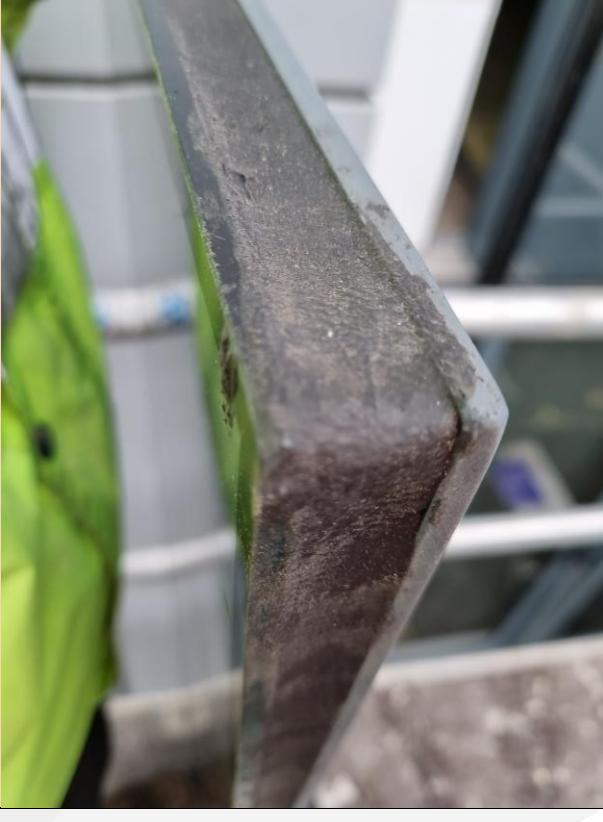
Description	Photograph 52
A glazed panel was removed from the system to reveal a double glazed unit with a gasket seal between

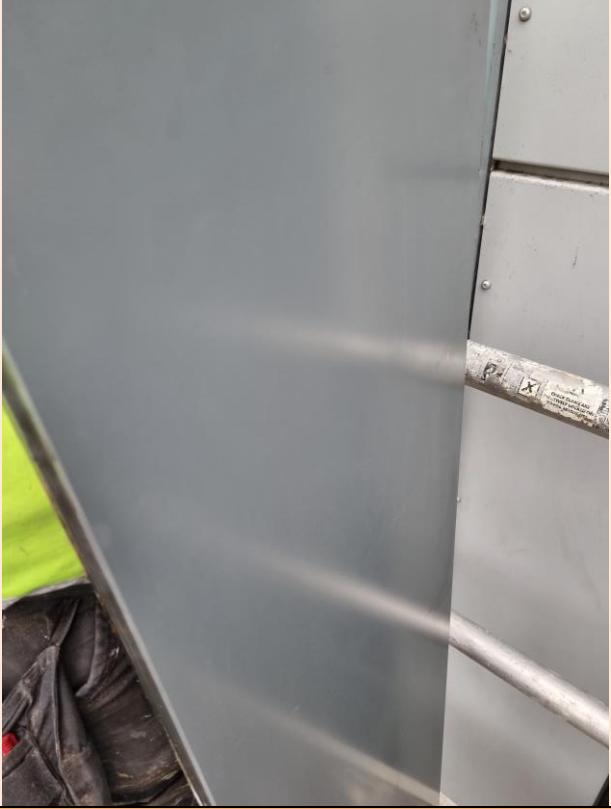
Description	Photograph 53
The glazed panel had a coloured black out backing on the inside glass

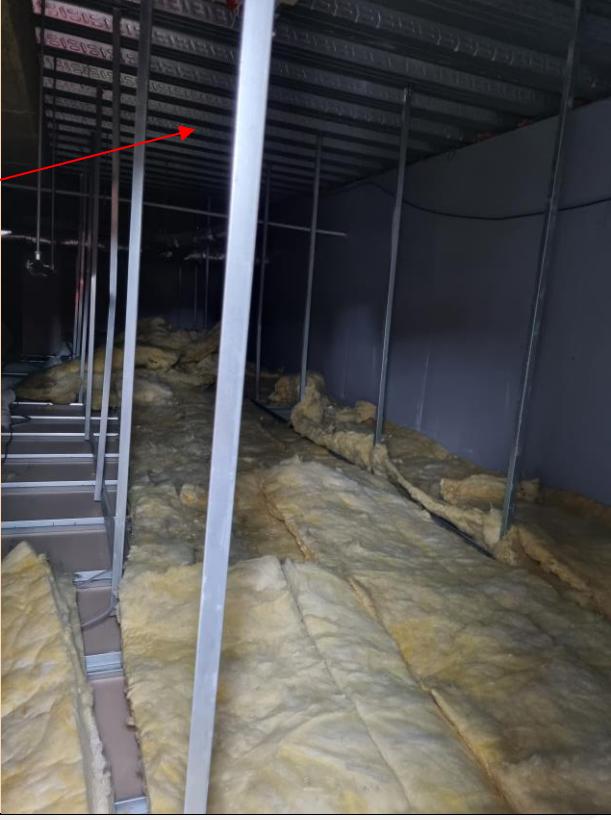
Description	Photograph 54
Beyond the glazed spandrel panel was a large void above the ground floor apartment A steel floor tray was present above the void for the concrete floor on the 1 st floor above

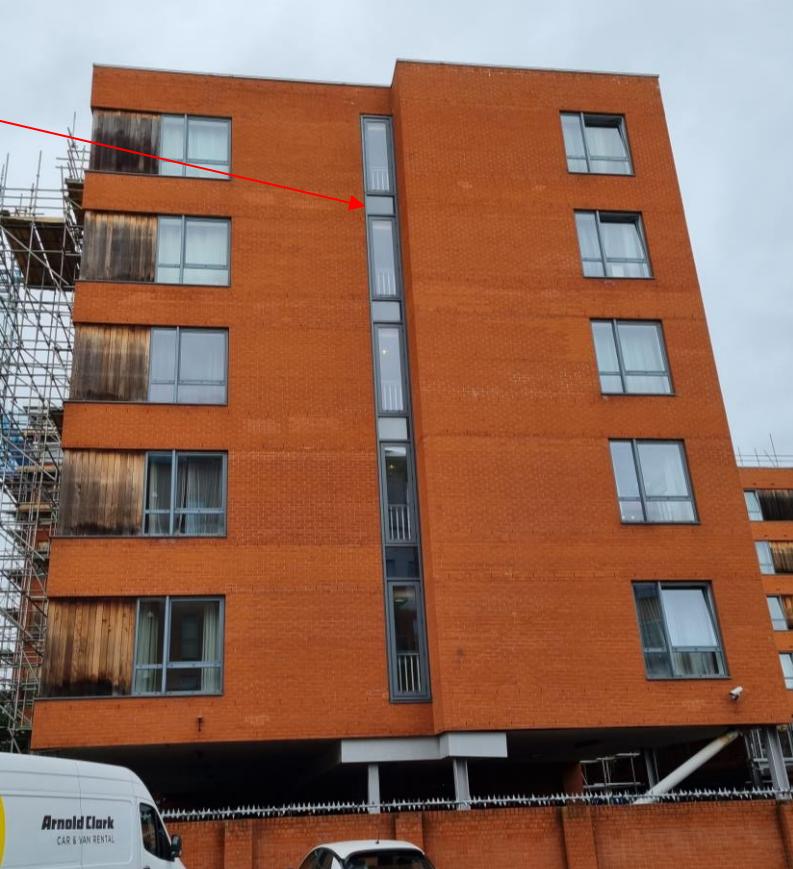
Significant Hazard	Additional Control Measures
<p>No intrusive investigation could be completed behind the glazed spandrel panels provided within the curtain wall systems at the ends of some common corridors.</p> <p>This is supported by Photograph 56 in Section 7.</p>	<p>During remedial works intrusive investigations should be carried out within the glazed spandrel panel system to ensure no combustible materials are present and where there is a cavity a suitable cavity fire barrier has been installed horizontally between compartment floors.</p>
<p>No cavity closers could be located around window openings in the brickwork system during intrusive investigations.</p> <p>Under the Building Regulations at the time of construction the building brickwork system would have been deemed acceptable to contain combustible insulation in the cavity and have no cavity fire barriers. The conditions of this were that the system be closed at the top and openings be provided with cavity closers to keep the brickwork cavity air tight.</p> <p>This is supported by Photograph 12, 13 and 18 in Section 7.</p>	<p>The lack of cavity closers around openings in the brickwork system can be accepted with the provision of a BS 8629 type system throughout the building.</p> <p>The BS 5839-1 fire detection and alarm system that is to be installed temporarily as an interim measure until the remedial works have been completed can be altered to become a BS 8629 type system in the long term.</p> <p>This system provides the fire service with the benefit of being able to evacuate residents from their apartments from a control panel in the building entrance foyer. The evacuation can be floor by floor or a full simultaneous evacuation.</p> <p>The provision of this system in place of cavity closers around openings in the brickwork system would act as a compensatory feature when it is considered that:</p> <ul style="list-style-type: none"> ❖ Although fire and smoke may spread into the brickwork cavity, fire and smoke would not easily spread into other apartments via the external wall cavity; ❖ The building is located in the centre of Leeds where fire service cover is good and response times to an emergency would be within 5 minutes of the first 999 call; ❖ Based on the fire service officer in charge assessment, all apartments in the building could potentially be evacuated remotely upon arrival of the first fire appliances; ❖ There are numerous protected escape stair cores for occupants to use in the event of a fire evacuation.

<p>Description</p> <p>Glazed spandrel panels are provided between floors within the curtain wall system in some small areas of the building external façade</p> <p>No intrusive investigation was completed in this area</p>	<p>Photograph 56</p>

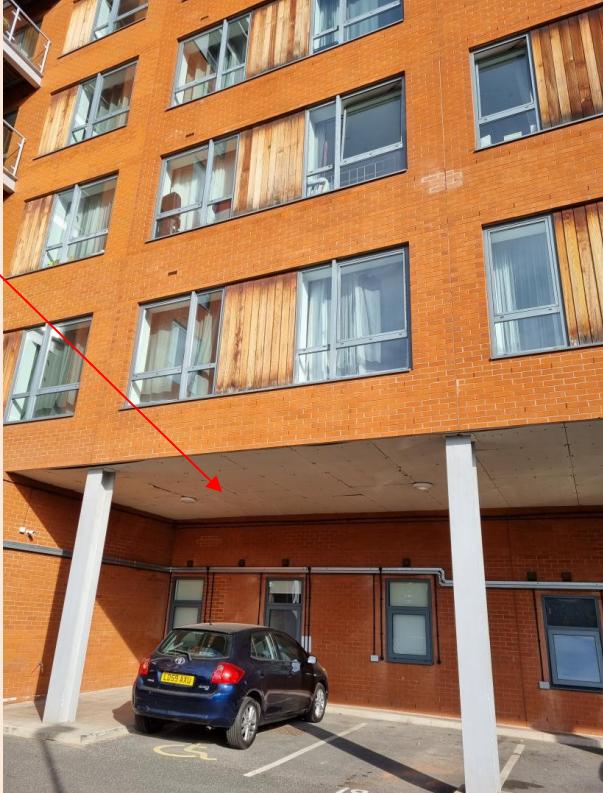
Description	Photograph 57
There is a soffit cladding system provided below the building 1 st floor level in the resident's carpark and above carparking spaces

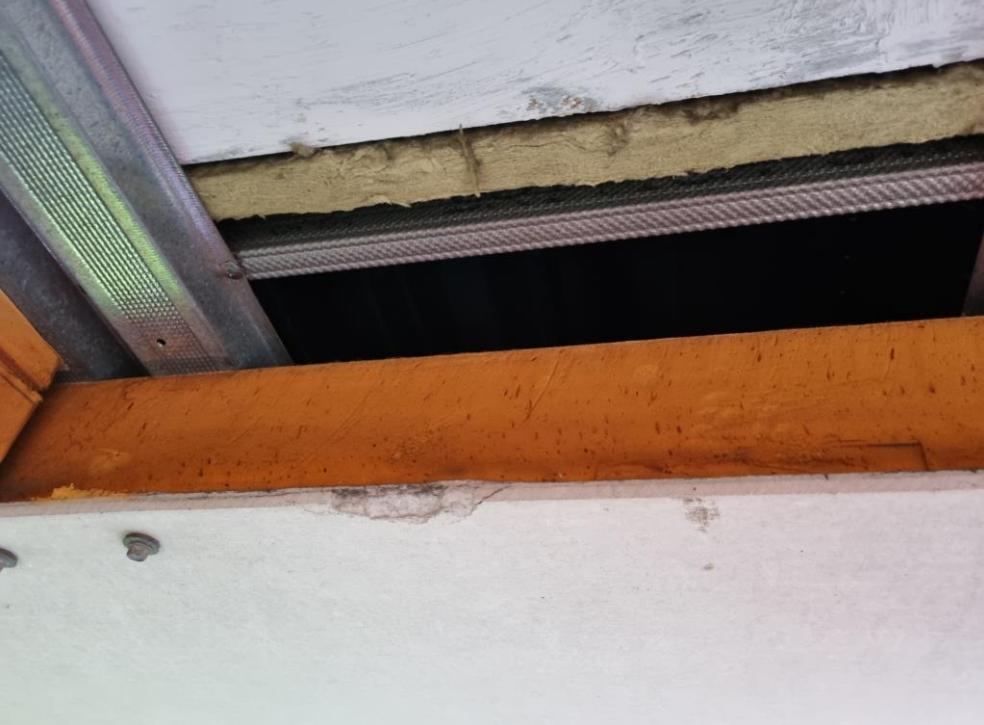
Significant Hazard	Additional Control Measures
<p>White faced cement particle board cladding panels are fitted to the soffit bordering the building below the 1st floor and above the under croft resident carpark areas on the building South elevation.</p> <p>The combustibility of the cladding panels is unknown, and numerous panels were found to be damaged during the intrusive investigation.</p> <p>This is supported by Photograph 58 and 59 in Section 7.</p>	<p>The white faced cement particle board soffit cladding panels that border the building on the South elevation and rear leg should be removed from the building and replaced with a surface material that achieves class A2-s1, d0 or better.</p> <p>The soffit cladding panels do not need to be removed in all areas of the under croft resident carpark. They only need to be replaced where they border the building external walls.</p>
<p>An unknown foil faced PIR foam insulation is provided within the white faced soffit cladding systems bordering the building North, East and South elevations, including the under croft resident carpark.</p> <p>The insulation is likely to be combustible.</p> <p>This is supported by Photograph 43, 44, 58 and 59 in Section 7.</p>	<p>The foil faced PIR foam insulation should be removed from the white faced soffit cladding system bordering the building below the 2nd floor on the North and East elevation and replaced with a product that achieves class A2-s3, d2 or better.</p> <p>The foil faced PIR foam insulation should be removed from the white faced soffit cladding system bordering the building on the South elevation and rear leg and replaced with a product that achieves class A2-s3, d2 or better.</p> <p>The foil faced PIR foam insulation does not need to be removed in all areas of the under croft resident carpark. They only need to be replaced where they border the building external walls.</p>

Description	Photograph 59
<p>The soffit intrusive investigation revealed cement particle board cladding panels attached to an aluminium support structure with a rigid foam insulation provided above</p> <p>Above the rigid foam insulation was a void with a steel floor tray and concrete floor slab for the 1st floor above</p>

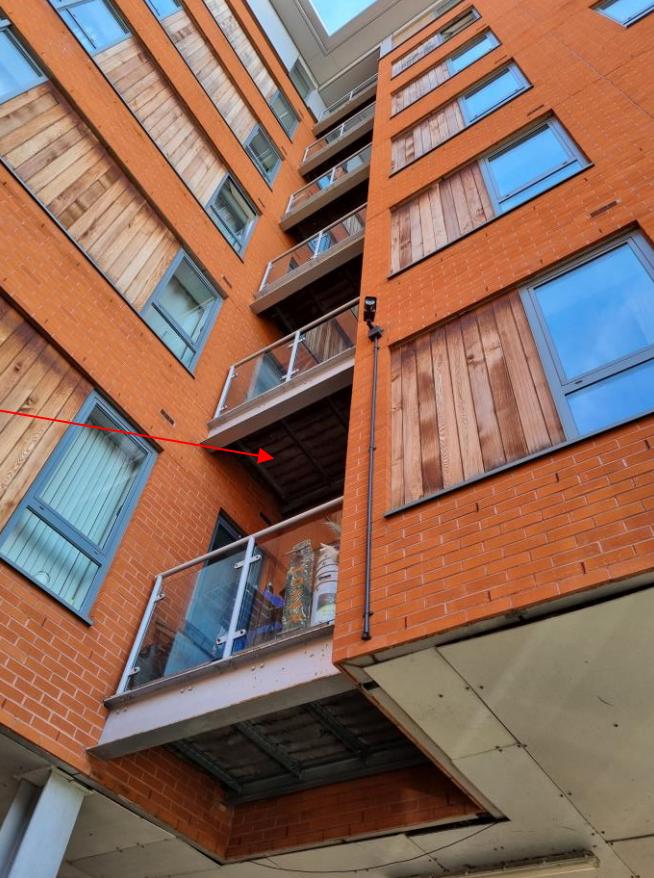
Significant Hazard	Additional Control Measures
<p>The residential apartment attachment type balconies are fitted with a timber decking floor and the balconies are stacked vertically.</p> <p>The timber boards are combustible with a European fire classification of D.</p> <p>In accordance with MHCLG <i>Advice for Building Owners of Multi-storey, Multi-occupied Residential Buildings</i>; balconies made with combustible materials are a potential source of rapid fire spread on residential buildings.</p> <p>This is supported by Photograph 60 and 61 in Section 7.</p>	<p>The timber decking boards on all residential apartment attachment balcony floors should be removed and replaced with materials that are of limited combustibility Class A2-s1, d0 or better.</p>
<p>The residential apartment attachment type balconies on the building West elevation are fitted with a timber enclosure around the outside of the balcony balustrade.</p> <p>The timber enclosure is combustible with a European fire classification of D.</p> <p>In accordance with MHCLG <i>Advice for Building Owners of Multi-storey, Multi-occupied Residential Buildings</i>; balconies made with combustible materials are a potential source of rapid fire spread on residential buildings.</p> <p>This is supported by Photograph 62 in Section 7.</p>	<p>The timber enclosure around the West elevation attachment type balconies should be removed.</p>

Description	Photograph 60
<p>The building is provided with attachment type balconies on the West and South elevations</p> <p>The attachment type balconies are vertically stacked and are fitted with a timber decking floor</p>

The timber decking boards and timber enclosures on the attachment type balconies are not suitable and should be replaced.

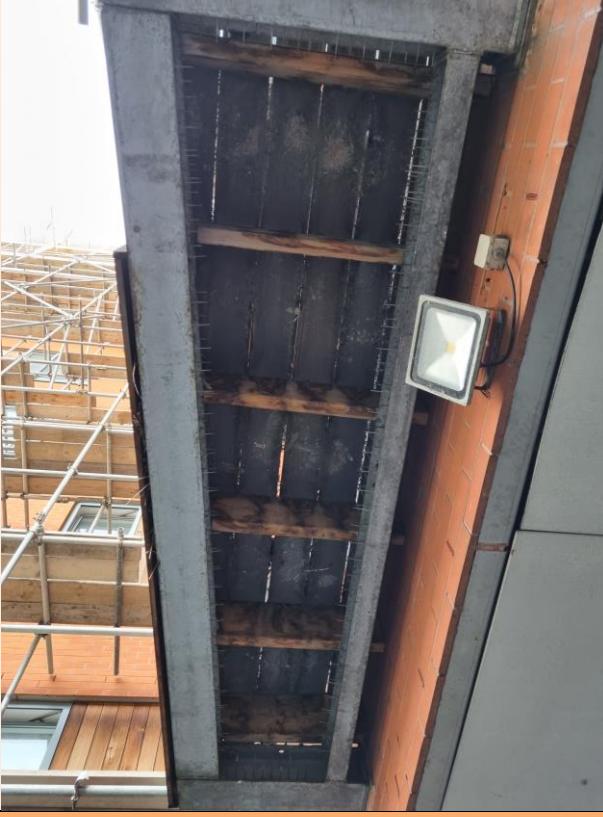
Description	Photograph 61
The timber decking floor on the attachment type balconies is fitted to a steel frame structure

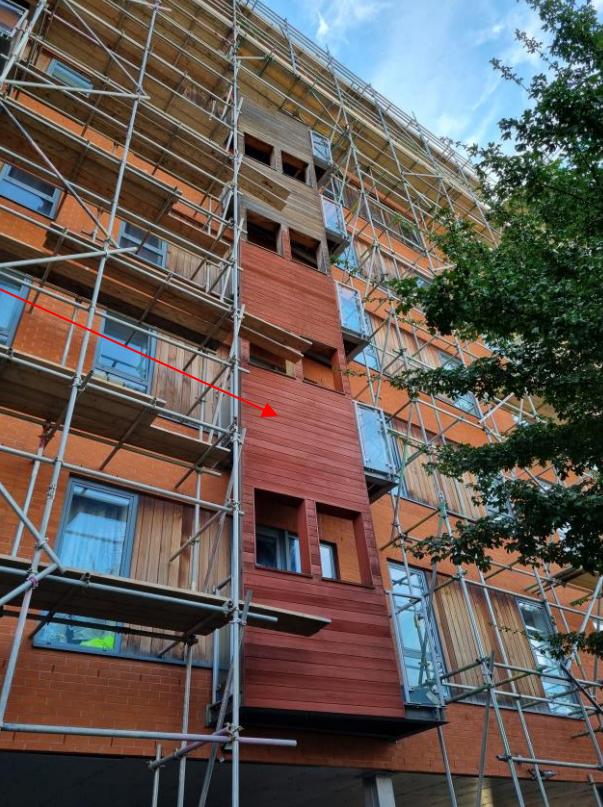
Description	<p>The attachment type balconies on the building West elevation were found to be provided with a timber outer wall</p>

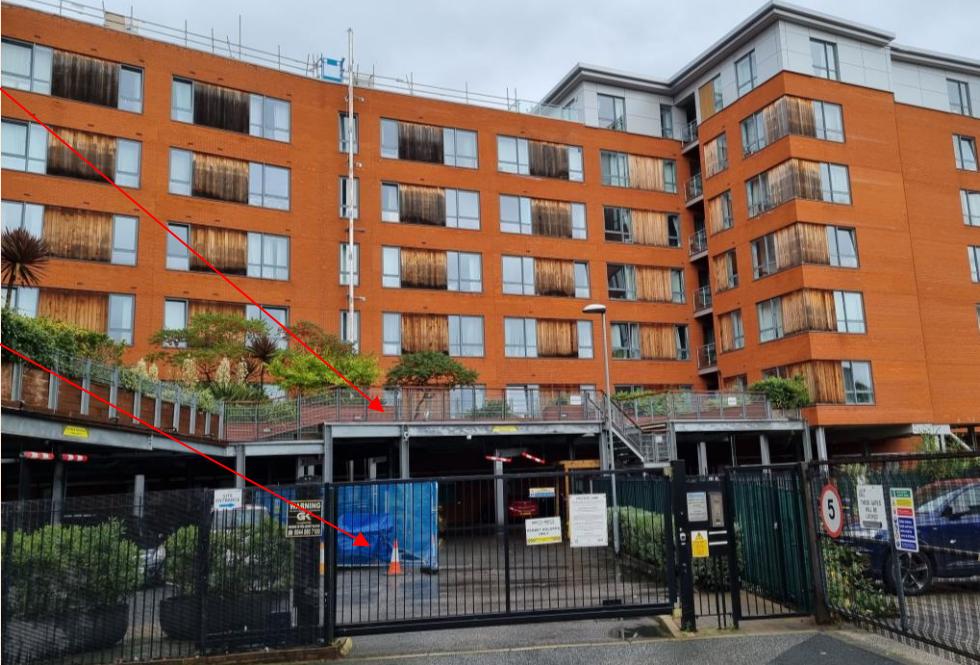
Description	Photograph 63
<p>There is an elevated garden area at the rear of the building, which is positioned at 1st floor level and accessed from the resident's carpark</p> <p>The resident's carpark is secured with metal electric gates</p>

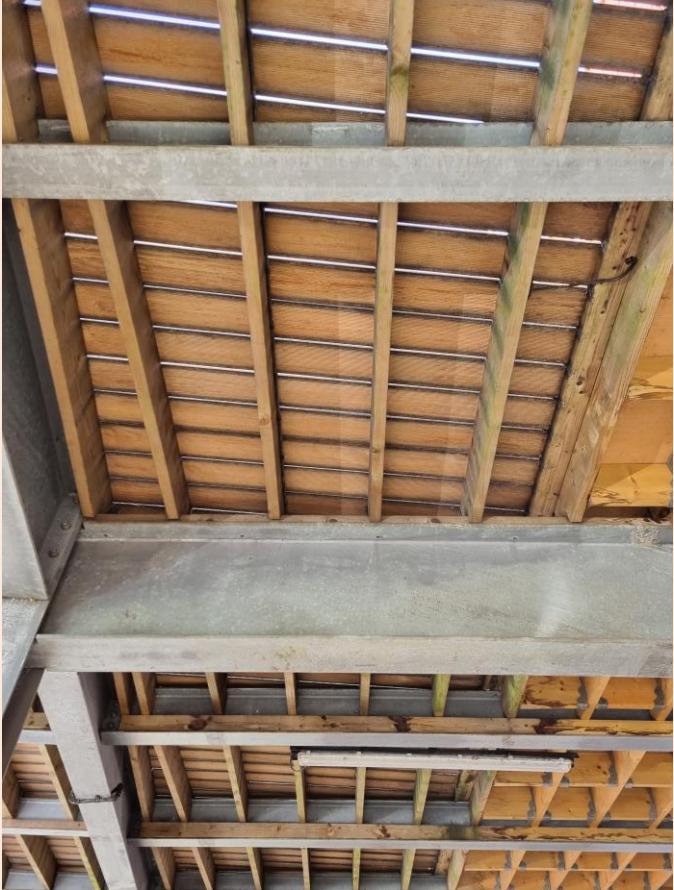
Description	Photograph 65
The elevated garden area is positioned above some resident carparking spaces
