Home Inspection Report

135 Beth Circle, Plymouth, WI 53073

Inspection Date:
Monday, March 2, 2015

Report Number:
3256

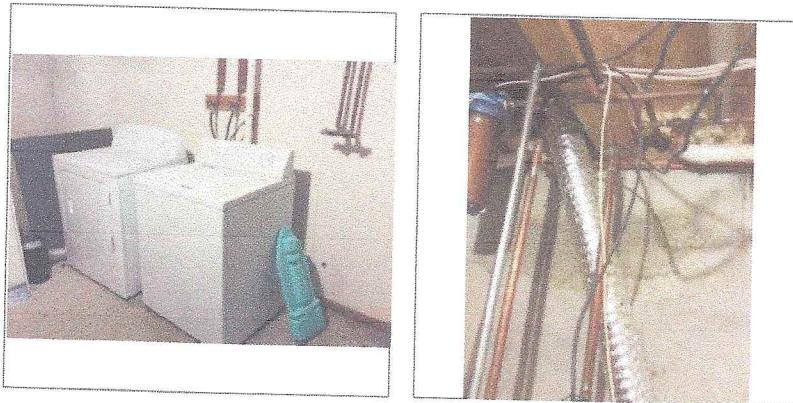
Laundry sink N/A
 Faucet leaks Yes No
 Pipes leak Yes No Not Visible
 Cross connections Yes No Potential Safety Hazard
 Heat source present Yes No
 Room vented Yes No
 Dryer vented N/A Wall Ceiling Floor Not vented Plastic dryer vent not recommended
 Not vented to exterior Recommend repair Safety hazard
 Electrical Open ground/reverse polarity: Yes No Safety hazard
 GFCI present Yes No Operable: Yes No Recommend GFCI Receptacles
 Appliances Washer Dryer Water heater Furnace/Boiler
 Washer hook-up lines/valves Satisfactory Leaking Corroded Not Visible
 Gas shut-off valve N/A Yes No Cap Needed Safety hazard Not Visible
 Comments Suggest solid aluminum dryer vent pipe
 Outlet plates missing

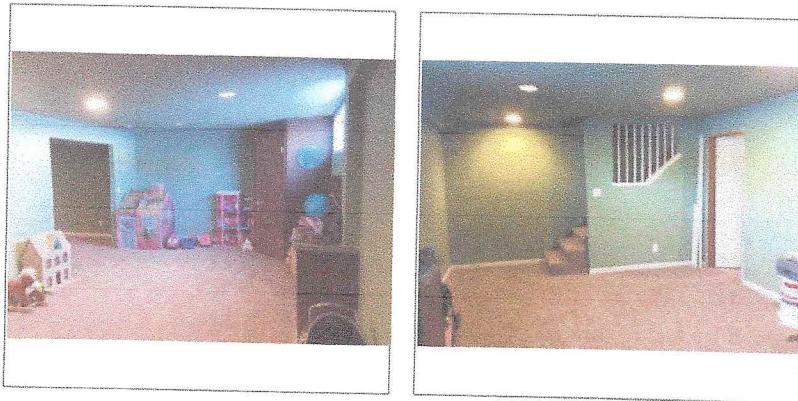
Heating source present	<input checked="" type="checkbox"/> Yes <input type="checkbox"/> No Holes: <input type="checkbox"/> Doors <input type="checkbox"/> Walls <input type="checkbox"/> Ceilings
Bedroom Egress restricted	<input checked="" type="checkbox"/> N/A <input type="checkbox"/> Yes <input type="checkbox"/> No
Doors	<input checked="" type="checkbox"/> None <input type="checkbox"/> Satisfactory <input type="checkbox"/> Marginal <input type="checkbox"/> Poor <input type="checkbox"/> Cracked glass <input type="checkbox"/> Broken/Missing hardware
Windows	<input type="checkbox"/> None <input checked="" type="checkbox"/> Satisfactory <input type="checkbox"/> Marginal <input type="checkbox"/> Poor <input type="checkbox"/> Cracked glass <input type="checkbox"/> Evidence of leaking insulated glass <input type="checkbox"/> Broken/Missing hardware
Comments	Light trims rings not mounted Replace lighting switch

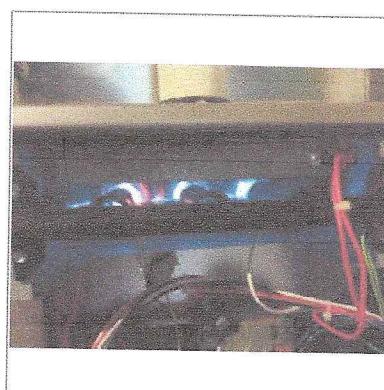
Comments Furnace was in normal working order at the time of the inspection.
