## Fairpoint Regional Utility System Repairs 2,800 LF Failed 30-inch Water Main by Slipling with Fusible PVC® Pipe

### Pipeline Details and Project Summary

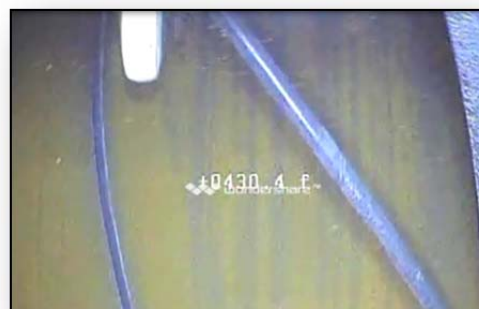
A key segment of the transmission main is a 2,800 foot crossing under the East Bay. This section of the line was originally installed via horizontal directional drilling (HDD) using 30-inch DR9 DIPS HDPE pipe (32-inch OD, 24.5-inch ID). In the spring of 2014 the HDPE crossing was determined to be leaking and was taken out of service for inspection. A video of the interior of the pipeline revealed a gradual, spiraling, longitudinal crack 13 feet in length. Based on the original bore profile, the location of the crack was determined to start 408 feet from the south side of the bore at a depth of approximately 55 feet below the bottom of East Bay.

Photo of Longitudinal Crack

Ric Delp, Project Manager with Baskerville-Donovan, Inc., commented: "The cause of the failure is currently unknown. However, this is the **second reported failure on an HDPE bore crossing in the system.**"

In May 2014, an RFP was issued for the repair of the main. Two repair options were solicited, including: 1) a point repair of the failure area, and 2) a complete slipline of the 2,800 foot crossing using a new pipe. Two proposals were received, with both contractors proposing to slipline the entire bore section with a new, structurally independent pipe. Fairpoint reviewed the proposals and selected T.B. Landmark to slipline the failed line with 20-inch DR18 DIPS Fusible C-905® PVC pipe.

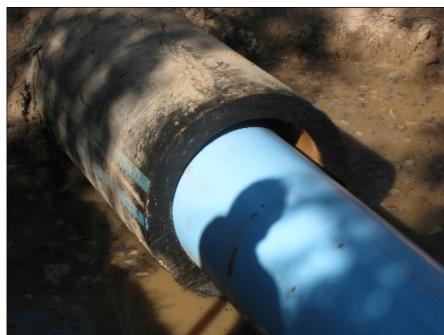
20" Fusible PVC® Pipe Entering  
30" Host Pipe

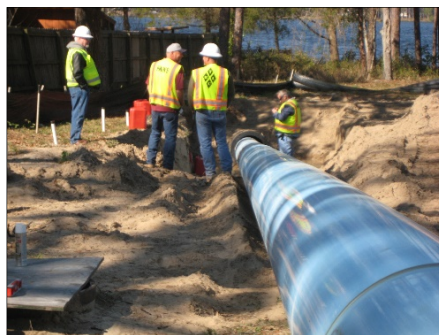
Fused Sections of New 20" Pipe

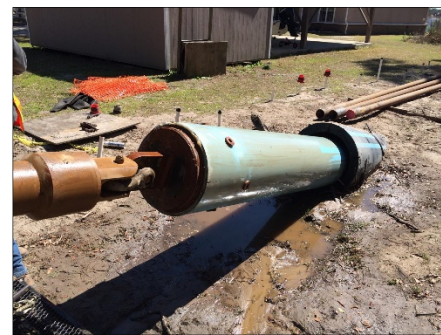
Pull Head and Fusible PVC® Pipe  
Exiting Host Pipe
