Subject: LER: 2016-004, Transformer Fault Results in Manual Scram and  
Secondary Containment Vacuum Below Technical Specification Limit

James A. FitzPatrick Nuclear Power Plant  
Docket No. 50-333  
License No. DPR-59

Enclosure: JAF LER 2016-004, Transformer Fault Results in Manual Scram and Secondary  
Containment Vacuum Below Technical Specification Limit

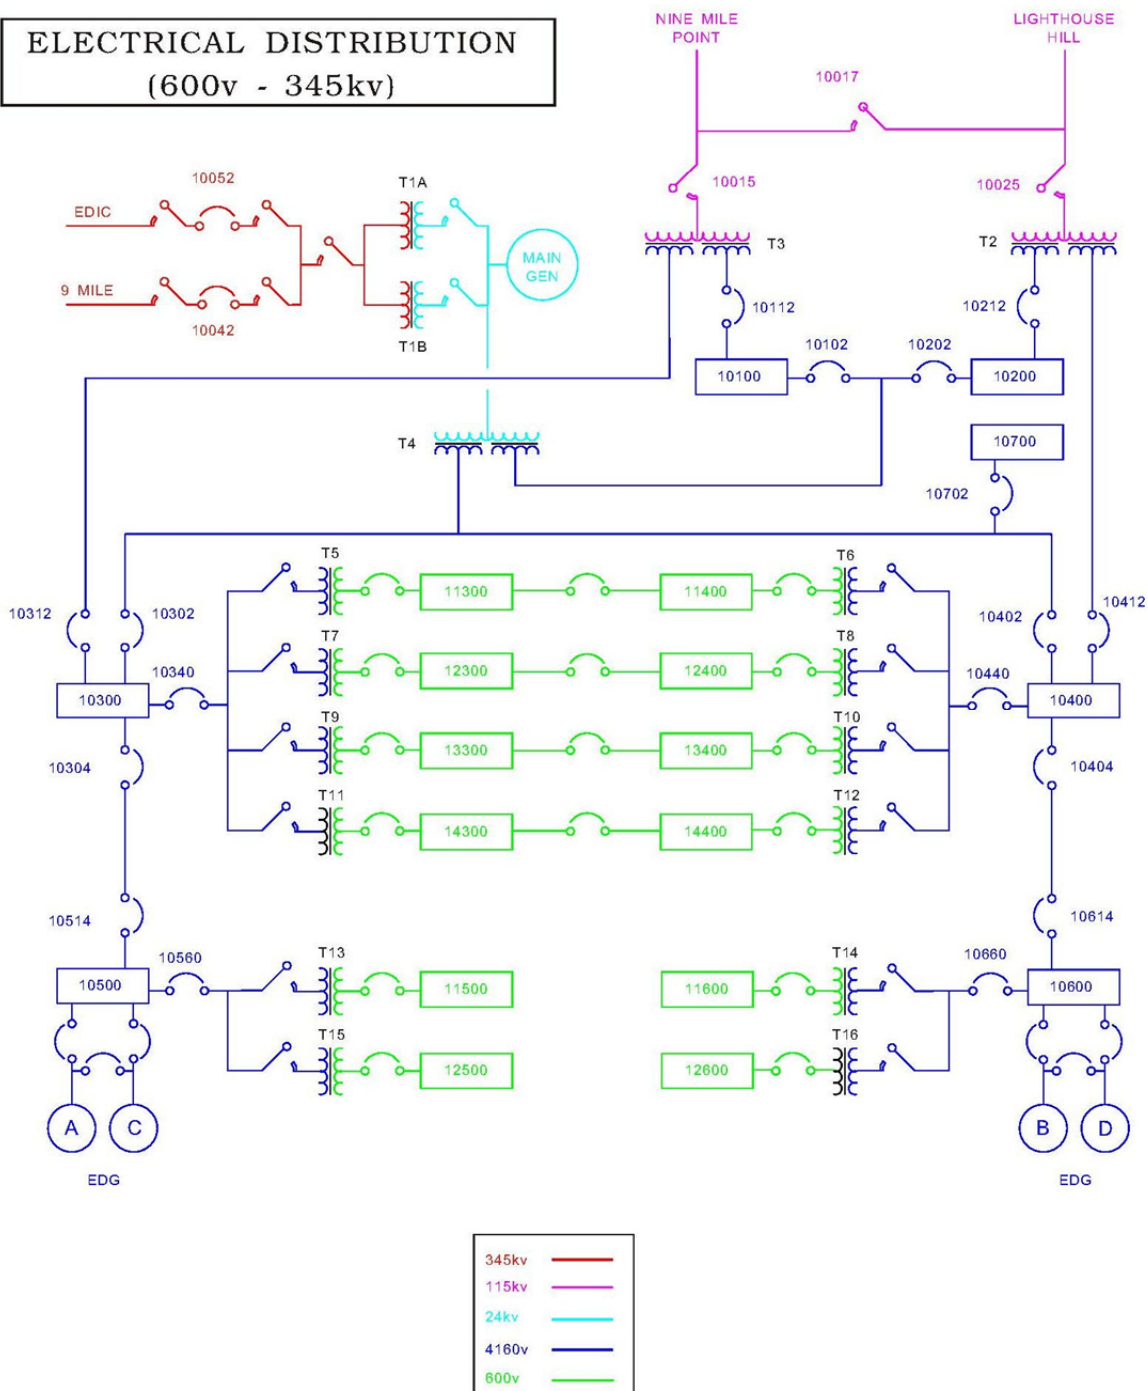
## ELECTRICAL DISTRIBUTION

James A. FitzPatrick Nuclear Power Plant (JAF) 600V electrical distribution system [EIS identifier: EC] is supplied by stepping down 4160V to 600V through one of twelve transformers (T-5 to T-16). Nonsafety-related electrical busses are supplied by T-5 to T-12 and safety-related electrical buses by T-13 to T16. (See Figure: Electrical Distribution).

This licensee event report (LER) addresses an electrical fault in T-5 caused by insulation breakdown.

On June 24, 2016, at 12:05, when JAF was operating at 100% power, several 600V electrical busses lost power. A fault in 71T-5 caused breaker 10340 to trip. This breaker connects 4160V to four transformers which each provide power to a 600V bus: 11300 (L-13), 12300 (L-23), 13300 (L-33), and 14300 (L-43). These electric buses provide power to a variety of nonsafety-related plant loads; notable equipment include:
