Saint Lukes Lofts
1860 Washington
Denver, CO 80203

Level 1 Reserve Analysis

Report Period – 01/01/05 – 12/31/05

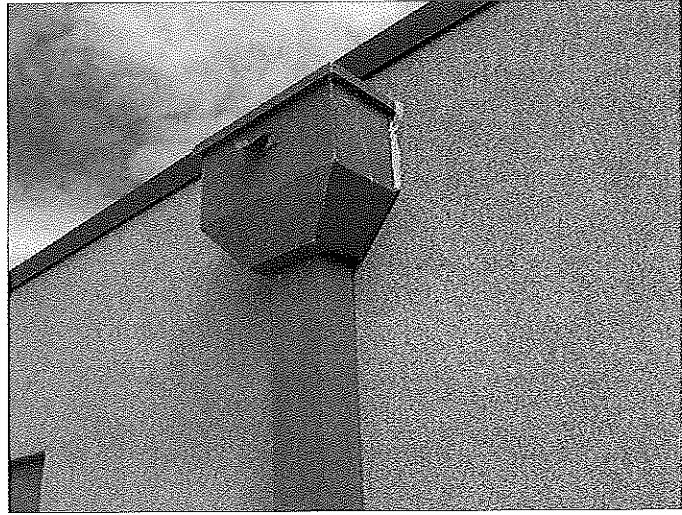
Comp #: 120 Downspouts - Replace

No unusual conditions observed at time of inspection. All areas inspected were attached to the sides of the buildings in a secure manner, with no signs of water stains around downspouts. The average life expectancy for downspouts ranges from 25 - 30 years, as long as they are cleaned out periodically.

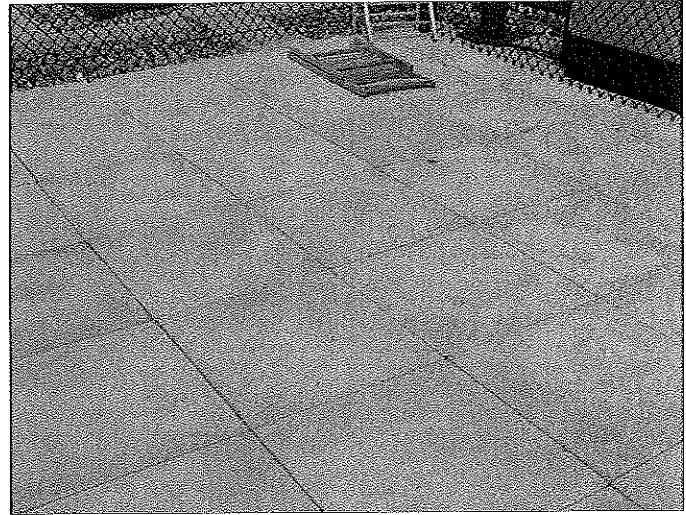
Comp #: 122 Concrete Walking Pads - Replace

A few stepping pavers had minor cracks and chips. Due to a limited amount of foot traffic, we suggest replacing these pavers on an as needed basis using operating funds. It is unlikely that all pavers will need to be replaced at the same time.

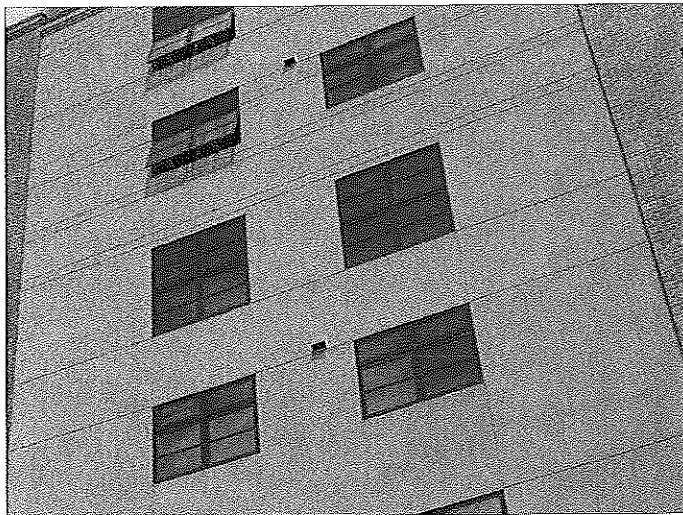
Comp #: 201 Stucco Surfaces - Repaint

All stucco surfaces were in good condition with no fading or stained surfaces noted during property inspection. While stucco surfaces have a long life expectancy (typically a 10 year labor warranty), it is recommended by industry professionals that it is inspected and any voids are repaired as soon as possible to prevent water intrusion into substrate. It is also recommended that a new coating is applied every 10 - 15 years to maintain an appropriate appearance. Coordinate painting with trim cycle for best cost estimate.

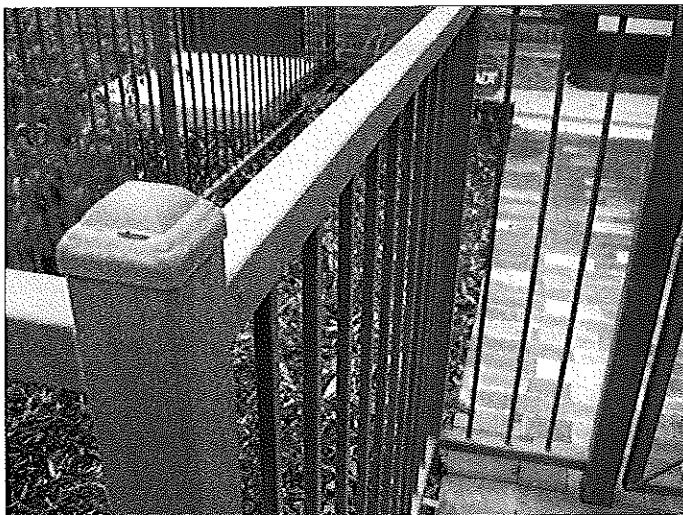
Comp #: 207 Iron Fencing - Repaint

The exterior areas we were able to access during inspection revealed faded paint and some areas where the paint was peeling, exposing the metal and causing the material to rust. Based on the current condition, we suggest repainting the metal surfaces as soon as possible to prevent further damage to the base materials. In this environment, it is recommended that these surfaces are painted every 2 - 3 years due to the effects from the ultraviolet rays drying and fading the paint. The interior handrails should be painted at the same time as interior wall surfaces.

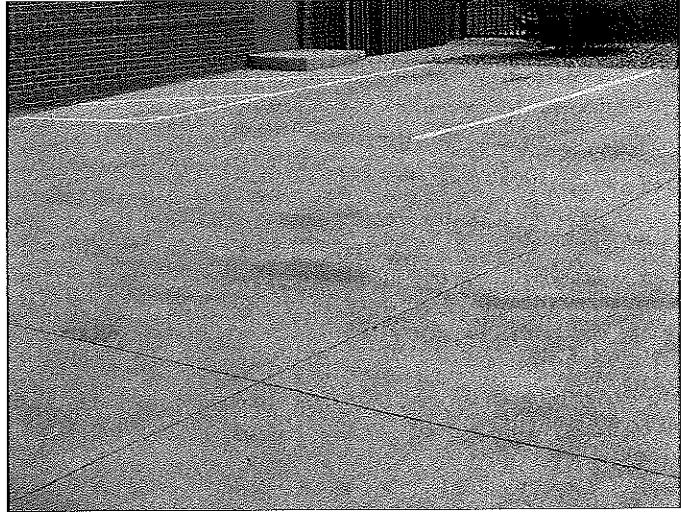
Comp #: 403 Concrete - Repair/Replace

The majority of the area (almost 75% of total GSF) is located inside as the parking garage and is not exposed to elements that will cause severe deterioration. It is unlikely that all concrete will need to be replaced at the same time. Therefore, Reserve an allowance for periodic repairs and replacement to concrete surfaces every 4 years. As a percentage, plan on repairing 10% of the exposed surfaces, and 1% of the inside garage surfaces for a total of approximately 850 GSF every 4 years.

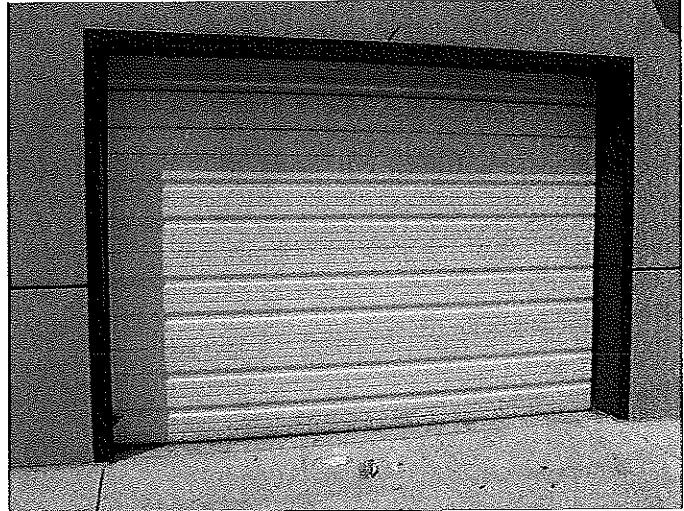
Comp #: 502 Garage Doors - Replace

All doors appeared to be in good operating condition with no signs of abuse or problems during inspection. These doors are heavily used on a daily basis, especially the main door serving the general parking garage. These doors are considered to be heavy duty commercial grade doors and have a life expectancy of 12 - 15 years under normal wear and tear. Maintenance, such as replacing springs and repairing tracks, should be treated as a separate issue from Reserves.

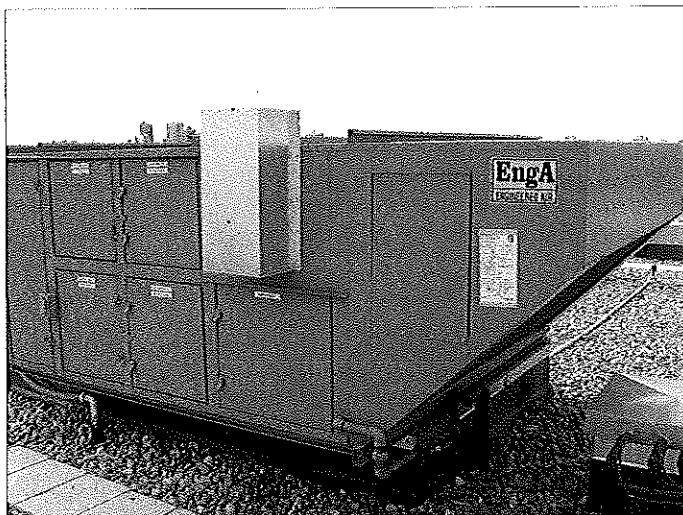
Comp #: 704 Air Handler Unit - Replace

No reported problems with operation of unit. It is unusual that the entire unit would need to be replaced. Expect to replace major parts and rebuild unit every 10 - 12 years. Timing of rebuilding depends on amount of use and maintenance. This line item is established to provide funding for any repairs that are necessary when required. It is unlikely that all moving parts of the system will need to be replaced at the same time.

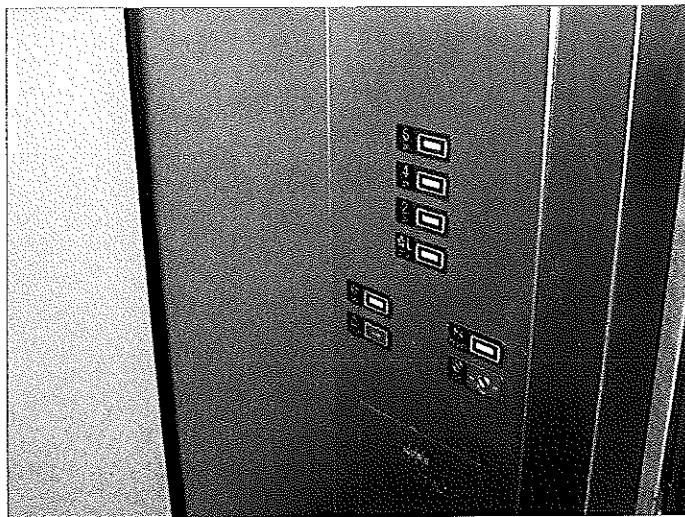
Comp #: 707 Elevator - Rebuild/Upgrade

The elevator was operating smoothly with no problems noted. The inspection and maintenance records on site did not report any unusual problems. This elevator is relatively new and in good condition. All elevators should be inspected annually by a professional to ensure proper operation and detect any safety concerns. The equipment that will eventually fail and need to be replaced include the control system (brain of the unit), door operator and tracks, and the pump unit. Due to a moderate use facility, Reserve to replace this equipment every 25 years.

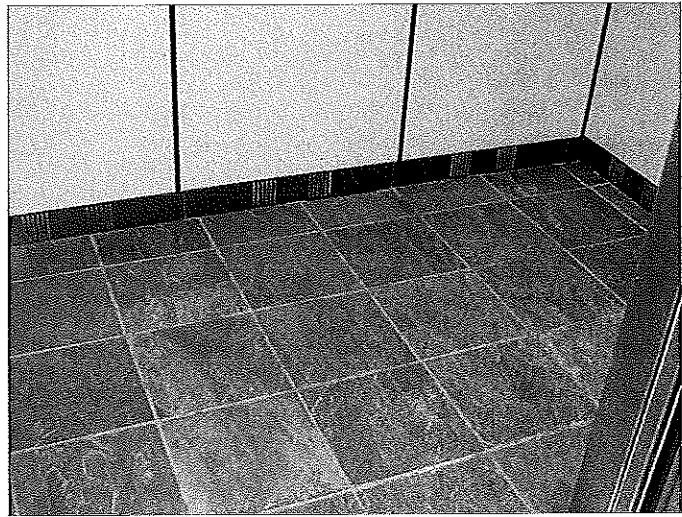
Comp #: 709 Elevator Cab - Remodel

Cab was in very good condition with no signs of abuse or mistreatment. There are moving pads available in the room behind the mailboxes for protection when moving in large furniture and equipment. Depending on the decorative tastes of the association and trend development, the average remodeling cycle ranges from 15 - 20 years. Cost could vary depending on extent of décor chosen at time of remodel.

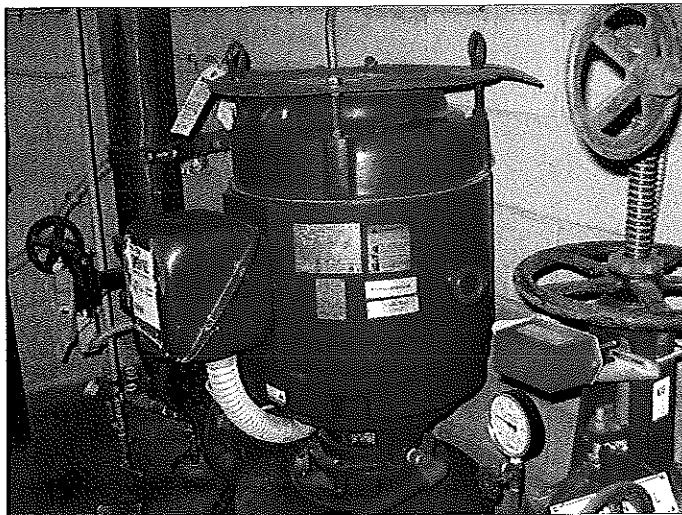
Comp #: 715 Pumps - Replace

The booster pump in the fire equipment room reportedly failed about 4 years ago and cost approximately \$2,900 to replace. The other pumps are used primarily in case of a fire erupts in the building. It is very difficult to predict when a pump will fail as there are many moving parts in a pump that could fail at any time. Due to fire pump hopefully never needing to be used, we do not suggest Reserving to replace this pump. While the booster pump could fail at any time, the average life expectancy ranges from 6 - 9 years.

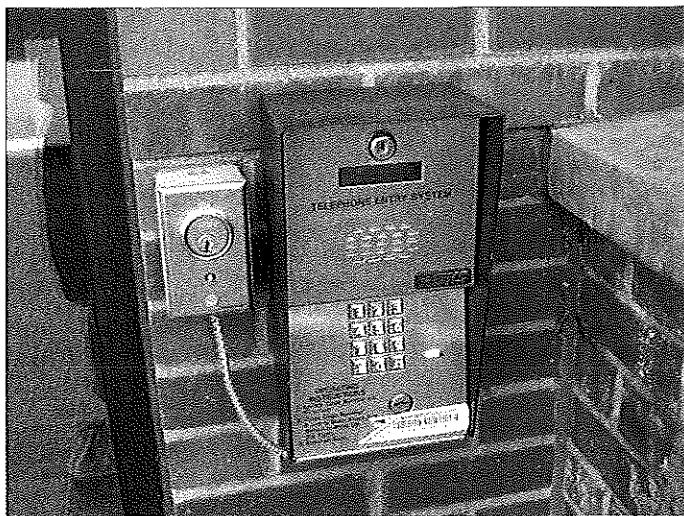
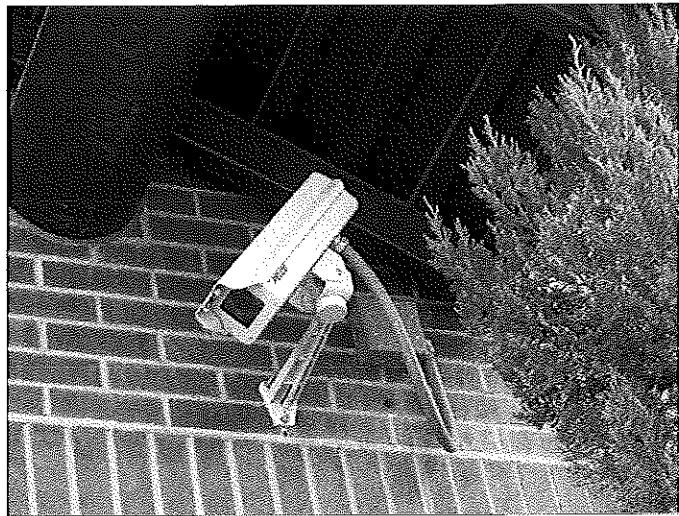
Comp #: 905 Intercom - Replace

No unusual conditions or reported problems with units and they are assumed to be functional and in good operating condition. The main reason for replacement will be due to advances in technology. Reserve to replace every 10 - 12 years, depending on amount of use and technological advances.

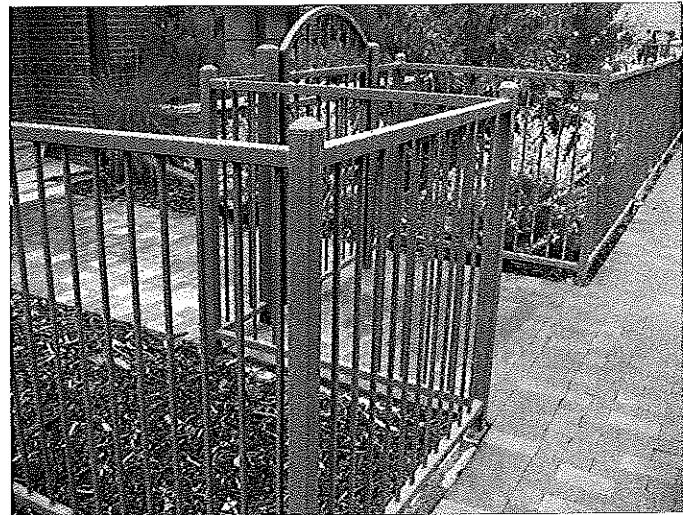
Comp #: 1002 Ironwork Fencing - Replace

The majority of the area is either interior or balconies which have limited exposure to elements. The only fence that may require periodic replacement is the fence on the north side of the building for the townhome units. Due to the overall small area, we suggest repairing as part of prep work before painting and separate Reserve funding is not required for replacement.

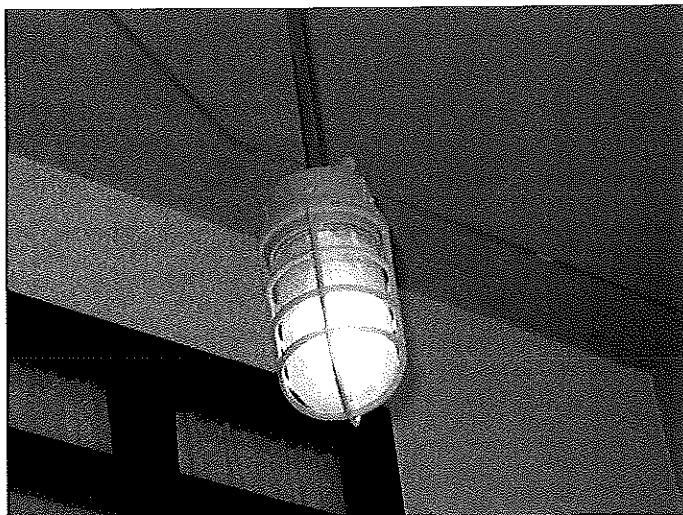
Comp #: 1601 Light Fixtures - Replace

No reports of problems, other than frequent bulb replacement required on the square lights by the garages. No Reserve funding was requested by client. Replace on an as needed basis with general operating funds.
