Stanisław Godlewski  
December 15, 2022

## **Remodeling sidewalks and hiking trails within and around Riverside Park with ArcGIS.**

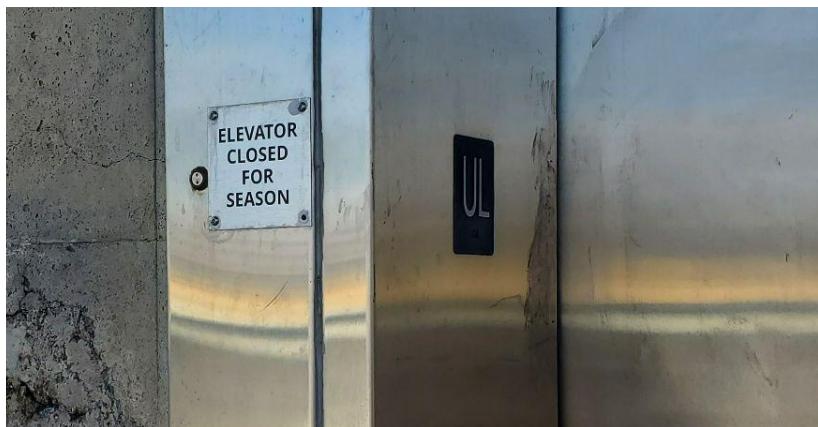
For one to access the riverfront of Riverside Park, elevators and staircases at Science Center and Travelers Plaza are the only way to access the riverfront of Riverside Park without the usage of a motorized vehicle. However, the elevators at the riverfront are only open seasonally. In addition, rough and uneven pavement along walkways toward the Riverfront. Lastly, the riverfront is completely inaccessible from northern downtown.

Source: Picture of the elevator from my camera.

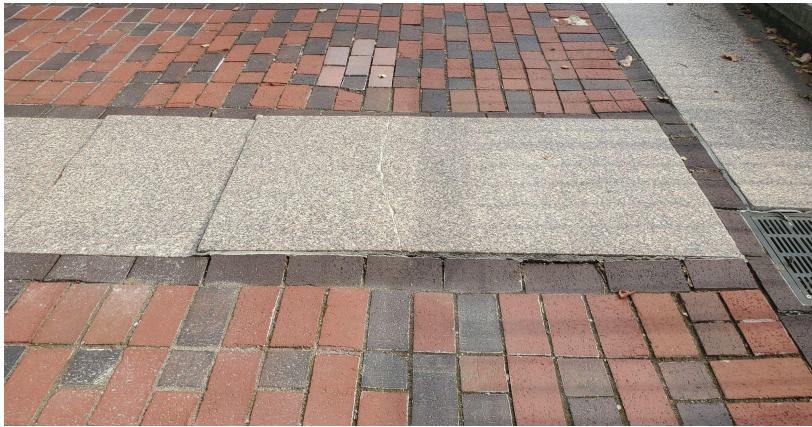
Source: Picture of the surrounding walkway from my camera.

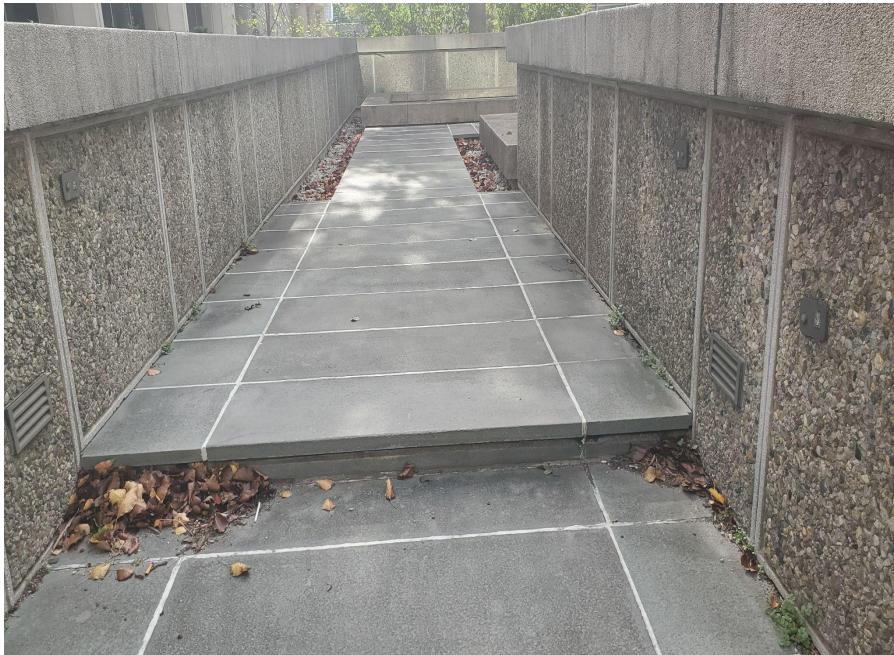
Source: Picture of the surrounding walkway from my camera.

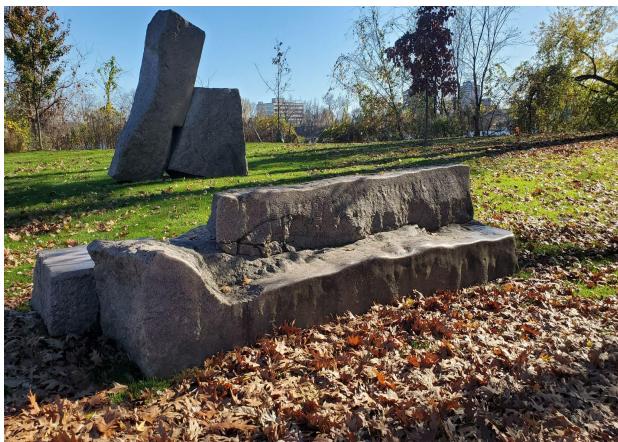
As one would travel northward alongside the Connecticut River at Riverside Park, they encounter a few playgrounds, bathrooms and picnic tables. However, they would also encounter steep slants and handicap inaccessible benches. Not only would these obstacles be tedious for the handicapped, but the noisy I-91 would interrupt the quaint and peaceful experience that park enthusiasts yearn for.

Source: Picture of a bench at Riverside Park from my camera.

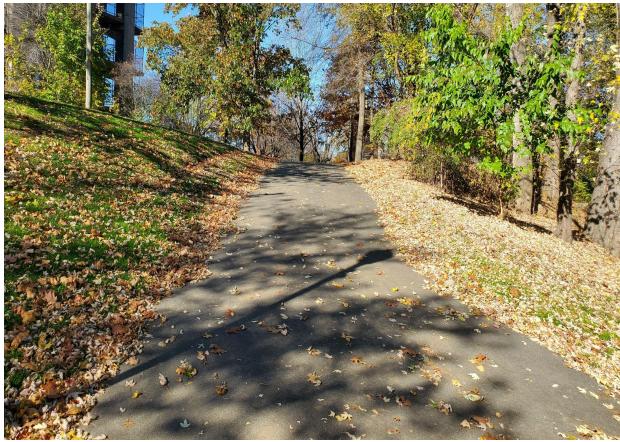
Source: Picture of a paved walkway at Riverside Park from my camera.
