This report summarises an automated condition survey of the runway, captured in a single drone pass at roughly 1.25 mm per pixel. Cracks are picked out by a crack-specialised segmentation model and vegetation by its colour; every finding is tied to a position along the runway (its chainage) so the results read as a map rather than a list. The aim is to show, at a glance, where the surface needs attention first — in line with the routine pavement-monitoring expectations of ICAO Annex 14, CAA CAP 168 and the ASTM D5340 distress framework.

Runway Surface Condition Report

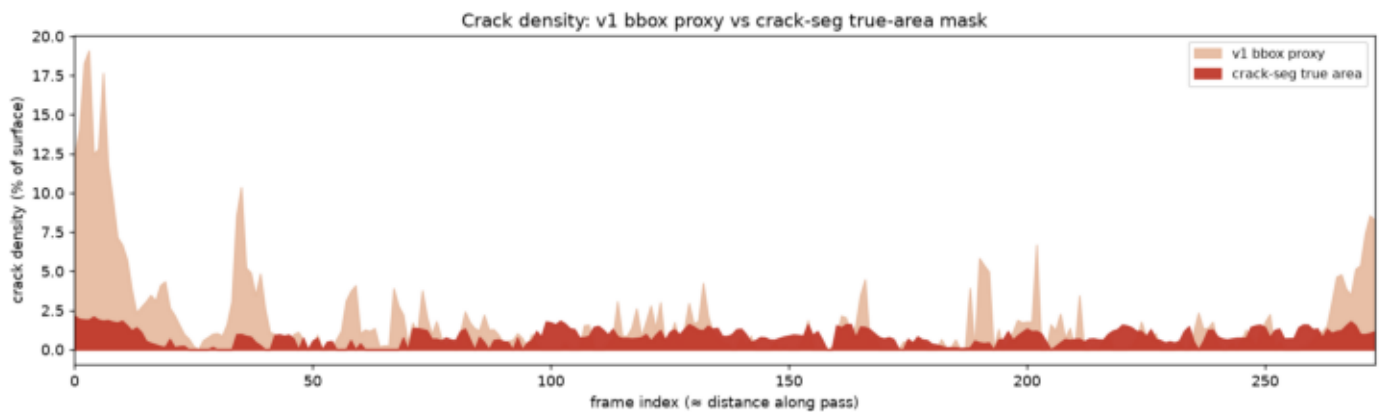
v1 bounding-box proxy vs crack-seg true-area mask.

A simple bounding box around a crack greatly overstates how much surface the crack actually covers. Outlining the crack instead (the darker band) measures the real affected area. The crack-specialised model is also more sensitive than the original detector, picking up finer cracking right across the surface — so read these density figures as a sensitive screening index rather than an exact inventory.

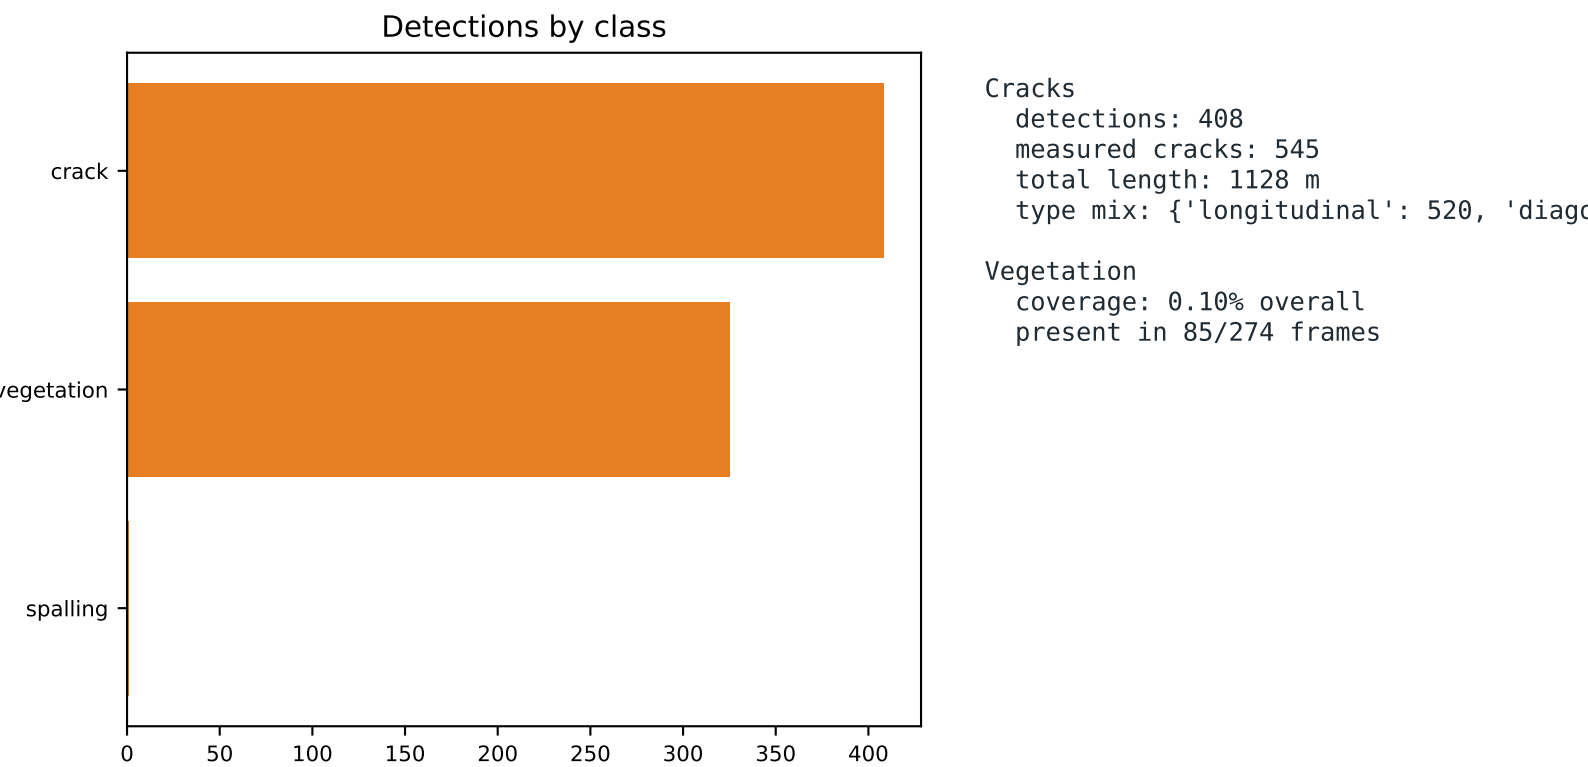
Crack type is from skeleton orientation (geometry is robust);  
vegetation from a green colour threshold (separable from asphalt).

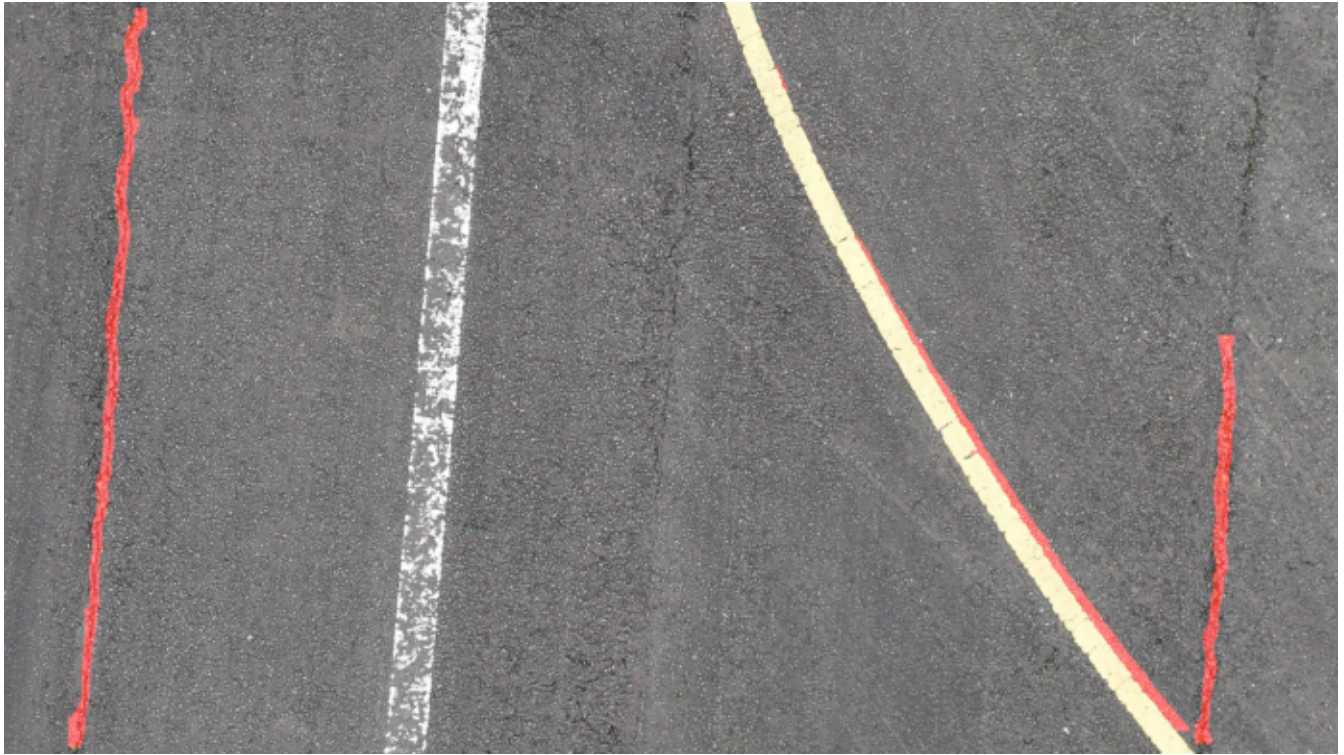
red = segmented crack

frame\_000001.jpg — STA 0.0 m — 2.15% density

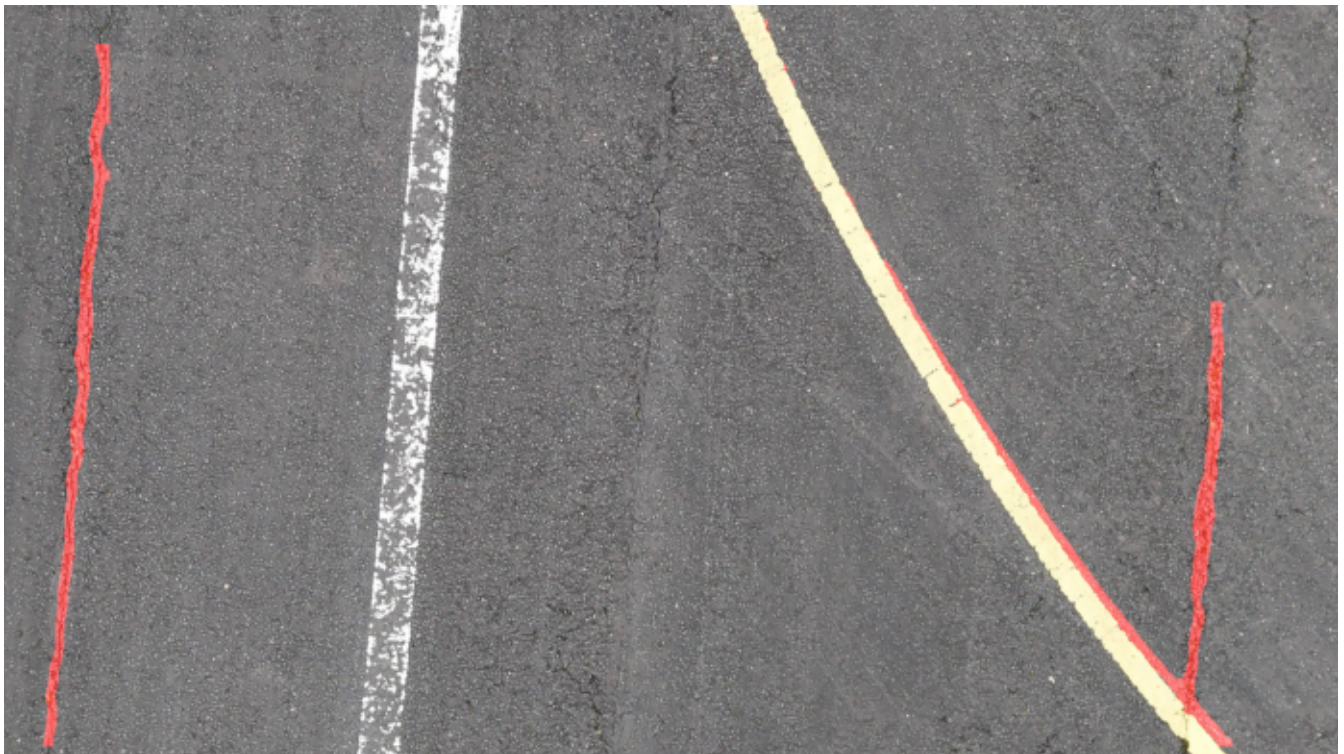
frame\_000005.jpg — STA 2.0 m — 2.10% density
