Automated surface screening of the runway from a continuous drone pass (cracks segmented by a crack-specialised model; vegetation by colour). Findings are referenced by chainage (distance along the pass) and summarised as crack density and vegetation coverage with hot zones to prioritise maintenance, consistent with routine pavement monitoring under ICAO Annex 14 / CAA CAP 168 and the ASTM D5340 distress framework.

Over 136 m surveyed the model maps 545 cracks (1128 m total length) across 207 frames, a true crack density of 0.82% of imaged surface, and vegetation in 85 frames.

Runway Surface Condition Report

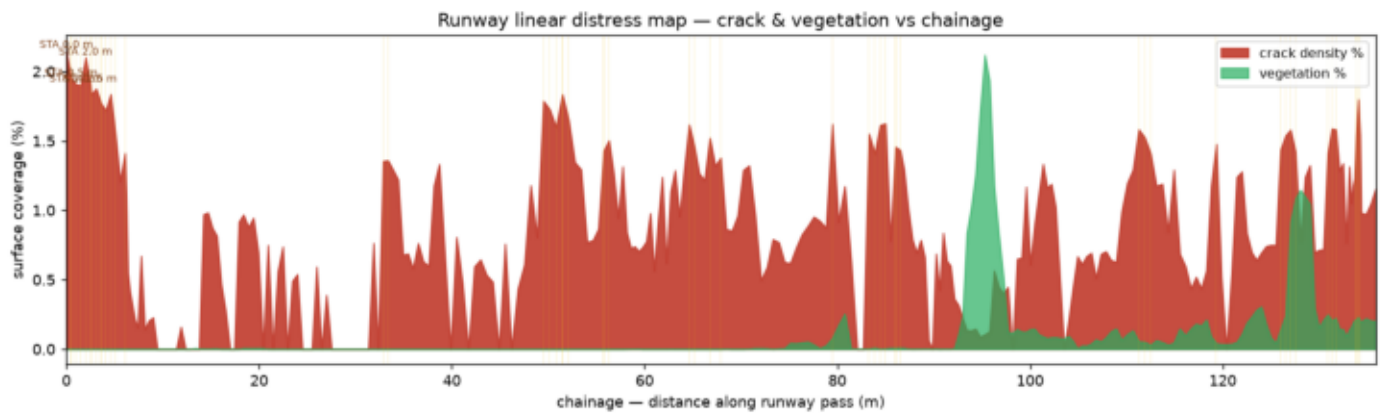
# Spatial distress map (by chainage)

Distance along the runway pass, recovered by frame registration.

Priority crack hot zones (station · density):

| STA | 0.0 m | 2.15% |
| STA | 2.0 m | 2.10% |
| STA | 0.5 m | 1.95% |
| STA | 1.0 m | 1.91% |
| STA | 2.5 m | 1.91% |
| STA | 1.5 m | 1.90% |
| STA | 3.1 m | 1.88% |
| STA | 4.6 m | 1.84% |

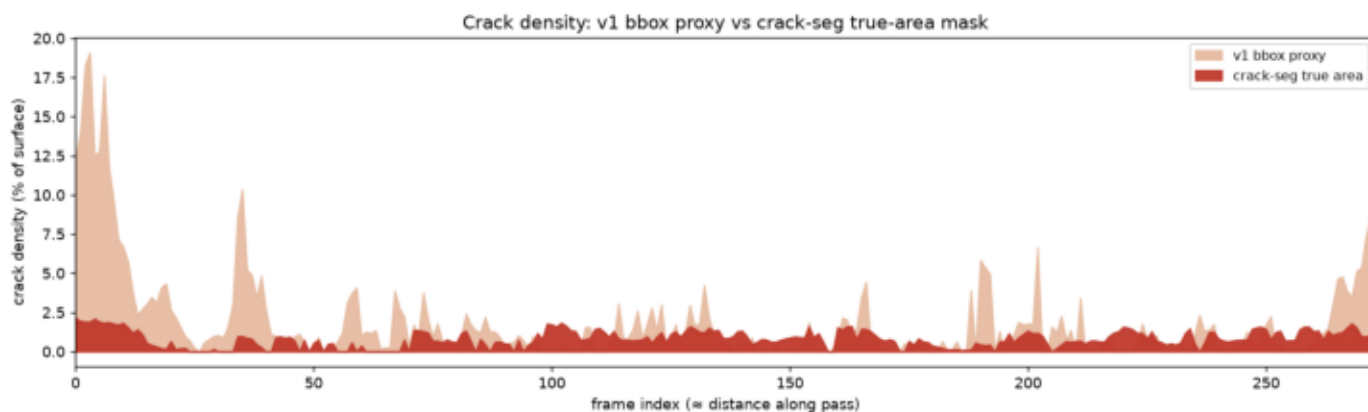
v1 bounding-box proxy vs crack-seg true-area mask.

Detection bounding boxes overstate crack area; the crack-seg masks give the true crack-covered area. Crack-seg is more sensitive than v1, tracing finer cracking across the surface.

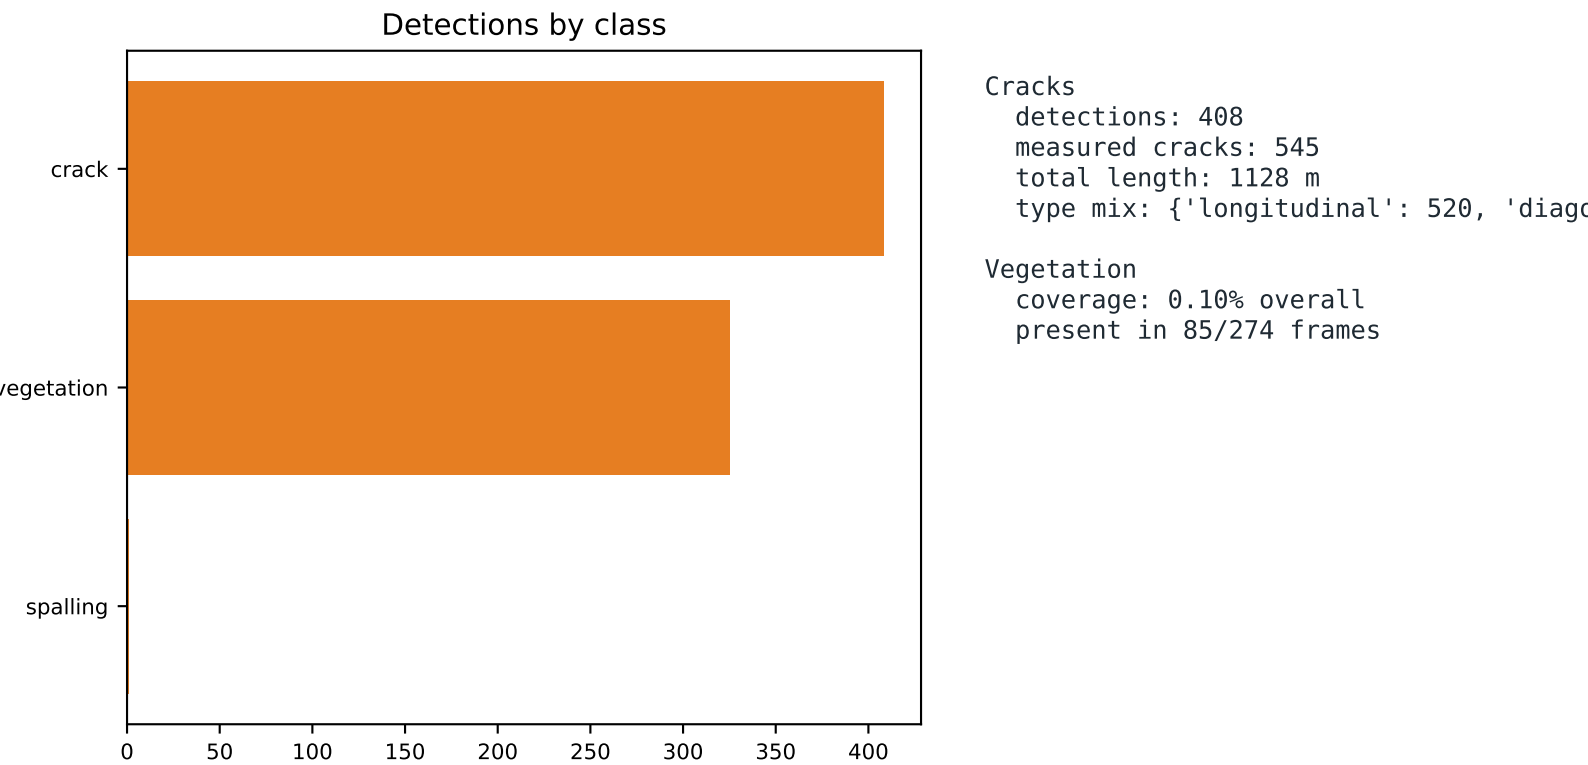
Crack type is from skeleton orientation (geometry is robust);  
vegetation from a green colour threshold (separable from asphalt).

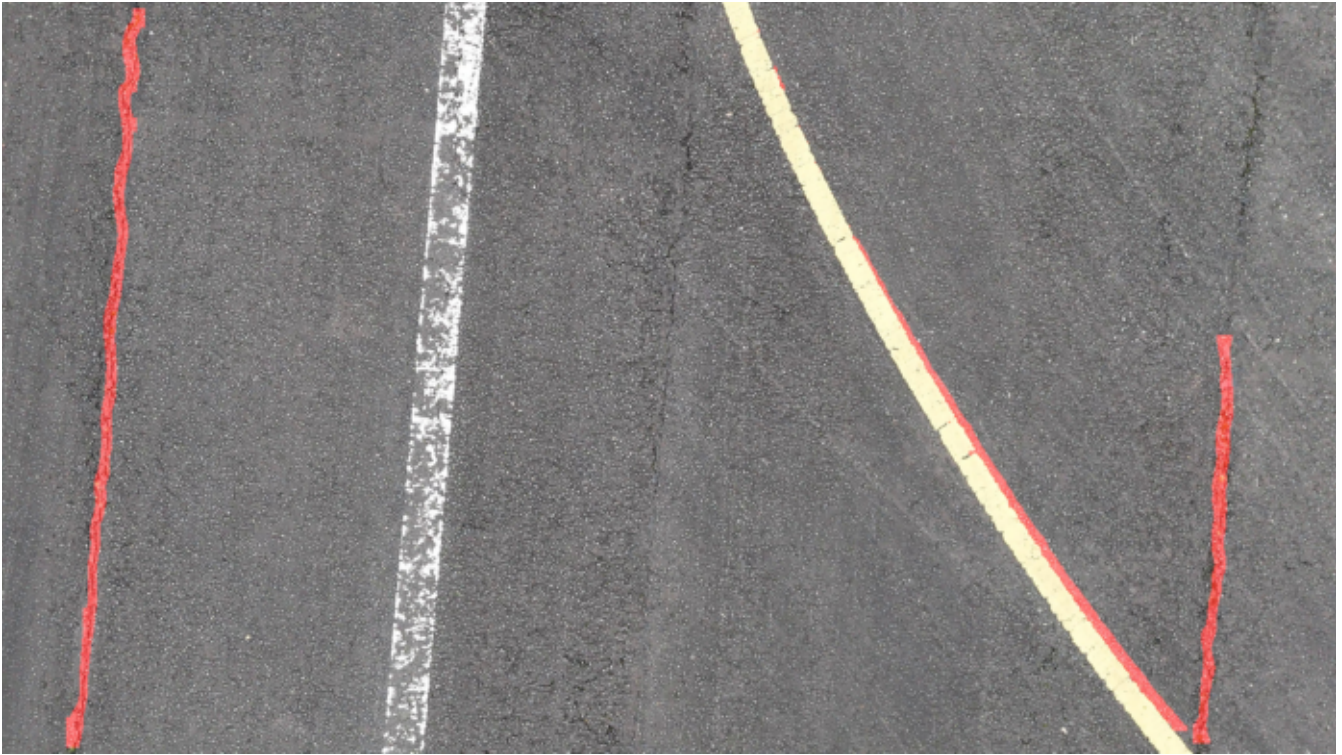
frame\_000001.jpg — STA 0.0 m — 2.15% density

red = segmented crack

| id | STA(m) | frame | type | len(m) | id | STA(m) | frame | type | len(m) |
|---|---|---|---|---|---|---|---|---|---|
| 1 | 0.0 | frame_000001.jpg | longitudinal | 2.61 | 47 | 5.1 | frame_000012.jpg | alligator | 3.26 |
| 2 | 0.0 | frame_000001.jpg | longitudinal | 2.55 | 48 | 5.6 | frame_000013.jpg | alligator | 3.45 |
| 3 | 0.0 | frame_000001.jpg | longitudinal | 1.56 | 49 | 5.6 | frame_000013.jpg | longitudinal | 0.32 |
| 4 | 0.0 | frame_000001.jpg | longitudinal | 2.40 | 50 | 5.6 | frame_000013.jpg | alligator | 2.33 |

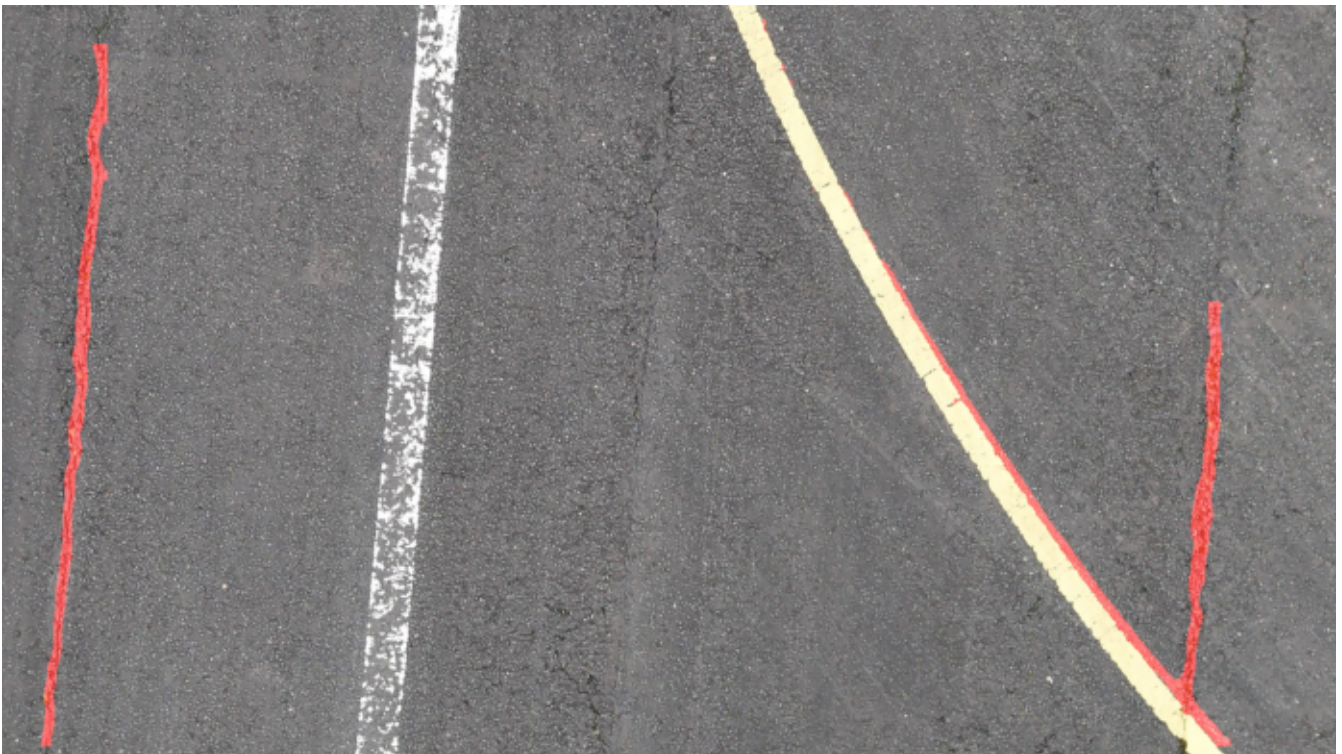
frame\_000005.jpg — STA 2.0 m — 2.10% density

| id | STA(m) | frame | type | len(m) | id | STA(m) | frame | type | len(m) |
|---|---|---|---|---|---|---|---|---|---|
| 15 | 2.0 | frame_000005.jpg | longitudinal | 2.71 | 61 | 7.4 | frame_000020.jpg | alligator | 1.53 |
| 16 | 2.0 | frame_000005.jpg | longitudinal | 2.65 | 62 | 7.8 | frame_000021.jpg | longitudinal | 0.66 |
| 17 | 2.0 | frame_000005.jpg | longitudinal | 1.73 | 63 | 7.8 | frame_000021.jpg | longitudinal | 0.60 |

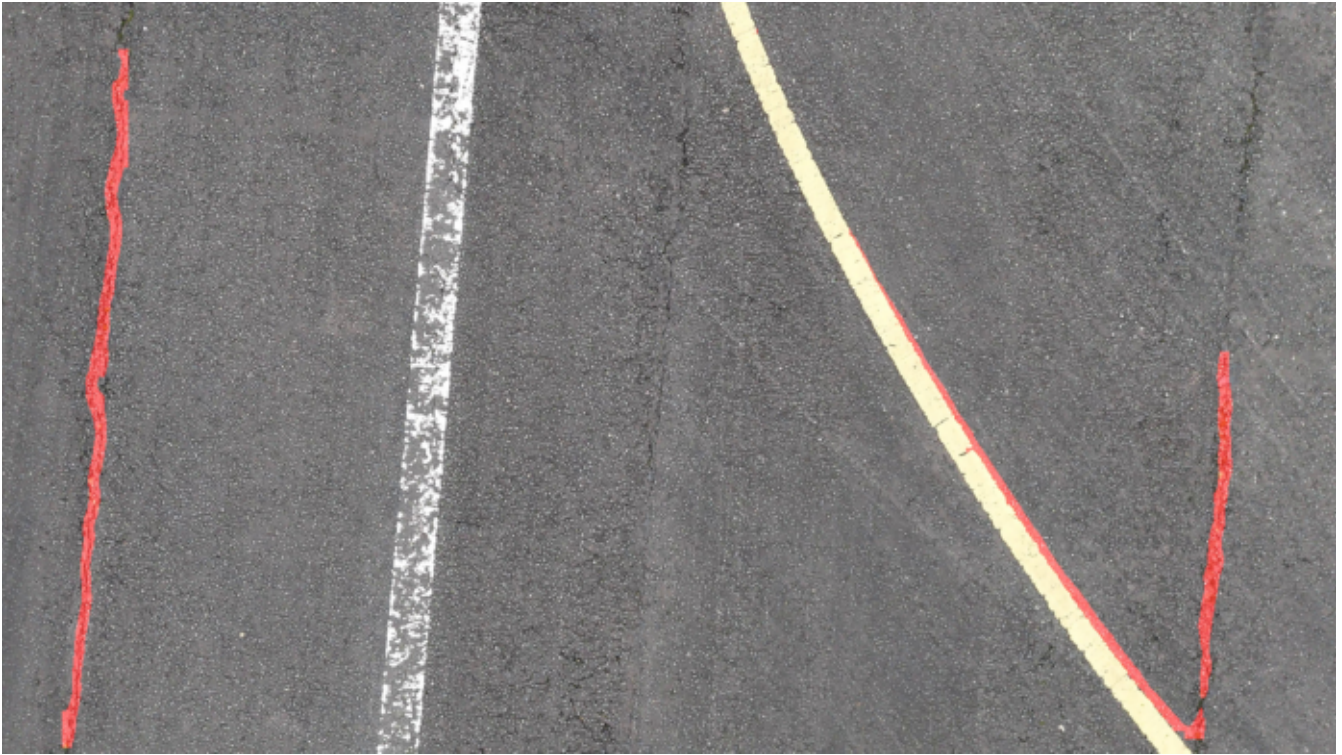
frame\_000002.jpg — STA 0.5 m — 1.95% density

red = segmented crack

| id | STA(m) | frame | type | len(m) | id | STA(m) | frame | type | len(m) |
|---|---|---|---|---|---|---|---|---|---|
| 5 | 0.5 | frame_000002.jpg | longitudinal | 2.19 | 51 | 6.1 | frame_000014.jpg | longitudinal | 1.87 |
| 6 | 0.5 | frame_000002.jpg | longitudinal | 2.62 | 52 | 6.1 | frame_000014.jpg | alligator | 3.93 |
| 7 | 0.5 | frame_000002.jpg | longitudinal | 1.47 | 53 | 6.1 | frame_000014.jpg | alligator | 3.15 |

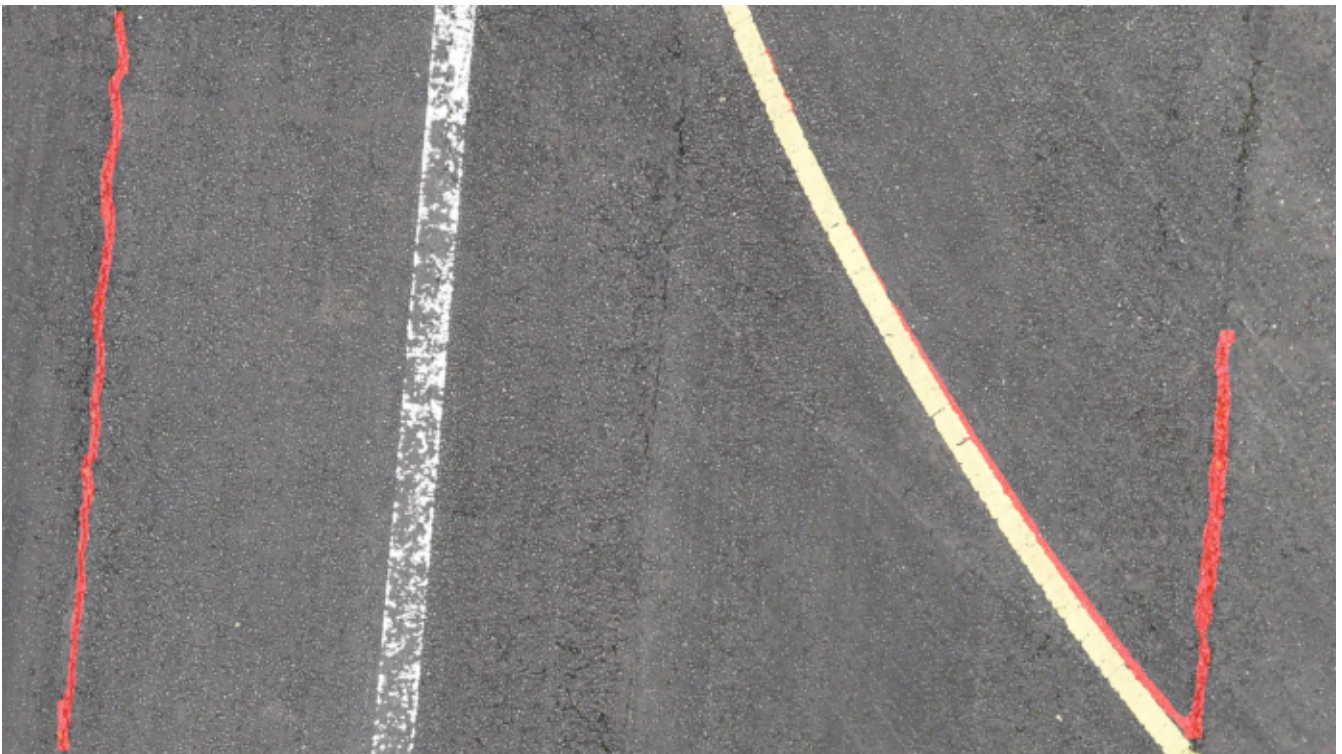
frame\_000003.jpg — STA 1.0 m — 1.91% density

| id | STA(m) | frame | type | len(m) | id | STA(m) | frame | type | len(m) |
|---|---|---|---|---|---|---|---|---|---|
| 8 | 1.0 | frame_000003.jpg | longitudinal | 2.39 | 54 | 6.1 | frame_000014.jpg | alligator | 3.54 |
| 9 | 1.0 | frame_000003.jpg | longitudinal | 2.54 | 55 | 6.2 | frame_000015.jpg | longitudinal | 2.02 |
| 10 | 1.0 | frame_000003.jpg | longitudinal | 1.65 | 56 | 6.2 | frame_000015.jpg | longitudinal | 2.23 |
| 11 | 1.0 | frame_000003.jpg | longitudinal | 1.93 | 57 | 6.4 | frame_000016.jpg | longitudinal | 2.30 |
