# Automated Condition Assessment of Runway Surfaces from Low-Altitude UAV Imagery

Shabaz Ahmad Hasib

Sequetrics · June 2026

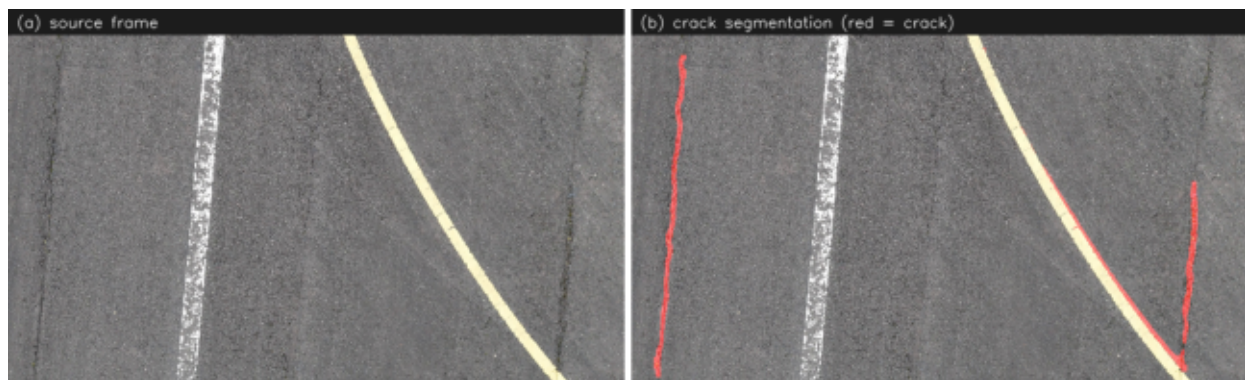
Figure 2. Source frame (left) and the crack outlines returned by the segmentation network (right). The model traces the cracking as thin shapes, which is what allows length and orientation to be measured rather than merely counted.

Cracks are the primary target and the hardest to see. Each frame passes through a segmentation network specialised for cracking (Figure 2), which returns one outline per crack. From each outline we reduce the shape to its centre-line and measure length along that line; the orientation of the line, relative to the runway axis, sorts the crack into longitudinal, transverse, or an interconnected 'alligator' pattern — the last being the one the airfield standard flags for debris risk. Across the survey the network maps 545 cracks totalling roughly 1128 m, dominated by longitudinal cracking (520 cracks) with 18 alligator patches flagged for attention.

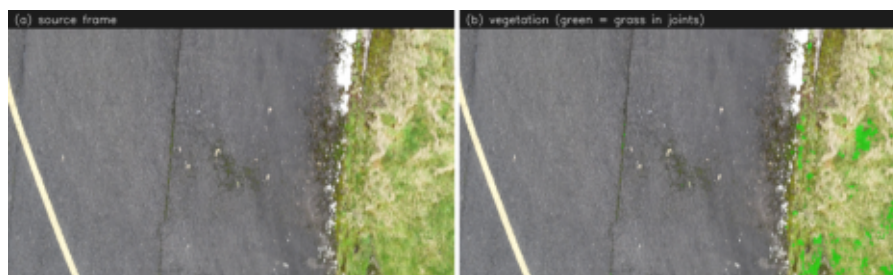
Figure 3. Grass growing through the joints along the verge is isolated by its colour, which is well separated from grey asphalt and needs no trained model.

Vegetation is the clearest of the three to pick out: living plant matter is green, and green is far from the grey of asphalt in colour space, so a simple hue-saturation rule isolates it reliably (Figure 3). It is also operationally meaningful — grass in the joints points to trapped moisture, is itself a debris source, and is a visible sign that maintenance has lapsed. Vegetation appears in 85 of 274 frames, concentrated along one verge and around the two-thirds mark of the pass, covering about 0.10% of the imaged surface overall.

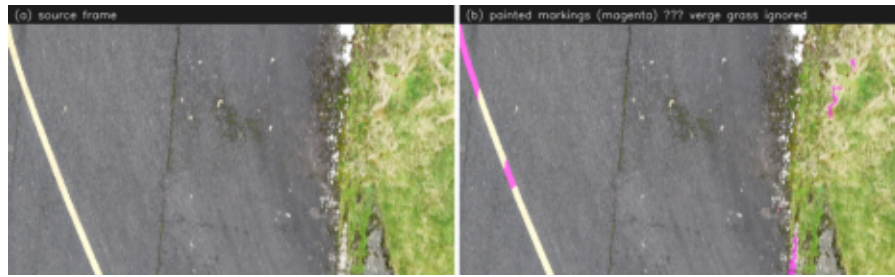
Figure 4. Painted lines are picked out by brightness and linear shape, not colour alone. The cream line on the asphalt is traced (magenta) while the grass on the verge — which shares almost the same hue — is correctly left out.

Markings are the subtlest of the three, and colour on its own is misleading: sunlit and dried grass take on almost the same warm hue as faded cream paint, so a plain colour rule flags the verge instead of the line. The track therefore keys on what genuinely sets a marking apart — it is brighter than the asphalt around it, it sits on the grey surface rather than the green verge, and it runs as a long thin line rather than a blob. With those three conditions together the white centre line and the brighter cream lines are traced cleanly and the grass is left alone (Figure 4); markings register in 240 frames. The case that remains hard is badly faded paint, which by then is barely brighter than the surface beneath it — so we read this track as a dependable locator of intact markings and a weaker guide to worn ones.

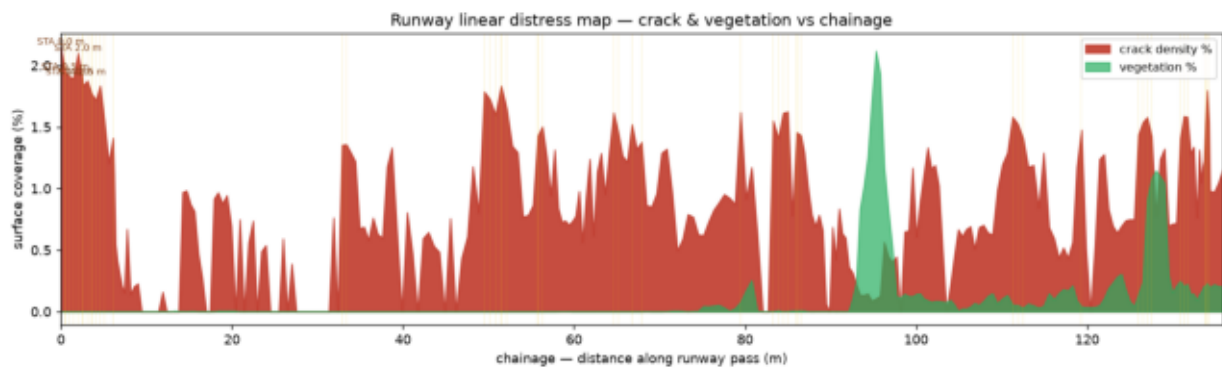
Figure 5. Crack and vegetation coverage plotted against chainage — distance along the pass in metres. The concentration of cracking in the first few metres marks the priority stretch; vegetation rises toward the far end.

A list of defects is only useful if each one can be found again on the ground. With no satellite positioning recorded, we recover position from the imagery itself: consecutive frames overlap heavily, so aligning each frame with the next gives the distance the platform moved between them, which accumulates into a chainage — a running distance along the runway. The platform advanced about half a metre per frame, and the surveyed length comes to 136 m. Every crack and patch of vegetation then carries a station value, and the survey reads as a map rather than a list (Figure 5).

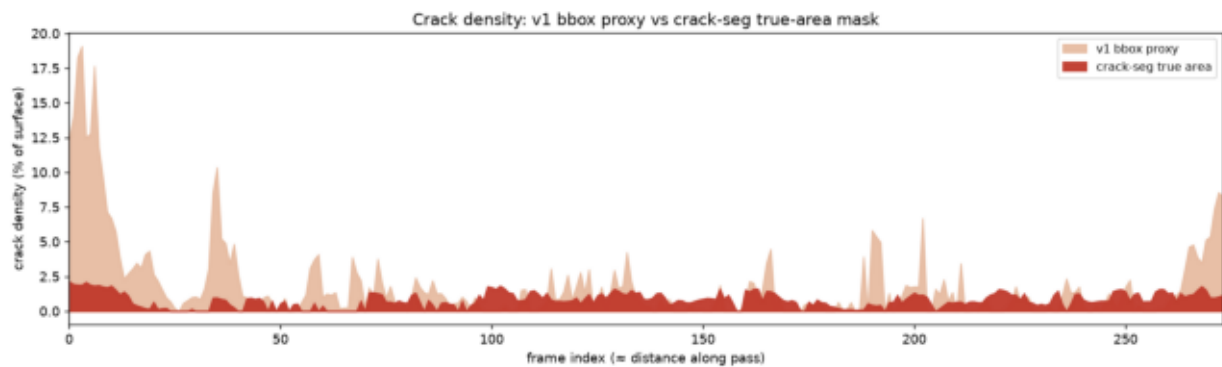
Figure 6. Crack density along the runway, comparing a coarse bounding-box estimate with the true area from segmentation. The outline measurement corrects the magnitude while preserving the pattern of where cracking concentrates.

Crack density — the share of surface taken up by cracking — is the headline figure for prioritisation. Measuring it from outlines rather than boxes matters: a box drawn round a thin crack vastly overstates the affected area, whereas the outline gives the true figure of about 0.82% of surface (Figure 6). Both views agree on where the trouble is — the heaviest cracking sits in the first few metres of the pass — but only the outline gives a defensible number. The vegetation track adds a second, independent map of where the verge is breaking down. Together they let a maintenance team see, at a glance, which stretches to walk first.
