# Automated Condition Assessment of Runway Surfaces from Low-Altitude UAV Imagery

Sequetrics · June 2026

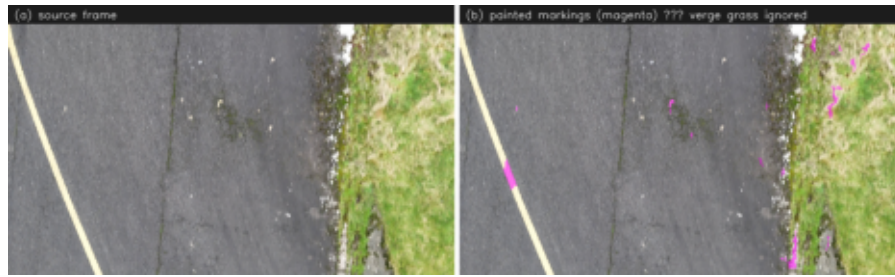
Figure 4. Painted lines are picked out by brightness and linear shape, not colour alone. The cream line on the asphalt is traced (magenta) while the grass on the verge — which shares almost the same hue — is correctly left out.

Markings are the subtlest of the three, and colour on its own is misleading: sunlit and dried grass take on almost the same warm hue as faded cream paint, so a plain colour rule flags the verge instead of the line. The track therefore keys on what genuinely sets a marking apart — it is brighter than the asphalt around it, it sits on the grey surface rather than the green verge, and it runs as a long thin line rather than a blob. With those three conditions together the white centre line and the brighter cream lines are traced cleanly and the grass is left alone (Figure 4); markings register in 240 frames. Two cases stay hard: very faded paint, by then barely brighter than the surface beneath it, and the bright concrete shoulder at the runway margin, itself a long pale line — so we read this track as a dependable locator of intact interior markings and a weaker guide to worn ones.
