Runway Surface Condition Report

Runway survey — UAV imagery, ~1.25 mm GSD · generated 2026-06-14 · detection confidence  $\geq 0.10$

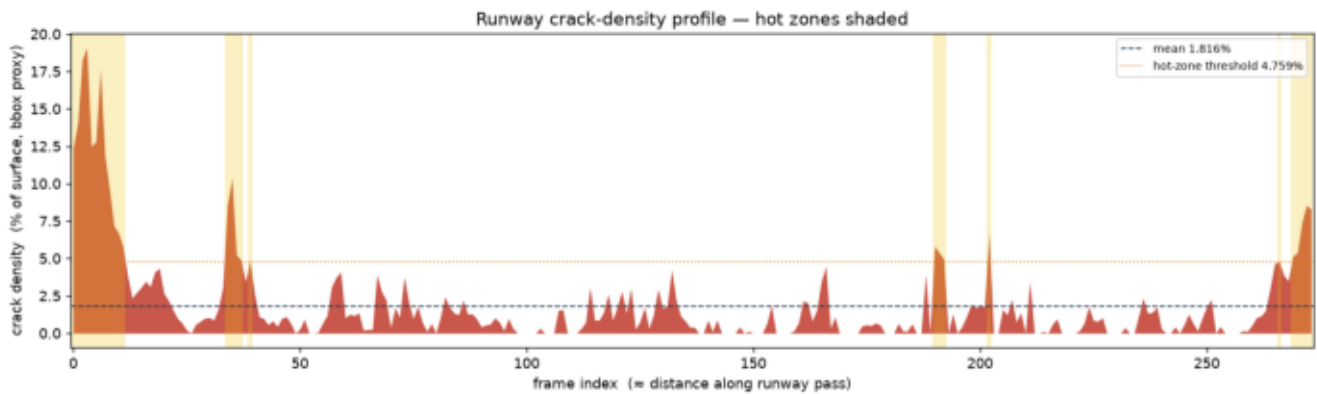
# Crack-density profile along the runway

Capture order  $\approx$  distance along the pass; shaded bands are hot zones.

Top hot zones (frame · density · cracks):

| frame_000004.jpg | 19.07% | 6 cracks |
| frame_000003.jpg | 18.27% | 6 cracks |
| frame_000007.jpg | 17.63% | 5 cracks |
| frame_000002.jpg | 14.01% | 4 cracks |
| frame_000006.jpg | 12.80% | 4 cracks |
| frame_000005.jpg | 12.48% | 4 cracks |
| frame_000001.jpg | 12.37% | 3 cracks |
| frame_000008.jpg | 11.81% | 3 cracks |
| frame_000036.jpg | 10.35% | 2 cracks |
| frame_000009.jpg | 9.61% | 3 cracks |

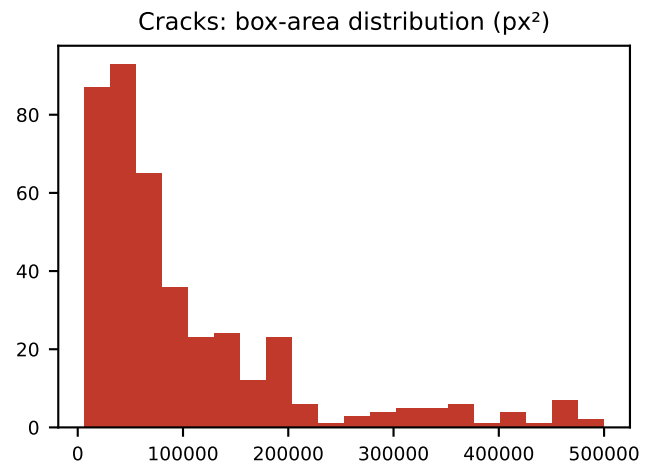
## Cracks

detections: 408  
frames affected: 207/274  
box area  $\text{px}^2$  – min 6202, median 65785,  
mean 101156, max 499895  
mean box: 122 × 736 px

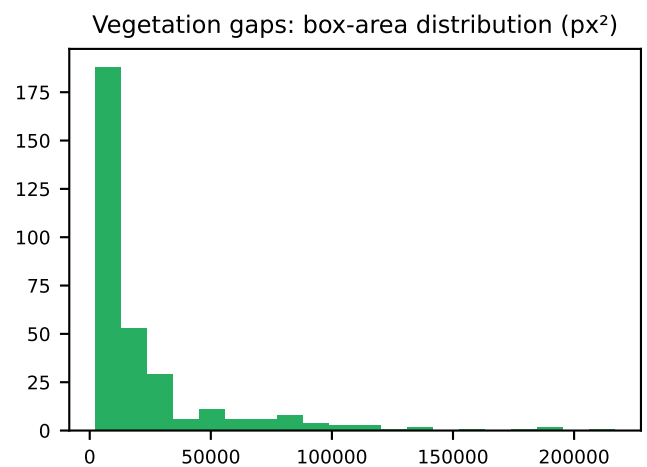
## Vegetation gaps

detections: 325  
frames affected: 89/274  
box area  $\text{px}^2$  – min 2286, median 11151,  
mean 23855, max 216877  
mean box: 111 × 166 px

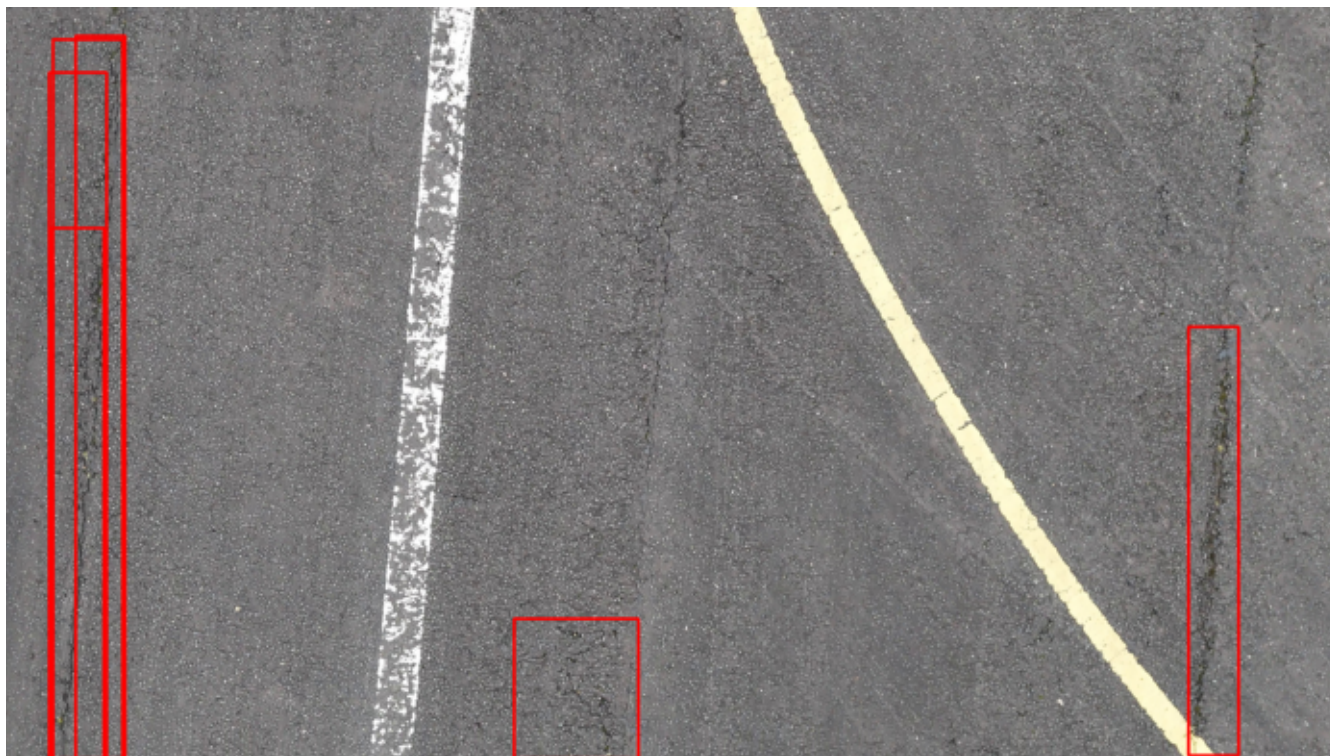
frame\_000004.jpg — 19.1% density · 6 cracks
