Automated surface screening of the runway from a continuous drone pass (custom YOLOv8 detection; crack masks refined with SAM2). Findings are referenced by chainage (distance along the pass) and summarised as crack density and vegetation coverage with hot zones to prioritise maintenance, consistent with routine pavement monitoring under ICAO Annex 14 / CAA CAP 168 and the ASTM D5340 distress framework.

# Spatial distress map (by chainage)

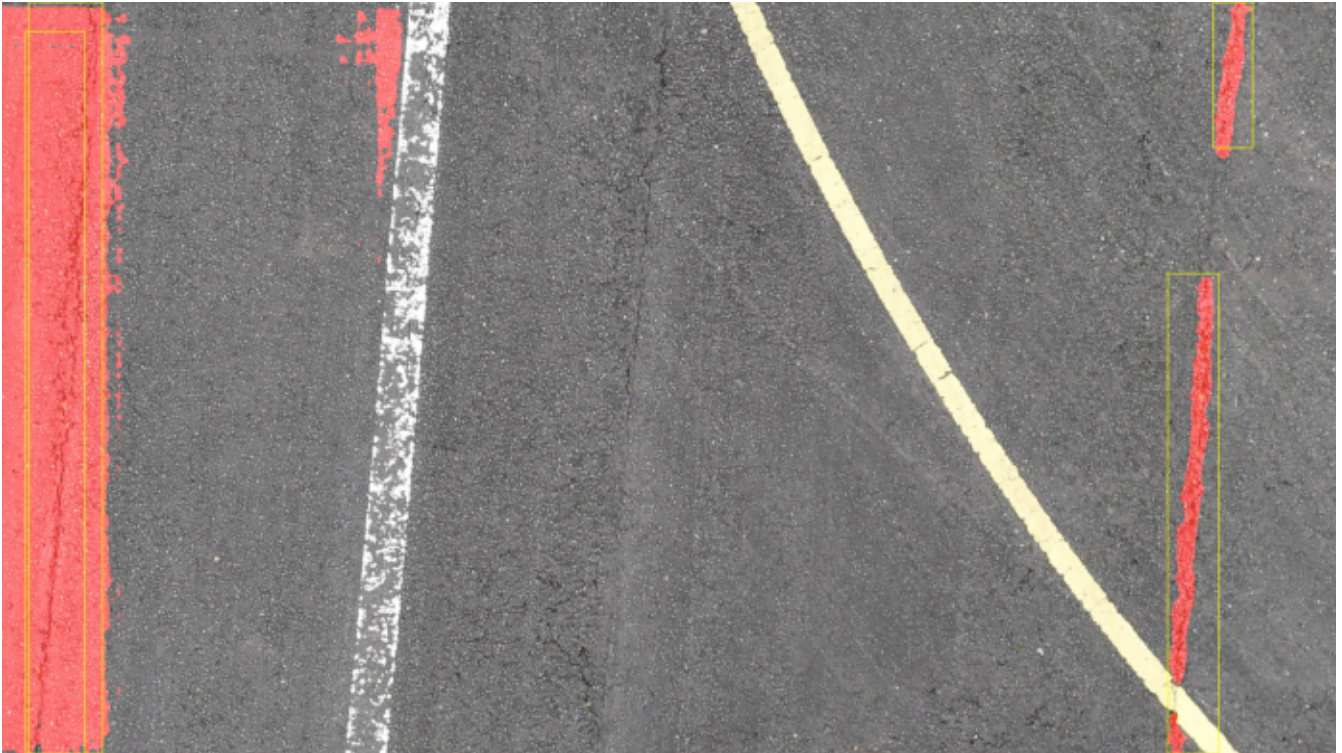
frame\_000006.jpg — STA 2.5 m — 9.53% density

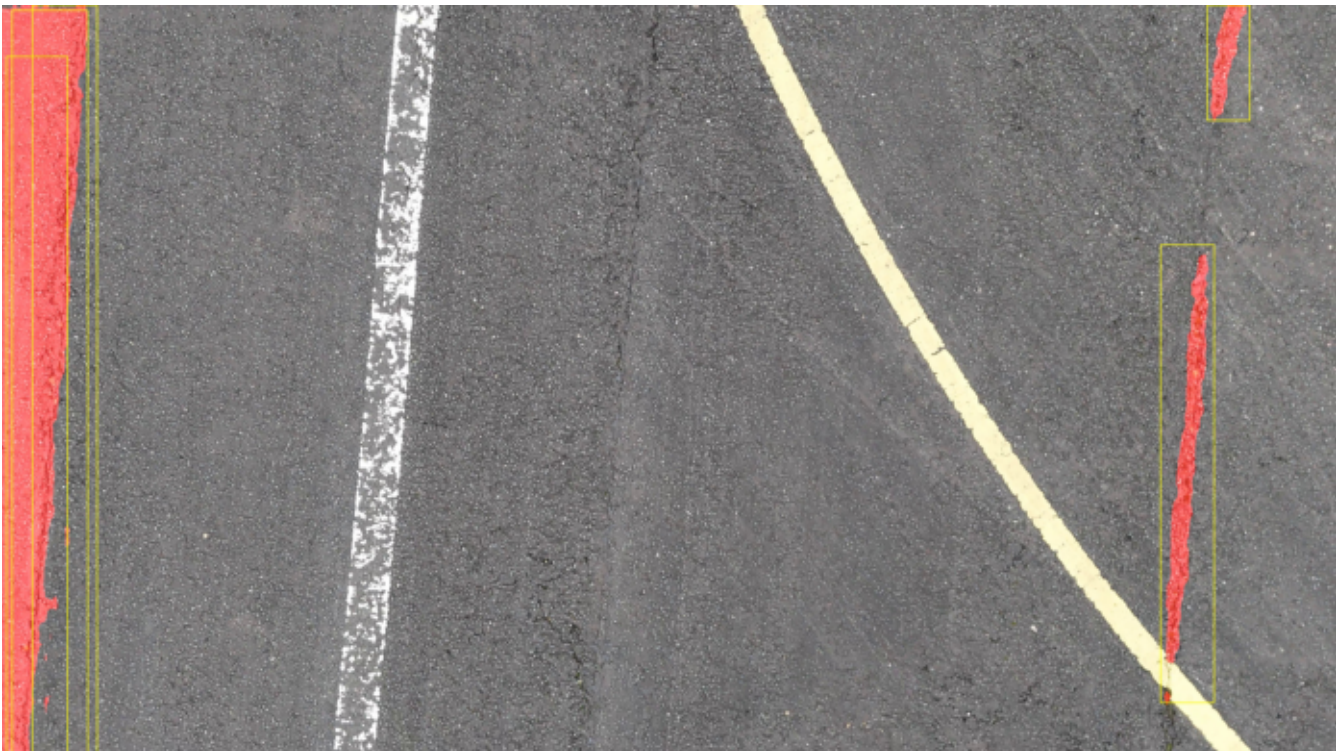
frame\_000007.jpg — STA 2.6 m — 5.26% density

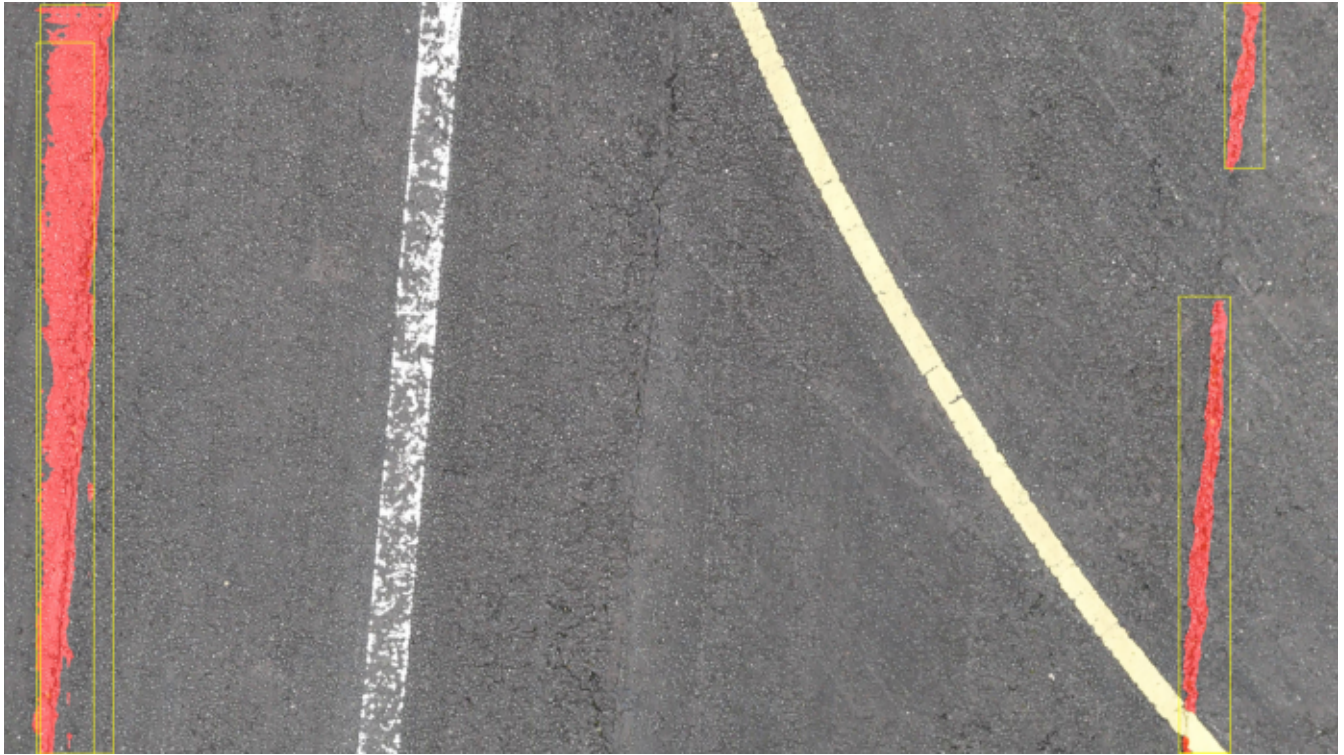
frame\_000005.jpg — STA 2.0 m — 4.08% density
