# Automated Condition Assessment of Runway Surfaces from Low-Altitude UAV Imagery

Shabaz Ahmad Hasib

Sequetrics · June 2026

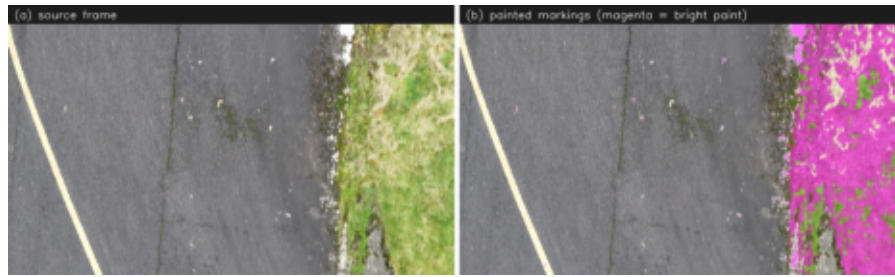
Figure 4. Bright paint is isolated by colour (magenta). Intact white and yellow lines are caught well, but the same rule also responds to the bright concrete shoulder on the right — a limitation discussed below.

The third track looks for painted markings by the same colour logic, keying on bright white and yellow (Figure 4). Intact lines are caught cleanly. The method is, however, the least dependable of the three: the bright concrete shoulder and verge satisfy the same brightness rule and are picked up alongside the paint, and faded markings — which are the ones an inspector most wants flagged — are missed because they are no longer bright. Markings register in 258 frames, but we treat this track as indicative of where paint is present rather than as a measure of its condition.

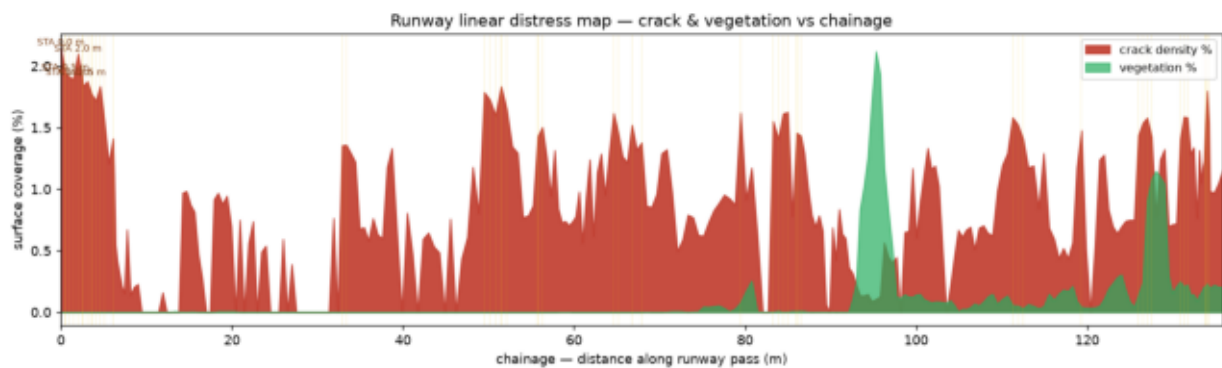
Figure 5. Crack and vegetation coverage plotted against chainage — distance along the pass in metres. The concentration of cracking in the first few metres marks the priority stretch; vegetation rises toward the far end.
