# Riverside Community Library - Facilities Permit Packet

Permit Application + Intake Cover | Rev 2 resubmittal 2026-06-11

| PERMIT NO. | PARCEL | ZONING | OCCUPANCY | TYPE |
|---|---|---|---|---|
| PR-26-18422 | 073W22AB-04400 | PS - Public Service | A-3 Library | II-B |

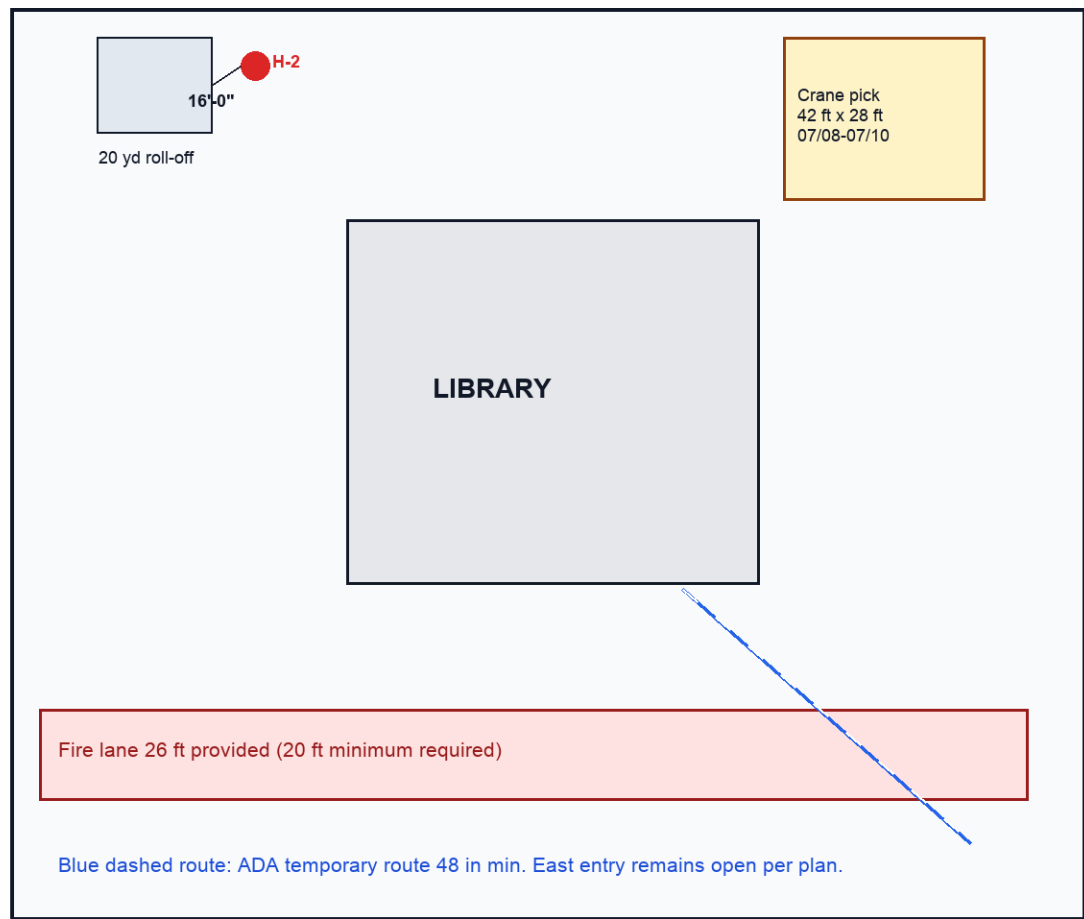
Fire access markup says do not stage within 20 ft of hydrant. Dimension string shows dumpster 16 ft from H-2.

- OBS-14: East entry route shown on logistics plan not maintained on 06/27; corrected route required before public opening.
- OBS-15: Dumpster within 20 ft hydrant clearance; move minimum 4 ft west.
- OBS-16: Room 114 chase revised per RFI-07; verify turning circle after lav shift.
- OBS-17: Curb C-3 field layout follows CO-02; confirm permit resubmittal reflects structural opening.

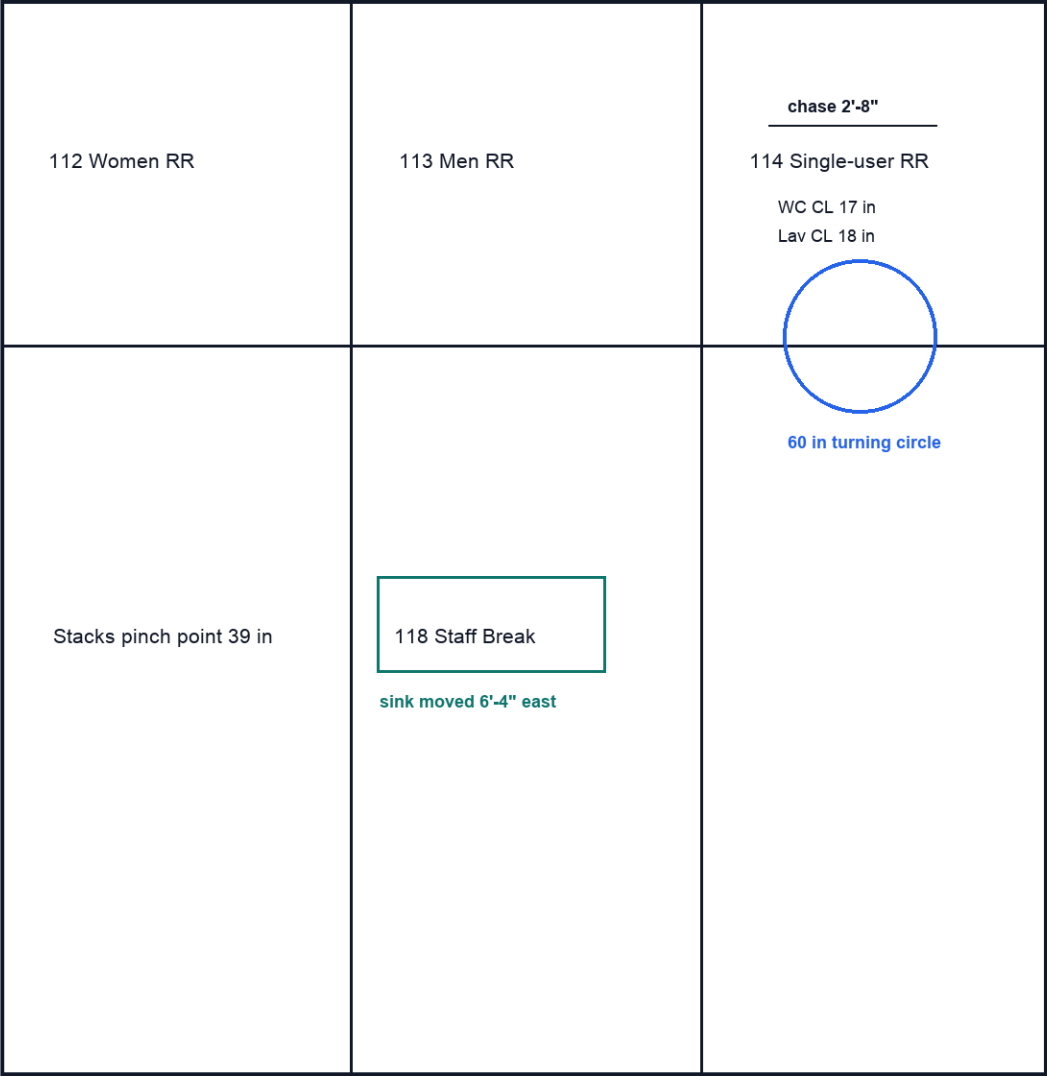
# A2.1 Enlarged Floor Plan / Restroom + Breakroom Alteration

Stacks aisle pinch point is 39 in clear, tagged EXISTING NONCONFORMING - DO NOT REDUCE.

Revises chase from 2'-8" to 3'-2"; maintain 60" turning circle; shift lav 4" east.

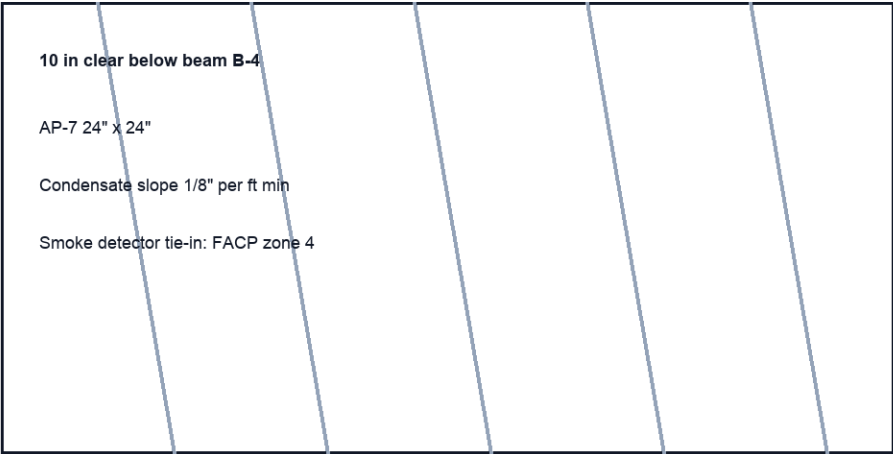
# M1.3 / E1.2 Mechanical + Electrical Coordination Overlay

Mechanical C-3 opening: 54" x 78". Structural curb detail / CO-02 later requires 58" x 80".

This sheet lists 4 RTUs totaling 25.5 tons. Do not add ERV-1 to the original mechanical schedule; CO-02 adds it later.

Upsize RTU-3 from 10 tons to 12.5 tons. Add ERV-1 with 450 CFM outside air. Modify curb C-3 to 58" x 80". Add electrical breaker 3P-80A in panel MDP.
