**BEFORE THE PUBLIC UTILITIES COMMISSION
OF THE STATE OF CALIFORNIA**

**CALIFORNIANS FOR GREEN NUCLEAR POWER, INC. REPLY
COMMENTS APPENDIX IN RESPONSE TO ALJ FITCH'S PROPOSED
DECISION DATED MARCH 18, 2019 RE ADOPTING PREFERRED
SYSTEM PORTFOLIO FOR 2017-2018 INTEGRATED RESOURCE PLAN**

Pacific Gas and Electric Company
Natural Gas Transmission Pipeline Rupture and Fire
San Bruno, California
September 9, 2010

Pipeline Accident Report

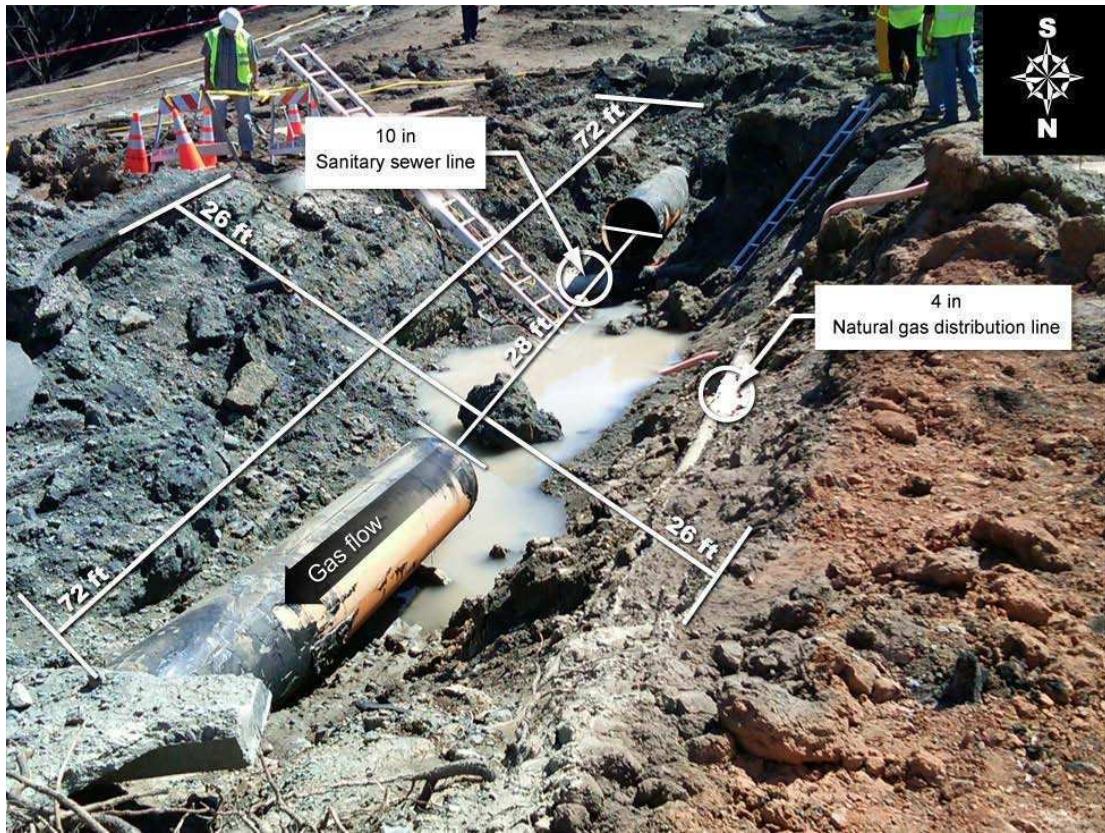
Figure 1. Picture of crater and ruptured pipeline.

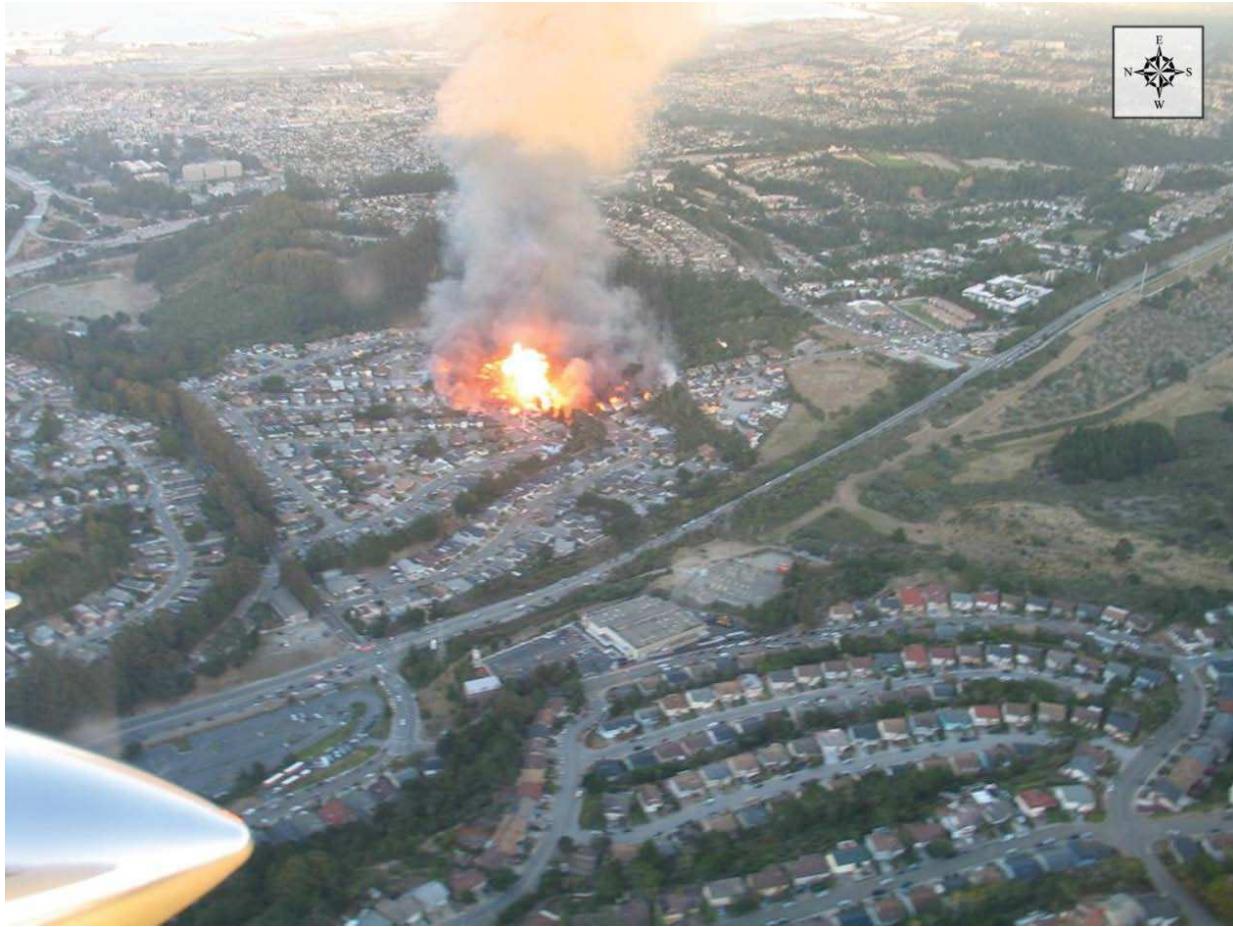
Figure 3. Aerial view of fire.

On September 9, 2010, about 6:11 p.m. Pacific daylight time,¹ a 30-inch-diameter segment of an intrastate natural gas transmission² pipeline known as Line 132, owned and operated by the Pacific Gas and Electric Company (PG&E), ruptured in a residential area in San Bruno, California. The rupture occurred at mile point (MP) 39.28 of Line 132,³ at the intersection of Earl Avenue and Glenview Drive. The rupture produced a crater about 72 feet long by 26 feet wide. (See figure 1.) The section of pipe that ruptured, which was about 28 feet long, and weighed about 3,000 pounds, was found 100 feet south of the crater. (See figure 2.) PG&E estimated that 47.6 million standard cubic feet of natural gas was released. The released natural gas ignited, resulting in a fire that destroyed 38 homes and damaged 70. (See figure 3.) Eight people were killed, many were injured, and many more were evacuated from the area.

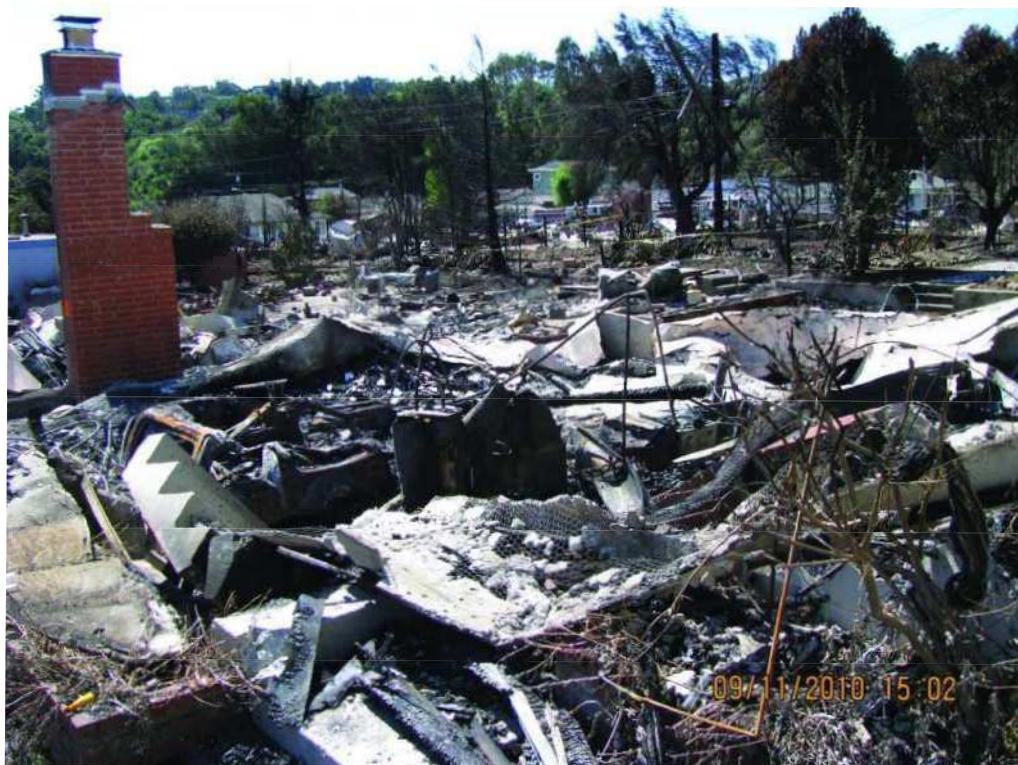
Figure|12. Picture of destroyed houses.

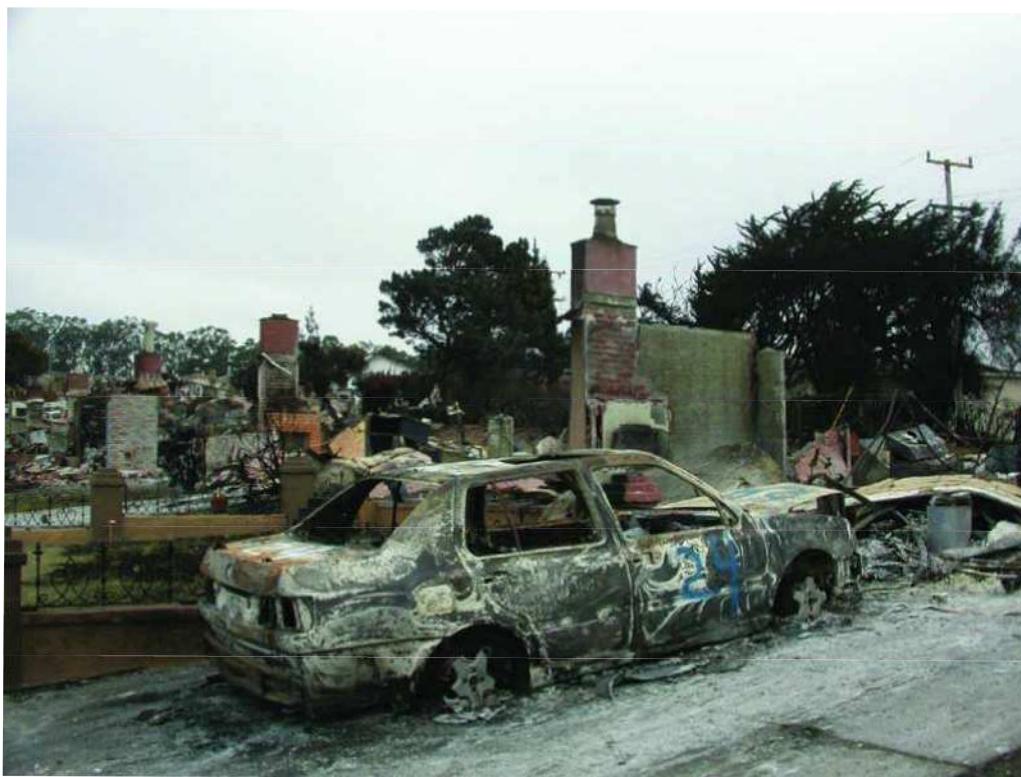
Figure|13. Picture of a burned car in front of several destroyed houses.

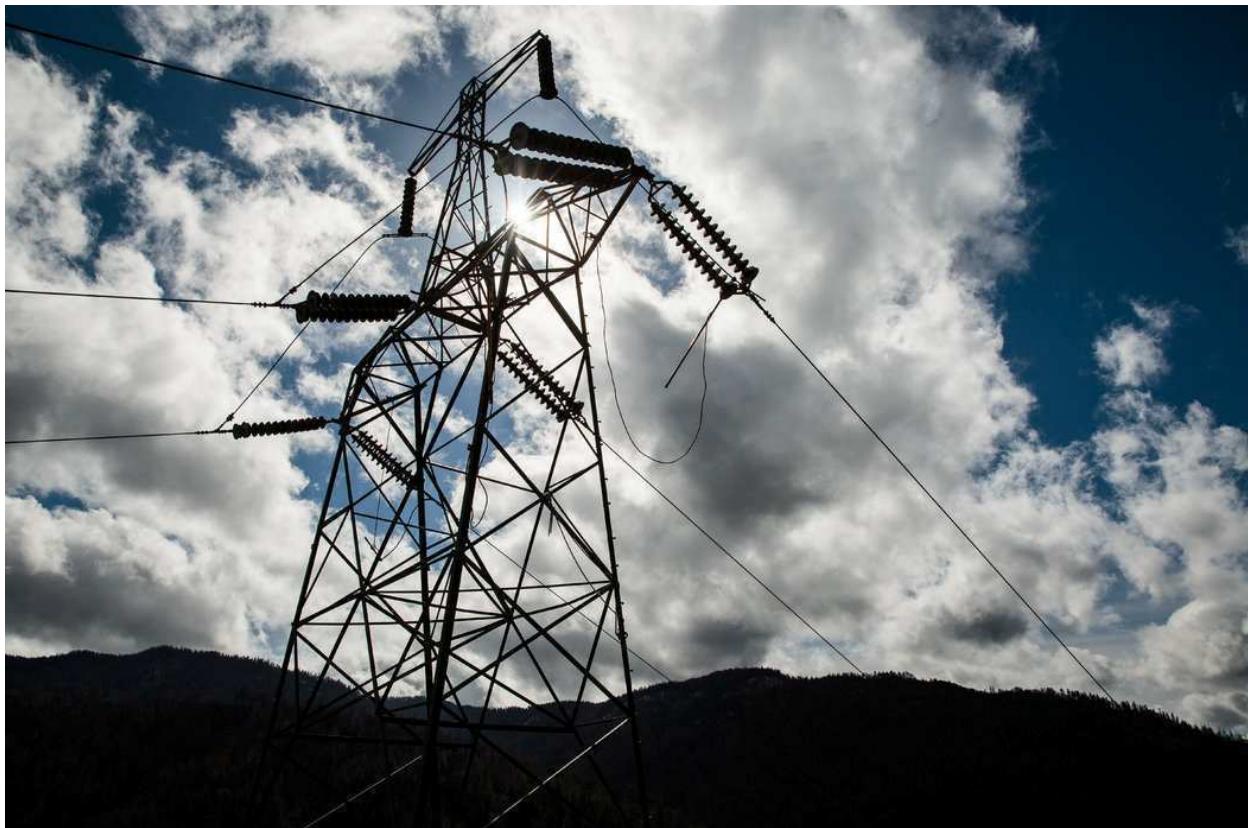
Long before the failure suspected in the Paradise fire, a company email had noted that some of PG&E's structures in the area, known for fierce winds, were at risk of collapse. It reported corrosion of one tower so severe that it endangered crews trying to repair the tower. The company's own guidelines put Tower 27/222 a quarter-century beyond its useful life — but the tower remained.

Tower 27/222. Utility experts have been incredulous that Pacific Gas & Electric let it stand for so long. Max Whittaker for The New York Times

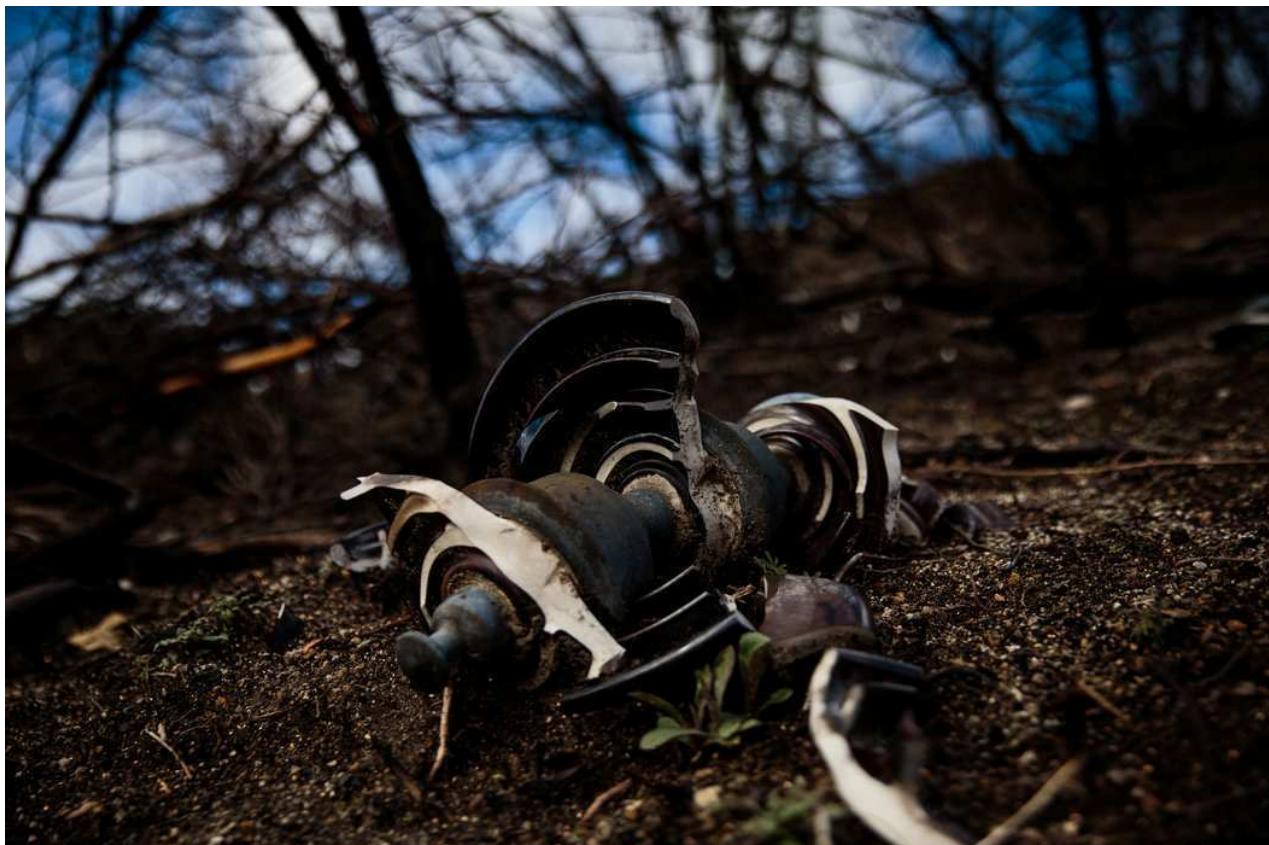
A broken insulator underneath a PG&E transmission line outside the town of Pulga, Calif. Max Whittaker for The New York Times
