# EMBANKMENT BREACH RESEARCH: OBSERVED INTERNAL EROSION PROCESSES

A. K. Ali, S. L. Hunt, R. D. Tejral

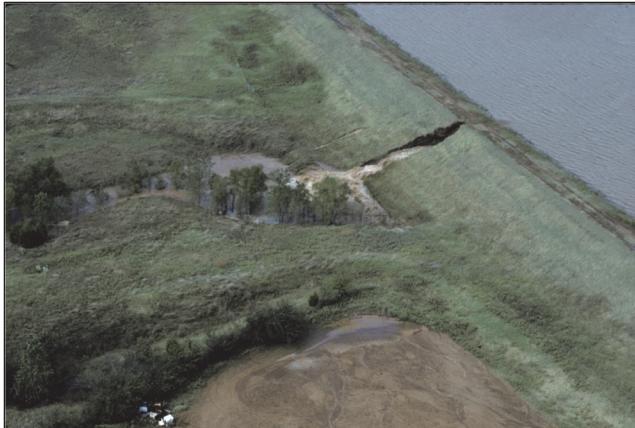
Hanson et al. (2010a) identified inadequate compaction during construction, differential settlement, desiccation, earthquakes, burrowing animals, and/or decay of roots as other causes that create cavities or voids, in addition to suffusion. Given the role of these structural defects in initiating the formation of voids, the ASCE Task Committee on Dam/Levee Breaching (2011) and Costa (1985) included structural defects as a separate category of dam failure causes, in addition to piping and overtopping. An example of a such a failure event is shown in figure 1, where preferential flow along the principal spillway pipe caused internal erosion of the void.

Figure 1. Internal erosion initiated along the principal spillway pipe of Upper Red Rock Site 20 in Oklahoma.
