**Annual Maintenance Completion Report**  
**(2025-2026)**  
**Generating Unit-2**

**Mechanical Maintenance Unit**  
**Tala Hydropower plant**

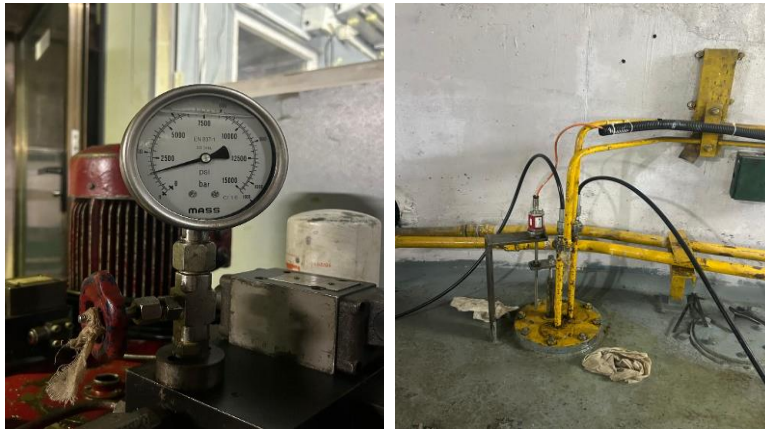
All nozzle injector assemblies underwent functional checks through in-situ oil pressure testing except J<sub>5</sub> because it has exceeded the recommended overhaul interval of four years. During the test, conducted at an initial pressure of 100 bar for a duration of 30 minutes, results were within the acceptable range for remaining four nozzles as shown in table 4.

Figure 1: Nozzle Pre-pressure test

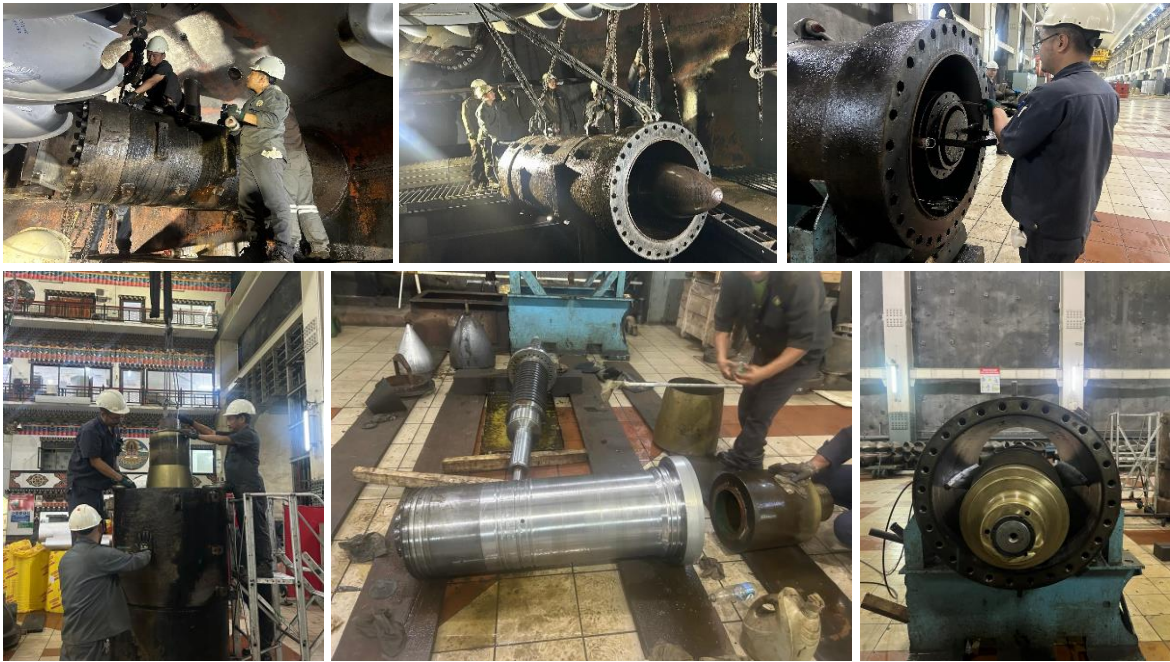
Figure 2: Overhauling and servicing of nozzle injector 1

Therefore, Nozzles 5 was dismantled for overhauling as part of the Annual Maintenance and for the remaining nozzle assemblies that did not require dismantling, were inspected and fasteners were replaced wherever necessary with new set such as such as replacement of needle tip holdings M20x150mm and M10x50mm bolts, O-rings, servicing of deflector shaft bolts. After necessary inspection tag weld was done bolts of nozzle hoods.

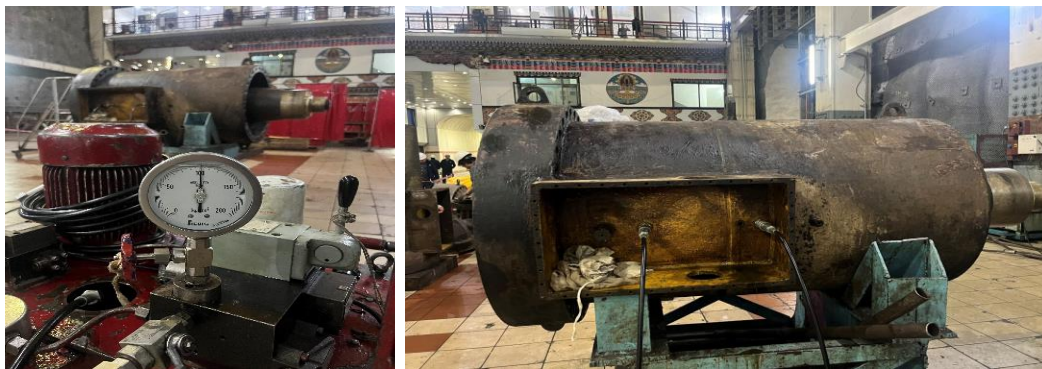
Figure 3: Post-Pressure Test of dismantled nozzle

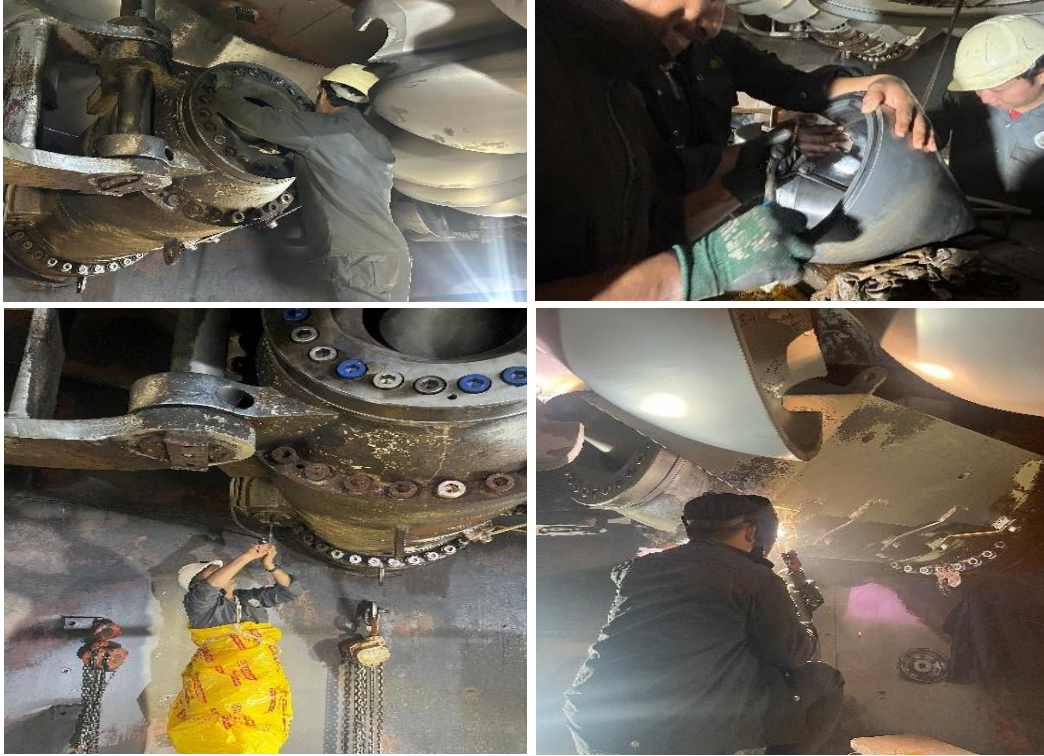
Figure 4: Changing of needle tip boldings bolts, O-rings, servicing of deflector shaft bolts and tag welding in nozzle boods holding bolts.

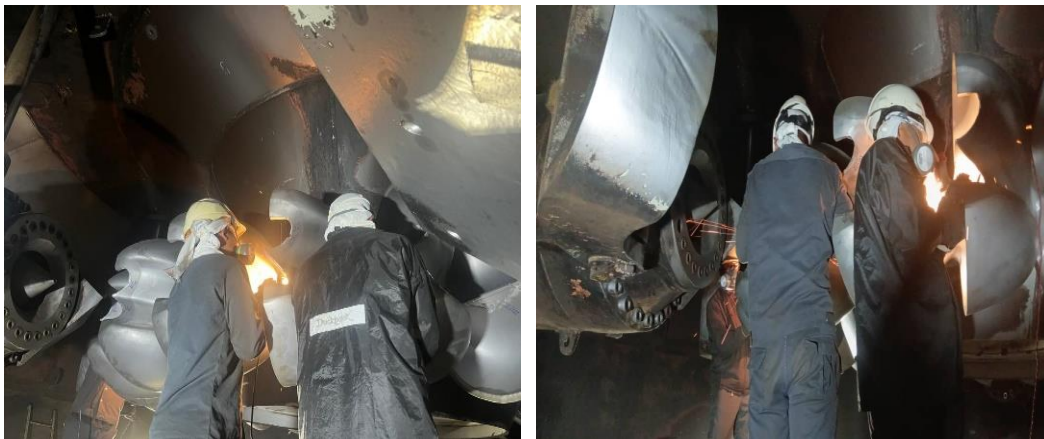
Figure 6: Runner bucket grinding on eroded part

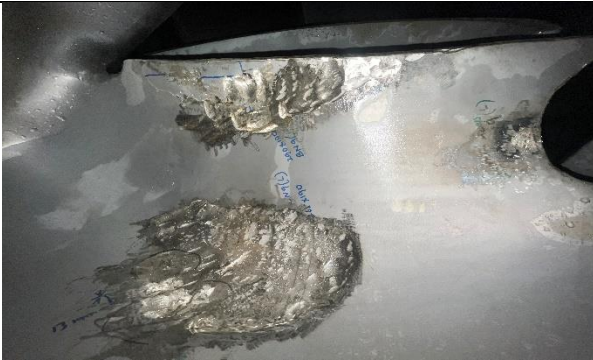
| Before | After |
|---|---|
| <p data-bbox="342 653 657 684">Fig 15A: Erosion cut on BN9 (L)</p> | <p data-bbox="954 653 1269 684">Fig 15B: Weld repaired on BN9 (L)</p> |

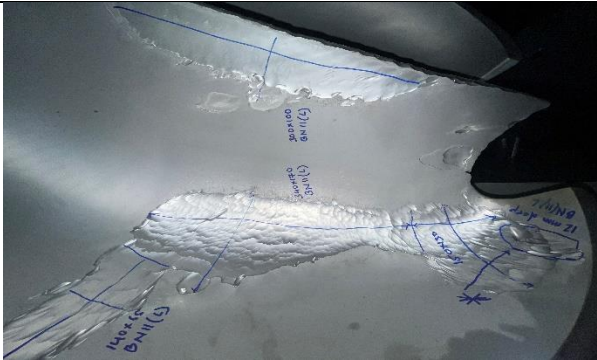
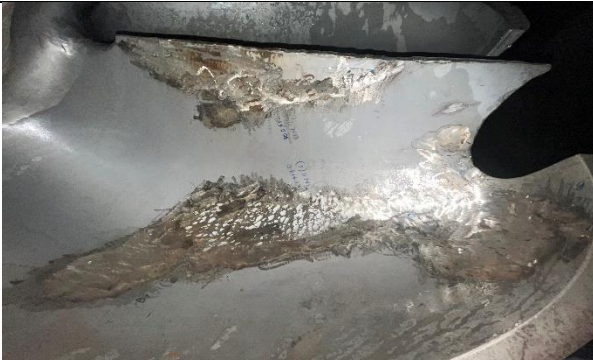
| Before | After |
|---|---|
| <p data-bbox="342 1062 657 1094">Fig 19A: Erosion cut on BN11 (L)</p> | <p data-bbox="954 1062 1269 1094">Fig 19B: Weld repaired on BN11 (L)</p> |

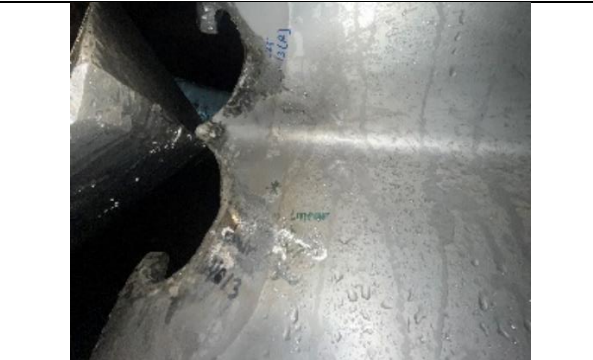
| Before | After |
|---|---|
| <p data-bbox="342 1472 657 1503">Fig 22A: Liner crack on BN13 (L)</p> | <p data-bbox="954 1472 1269 1503">Fig 22B: Weld repaired on BN13 (L)</p> |

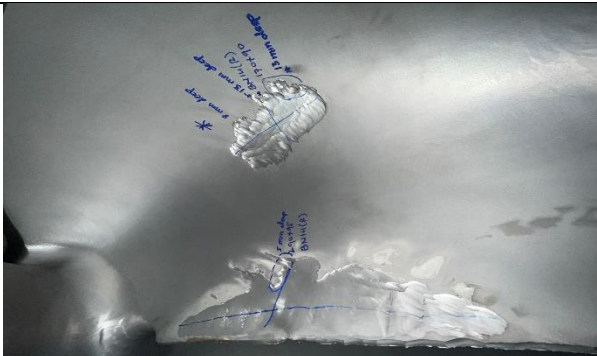
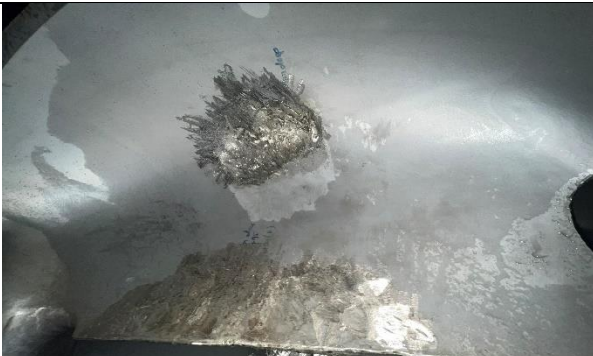
| Before | After |
|---|---|
| <p data-bbox="342 1877 657 1908">Fig 22A: Liner crack on BN13 (L)</p> | <p data-bbox="954 1877 1269 1908">Fig 22B: Weld repaired on BN13 (L)</p> |

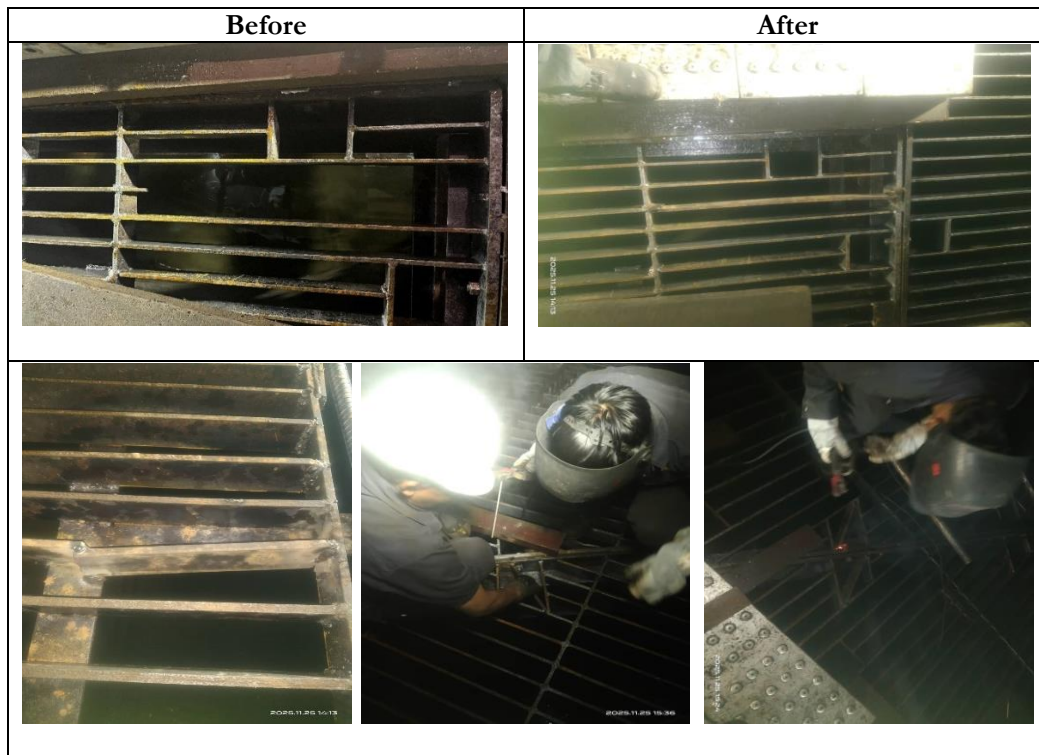
During this Annual Maintenance, several broken metal plates were repaired by welding, and additional plates were added wherever there were larger gaps that could lead to mishaps.

Figure 8: Repairing of center frame.

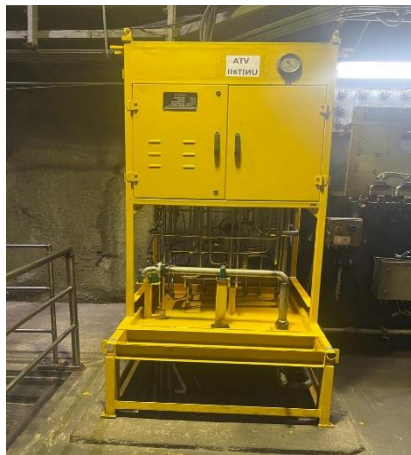
Figure 9: VTA

The VTA is a critical component of the hydraulic control system, primarily responsible for directing and regulating oil flow to the servomotors of the needle and deflector systems. It houses the solenoid valves, pressure gauges, and other control elements that interface with the SCADA system for remote operation and monitoring.

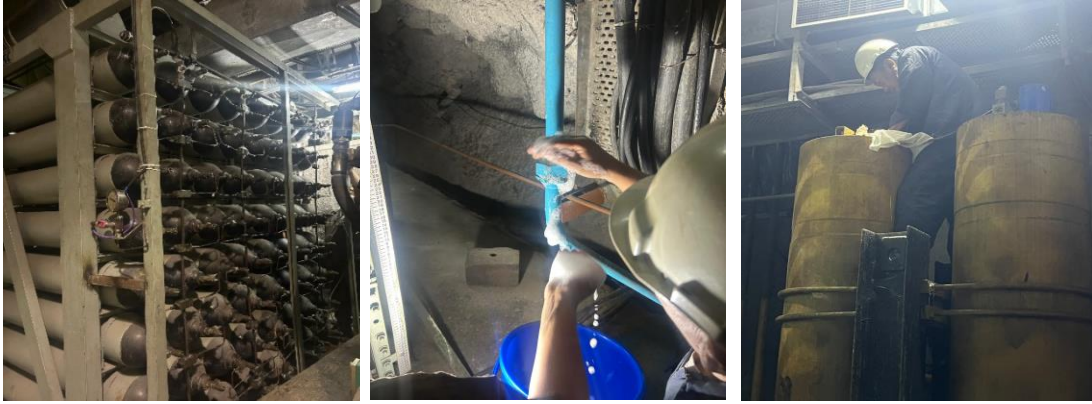
The MIV system is the primary isolation for turbine and principal protection for the station against penstock water. The N<sub>2</sub> gas bank for MIV was replenished and tested for N<sub>2</sub> gas leakage with surf foam bubble.

Figure 11: Leakage checking of N2 gas bank for MIV

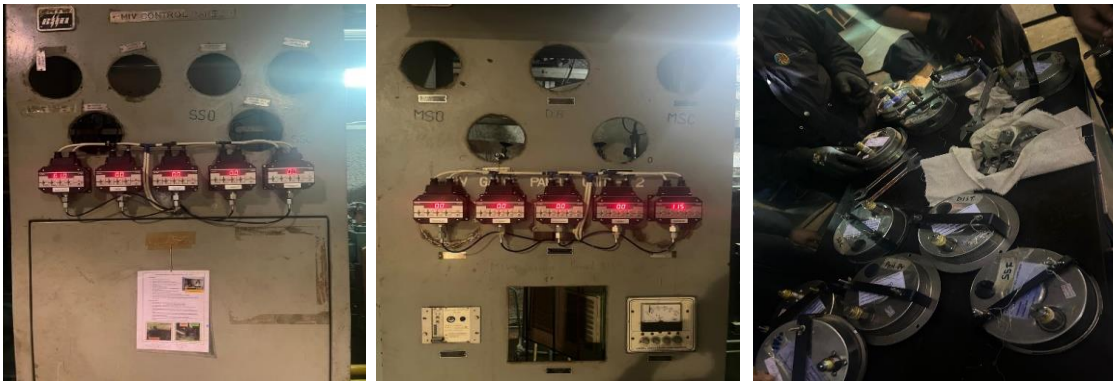
The pressure gauges of MIV control panel and accumulator have been calibrated at HRDC and all are found to be in good working condition. The report is attached in the annexure.

Figure 12: Removing of MIV pressure gauges to be sent for Calibration

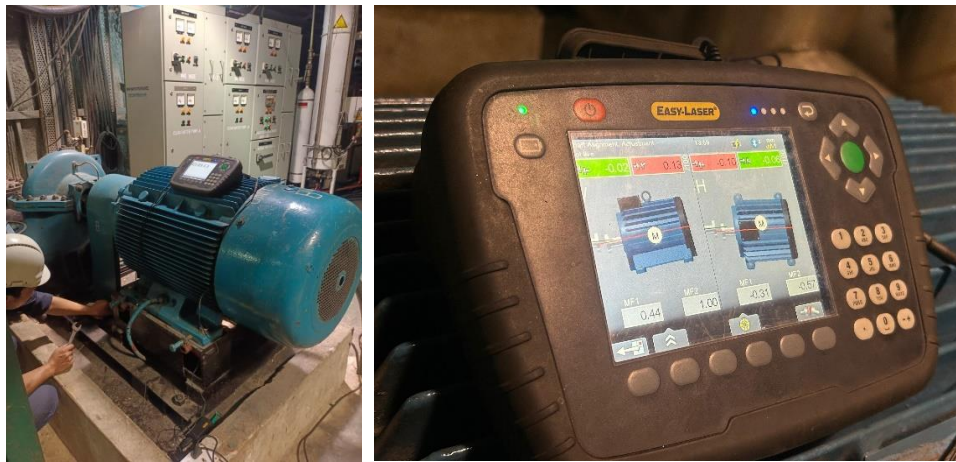
Following the overhauling, servicing and reassembly, shaft alignment between the pump and motor was carried out using an Easy-Laser alignment system. The laser alignment process ensured accurate correction of both angular and parallel misalignments, thereby minimizing vibration and mechanical load on the coupling. Final alignment readings were recorded and confirmed to be within acceptable tolerance limits. The alignment readings have been attached as annexure.

Figure 13: CCW pump alignment check

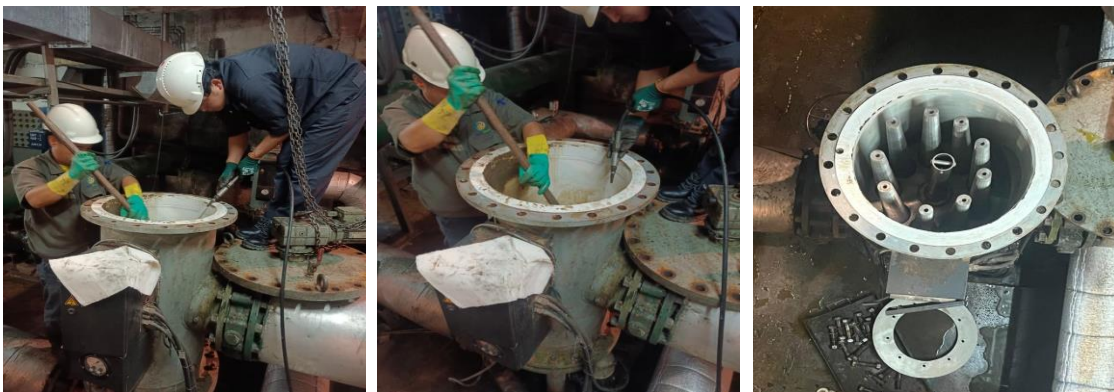
Motorized water strainer was overhauled and cleaned thoroughly, replaced digital flow meter and assembled back. The debris accumulated on strainer cones were huge and is recommended to clean during every annual maintenance during prevent the debris accumulation and choking of outlet holes. The NRVs of both the RCW pumps of the unit were inspected and found to be healthy.

*Figure 15: Cleaning and servicing of RCW strainer.*

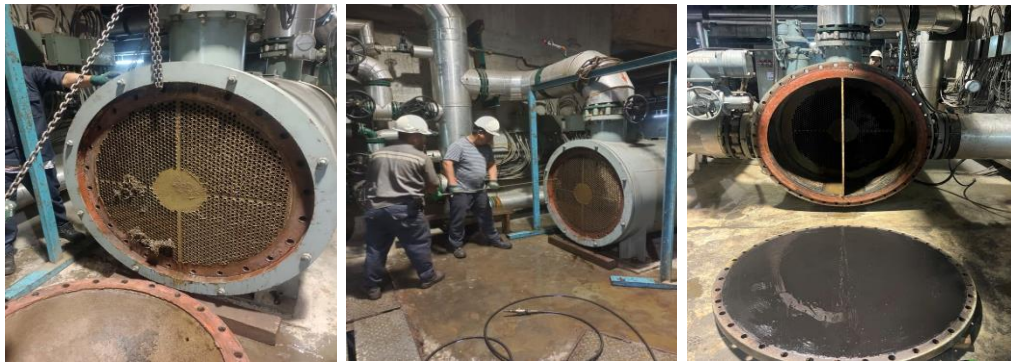
During the annual maintenance, the heat exchanger was opened, and the tubes were thoroughly cleaned and flushed to remove any scaling or deposits that could impede heat transfer efficiency. After cleaning, the end covers were reassembled, and pressure testing was conducted at 8kg for 30 minutes to ensure there were no leaks and that the unit was fit for continued operation.

*Figure 16: Cleaning and servicing of Heat Exchanger.*

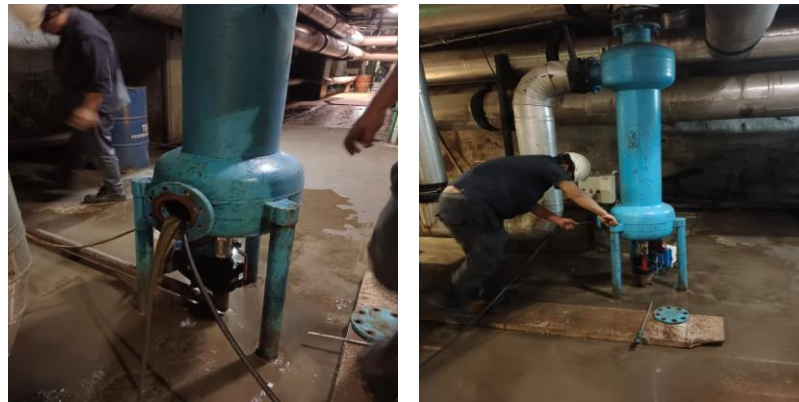
The cyclone separator is used to trap the coarse sediments from the raw water for unit was also overhauled for cleaning and servicing. The sediments collected at the bottom during operations are taken out by hand and flushing method.

*Figure 17: Flushing of sediments from cyclone separator*
