## Annual Maintenance Completion Report

(2025-2026)

### Generating Unit-4

Tala Hydropower plant

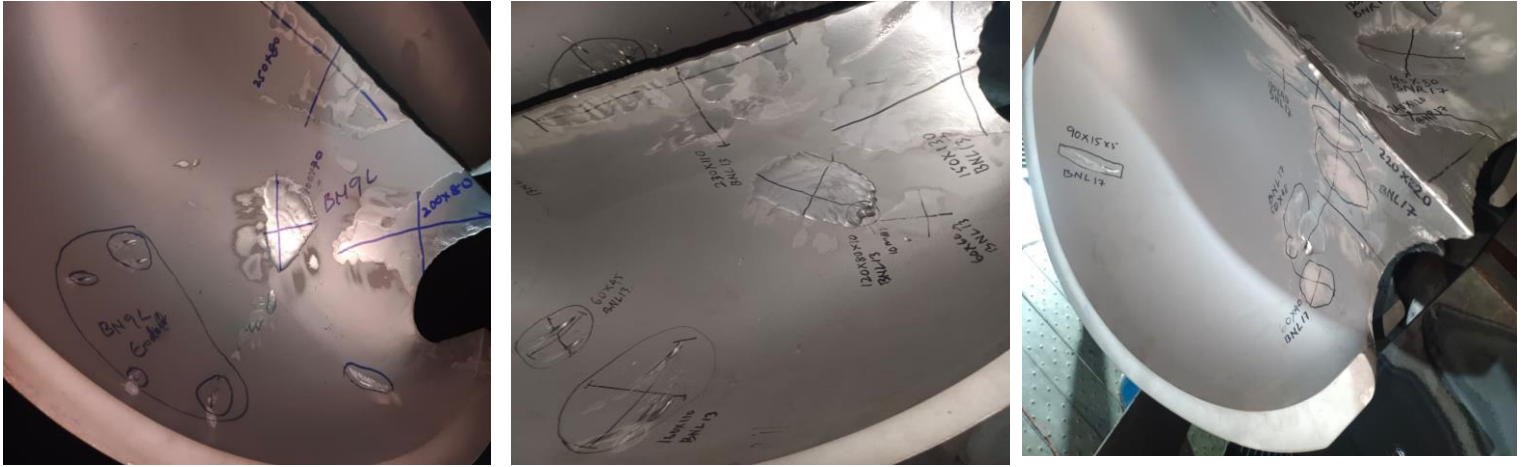
FIGURE 2: Runner bucket grinding on eroded parts

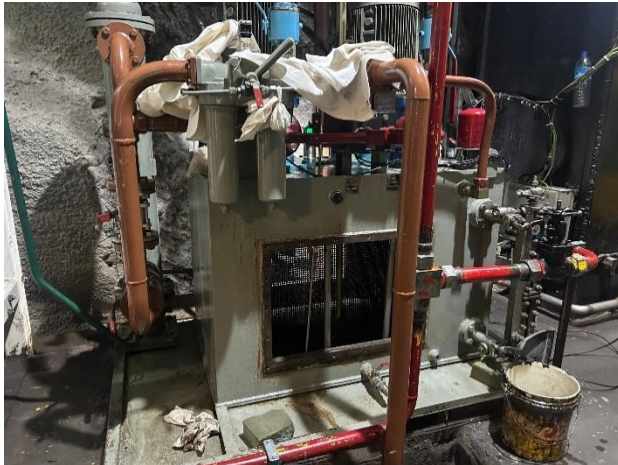
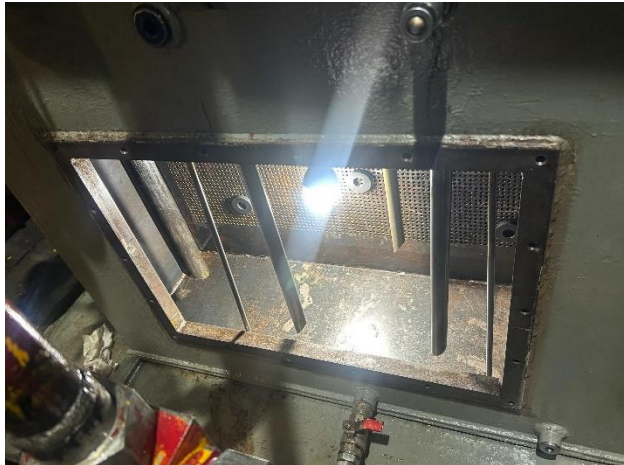
FIGURE 4; GOVERNOR OPU SUMP CLEANING

As part of the Annual Maintenance 2025–2026, cleaning of the Governor OPU sump and replacement of the pressure line filter between the OPU and VTA were completed. During the pre-check of all GE nozzles, pressure retention was found to be within acceptable limits. Therefore, no nozzle removal or associated control pipeline work was required.

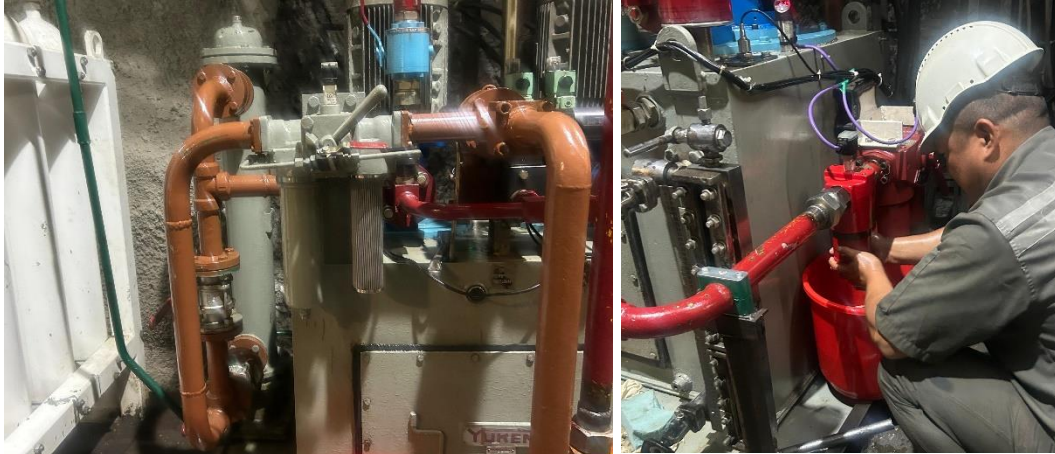
*FIGURE 5; DRAINLINE AND PRESSURE LINE FILTER REPLACEMENT*

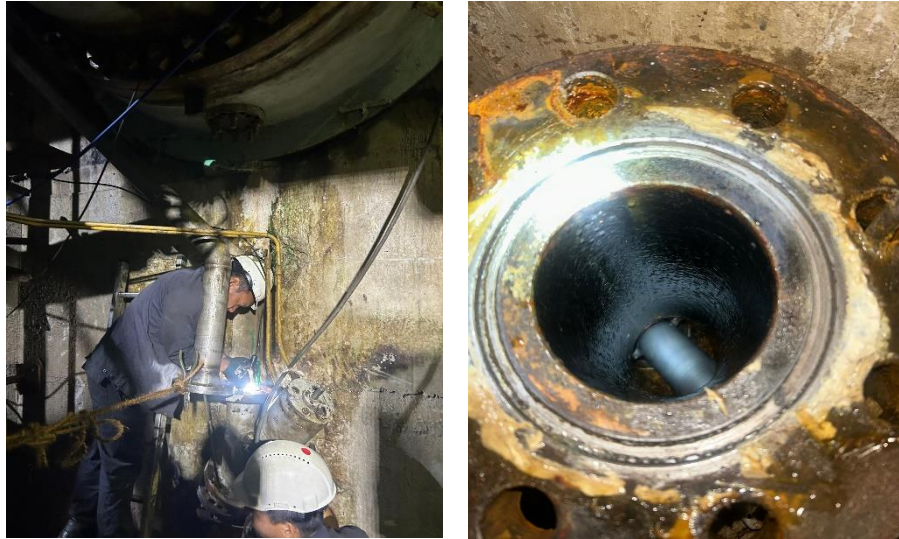
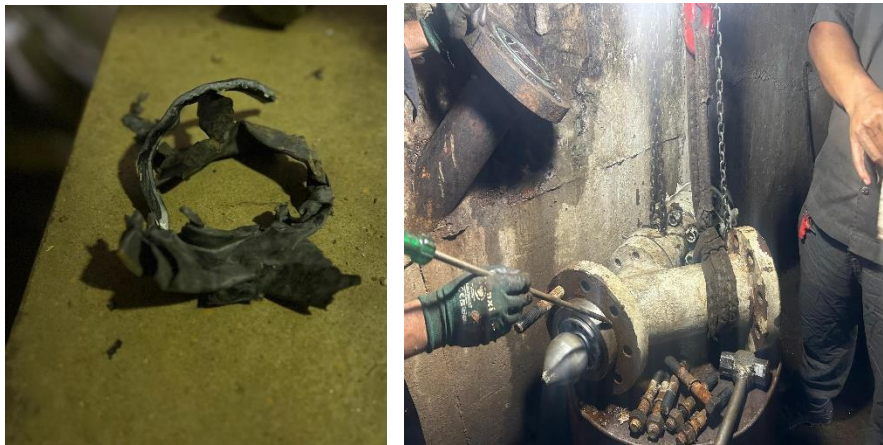
*FIGURE 7; INSPECTION OF DECOMPRESSION SERVO SEATING VALVE FOR ANY FOREIGN DEBRIS*

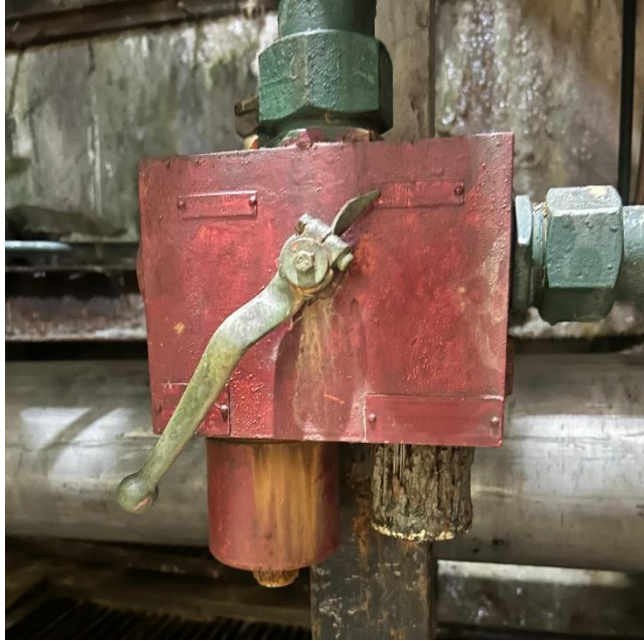
Replacement of the service seal water filter elements was carried out. This activity was mainly undertaken due to the flood that occurred on 10<sup>th</sup> October 2025, which resulted in a significant accumulation of debris in the system. The filter elements were replaced to prevent potential choking and ensure proper flow in the service seal

*FIGURE 8; REPLACEMENT OF SERVICE SEAL FILTER*

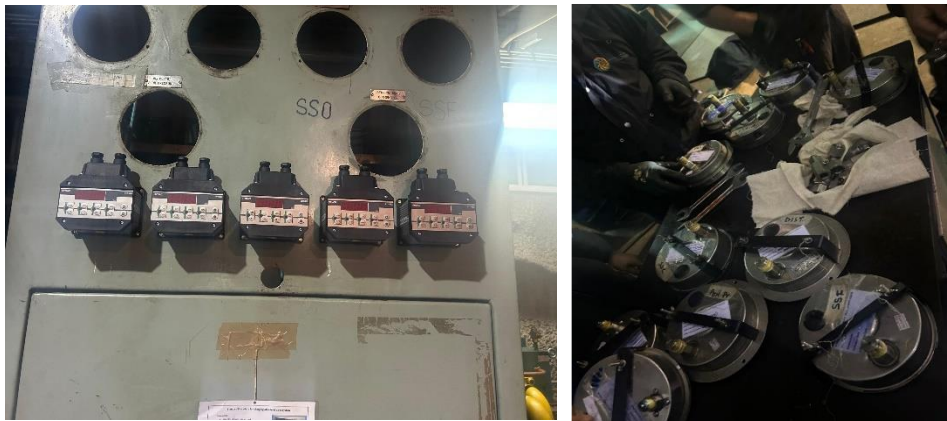
*FIGURE 10; FITTING BACK THE CALIBRATED PRESSURE GAUGES*

The pressure gauges of the MIV control panel and gauge panel were removed and sent for calibration. After completion of calibration, the gauges were refitted in their respective locations.

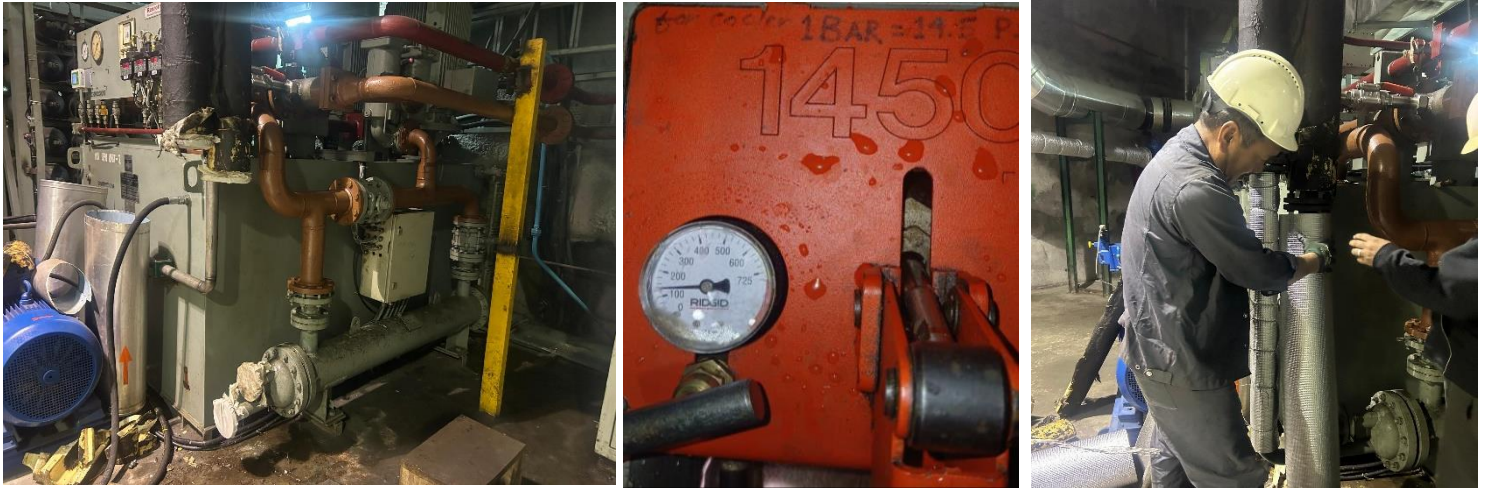
Pressure retention testing of the MIV OPU cooler was carried out to check for any tube puncture. During the test, the cooler retained the pressure and no leakage was observed from the tubes. Cleaning and servicing of the MIV OPU were carried out. The oil was replenished after filtration using the LVDH machine as part of the annual maintenance activity.

FIGURE 11; PRESSURE TESTING OF MIV OPU COOLER AND WRAPPING ITS PIPELINE

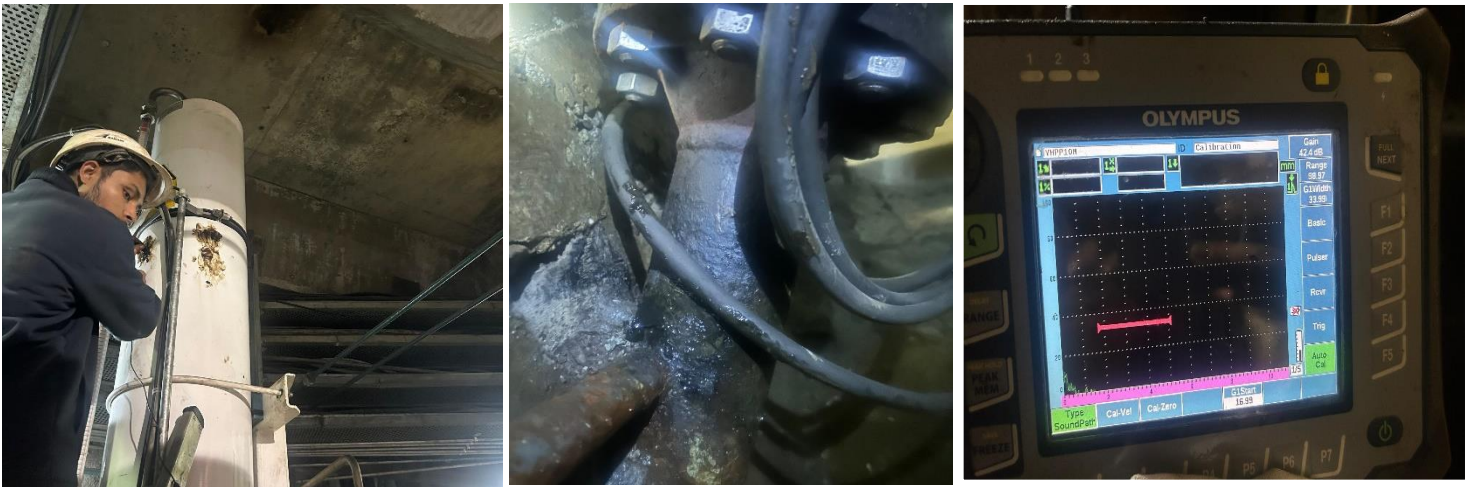
The ultrasonic testing of Decompression pipeline, bypass pipeline and pressure accumulators checked for any possible deviations in thickness and cracks by the NDT personnel from HRDC to ensure safe parameters of the control pipelines for safe and smooth operations.

FIGURE 12; ULTRASONIC TESTING(UT) ON HIGH Pr. PIPELINES AND ACCUMULATORS

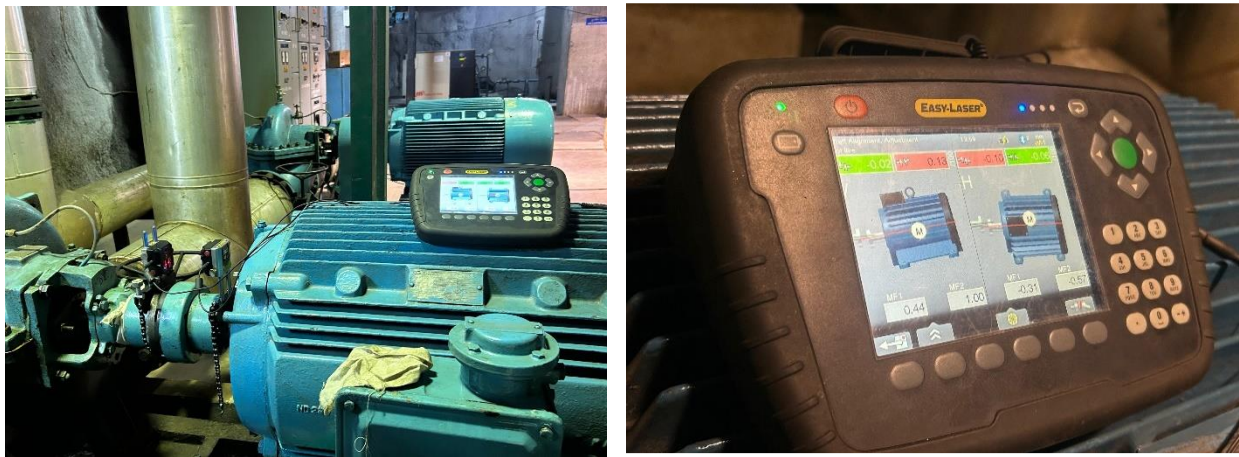
Pre-alignment checks were carried out to verify that there was no disturbance in the base foot positioning and to ensure proper alignment between each pump and its motor. Since both pumps were operating satisfactorily and their condition was found to be healthy, overhaul servicing was not considered necessary.

FIGURE 13; CCW pump alignment check

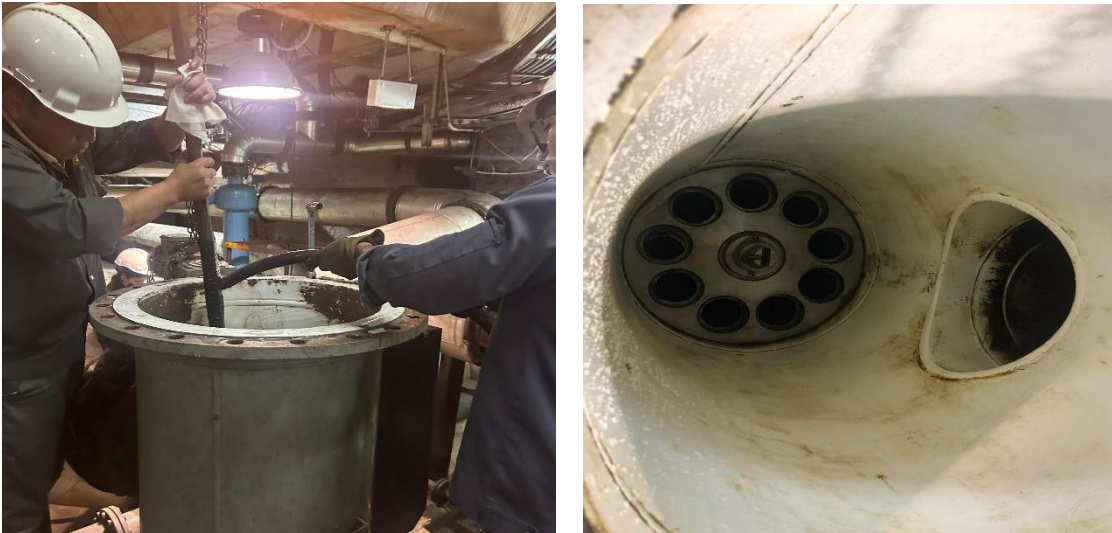
FIGURE 14: Cleaning and servicing of RCW strainers

During the maintenance shutdown, the motorized water strainer was completely overhauled, thoroughly cleaned, and reassembled. A significant amount of debris was found accumulated on the strainer cones. It is recommended that the strainer cones be cleaned during every annual maintenance outage to prevent excessive debris buildup and blockage of the outlet holes. Additionally, the non-return valves (NRVs) of both RCW pumps were inspected and found to be in satisfactory condition.

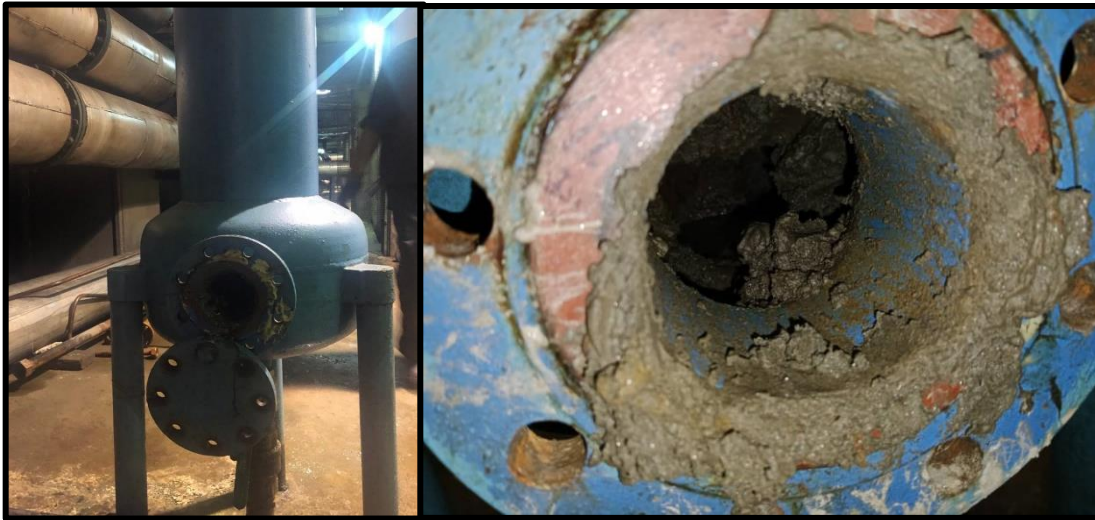
The cyclone separator, which is used to remove coarse sediments from the raw water supplied for transformer cooling, was overhauled, cleaned, and serviced during the maintenance period. Sediments accumulated at the bottom during operation were removed manually and by flushing.

*FIGURE 15: Flushing of sediments from cyclone separator*
