Annual Maintenance Completion Report  
(2025-2026)  
Generating unit-I

Mechanical Maintenance Unit  
Tala Hydro Power Plant

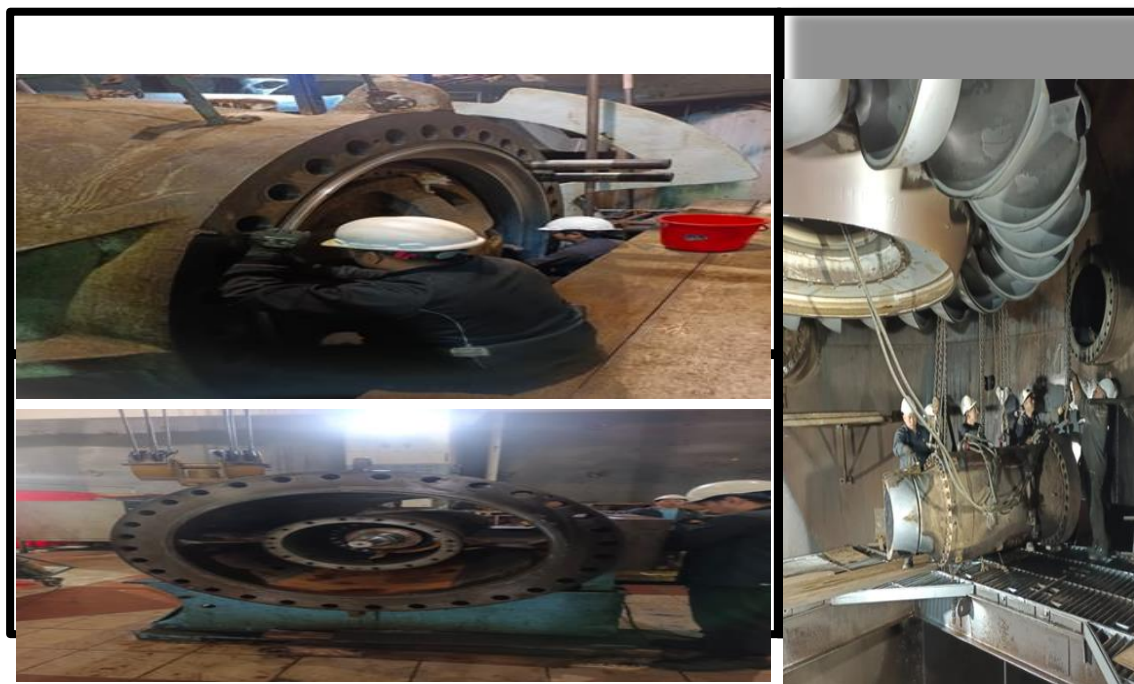
All the nozzle were pre-pressure tested for its ability to retain the required amount of pressure (90-100 kg/cm<sup>2</sup>) and based on the test result; nozzle -J1 and J5 was dismantled and taken to service for overhauling.

**Figure 1: Overhauling & servicing of nozzle injectors**

The replacement of needle tip holding bolt M20x150mm of all the nozzles have done. One or two necessity internal fasteners were also replaced, and a balanced tightening of the fasteners was ensured. Assembling of all critical components of the nozzles was carried out under a close supervision and check formats are maintained for record and reference.

Other three nozzle injector assemblies that did not require to be dismantled except their needle tip center bolts and few numbers fasteners. All the internal fasteners were replaced with new set such as replacement of needle tip holdings bolts M20x150mm.

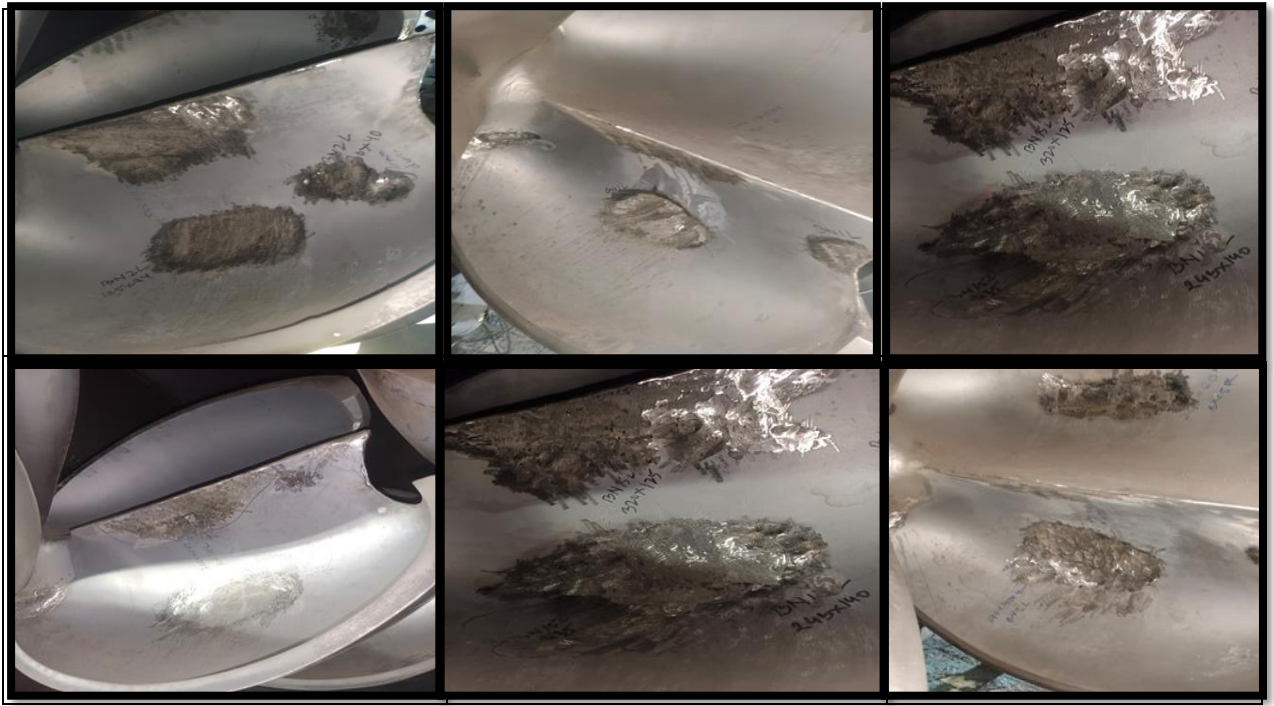
The physical condition of the runner buckets was visually inspected, and erosion was observed on all buckets. Considering the significant extent of erosion and that the runner had already operated for more than 37,149.34 hours

**Figure-2: Erosion observed on runner buckets**

The physical condition of the runner buckets was visually inspected, and erosion was observed on all buckets. Considering the significant extent of erosion and it was under took extensive repaired wherever there is major damaged. that the runner had only achieved 30,362.41 hours already operated for more than 71,000 hours, it was decommissioned and replaced with reclaimed runner 2020.

During the Annual Maintenance shutdown, detailed inspection of the turbine runner revealed localized cavitation erosion, surface pitting, and material degradation on the runner blades and crown portions. To restore the original hydraulic contour and sustain operational efficiency, repair welding activities were undertaken on the affected areas of the runner assembly. Prior to commencement of welding, all damaged surfaces were thoroughly cleaned, dressed, and prepared in accordance with standard repair procedures. Appropriate welding consumables compatible with the runner base material were utilized as per approved repair specifications and maintenance standards. Upon completion of welding, the repaired zones were subjected to grinding and surface finishing to achieve the required dimensional profile, surface smoothness, and hydraulic contour.

Post-repair inspection confirmed substantial improvement in the overall condition of the turbine runner, including restoration of blade geometry, elimination of surface irregularities, and reduction of cavitation-affected defects. The completed repair welding is expected to enhance hydraulic performance, improve operational reliability, minimize vibration induced by uneven runner surfaces, and extend the service life of the runner during subsequent operation cycles.

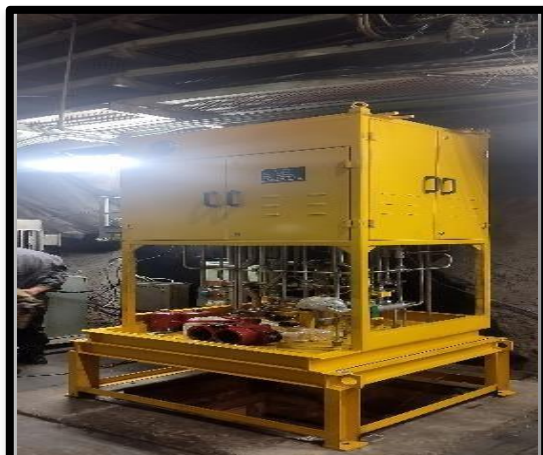
**Figure 5: Valve Table Assembly**

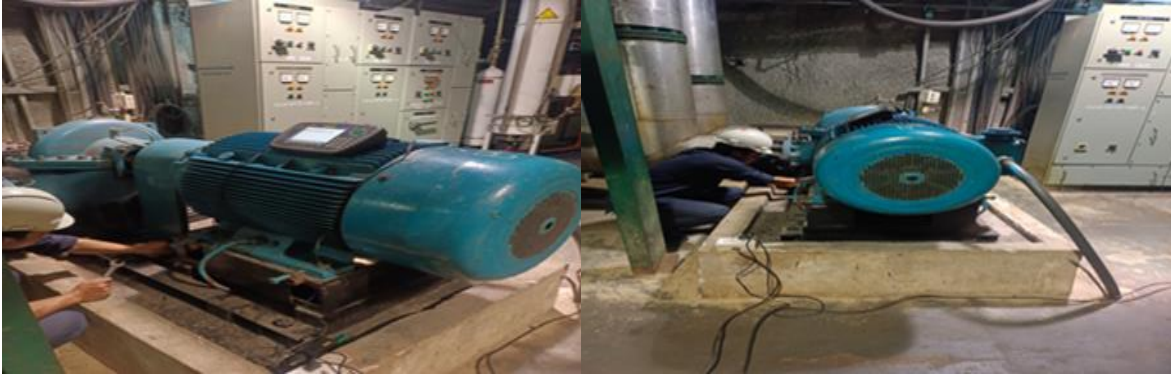
**Figure 7: Overhauling and servicing of CCW pump**

During the Annual Maintenance, both the Centrifugal pumps or Clean Cooling Water Pumps (CCW-pump) was subjected to comprehensive overhauling activities, including complete dismantling, detailed internal inspection, cleaning, and replacement of critical wear components such as mechanical seals, bearings, and gland assemblies.

Subsequent to overhaul, servicing, and reassembly, precision shaft alignment between the pump and drive motor was performed using the Easy-Laser alignment system. The alignment process enabled accurate correction of both angular and parallel misalignments, thereby reducing coupling stress, vibration levels, and undue mechanical loading on rotating components. Final alignment measurements were verified and confirmed to be within the prescribed tolerance limits. Additionally, alignment verification of both the pumps was also carried out.

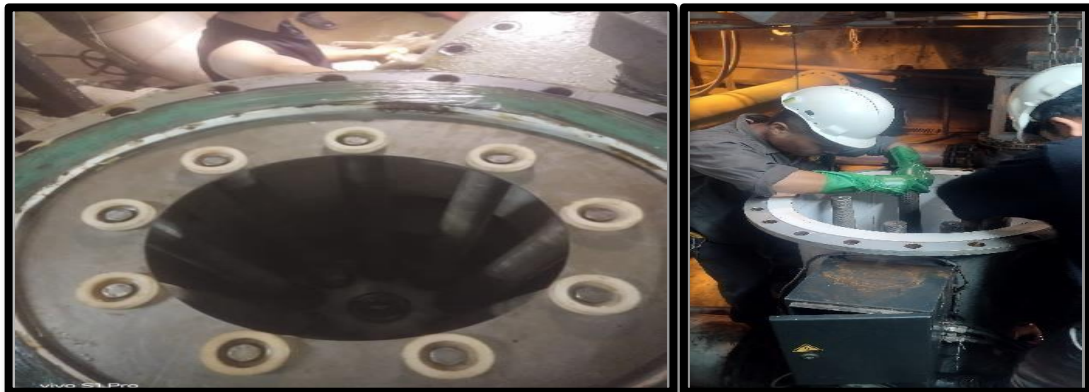
**Figure 8: Cleaning of strainer filter elements**

Furthermore, the motorized strainer and cyclone separator assemblies were dismantled and comprehensively cleaned to restore effective filtration efficiency and maintain uninterrupted fluid flow within the system.

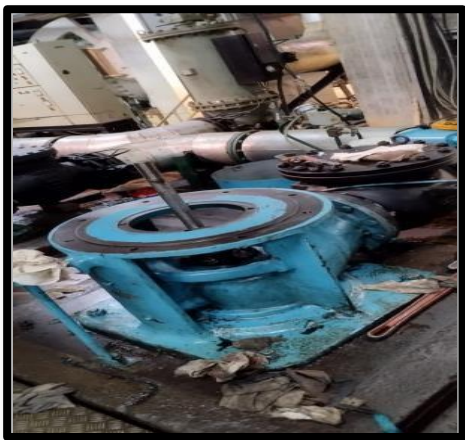
**Figure 9: Overhauling of RCW pump**

For these Pumps, the lubricating oil tank was cleaned internally, and the deteriorated oil hose was replaced to ensure reliable lubrication performance. In addition, the Non-Return Valve (NRV) associated with the pump system was replaced due to operational wear.
