# Annual Maintenance Completion Report

2025-2026

Generating unit III

Tala Hydropower Plant

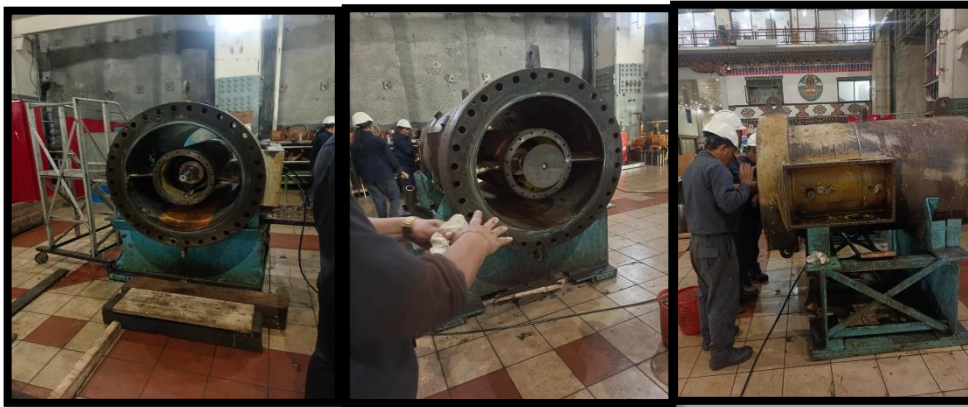
All the five nozzle injector assemblies were subjected to functional check with in-situ oil pressure testing. During the testing with an initial pressure of 100 bar for time duration of 30 minutes, nozzle J1 And J5 was found to have heavy water leakage and maximum pressure drop was observed in nozzle J1. Therefore, both nozzles J1, and j5 were dismantled for overhauling during the 2025-2026 annual maintenance. Those nozzle injector assemblies that did not require to be dismantled had their needle tip and liner assemblies overhauled and thoroughly cleaned in-situ. The needle tip-holding bolts were replaced. While overhauling, all the internal fasteners were replaced with new set.

FIGURE 1 UNDER WATER COMPONENT INSPECTION WHILE OVERHAULING THE NOZZLE INJECTOR SUB ASSEMBLIES

Due diligence was given while tightening the fastener ensuring equal tightening torque is provided. All the critical assemblies of these components were carried out under the supervision of the concerned engineers. The checklist that are maintained and recorded are attached as annexure.

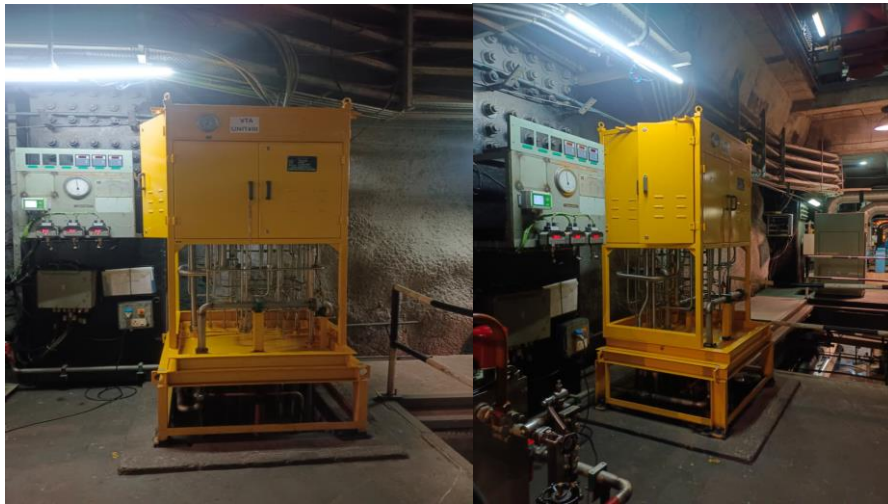
Figure 3 VTA system

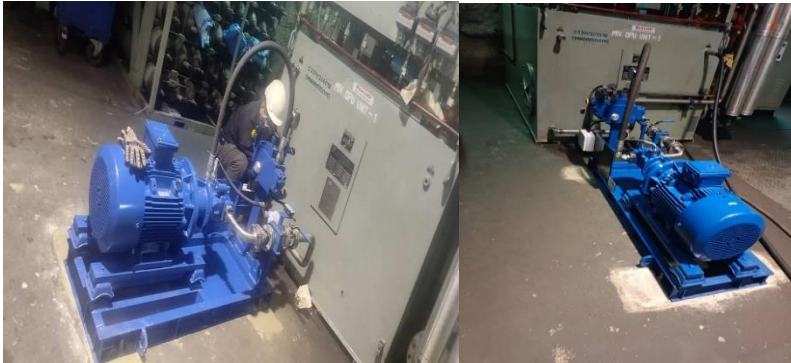
FIGURE 4 jockey pump

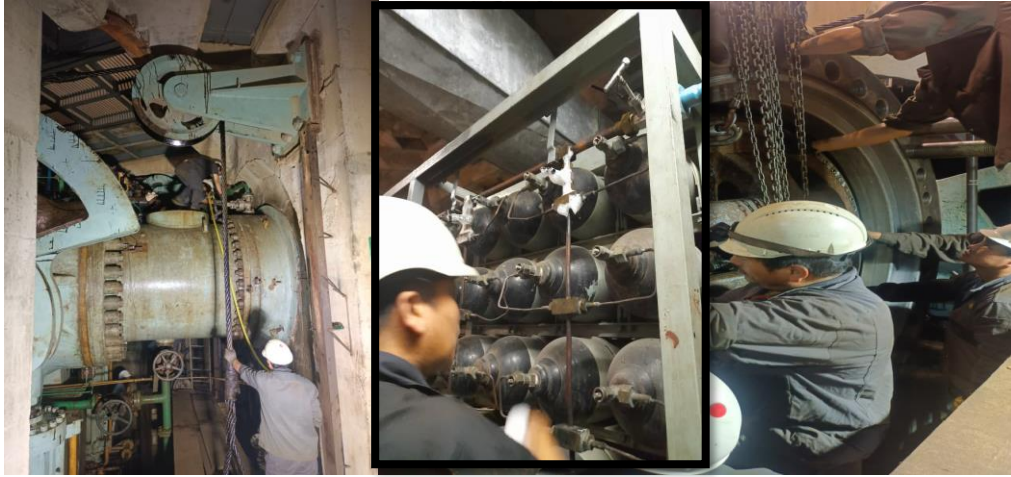
The N<sub>2</sub> gas for MIV N<sub>2</sub> bank has been topped up and tested for N<sub>2</sub> gas leakage with surf foam bubble, arresting the leakage by replacing O-ring in the main outlet valve. The N<sub>2</sub> gas piston accumulator for Governor OPU was checked and replenished to maintain the minimum pressure of 60 kg/cm<sup>2</sup>.

The pressure gauges of MIV control panel and accumulator have been calibrated at HRDC and three of them viz. maintenance seal opening, penstock pressure and service seal opening gauges have failed during the calibration and testing.

FIGURE 5 NITROGEN REPLENISHMENT IN ACCUMULATORS/ REPLACEMENT OF PRESSURE GAUGES AFTER CALIBRATION

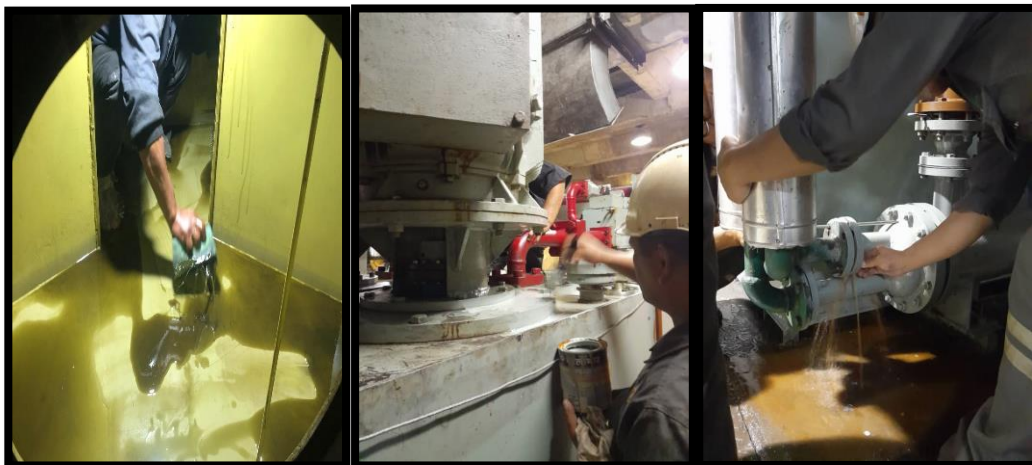
OPU pump capacity was checked and found normal. Functionality check for internal leakages and servicing was carried on all the directional control solenoid valves provided in OPU and MIV control panel. The MIV lubricating oil was drained and the oil sump was cleaned thoroughly. The reconditioned oil was replenished again. All setting and dry operation on MIV system was checked and verified from the control panel. Contactors and limit switches of MIV were checked for their healthiness and replacement done wherever necessary. During the functionality check, no N<sub>2</sub> gas leakage was observed.

FIGURE 6 DRAINING OF MIV OPU TANK OIL AND CLEANING

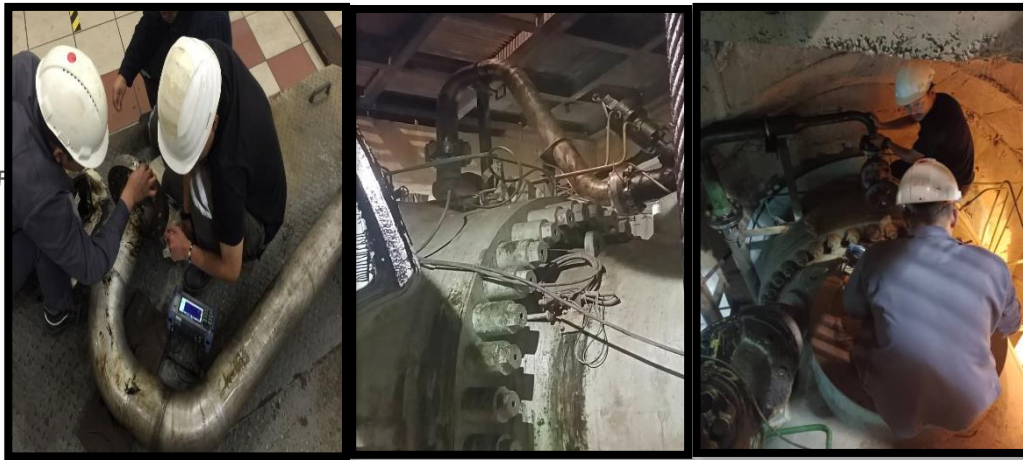
The ultrasonic testing of MIV bypass pipeline, pressure accumulator and distributor pipeline for thickness verification was done by the NDT personnel from HRDC to inspect any possible deviations in the pipeline thickness or any crack development before it amplifies.

FIGURE 7 miv system

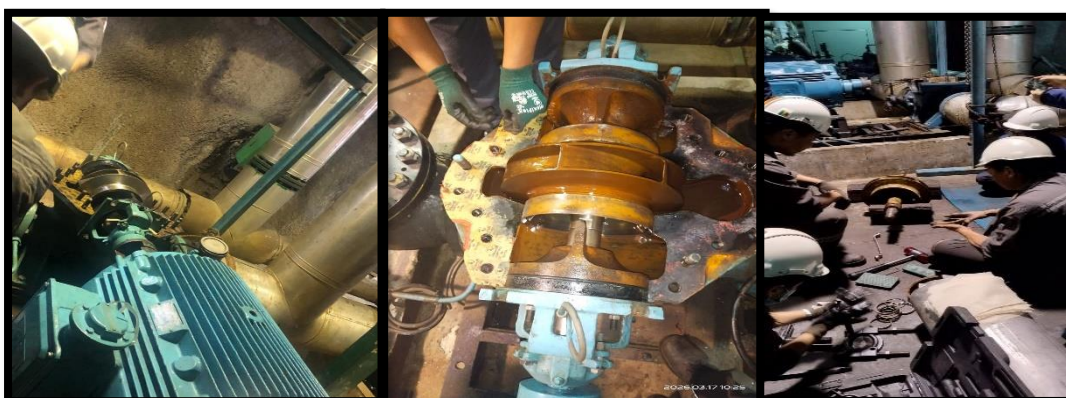
Two circulating pumps, one main and other standby, are provided for pumping clean water for cooling of the generator stator, bearing coolers, and the lubrication system. During Annual Maintenance, the pump components were dismantled for servicing and inspection. The mechanical seals, bearings and glands and shaft sleeve were replaced with new sets in Pump A. The functionality test and thorough servicing of motors and pumps were carried out. The motor casing was scrapped and painted in order to avoid corrosion. Besides, the non-return valve (NRV) was also serviced. The alignment work for both the pumps A and B was carried out after completion of servicing and assembly. After rectifications, the pumps were checked for operation and found healthy.

FIGURE 8 OVERHAULING AND SERVICING OF CCW PUMPS AND REPLACEMENT OF RADIAL BALL BEARINGS

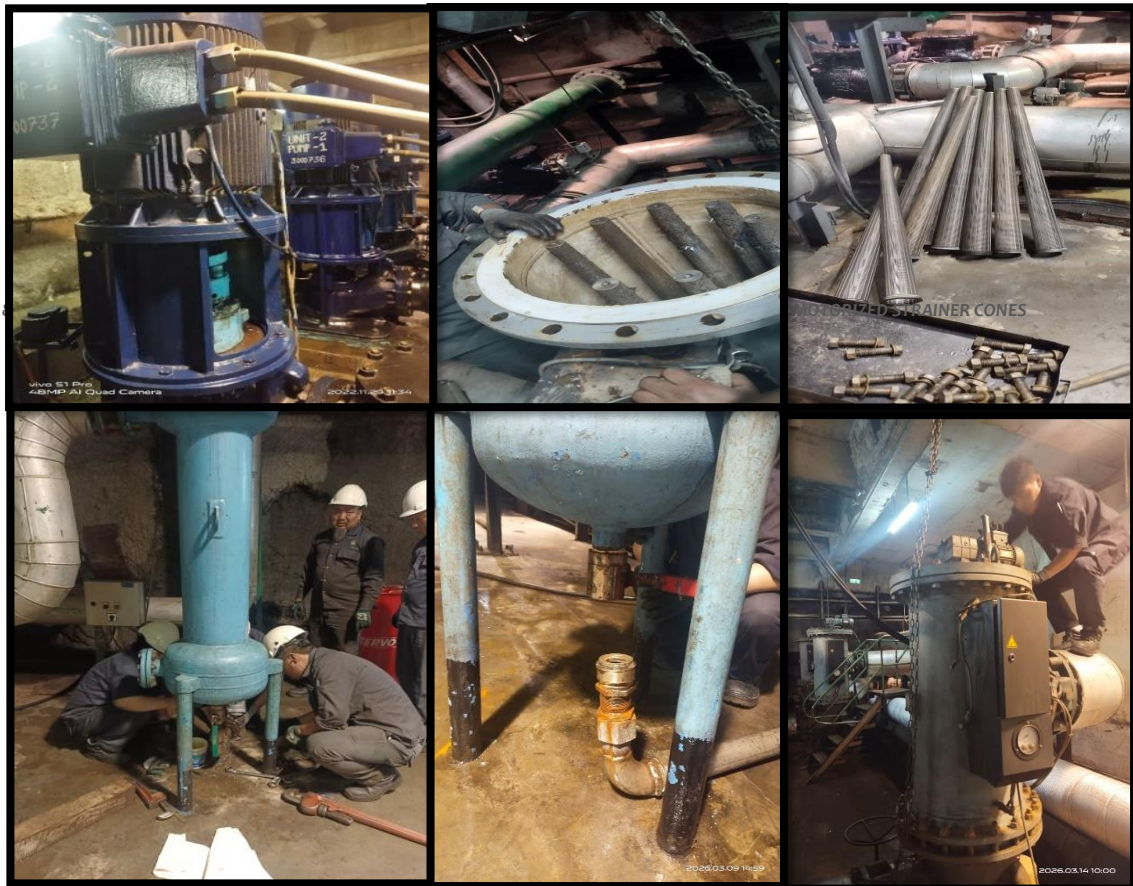
FIGURE 9 CLEANING AND FLUSHING OF CYCLONE SAND SEPARATOR

Motorized backwash strainer which is used to trap the coarse sediments from the raw water was overhauled, thoroughly cleaned and assembled back. The filter elements were removed and replaced with a spare set. Visual inspection, thorough cleaning and replacement of lubrication oil were done. The foundation bolts were checked for looseness and grease applied wherever necessary, Installation of Actuator in cyclone separator. After servicing, the pump-motor and the strainer were functioning normally. The cyclone sand separator was also cleaned and rinsed. The sediments collected at the bottom during operations were taken out manually and then flushed

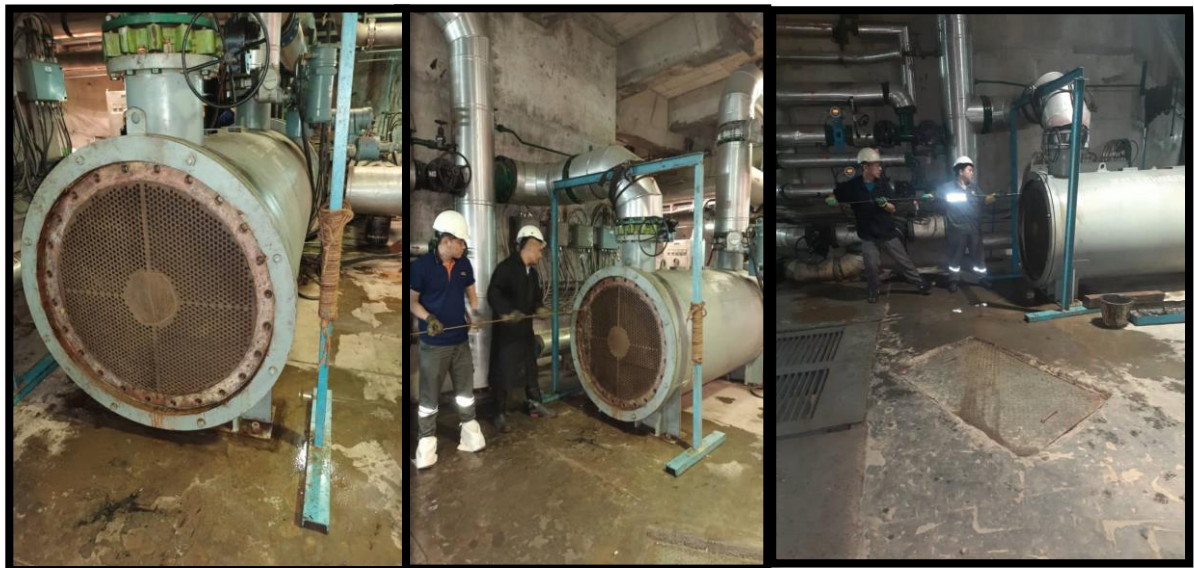
A heat exchanger (MHE) is provided in each unit in order to circulate clean cooling water in the generating system for the cooling of stator air coolers, OPU coolers and bearing coolers, with the help of raw water supplied into the tubes inside the heat exchanger. The shell-and-tube type heat exchanger was opened, the tubes were thoroughly cleansed and then flushed out, Replace the out let Flowmeter in MHE. The pressure testing of the heat exchanger was carried out after cleaning and fitting back of end covers. The test result is attached as annexure.

FIGURE 10 SERVICING AND PRESSURE TESTING OF MAIN HEAT EXCHANGER
