# Annual Maintenance Completion Report (2025-2026)

## Generating unit V

## **Mechanical Maintenance Unit**

Tala Hydropower Plant

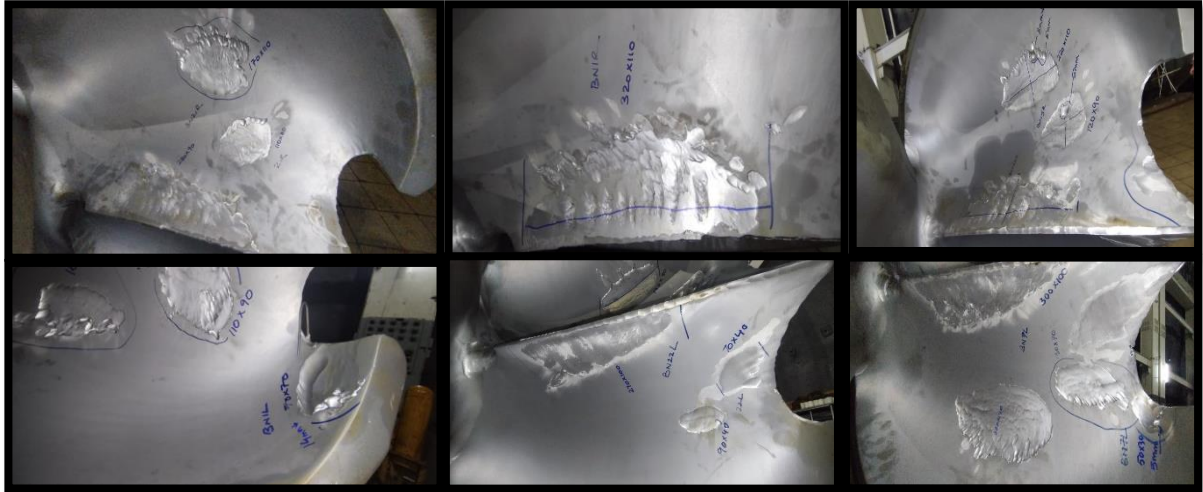
Figure 2: Erosion observed on runner buckets

The physical condition of the runner buckets was visually inspected, and erosion was observed on all buckets. Considering the significant extent of erosion and that the runner had already operated for more than 71,000 hours, it was decommissioned and replaced with reclaimed runner 2020.

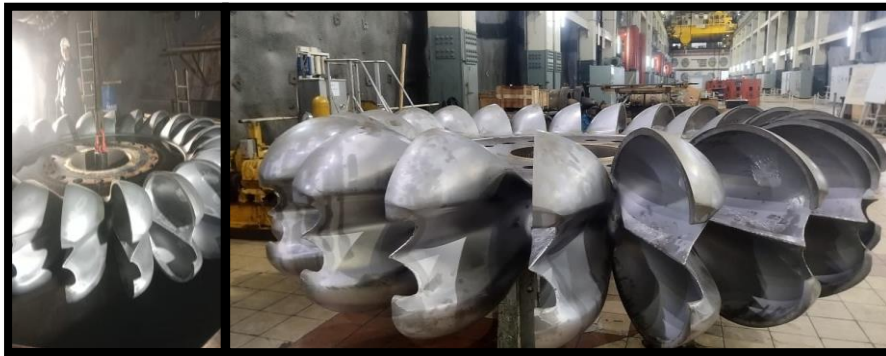
Figure 4: Runner 3020 removed from unit 5

The runner will be dispatched for reclamation at BHSL.

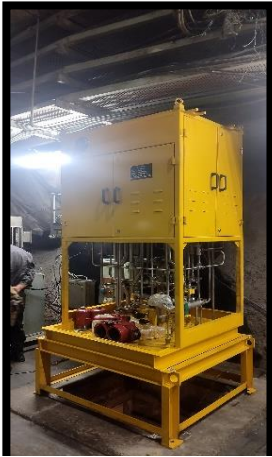
Figure 5: Valve Table Assembly

The VTA is a critical component of the hydraulic control system, primarily responsible for directing and regulating oil flow to the servomotors of the needle and deflector systems. It houses the solenoid valves, pressure gauges, and other control elements that interface with the SCADA system for remote operation and monitoring.

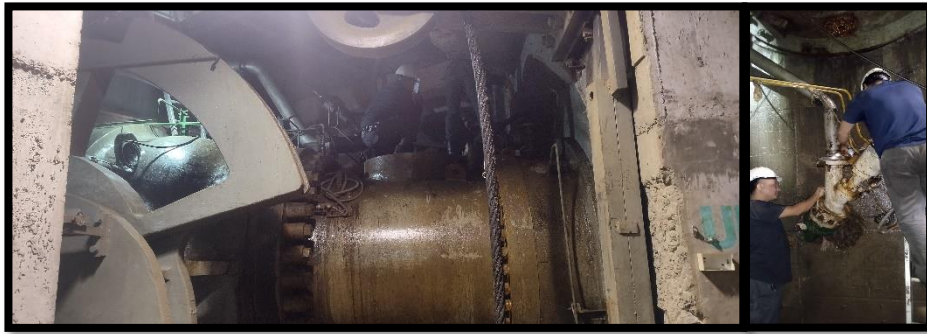
The servo valve of the decompression pipeline was opened and inspected for debris. This activity is recommended during every annual maintenance and also during runner inspections to ensure

that no foreign particles or sediments obstruct the valve operation, which could affect the proper functioning of the decompression system and lead to abnormal pressure conditions.

Figure 6: Inspection on MIV decompression line

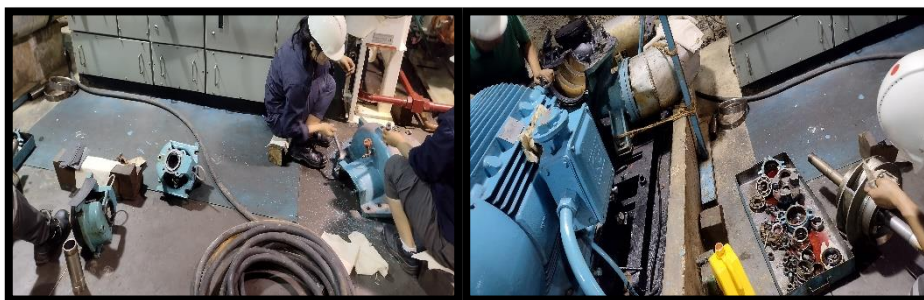
During this Annual Maintenance, CCW pump B underwent a complete inspection with dismantling, cleaning, and replacement of critical components such as the mechanical seals, bearings and glands.

Figure 7: Overhauling and servicing of CCW pump

Following the overhauling, servicing and reassembly, shaft alignment between the pump and motor was carried out using an Easy-Laser alignment system. The laser alignment process ensured accurate correction of both angular and parallel misalignments, thereby minimizing vibration and mechanical load on the coupling. Final alignment readings were recorded and confirmed to be within acceptable tolerance limits. The alignment of pump A was also checked.

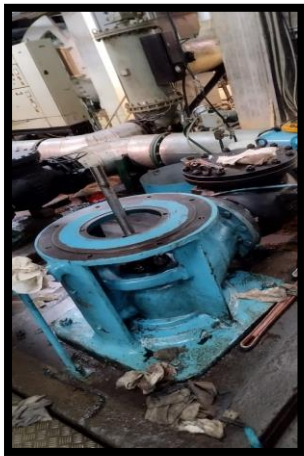
Figure 9: Overhauling of RCW pump

After completion of the annual maintenance of Unit 5, overheating was observed in RCW Pump 1 during unit spinning. The pump also exhibited abnormal vibration and noise during operation. In coordination with EMU, the pump was overhauled for inspection, and components such as the end-cap bearing and thrust bearing were replaced.

However, the issue persisted even after the replacement. An official from HRDC was subsequently called to carry out vibration testing, which confirmed that the source of the vibration was the motor. The rectification process is still underway; meanwhile, the unit has been synchronized and brought into operation, with the standby pump being operated for the time being.

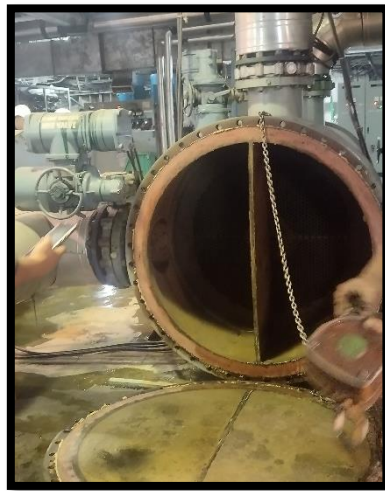
During the annual maintenance, the heat exchanger was opened, and the tubes were thoroughly cleaned and flushed to remove any scaling or deposits that could impede heat transfer efficiency. After cleaning, the end covers were reassembled, and pressure testing was conducted to ensure there were no leaks and that the unit was fit for continued operation. Leakage was detected in 20 tubes at the inlet side and 16 tubes at the outlet side. These tubes were plugged to ensure continued safe operation.

Figure 10: Cleaning of MHE
