# Annual Maintenance Completion Report (2025-2026)

## Generating unit VI

## Mechanical Maintenance Unit

Tala Hydropower Plant

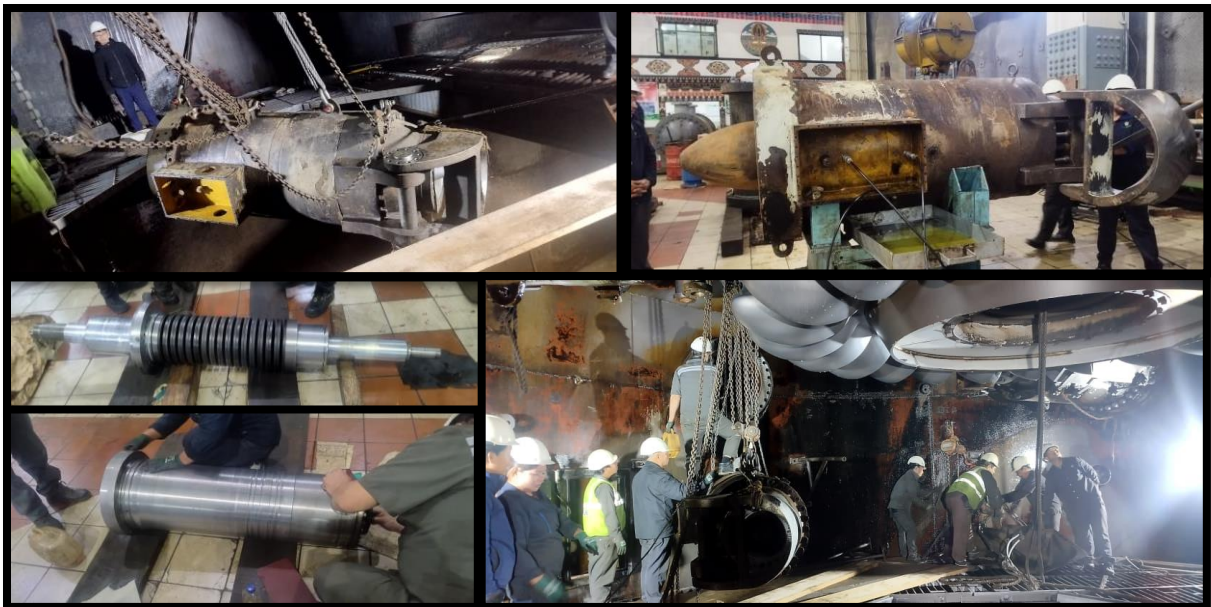
All five nozzle injector assemblies underwent functional verification through in-situ oil pressure testing, conducted at an initial pressure of 100 bar for 30 minutes. No signs of failure were observed in any of the nozzles. However, nozzle 2 was dismantled for overhaul as part of the Annual Maintenance, having completed over seven years of operation without servicing. For the remaining assemblies that were not dismantled, the needle tips and liner assemblies were inspected, and fasteners were replaced as required.

Figure 1: Overhauling & servicing of nozzle injectors

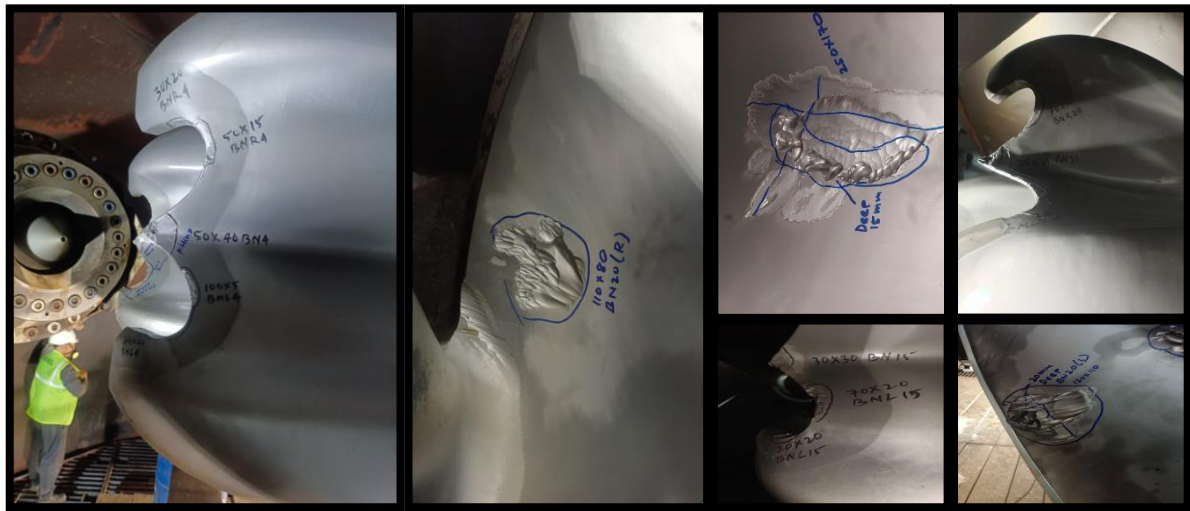
Figure 2: Erosion observed on runner buckets

The NDT personnel from HR&DC examined the physical condition of all the runner buckets after visual inspection with Magnetic particle testing on the roots and eroded parts on all 22 buckets. Following the dam overtopping incident on 5<sup>th</sup> October, the runner buckets were found to have some deep erosions which needed weld repair. The in-situ weld repair was carried out.

The weld repair was performed in parallel with the nozzle servicing activities. Upon completion, the bucket surfaces were ground to achieve a smooth finish, removing surface irregularities and enhancing flow characteristics. Magnetic Particle Testing was then carried out to verify that no defects remained.

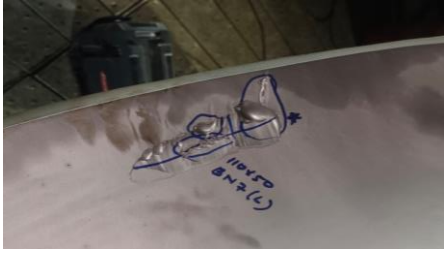
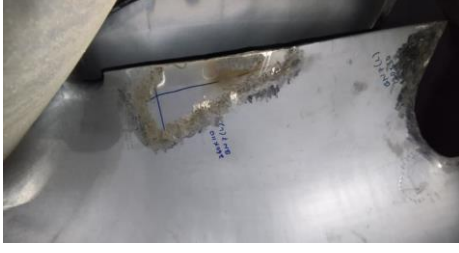
| 7 (L) | | |

Weld repair using GTAW was carried out on buckets 20, 21, 7 and others, as shown in the pictures below.

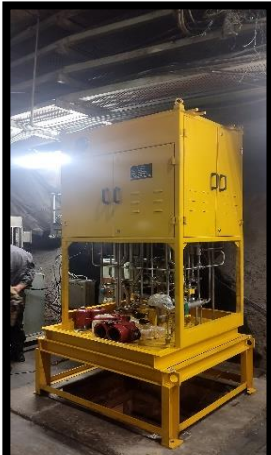
Figure 4: Valve Table Assembly

The VTA is a critical component of the hydraulic control system, primarily responsible for directing and regulating oil flow to the servomotors of the needle and deflector systems. It houses the solenoid valves, pressure gauges, and other control elements that interface with the SCADA system for remote operation and monitoring.

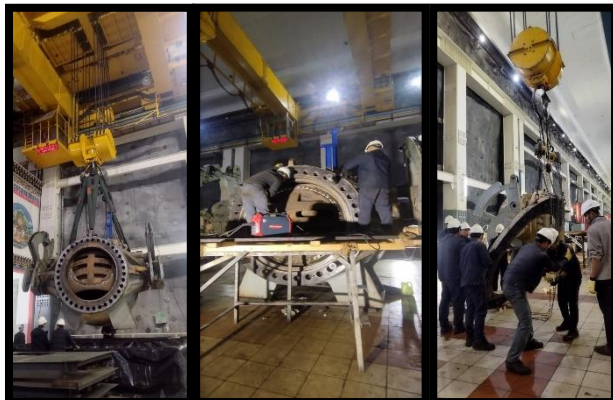
The MIV system is the primary isolation for turbine and principal protection for the station against penstock water. The major work activity this maintenance in the unit was the replacement of MIV seals. Heavy leakage had been observed from both the seals during the peak months. Particularly after the dam overtopping incident on October, replacement of both the seals had been planned.

Figure 5: MIV seal replacement

For the replacement of both maintenance and service seals, the entire MIV body was lifted to the service bay. Following overhauling and detailed inspection, the door seating rings and body sealing rings were replaced, after which leakage testing was carried out. The total duration of the work was 41 days.

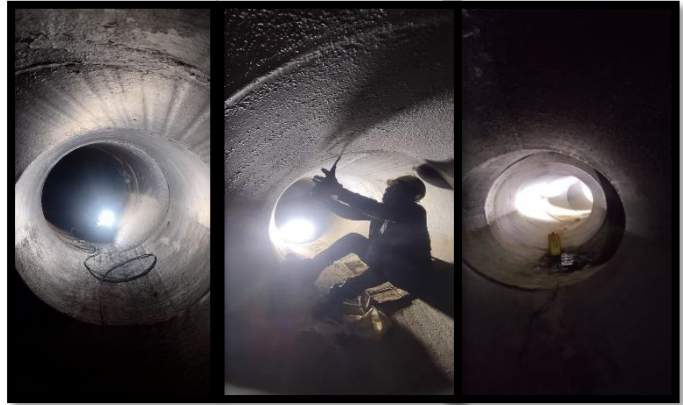
During the MIV seal replacement, the internal surfaces of the distributor, particularly at the pipe joint sections, were scraped and repainted. These areas are subjected to continuous water pressure and are therefore prone to wear over time. The distributor directs high-pressure water from the MIV into high-velocity jets aimed precisely at the buckets of the runner through 5 nozzles.

Figure 6: Scraping and painting in distributor

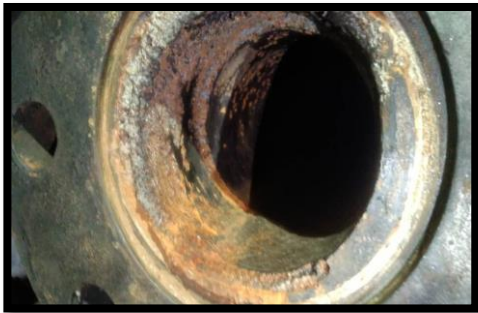
Figure 7: Erosion on MIV bypass pipeline

The internal sections of the bypass pipeline were found to be eroded and were subsequently repaired by welding. As this section is made of MS and operates under high pressure, leaving the erosion unattended could pose a significant risk during operation.

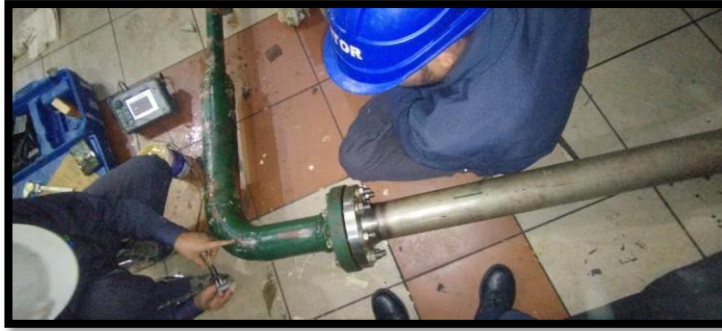
The ultrasonic testing of MIV bypass pipeline, decompression pipeline and pressure accumulators for thickness verification was done by an inspection team from HRDC to inspect any possible deviations in the pipeline thickness or any crack development before it amplifies. The test result has been attached.

Figure 6: UT on high-pressure pipelines

In order to ensure safe parameters of the control pipelines for safe and smooth operations, periodic NDT is highly recommended to be done annually since these are considered among the most critical parts.

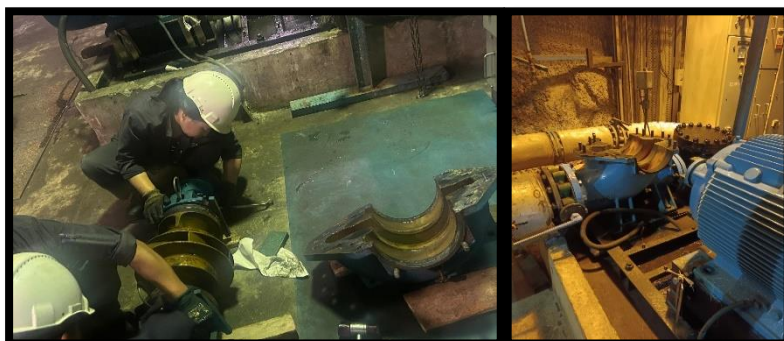
During this Annual Maintenance, both pumps underwent a visual inspection. No overhauling or replacement of parts was carried out.

Following the inspection, shaft alignment between the pump and motor was verified using an Easy-Laser alignment system. The laser alignment process confirmed that both angular and parallel alignments were within acceptable tolerance limits, minimizing potential vibration and mechanical stress on the coupling.

Figure 7: Overhauling and servicing of CCW pump

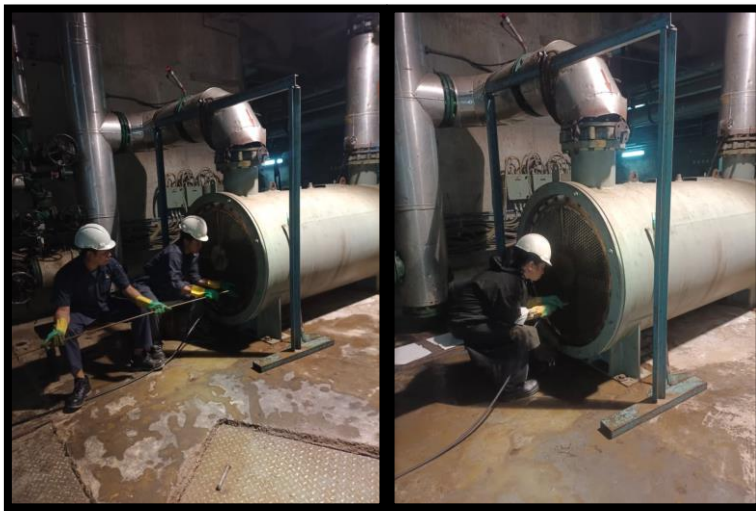
During the annual maintenance, the heat exchanger was opened, and the tubes were thoroughly cleaned and flushed to remove any scaling or deposits that could impede heat transfer efficiency. The flowmeter at the outlet was replaced to ensure accurate monitoring of the flow. After cleaning, the end covers were reassembled, and pressure testing was conducted to ensure there were no leaks and that the unit was fit for continued operation.

Figure 8: Cleaning of Main Heat Exchanger
