## Inspection Report

| <b>Project</b> | <b>LBST Jetty Pile and Headstock Remediation</b> |
| <b>Date</b> | <b>10<sup>th</sup> July 2026</b> |

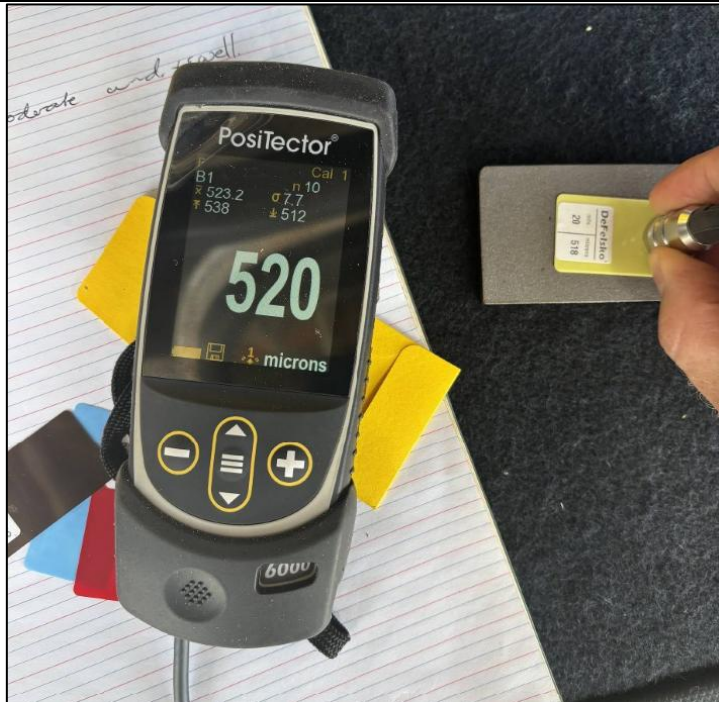
### 1. DFT gauge check

- Accuracy confirmed on 518µm shim on flat steel plate blasted by AAB during the works.
- Rod's DFT gauge and my DFT gauge seem to read differently by around 50 to 100µm with mine reading lower. We need to check them together on a shim or certified thickness standard.
- Both gauges are recently calibrated and are within acceptable error margins. Rod's gauge is 0-5000µm and mine is 0-2000µm range.
- As Contractor is generally easily meeting DFT specification, there is unlikely to be a dispute arising from gauge differences.

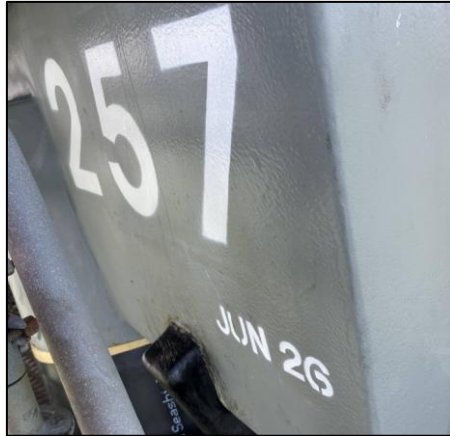
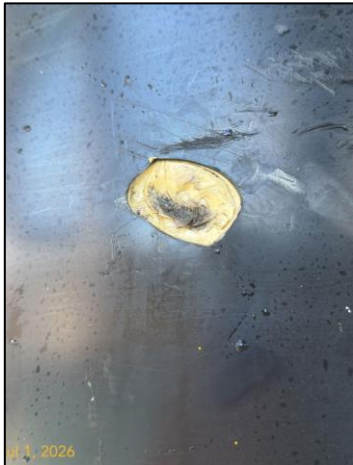
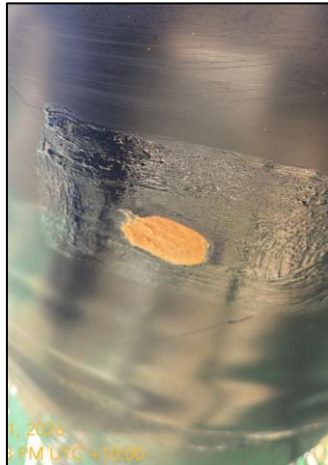
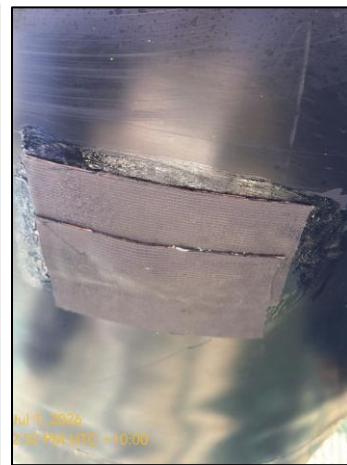
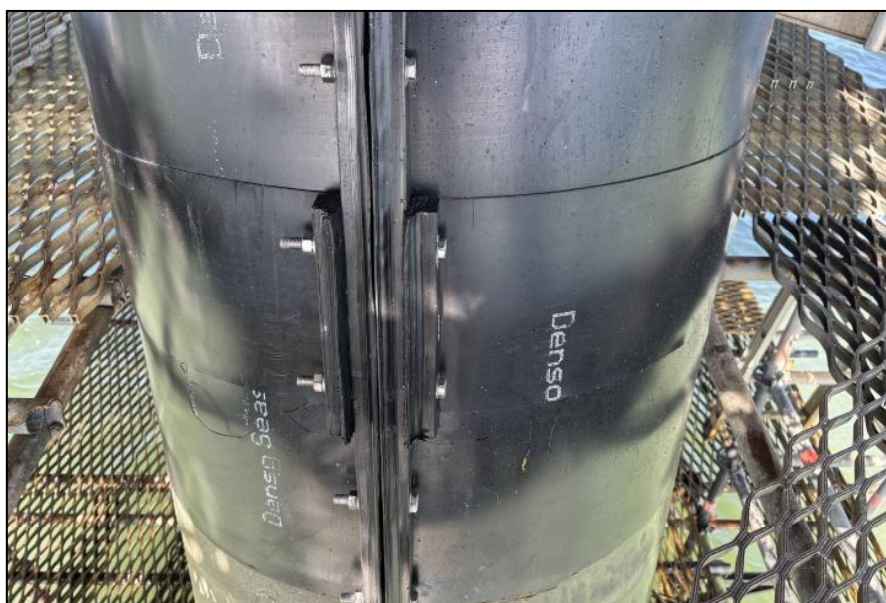
**2. PB257**

- Scaffold has been available for removal for over a week but has been delayed by poor weather.
- Seashield jacket repair inspected onsite and through dashpivot photos and is satisfactory.
- Clipping of top mesh decks plus bolting and wrapping of ladder feet to be completed following removal of scaffold.

- Date painted
- Jacket repair completed

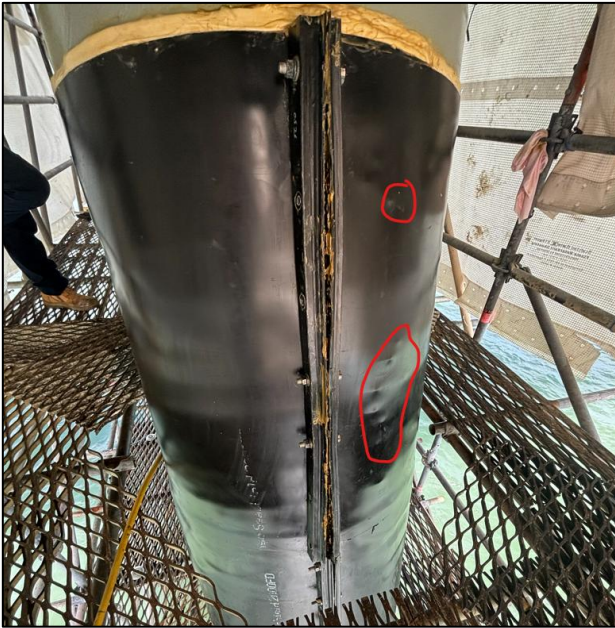
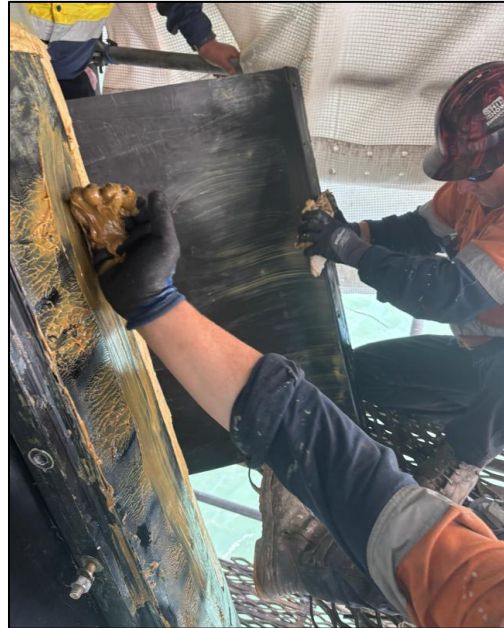
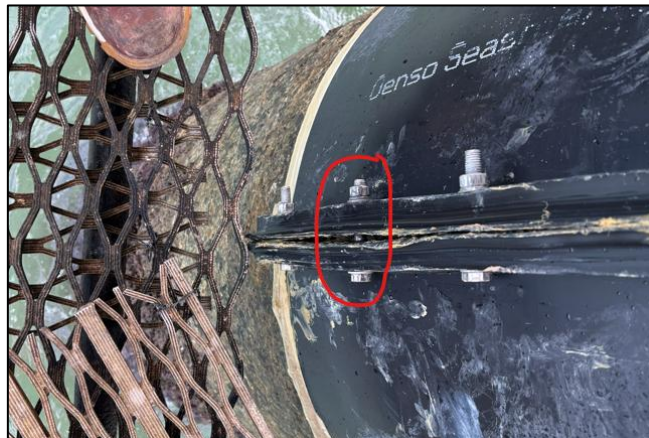
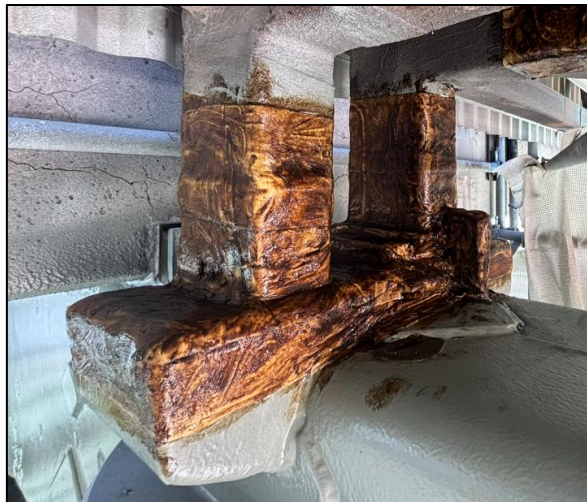
### 3. PB263 – Final inspection

- Small stones under jacket were removed after being noticed by Contractor QA process
- 2 galled bolts removed and replaced on lower deck

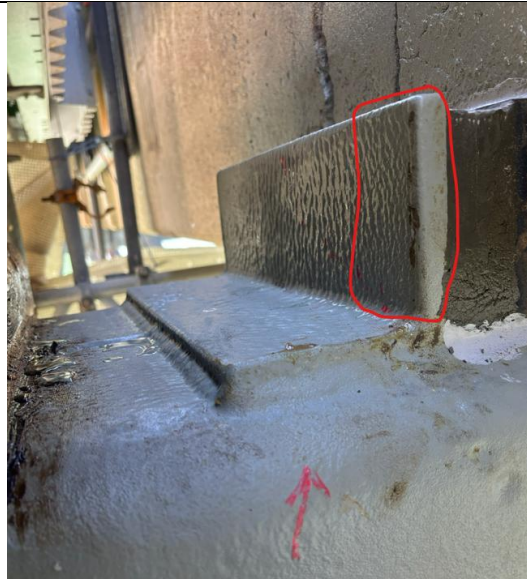
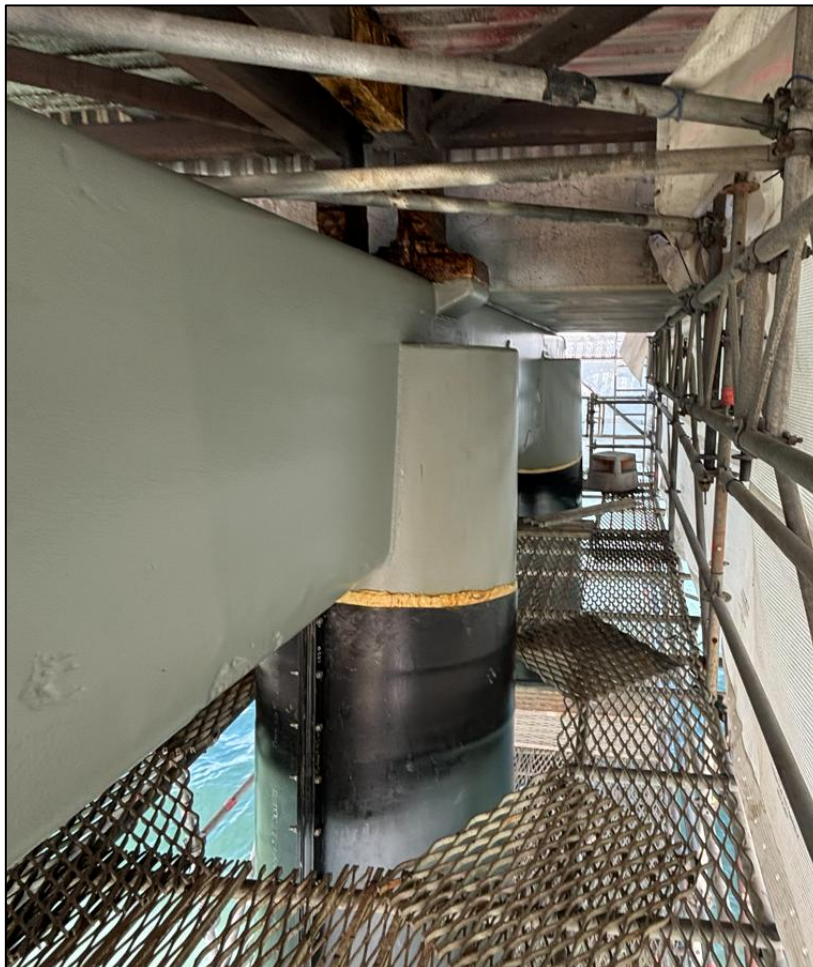
**4. PB263 – Final inspection**

- ^Area of low thickness was confined to one end of one keeper angle, an area of approximately 10cm x 5cm. Contractor marked the area for touch-up. Note that this is not considered an NCR as the Contractor has agreed to rectify. NCRs will only be raised where the Contractor either can no

longer amend the non-conformance (eg due to scaffold removal) or where the Contractor refuses to do so.

- One isolated low DFT area marked up for repair

| Item | Who/When |
|---|---|
| Pilebent 263: Touch up single low area on western end of northern keeper angle to meet specified DFT | AAB prior to removal of scaffold |

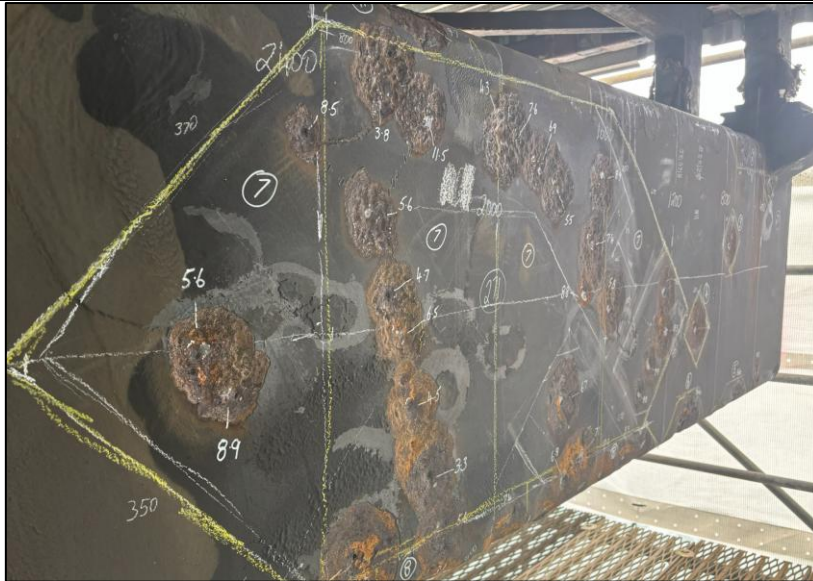
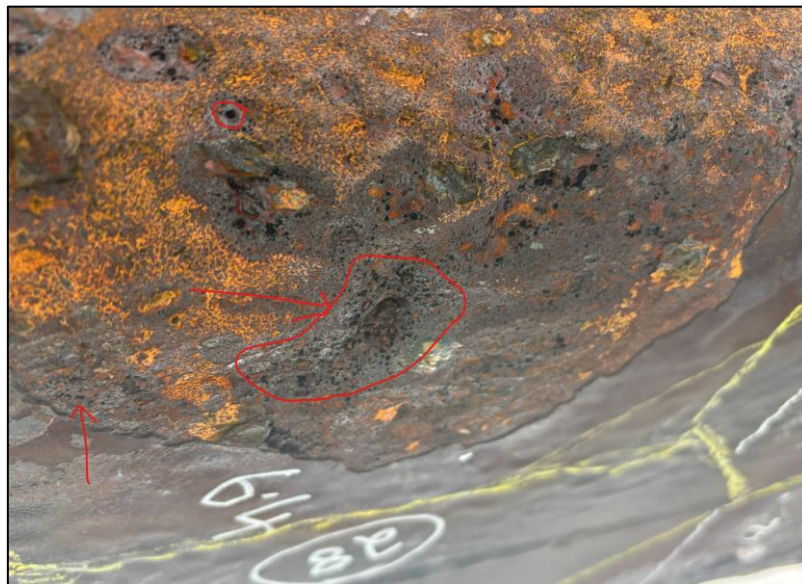
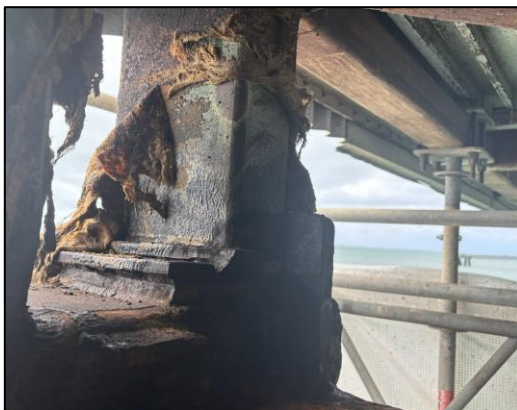
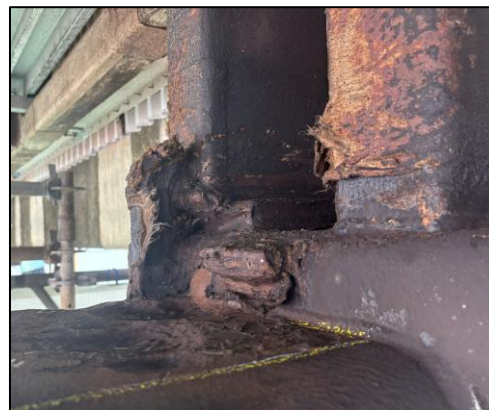
**5. PB271 – Awaiting welding**

- Pilebent 271 is a headstock only pilebent. It is in very poor condition with very large areas of corrosion as per weld repair sheet supplied 08/07/2026.
- Direction regarding repair patches was to provide full plating on underside. If possible, in 8mm rolled plate in a U-shape.
- The corrosion on the underside was evidently of the deeply pitted variety that cannot be effectively coated without welded repair (see photos)
- The large amount of welded repair on the headstock is likely to cause a schedule delay to the works.
- Gallery feet appear in good condition with likely only jacking and grease injection required.

- Large areas of weld repair required
- Deep small pitted/porous areas that can't be painted on underside
- Feet look good (though not fully cleaned)

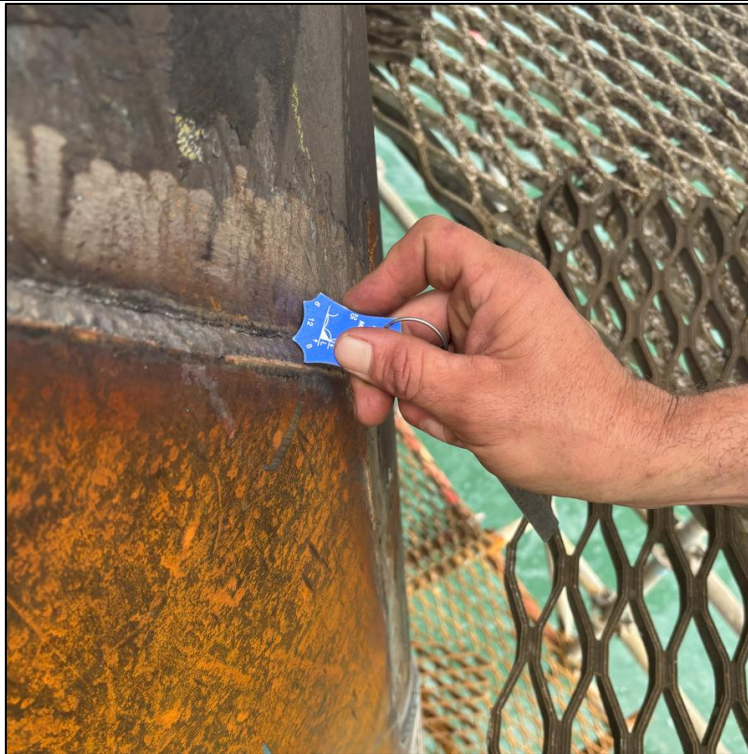
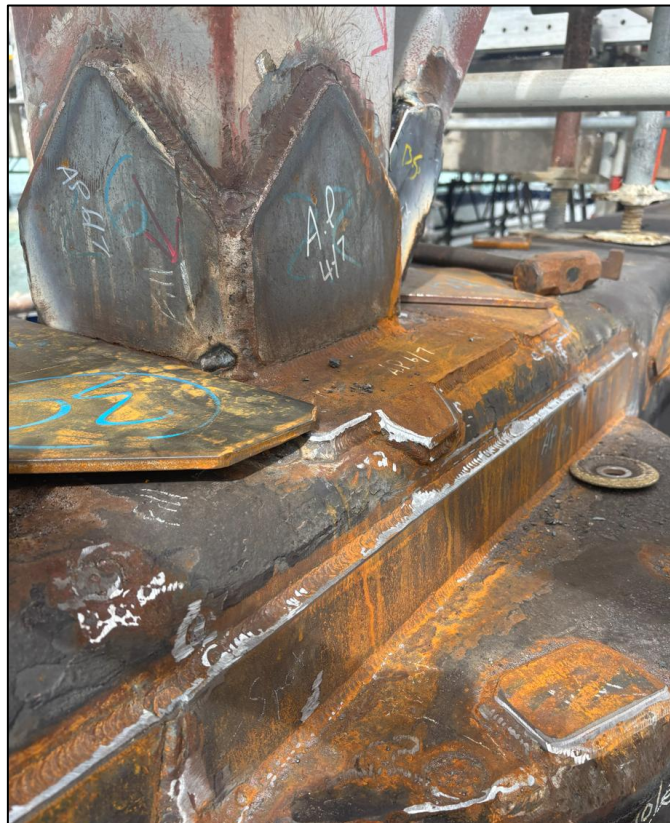
**6. PB281 – Welding underway**

- Welding works underway. Works on top and middle deck likely to be completed by Monday.
- Lower deck is not in place to finish welding works as one repair plate requires access to the lower deck.

- Contractor may choose to complete blast and paint on upper deck prior to completing lower deck works.
- Weld quality appears much improved. Weld QA procedure including traceability of welder and inspector will be implemented on this pilebent. This procedure/records have not been observed as yet.
- Welding wire has been changed in accordance with updated weld procedure for AAB. (previous weld procedure was from Ingham agencies). Welding supervisor reports good results achieving 8mm fillet weld in one pass with this wire and new welding equipment.

- Lee supervising and checking quality
- Almost complete on top and middle deck
