## Inspection Report

| <b>Project</b> | <b>LBST Jetty Pile and Headstock Remediation</b> |
| <b>Date</b> | <b>15<sup>th</sup> July 2026</b> |

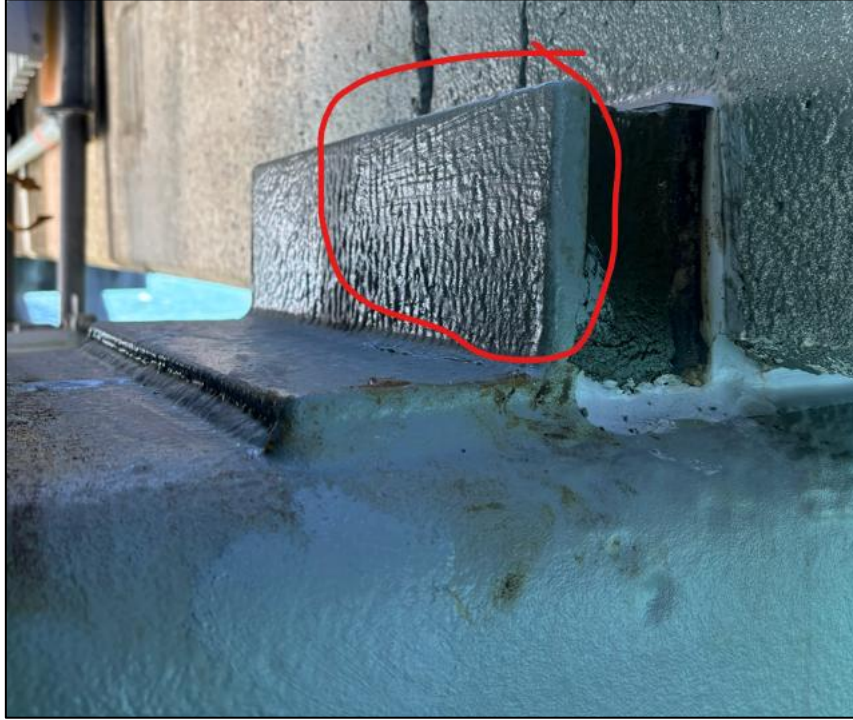
### 1. PB263 – follow up

- Scaffold was still in place
- The low DFT area and minor damage noted on previous inspection was inspected. An additional coat had been added to remedy this.

- Low DFT area noted at previous inspection has been touched up

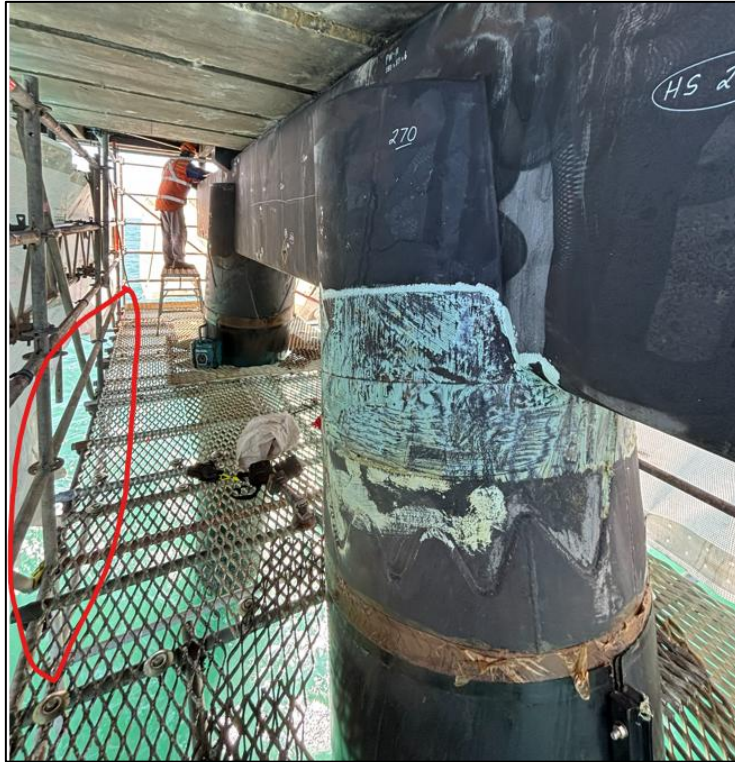
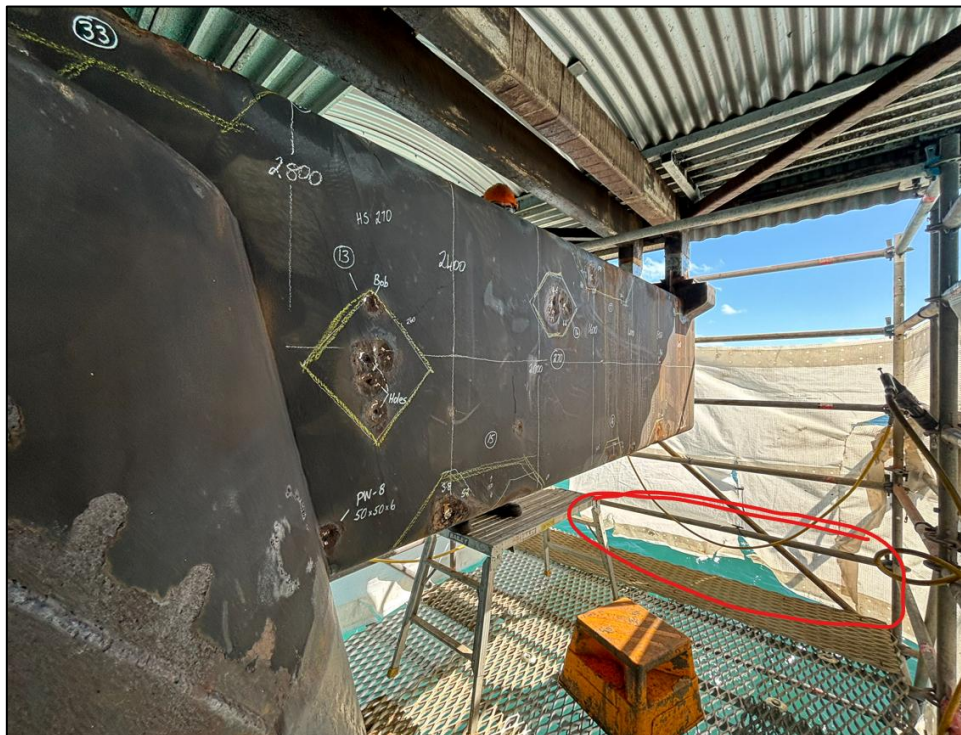
**2. PB270**

- The encapsulation on PB270 is damaged and not tied down at the base. It is therefore not performing the function as intended per revised AAB SWMS. AAB to assess and ensure top deck encapsulation is tied down at base.

- Encapsulation on this pilebent was not tied to deck as per note in safety section
- Amount of weld repairs is typical for project to date. No issues with proposed repairs as drawn, pending submission of repair sheet.
- Gallery feet are in reasonable condition but are stuck due to corrosion jacking. Northern hook has lost significant thickness due to corrosion. Suggest Principal give direction to cut both hooks off, jack to clean corrosion (including removing brass plate if practical), grease and reinstate hook.

- Encapsulation not tied down to deck
- Weld repair inspection underway

| Item | Who/When |
|---|---|
| Pilebent 270: AAB to fix encapsulation at deck level as per revised SWMS. Review all other workfronts. | AAB, as soon as possible |

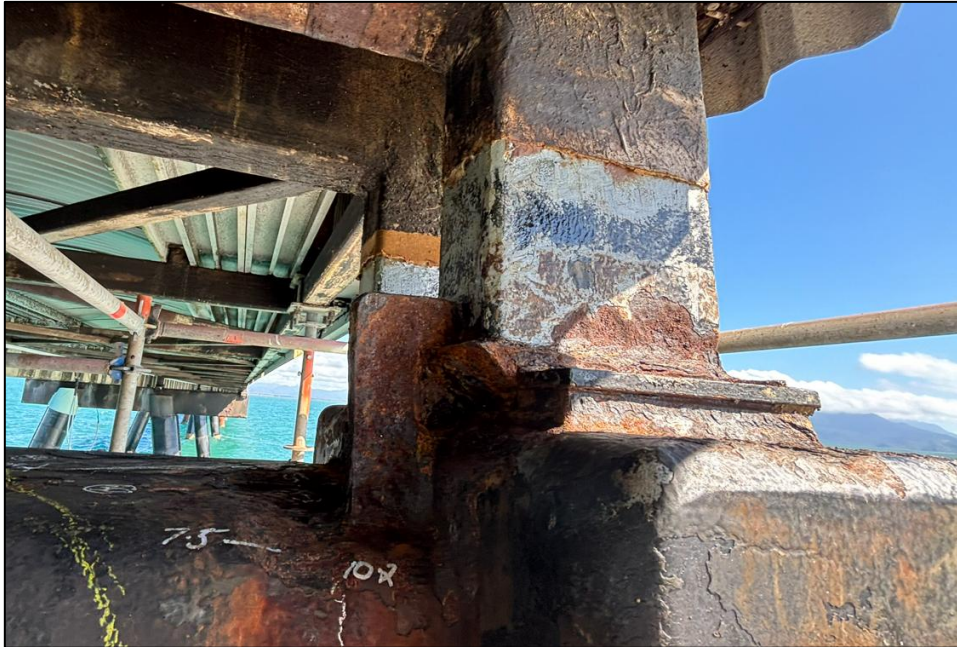
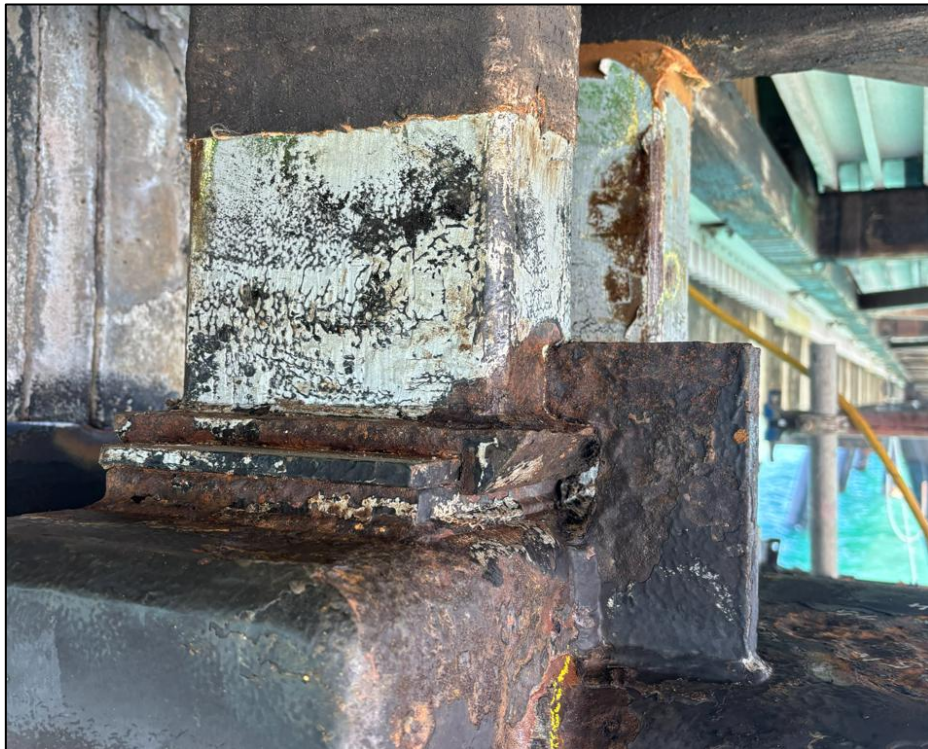
### 3. PB270 – Gallery feet

- Northern hook has lost significant steel thickness
- Both feet stuck due to corrosion jacking.
- Suggest both hooks be cut off for ceaning of corrosion

| Item | Who/When |
|---|---|
| Principal to provide direction to remove gallery hooks on pilebents 271 and 270 to remediate corrosion. AAB to attempt removal of brass plates for cleaning under. | Principal to give direction asap to avoid delays |

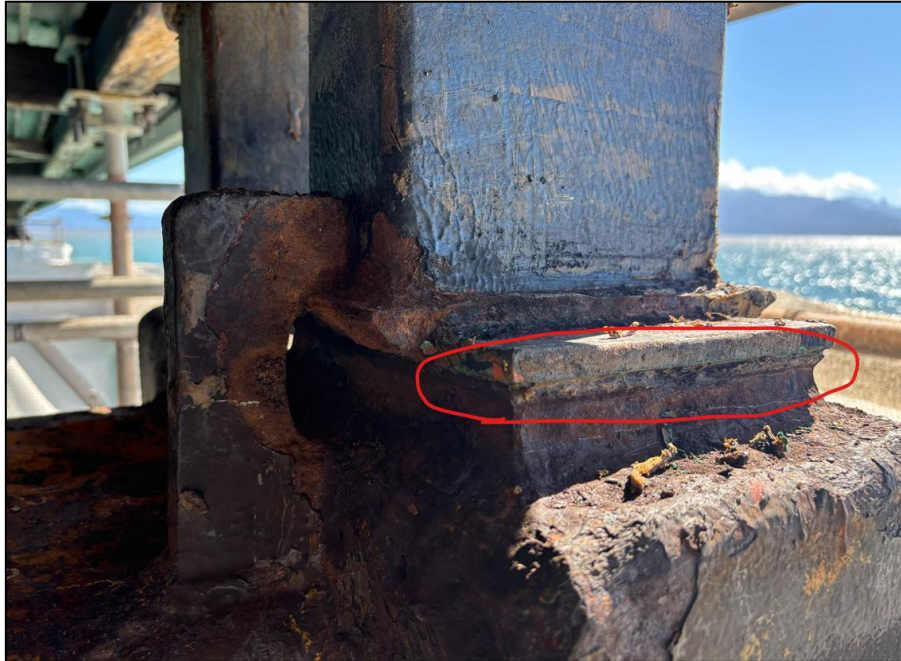
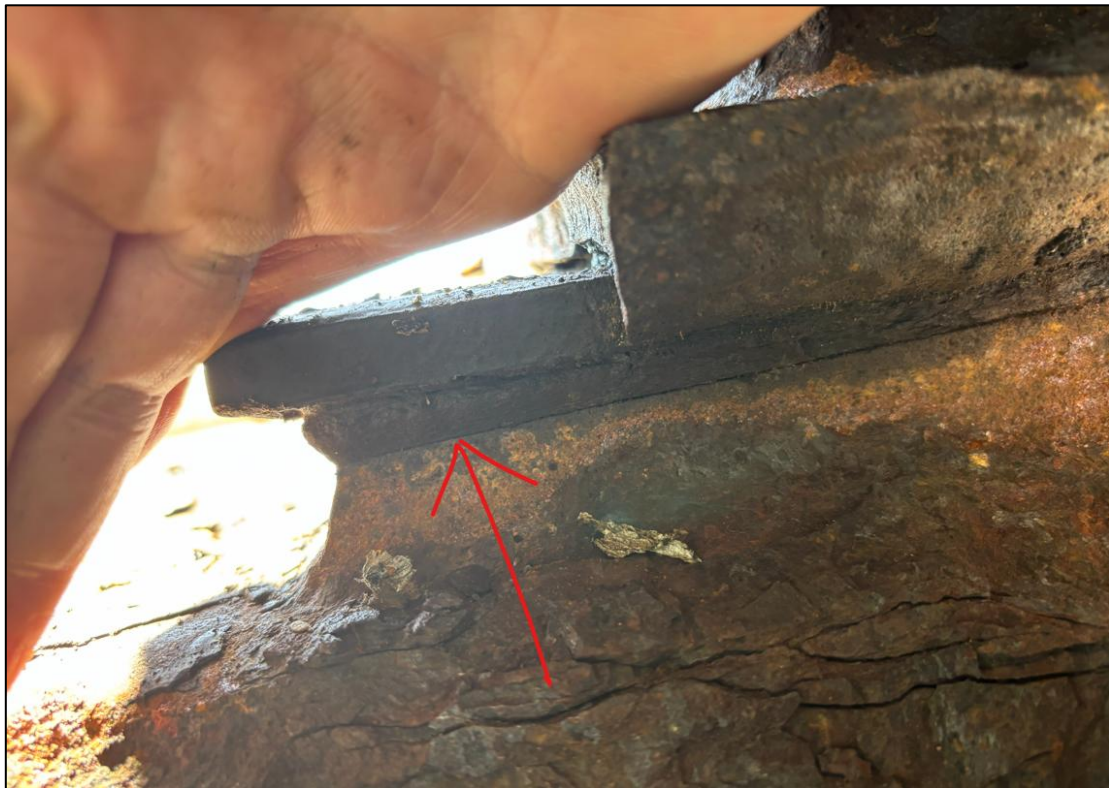
**4. PB271 – Gallery feet**

- Plates had arrived for commencement of weld repairs and tacking on of plates commenced.
- Gallery feet had been further cleaned for inspection. Feet are stuck against hook due to corrosion jacking, with most of this corrosion being under the brass plate. Suggest hooks be cut off. Gallery jacked up. Brass plates removed if possible to clean corrosion under, and hooks reinstated.

- Both feet stuck due to corrosion jacking
- On northern foot, the corrosion jacking is largely under the brass plate. If possible and practicable, this should be removed following removal of hook and jacking.
- Suggest both hooks be cut off for cleaning of corrosion

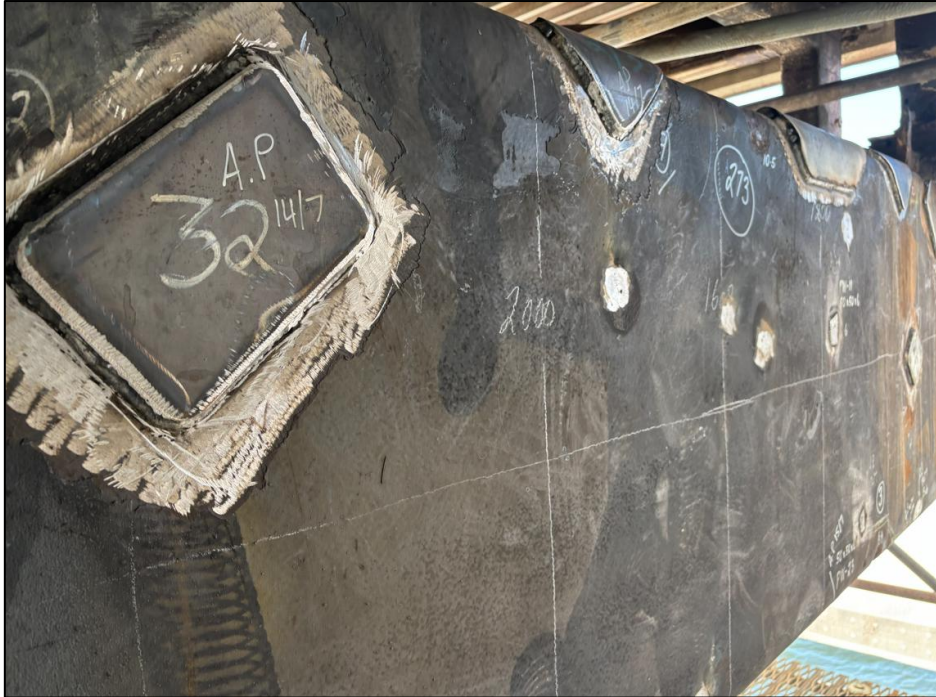
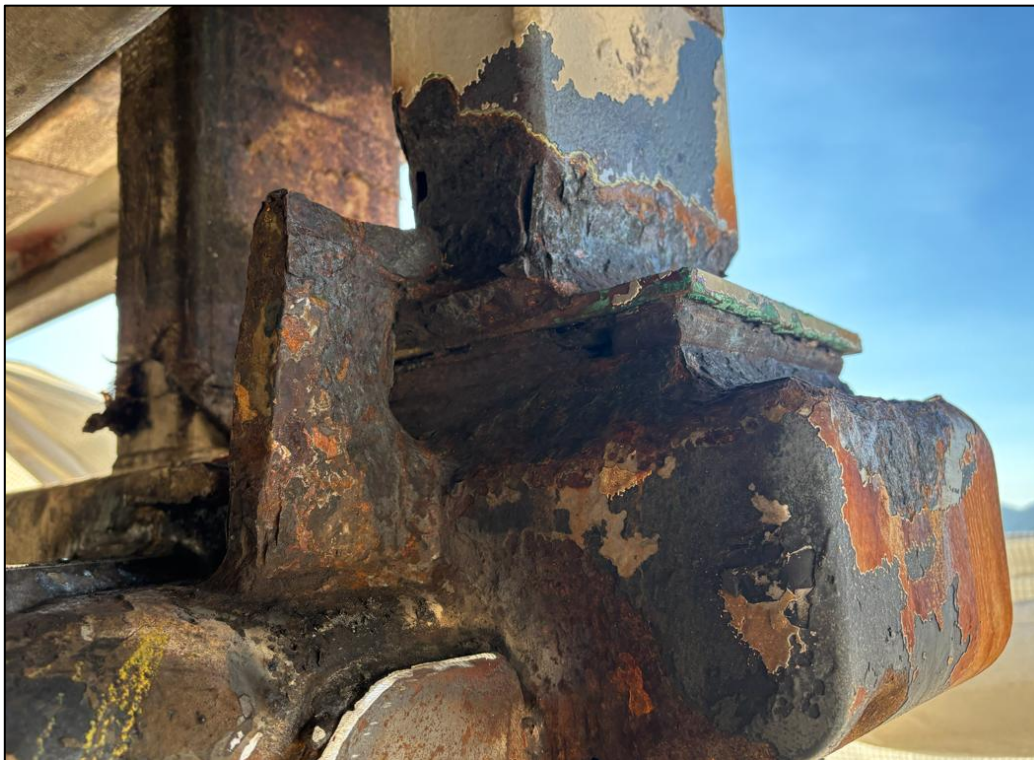
**5. PB273 – Welding progress**

- Welding of repair plates largely completed, with some welding and general grinding etc to be completed.
- Likely welding completion 16<sup>th</sup> July and delay will accumulate following that date pending direction on gallery feet treatment.

- Welding appears largely completed with a few patches to be welded out

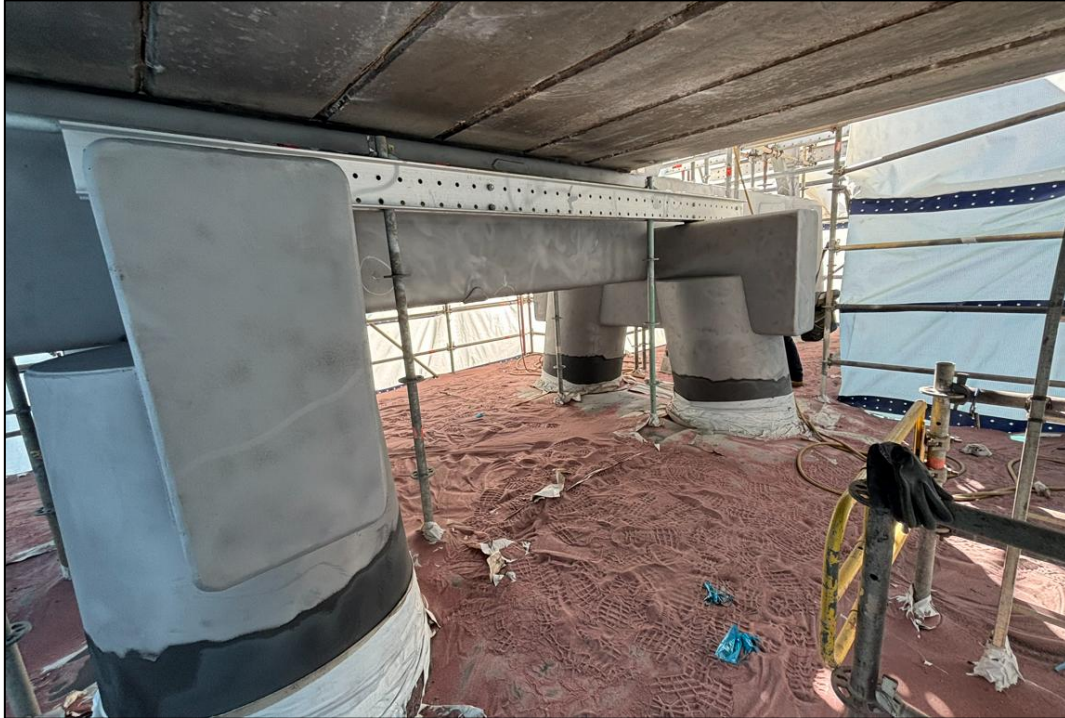
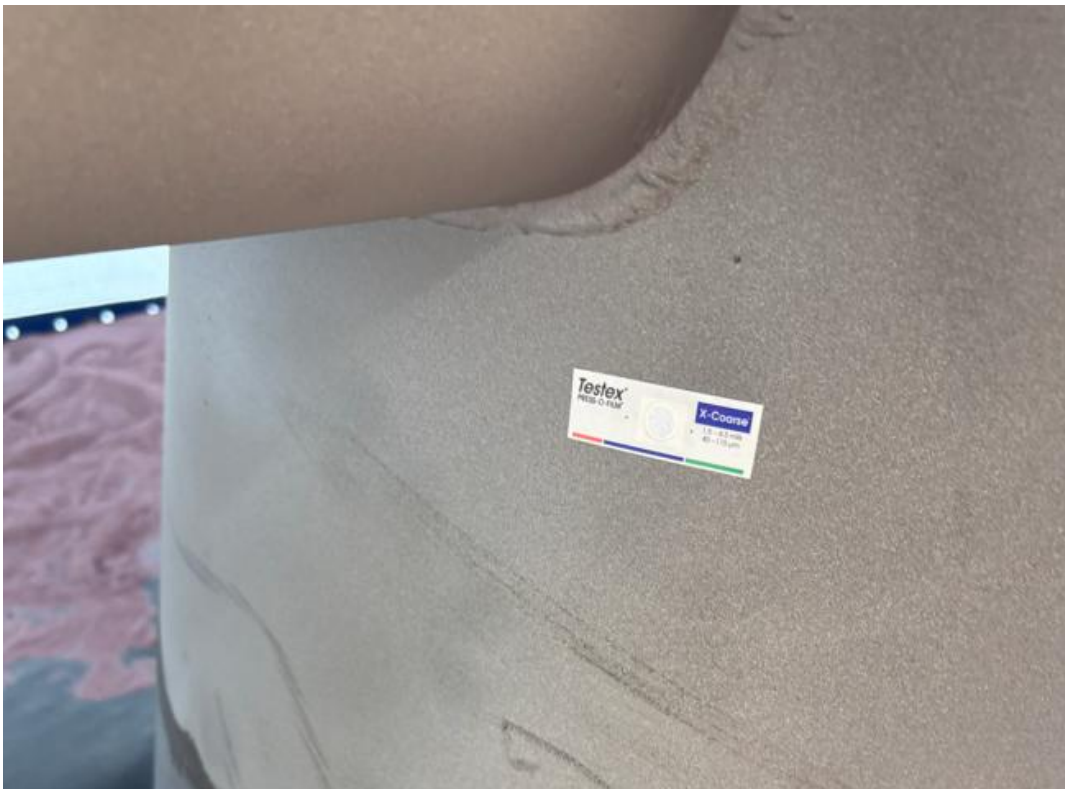
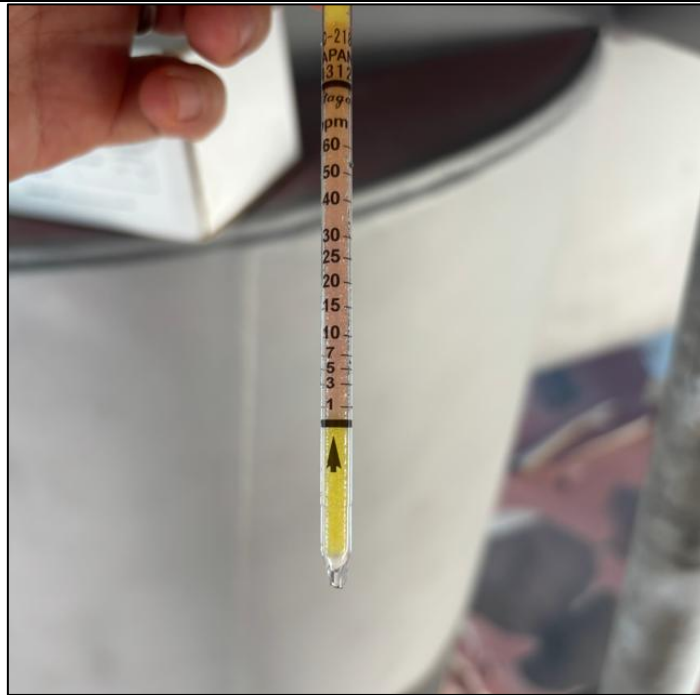
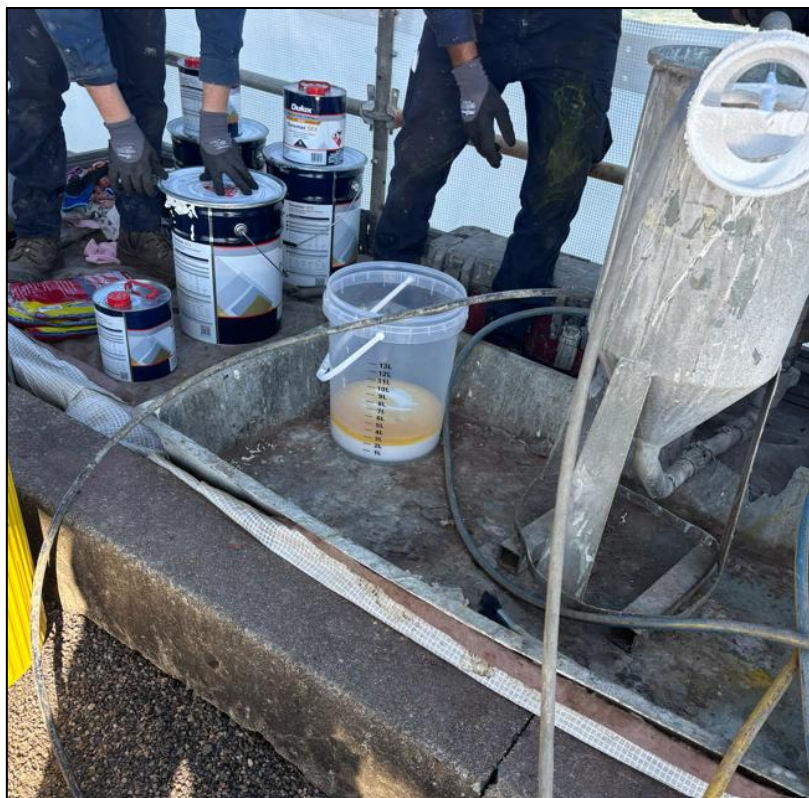
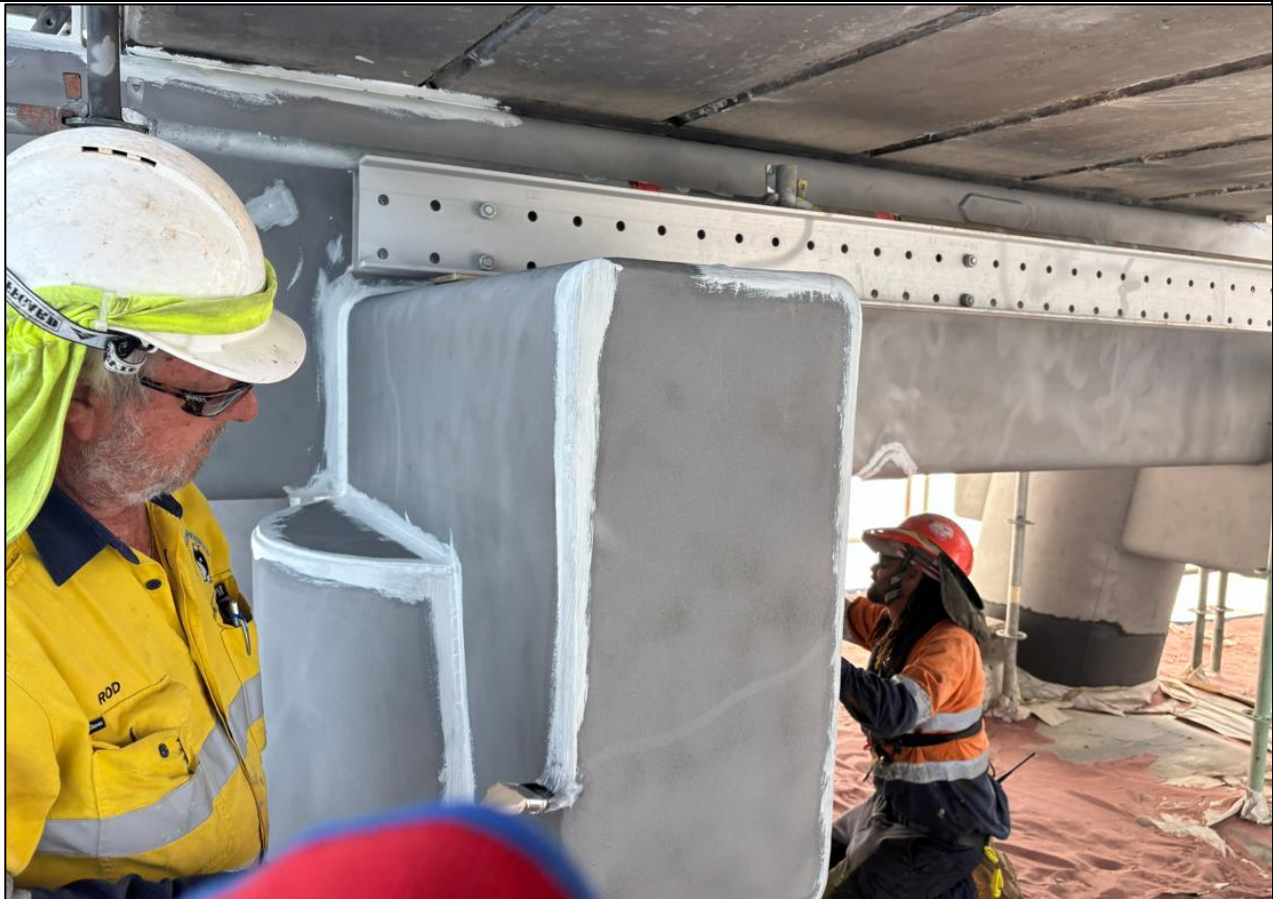
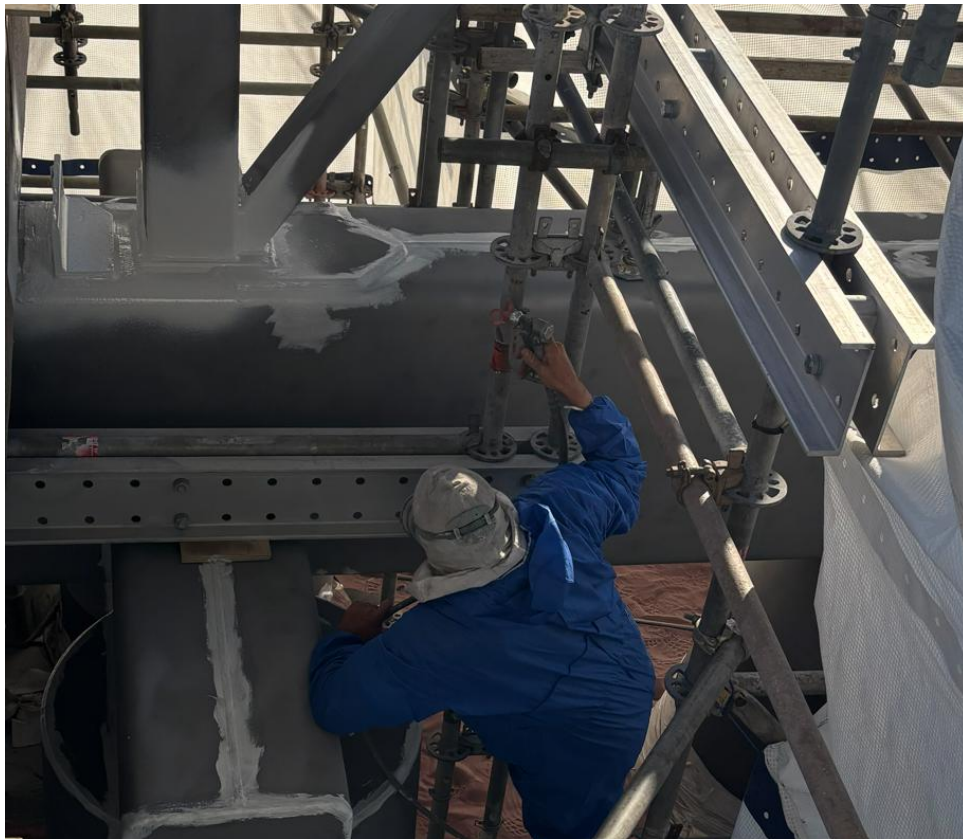
**6. PB281 – Blast and paint**

- Mixing of stripe coat mix was observed. AAB were intending to mix 2.5L of coating. They did not have graduated 5L, measuring jugs available and used a larger 20L bucket with 1 litre increments and a wide base. While the mix ratio was likely sufficiently accurate, the method was not acceptable for ongoing use as it cannot guarantee accuracy for that small quantity. AAB to please provide evidence of use of accurate part mixing methodology on future pilebents.
- Stripe coating was observed and was well performed.
- Mixing of full coat was by full kit mixing.
- Coating was observed. Some challenges were evident in some areas due to scaffold features unique to pilebent 281.

- Blasted surface
- Surface profile testing
- Chloride testing
- Measuring using wide-base bucket not acceptable

| Item | Who/When |
|---|---|
| Mixing of part kits to be as per AABs procedure at all times using appropriate measuring jugs. If suitable smaller jugs are not available, full kits or larger minimum quantities shall be used to ensure accuracy.<br>AAB to provide evidence of accurate part mixing on remainder of pilebent 281 and future pilebents. | AAB, evidence to be provided on next several pilebents, plus ongoing adherence to procedure. |
