## Inspection Report

| <b>Project</b> | <b>LBST Jetty Pile and Headstock Remediation</b> |
| <b>Date</b> | <b>25<sup>th</sup> July 2026</b> |

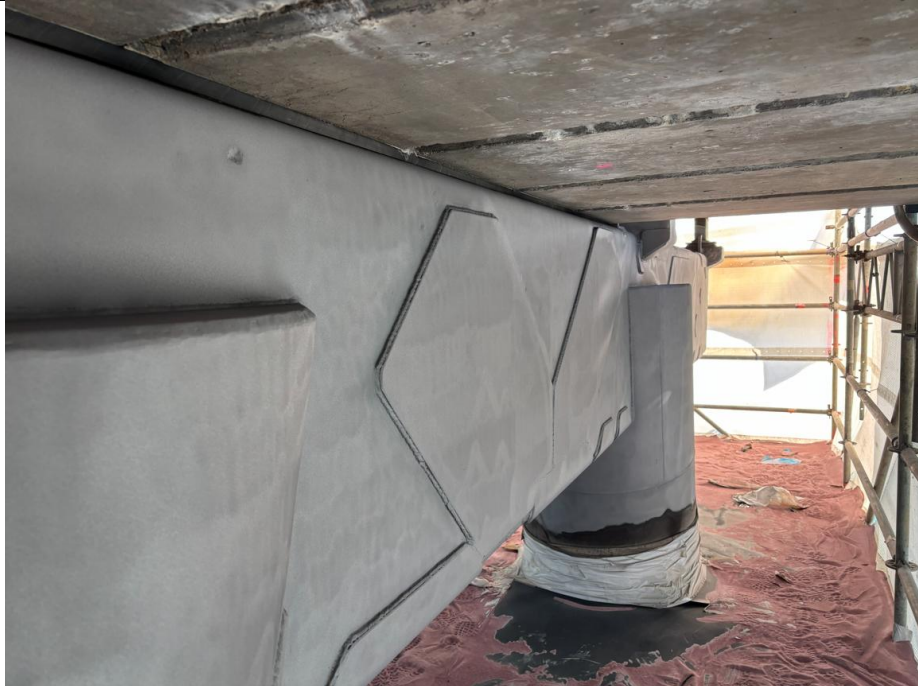
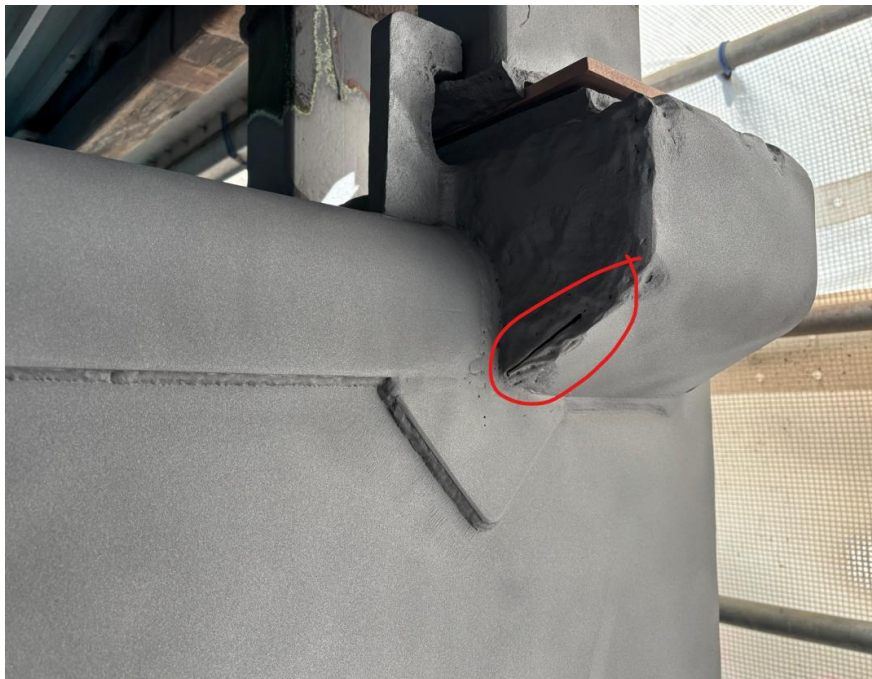
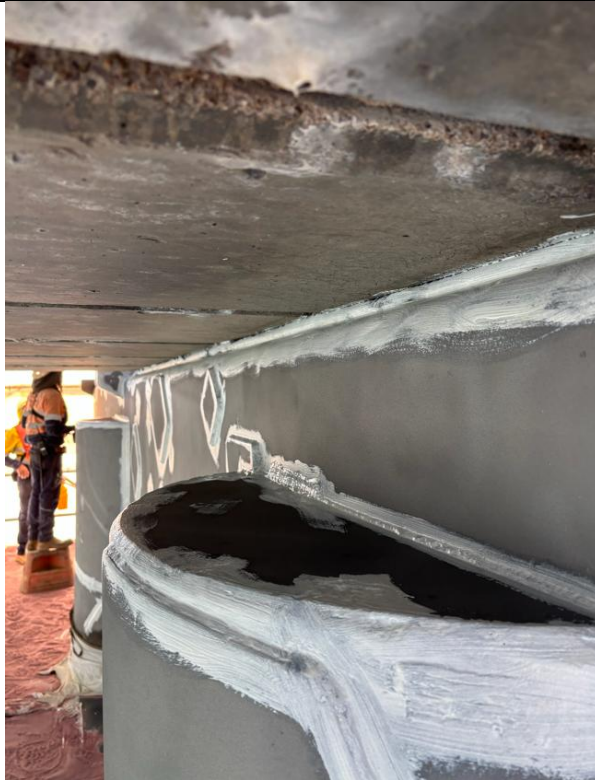
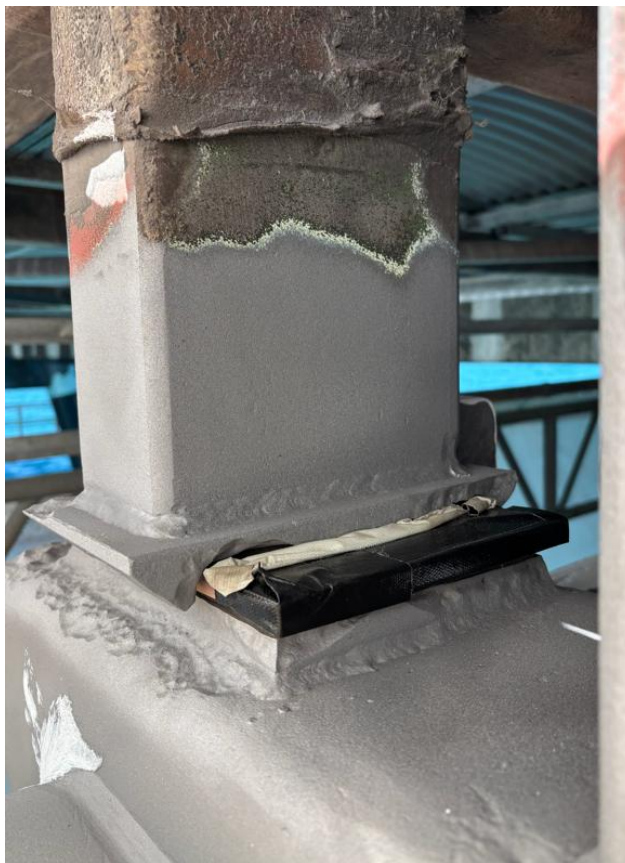
### 1. PB270 – abrasive blasting and painting

- Blasting completed around 10:30AM
- A hole along the existing weld was identified at the corner butt weld of the gallery leg shoes following blasting. Some minor weld defects were also found and a small sharp edge. These were found by the Contractor's inspection process. These defects were repaired and the areas reblasted by use of an MBX bristle blaster, with satisfactory cleanliness achieved.
- Weld quality was much improved from previous pilebents with much less porosity and undercutting observed. However, records of weld inspection by the welding supervisor have not been provided as yet. It was indicated that the welding supervisor has carried out checks using a paper-based checklist. A photo of this checklist should be uploaded.

- Very clean blast
- Hole along weld not visible until blasting was completed. Was repaired and reblasted prior to coating
- Stripe coating carried out
- Masking of gap between sliding foot and brass plate

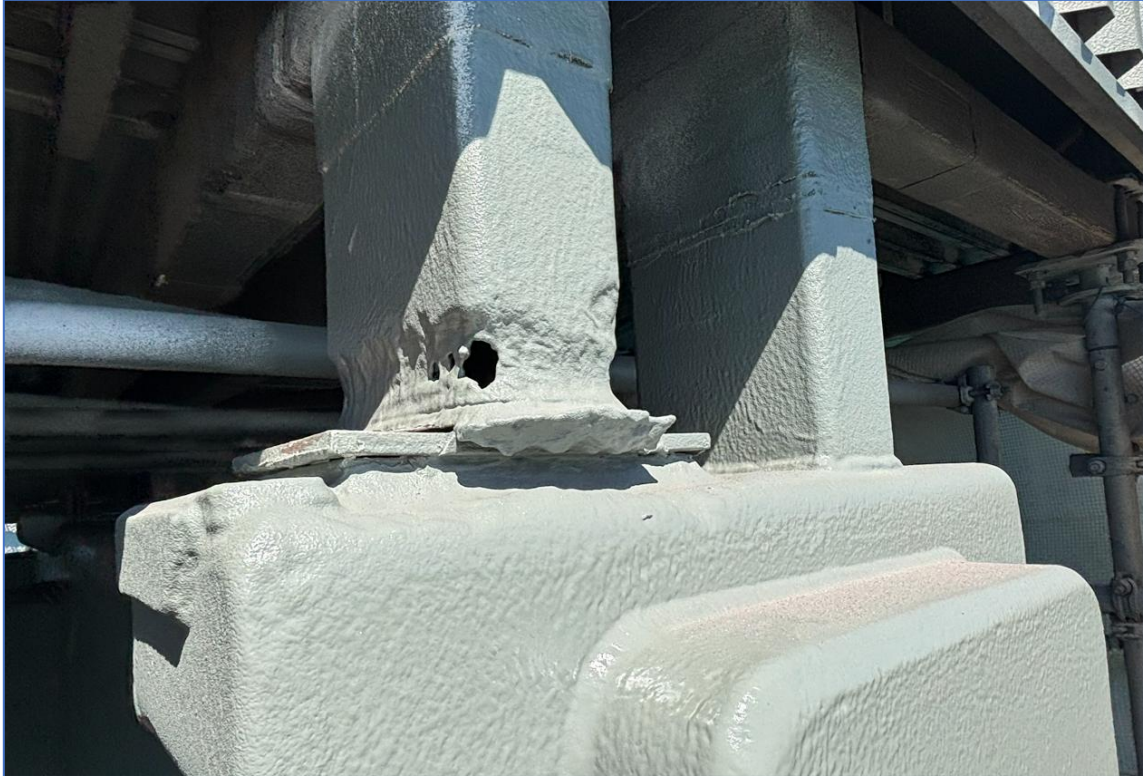
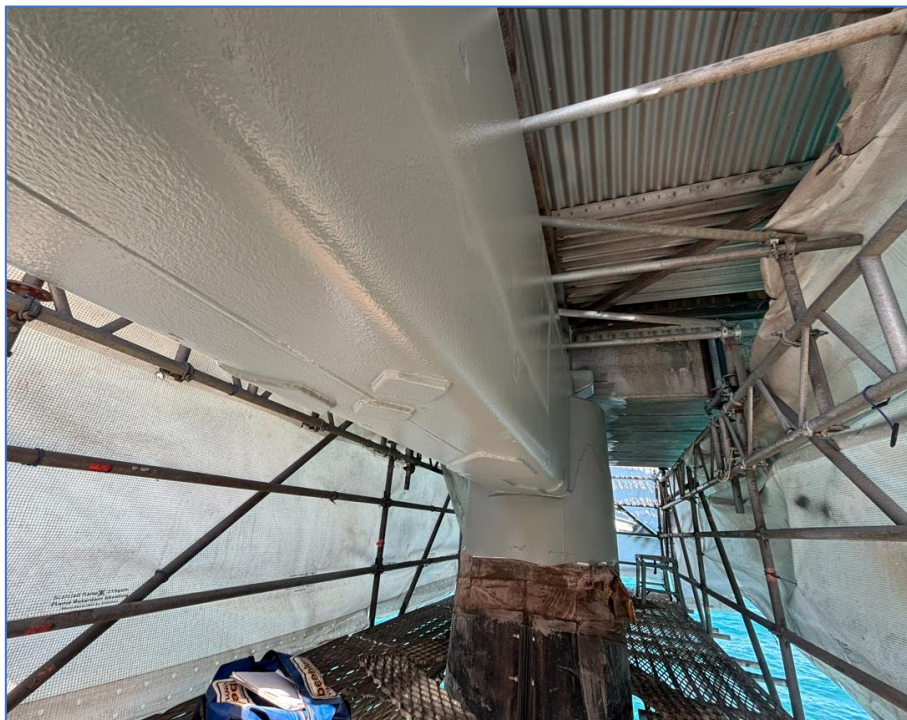
**2. PB273**

- Pilebent 273 works are completed excluding wrapping of gallery feet and replacement of top Denso jackets. These works are currently on hold pending direction on remediation of gallery feet.
- Coating dry film thickness (DFT) measurements

- Coating completed but awaiting direction on severely damaged gallery leg

| Item | Who/When |
|---|---|
| Superintendent to provide direction re PB273 gallery sliding feet | Superintendent, ASAP to minimise delay costs |

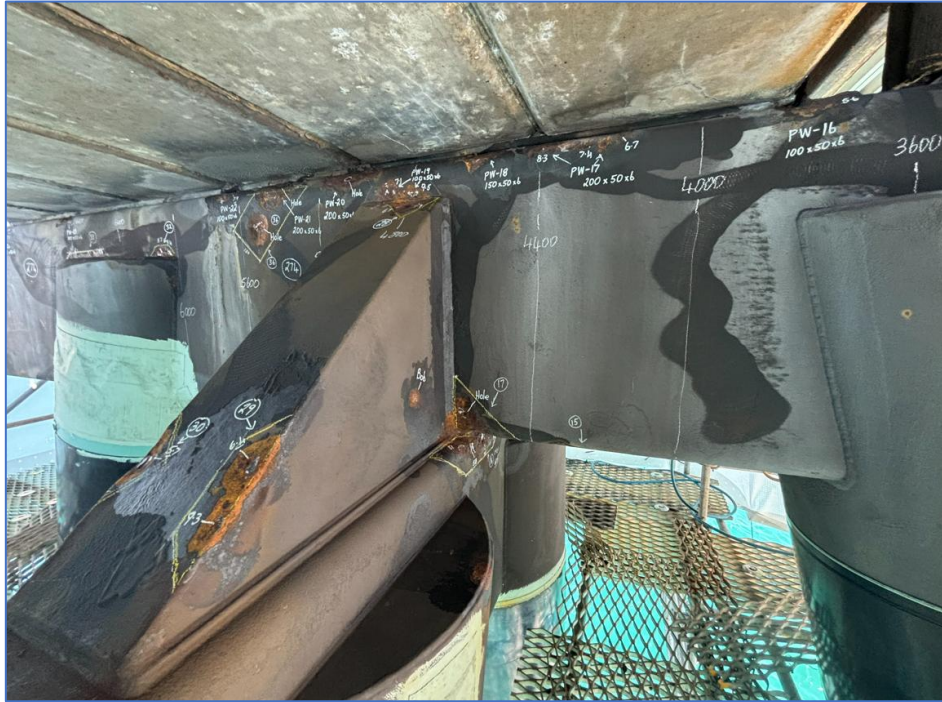
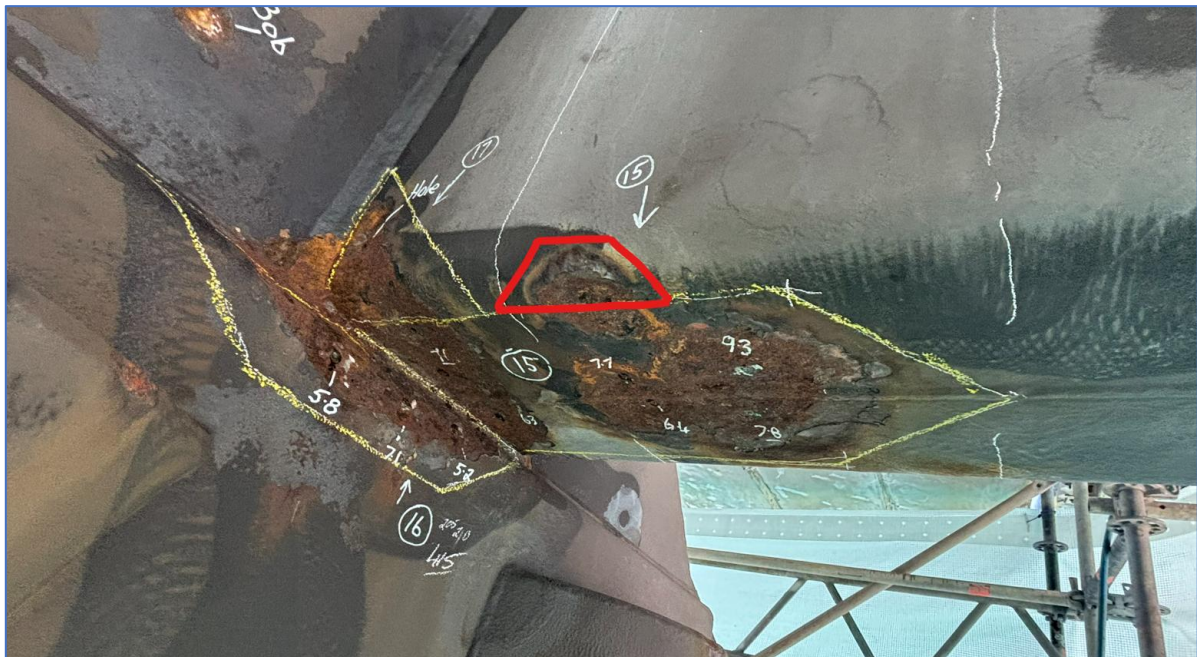
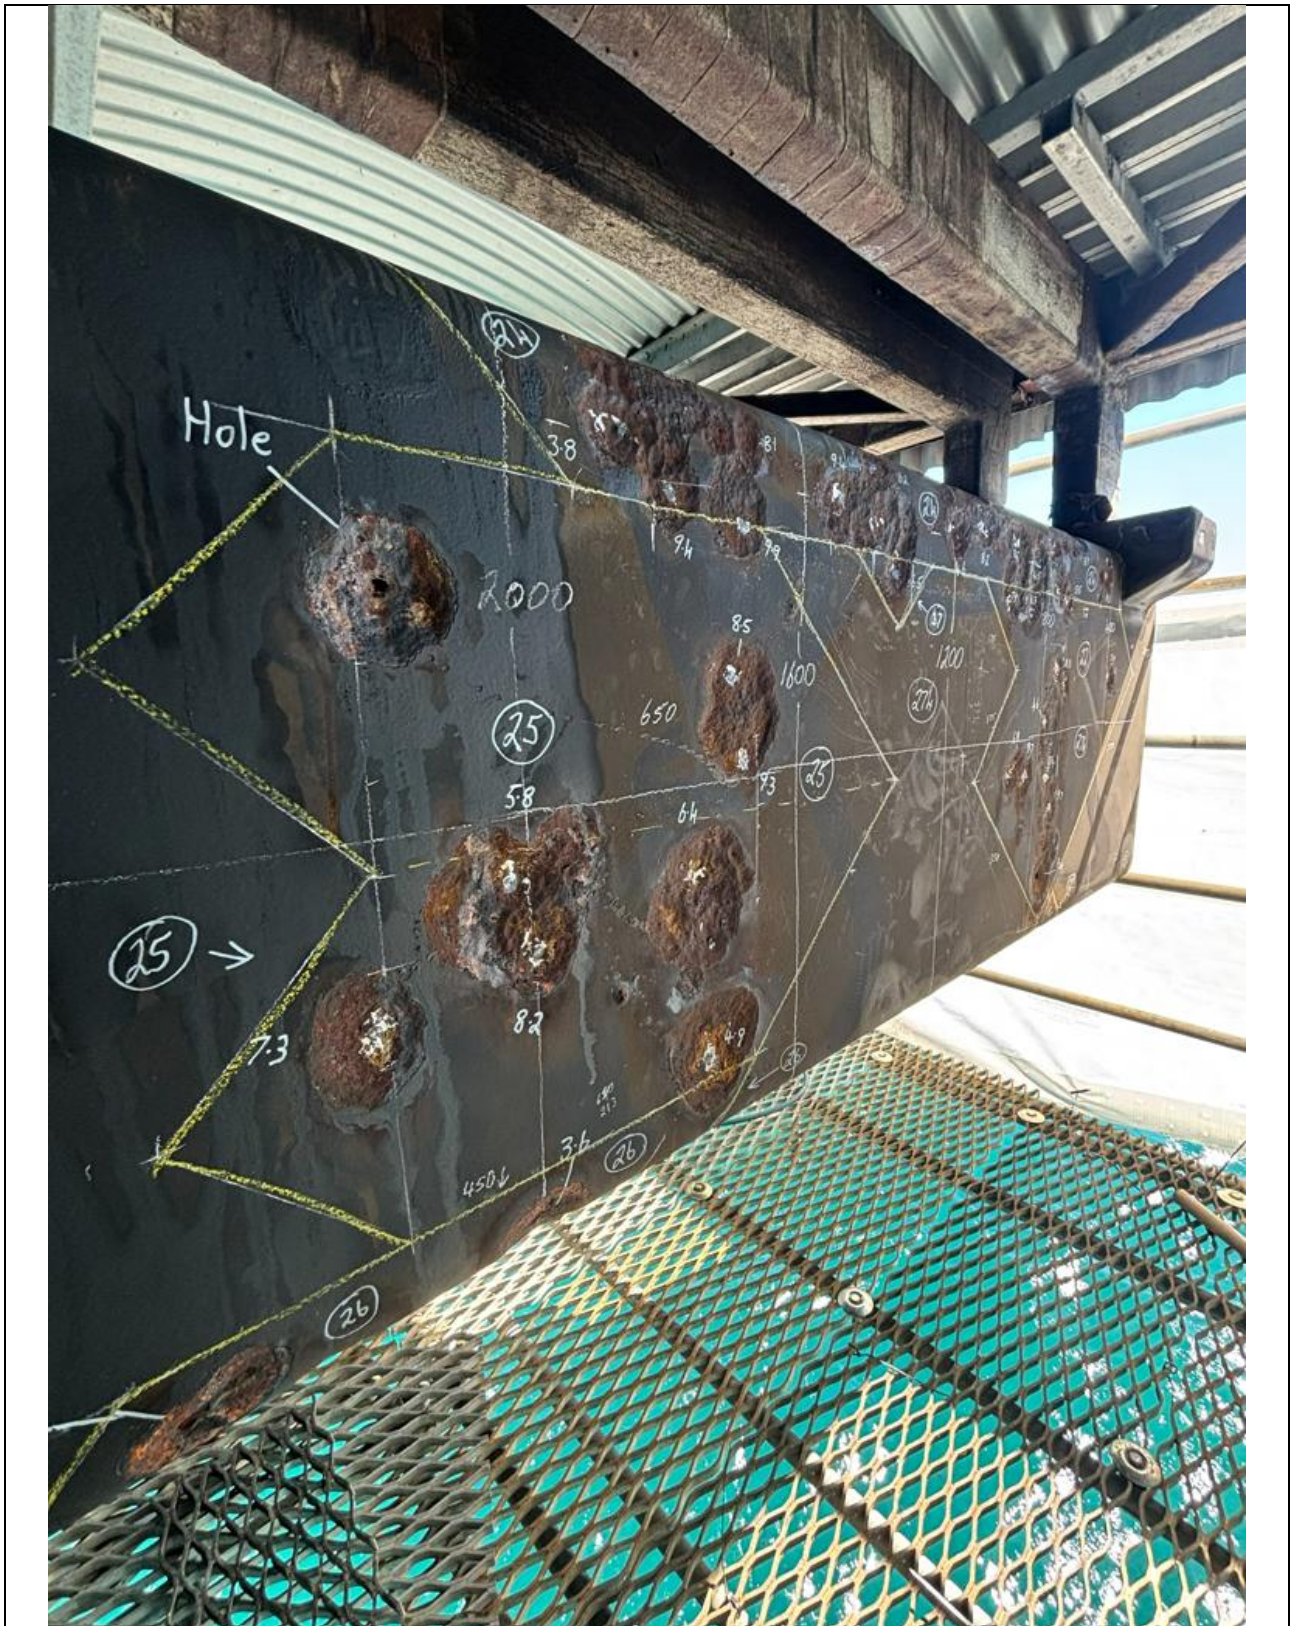
### 3. PB274 – Weld patches proposed

- Proposed repair plates are appropriate. One small extra plate will be requested at the edge of repair plate 15.
- Verbal direction was provided to progress with cutting of repair plates as drawn and additional plate can be a small addition.
- PB274 is an anchor bent and does not have sliding gallery feet
- There is a section on the underside of the lower headstock that has not yet been inspected as the scaffold mid-level is not constructed. AAB to send through inspection report for underside once scaffold is built.

- Patches approved
- Additional patch adjacent to patch 15
- PB274 is a good example of where an allowance of 8mm vertical edge plates (rather than 45 degree angle) on northern end of headstock may allow reduced repair plate qty. It has extensive low areas in a vertical line. These are better treated as one large plate with the 45 degree requirement but may be smaller plates if vertical edges were accepted.

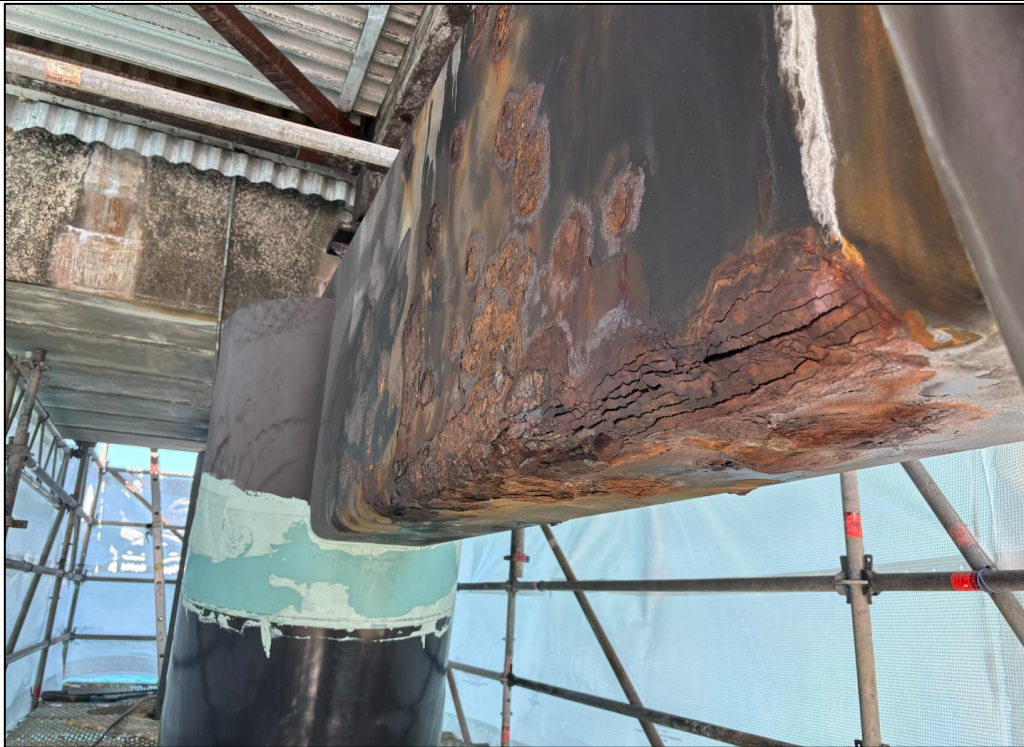
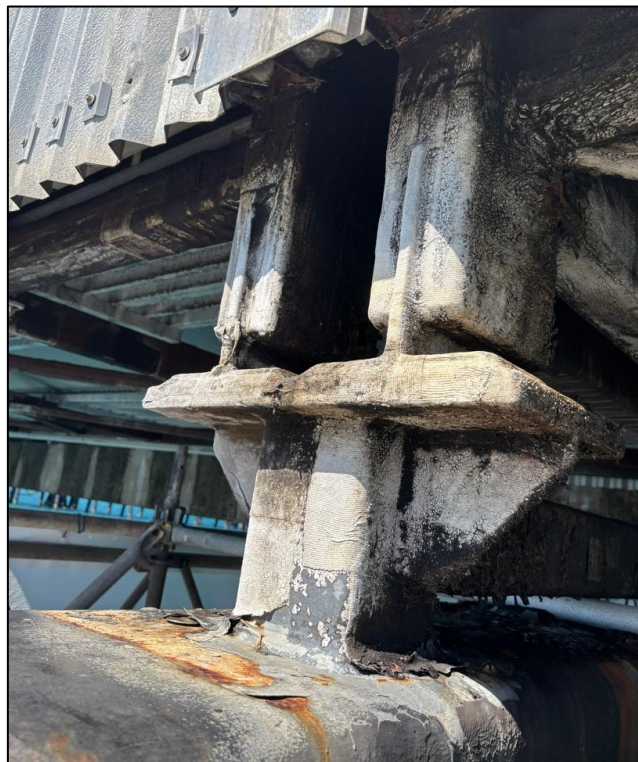
**4. PB275 – prior waterblasting**

- Had not yet been waterblasted
- Filter mesh on floor was in the process of being set up. Waterblasting commenced later that day but was not completed on time for reinspection.
- Pilebent 275 does not have sliding feet.
- The Denso tape encapsulation of the gallery feet is very dry externally. Suggest that when the tape is partially removed under the contract (~300mm from headstock top face), full removal is carried out if the tape is observed to be dry. The age of this tape may be 30 years+ and exposed to sunlight, so it likely needs replacement up to gallery level. This tape can be reached as part of JMV-based maintenance activities, so tape can be left as-is if still providing protection.
- Contractor to report on condition of tape during removal.

- Extensive corrosion
- Denso tape on gallery legs is dry but feels like it might still be OK underneath

| Item | Who/When |
|---|---|
| Contractor requested to take photos and provide report on condition of Denso tape on pile bent 275 gallery legs during removal. | AAB |

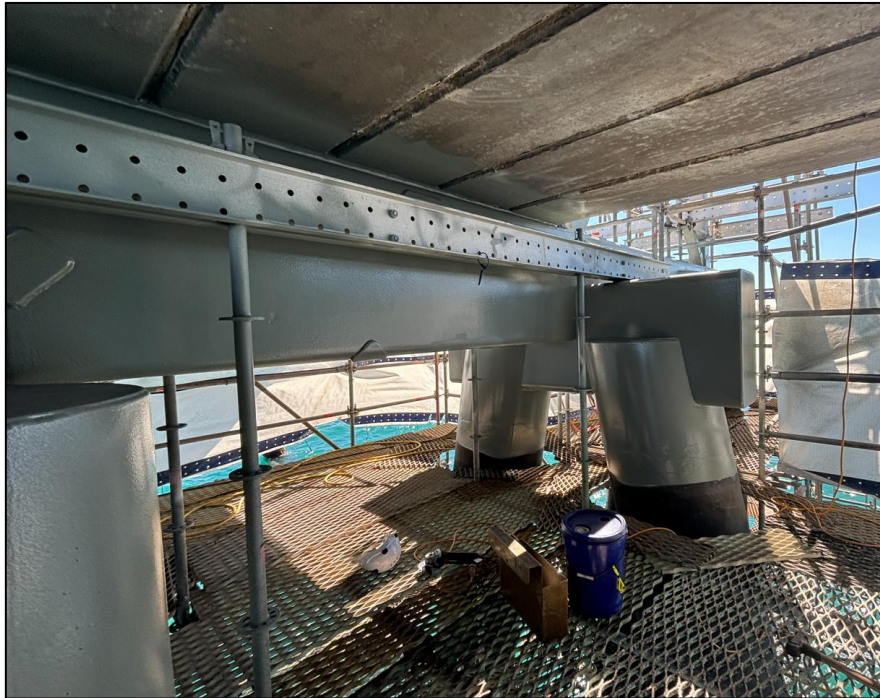
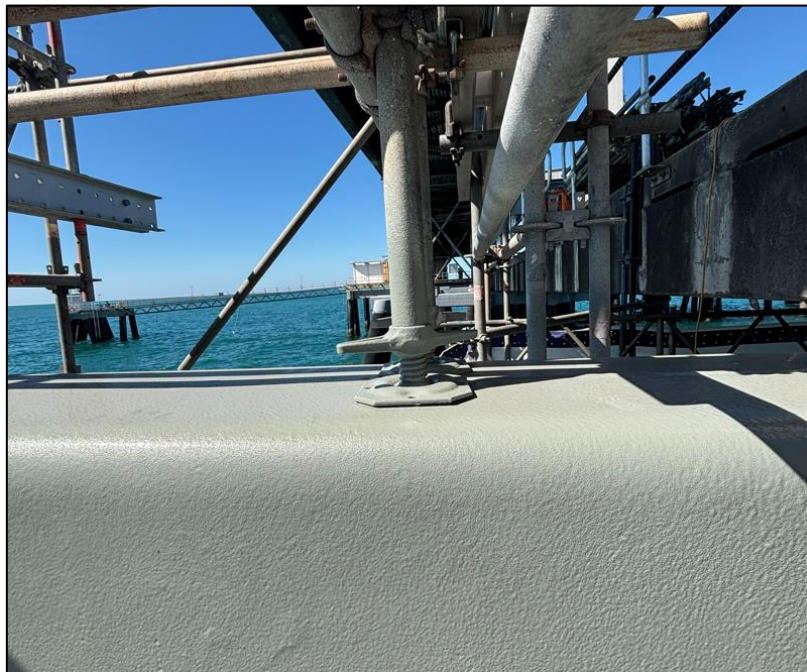
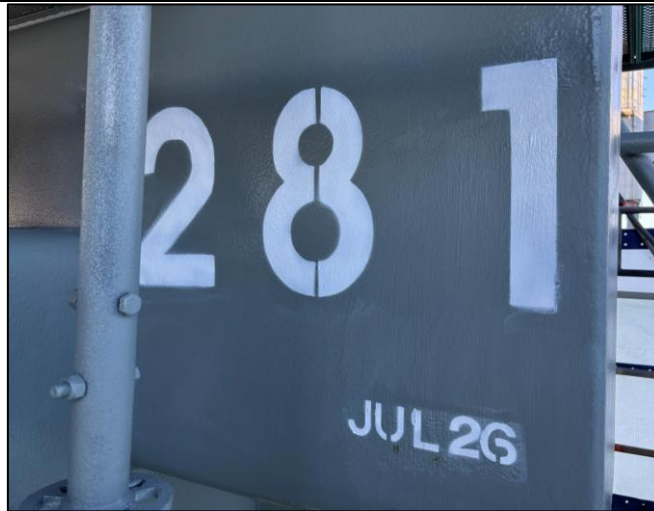
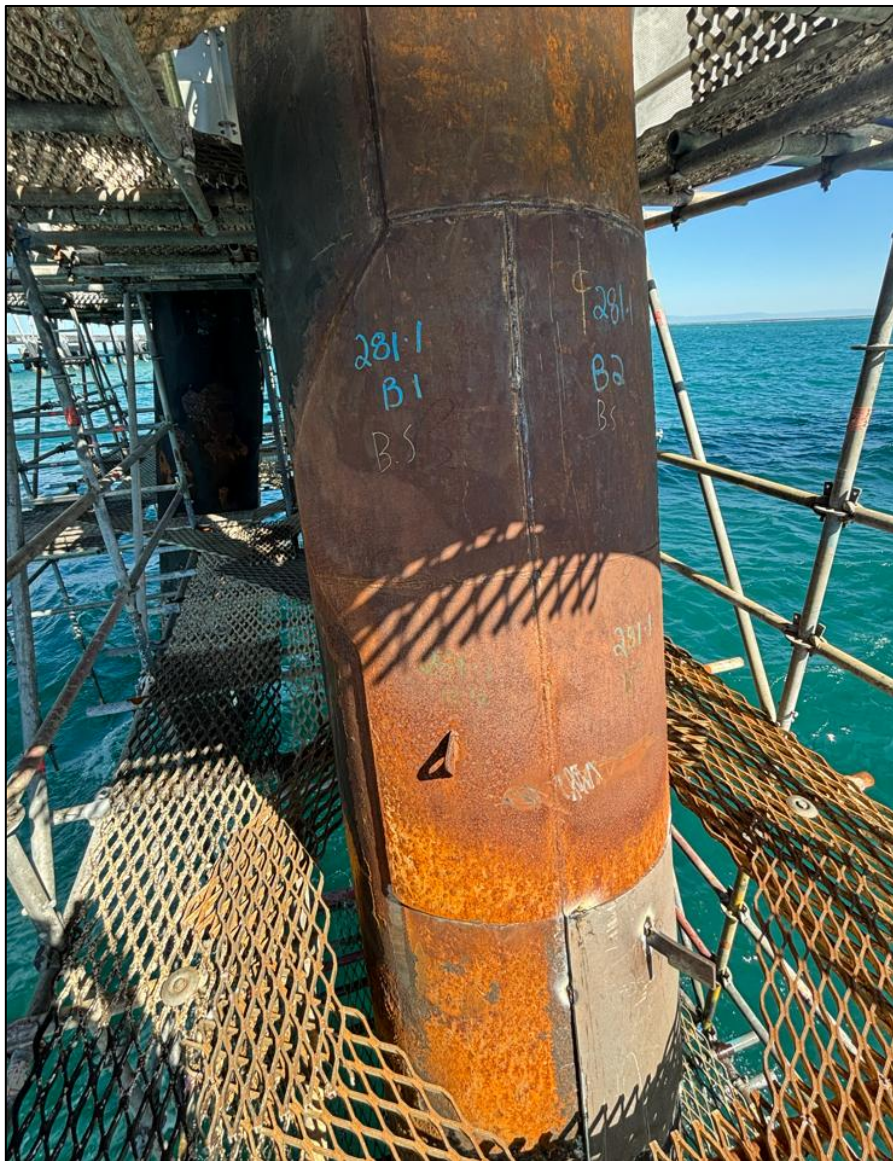
**5. PB281 – main coating completed, piles underway**

- Blasting and painting main works have been completed.
- Works underway include completion of one repair plate low down on one pile. Waves were restricting access to the lowest deck to complete these works. Pile jackets for all 6 piles will be applied following completion of scaffold bottom deck.
- There will be extensive coating touch up works at scaffold support areas. These areas will be completed as scaffold lower decks are removed and as scaffold is progressively dismantled.

- Will be lots of coating touch up points where scaffold prevented coating. This problem is unique to this pilebent and therefore was accepted at time of tender. Generally scaffold design was developed to avoid touching headstocks.
- Piles underway – require last bit of welding from bottom deck and completion of bottom deck scaffold build before jackets can be completed.

Contractor to carry out robust QA on these areas. Scaffold support points have been areas of coating breakdown on previous projects.
