# Lucinda Bulk Sugar Terminal (LBST)

Phase 1 Summary Report | Modelling of Maintenance Strategy Costs of the LBST Substructure

SCMC-22020-REP-001 | Revision 1 | 20 March 2023

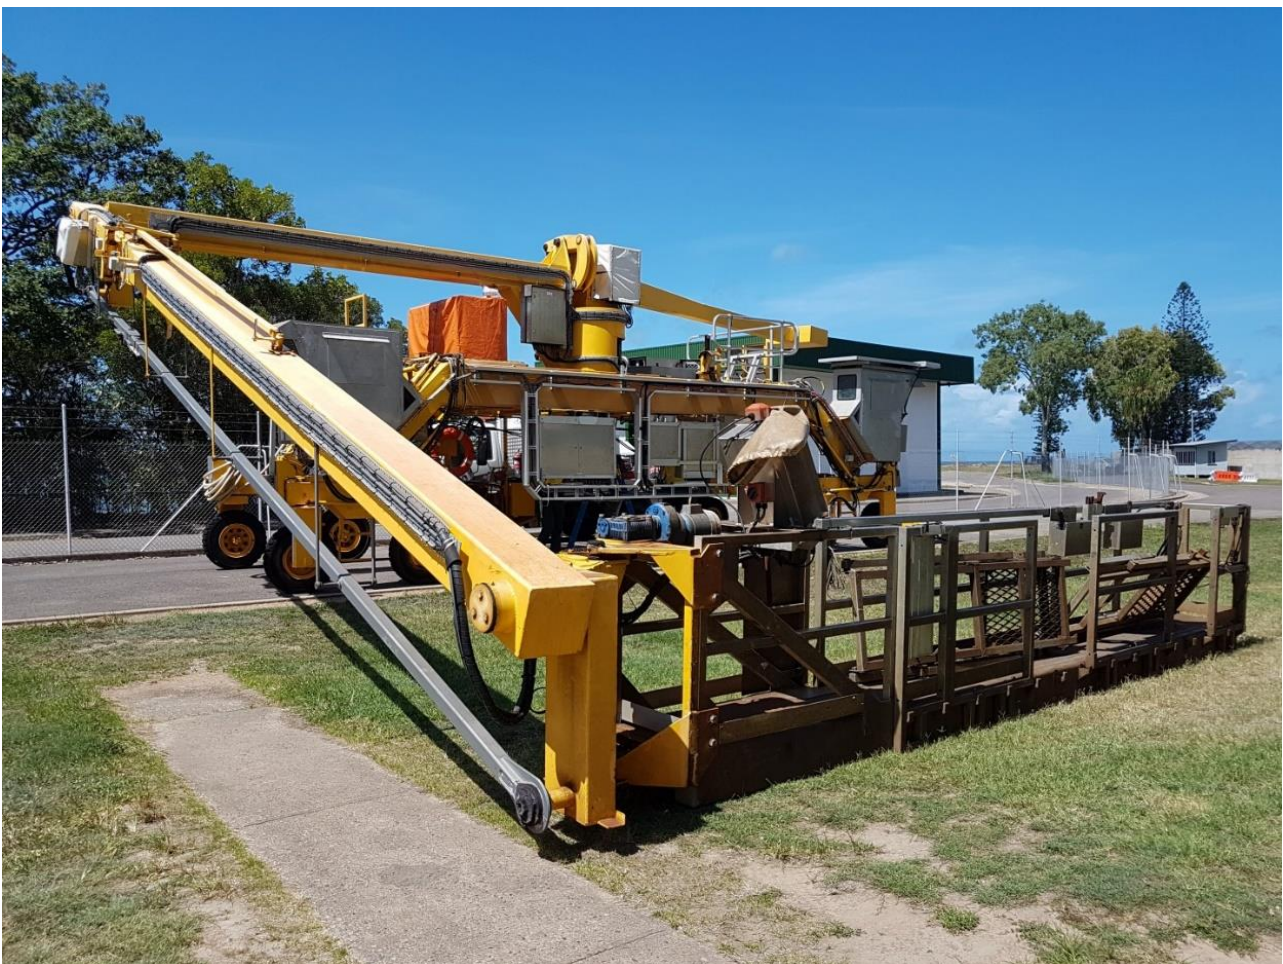
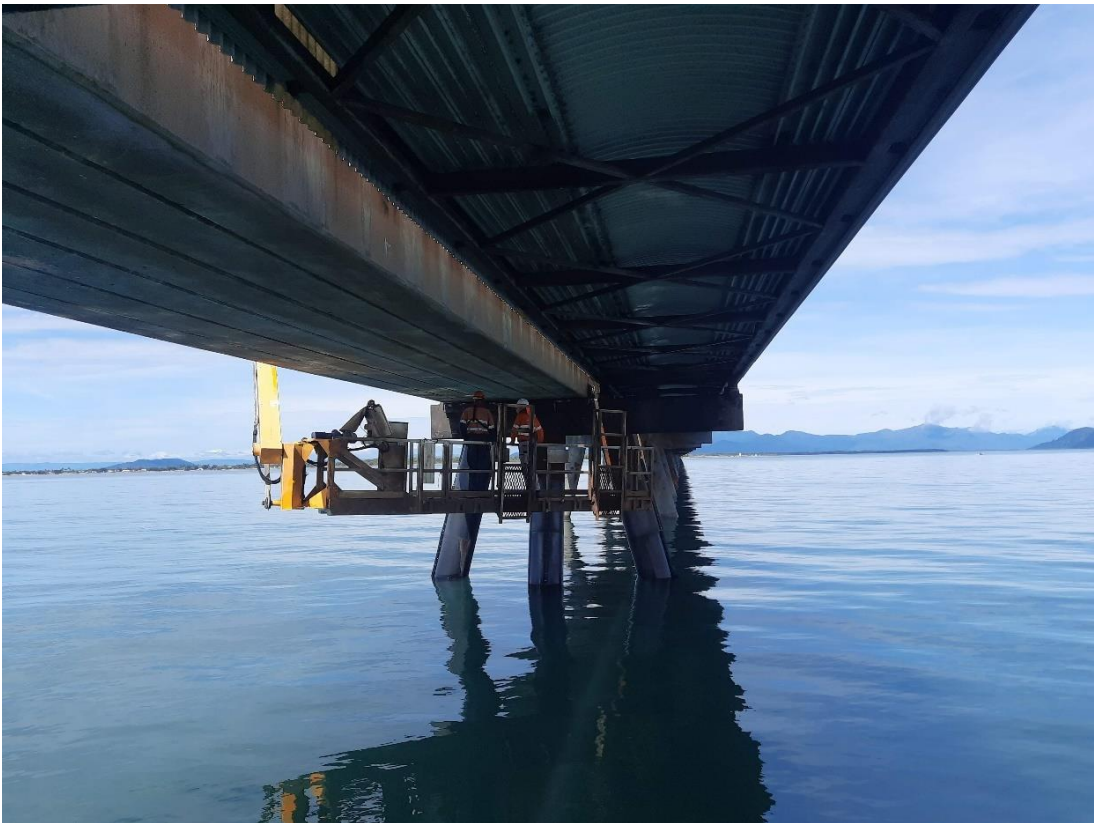
The Jetty Maintenance Vehicle (JMV – refer Figure 4 and Figure 5) is currently the primary method of access for the jetty pile and headstock repairs. In recent years, the main maintenance activity on the jetty has been pile wrapping and weld repairs. QSL and AAB have advised that the key production rate constraints in the current work repair methodology include the following:

- Repair/s production rate limited by access with only 1 JMV available
- Key JMV issues and limitations:
  - a. Reliability issues (due to age (estimated at ~40years old) and corrosive environment results in issues with control box, mechanical & electrical gear).

- c. Full encapsulation is not practical which is required for capture of sandblasting garnet (it is also noted that encapsulation also improves the quality of coating application and can reduce weather downtime).

- d. JMV is not able to access the full length of the landward side of headstocks due to rotation angle limitation of the JMV platform.
- Multi-stage sequential repair procedure for the piles with different equipment required for each stage (i.e. Blasting / cleaning -> inspection and UT testing -> weld repair -> pile wrap)

**Figure 4:** LBST Jetty Maintenance Vehicle (JMV, January 2021)

**Figure 5:** LBST JMV underneath the jetty (JMV, February 2023)

Based on the documentation review and discussions during the workshop, it is SCMC's opinion that one of the key production constraints with the current repair methodology is the JMV and that alternative access methodologies will be required to speed up the repair production rate. This will also enable multiple work fronts to work simultaneously in parallel.

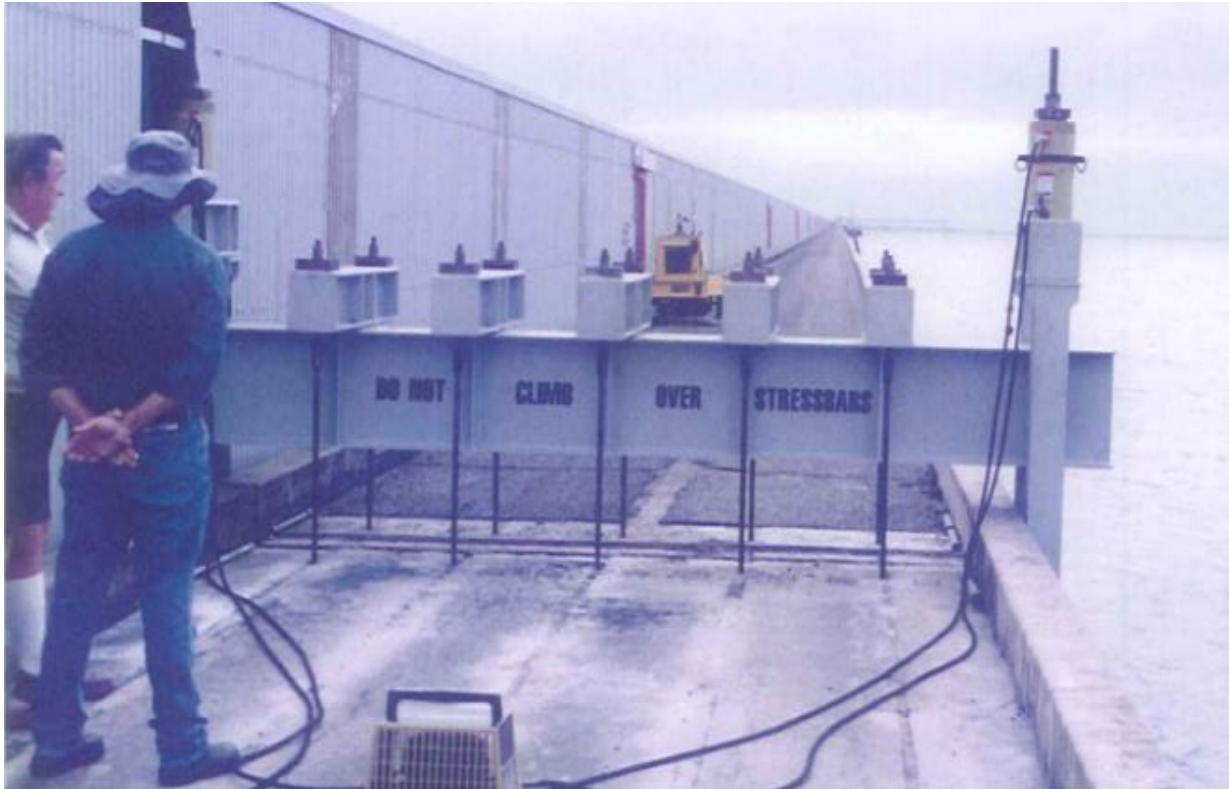
Based on documents provided by QSL, in 1997 / 98, 6no. of the 26no. expansion joints headstocks were inspected and repaired. In addition, it is understood that Bent 280 was also repaired as part of the Cyclone Yasi repairs in 2012/13. The deck units were jacked up using a lifting frame as shown in Figure 7. It is understood that the top surface of the headstocks were found to be in very poor condition with corrosion, pitting and holes evident.

In general, welding repairs were required to the top surface of the headstocks which involved welding a ~3mm thick stainless steel plate with "Flurogold" bearings bonded onto the plate for each PRC deck unit.

**Figure 7:** Photo showing lifting frame used to lift the deck units on a expansion joint headstock
