REPORT #: **UT-BELKAR-26-052**

PROJECT: Corrosion 2026

ITEM(S) EXAMINED: **CML 1.52, 1.29 & 4.09**

SCOPE: Perform UT Thickness scans as per request.

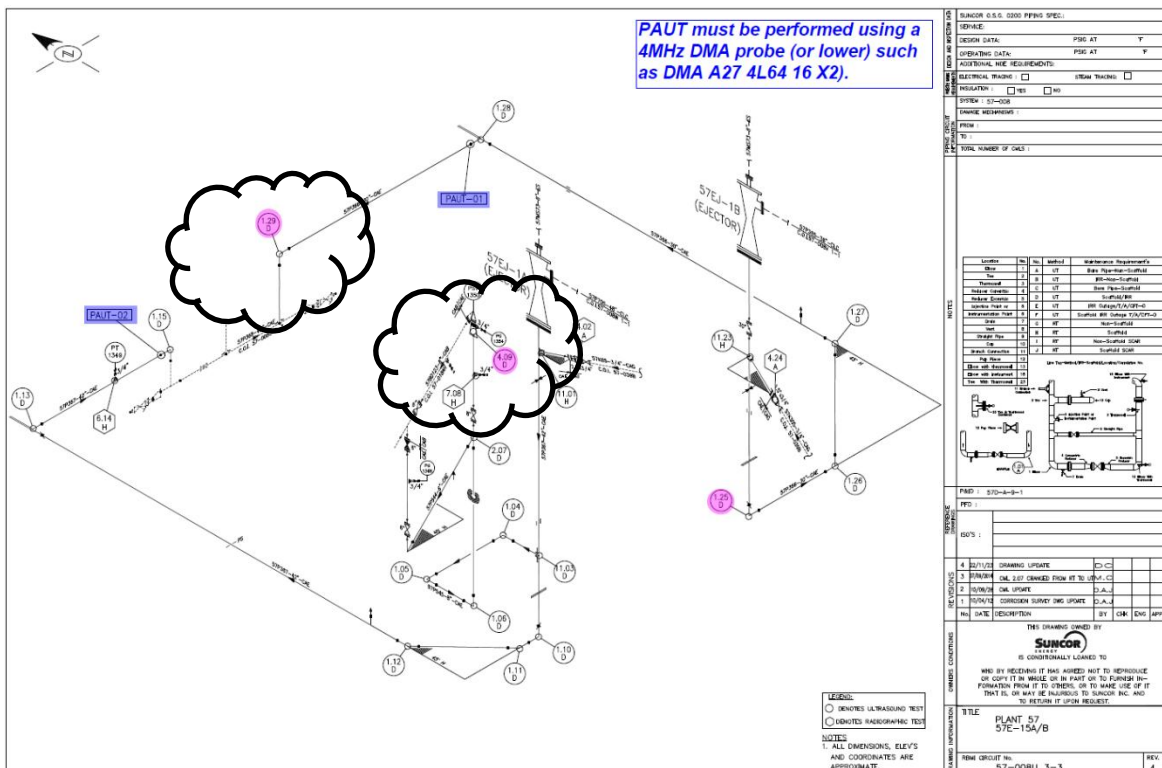
## CML 1.52 ELBOW:

A 4"x4" GRID SCAN WAS PERFORMED AT CML 1.52 ELBOW. "A-M" STARTS AT THE TOP AND GOES CLOCKWISE WITH RESPECT TO FLOW. "1-12" GOES WITH THE FLOW.

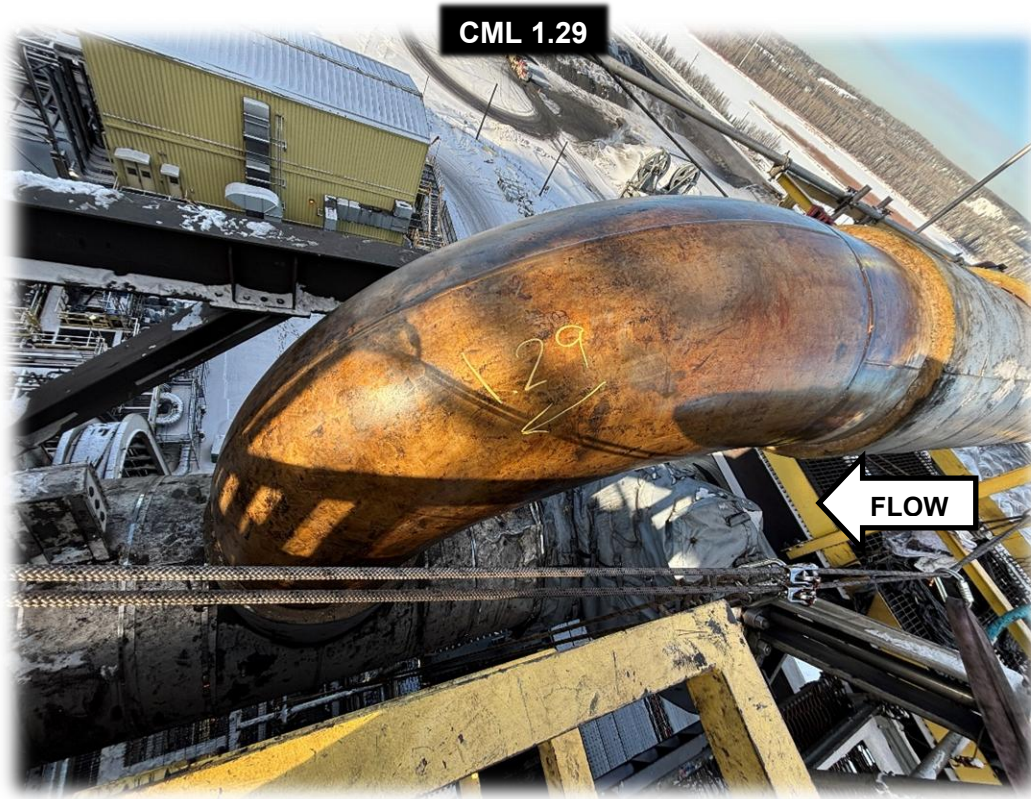
### UT REPORT - ELBOW

| PORT HOLES - CORROSION | | | | | | | | | | | | | FULL SCAN - EROSION | | | | |
|---|---|---|---|---|---|---|---|---|---|---|---|---|---|---|---|---|---|
| 57-008U 1-3 | 1.52 | 1 | 16" | | | | | | 0.357 | | | | | | | | 40F |
| | | 2 | 16" | | | | | | | | | | 0.358 | | | SEE GRID | |
| 57-008U 3-3 | 1.29 | 1 | 30" | | | | | | | | | | 0.342 | | | 0.374 | 150F |
| | | 3 | 30" | | | | | | 0.372 | | | 0.287 | | | | 0.388 | |

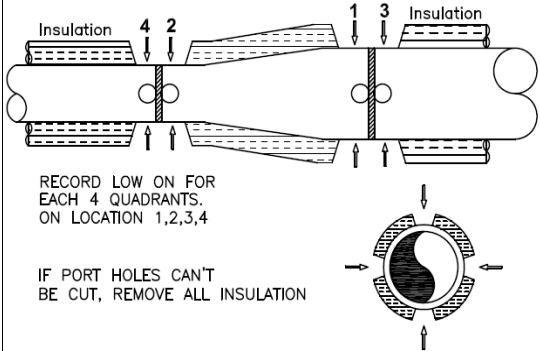
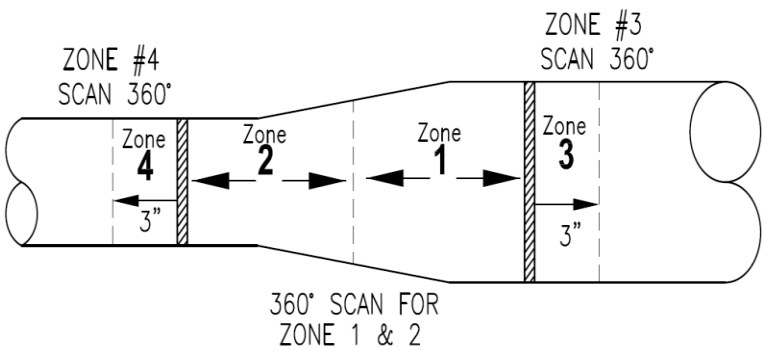
| UT REPORT - REDUCER | | | | | | | | | | | |
|---|---|---|---|---|---|---|---|---|---|---|---|
| 57-008U 3-3 | 4.09 | 1 | 8" | 0.296 | | | | | | 0.325 | |
| | | 2 | 6" | | 0.326 | | | | | 0.365 | |
| | | 3 | 8" | | 0.318 | | | | | 0.340 | |
