## NONDESTRUCTIVE EXAMINATION

REPORT #: **UT-BALJIN-2026-18**

PROJECT: Corrosion 2026

ITEM(S) EXAMINED: **CML 1.33**

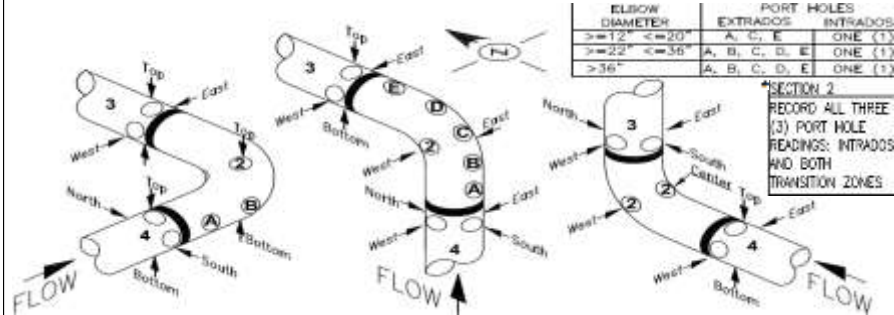
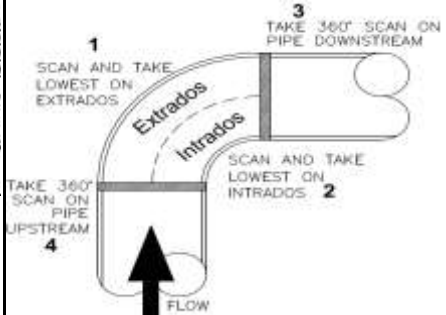
| UT REPORT - ELBOW | | | | | | | | | | | | | | | | | | |
|---|---|---|---|---|---|---|---|---|---|---|---|---|---|---|---|---|--|--|
| 52-001C 1-2 | 1.33 | 1 | 14" | | | | | | | | 0.388 | | | | | 0.450 | | |
| | | 2 | 14" | | | | | | 0.408 | | | | | | | 0.451 | | |
| | | 3 | 14" | | | | | | | | | | | 0.426 | | 0.458 | | |
| | | 4 | 14" | | | | | | | | | | | 0.421 | | 0.468 | | |
