## NONDESTRUCTIVE EXAMINATION

REPORT #: **UT-ROBJOS-26-061**

PROJECT: **CORROSION 2026**

ITEM(S) EXAMINED: **CML 2.37**

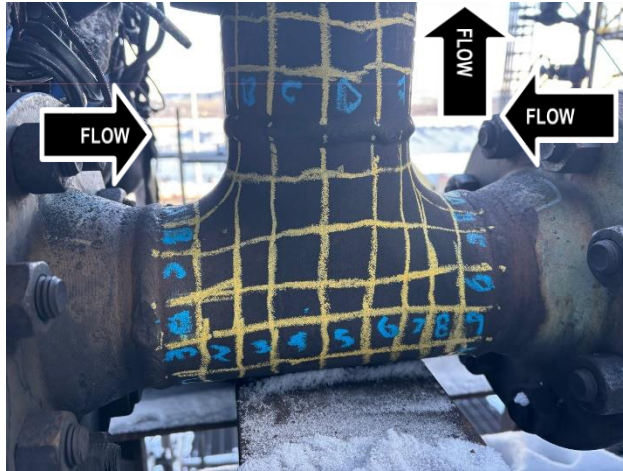
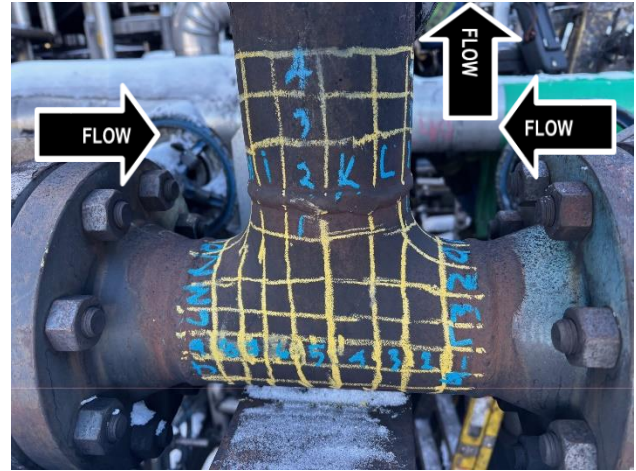
### CML 2.37

**NOTE: STRUCTURAL OBSTRUCTION PRESENT ON BOTTOM OF TEE PREVENTING FULL SCAN ON BOTTOM OF SECTION 4 AND 2.**
