## NONDESTRUCTIVE EXAMINATION

CLIENT: **Suncor Energy Inc.**  
**Suncor Oil Sands**  
**Fort McMurray, AB**

REPORT #: **UT-AUTNAR-26-33**

**Circuit:**  
**57-008V 1-1**  
**CML**  
**1.02, 11.03**

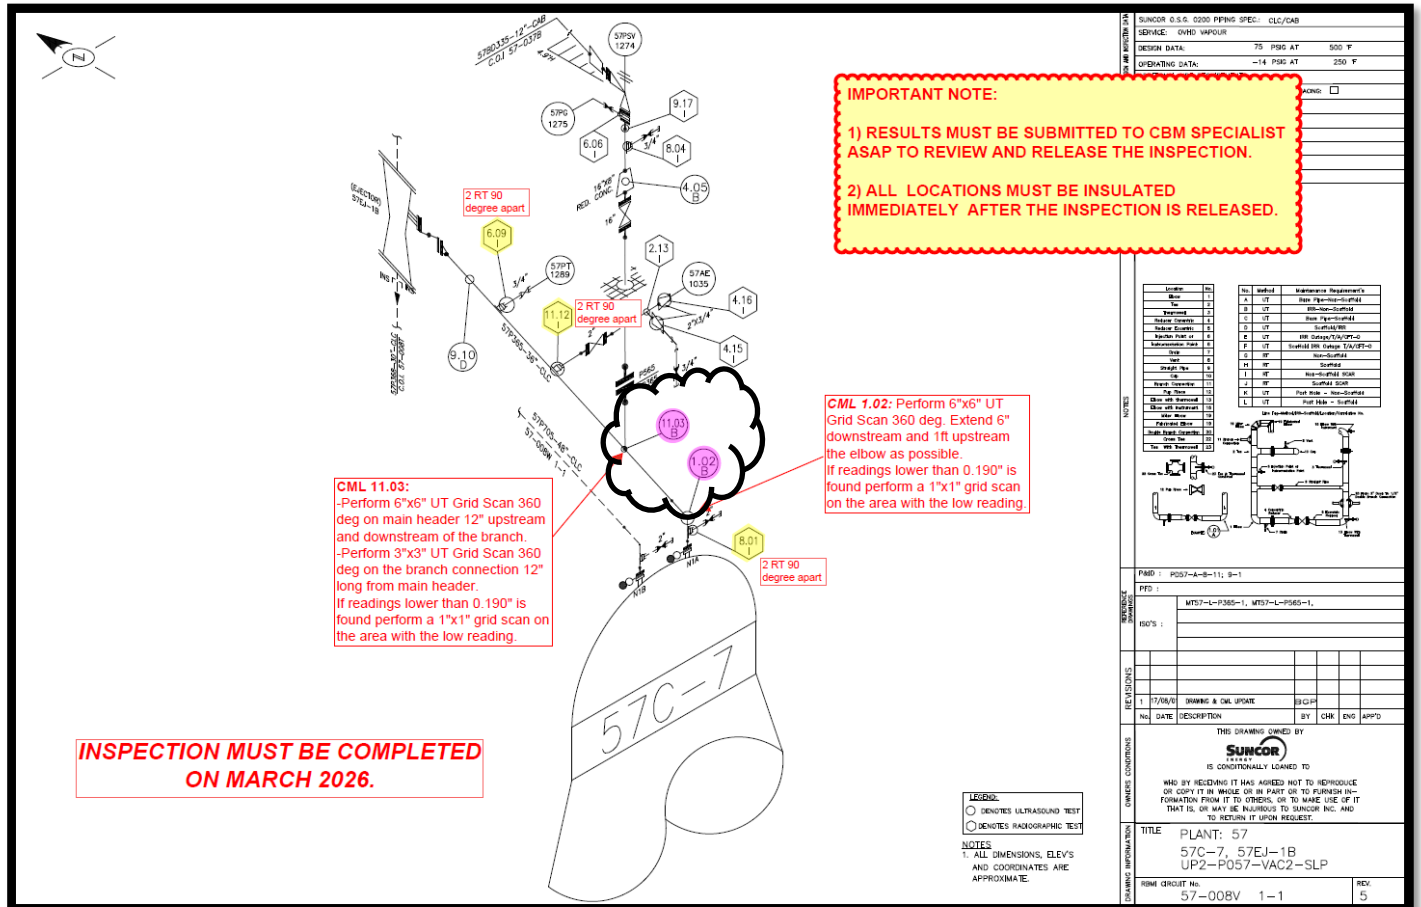
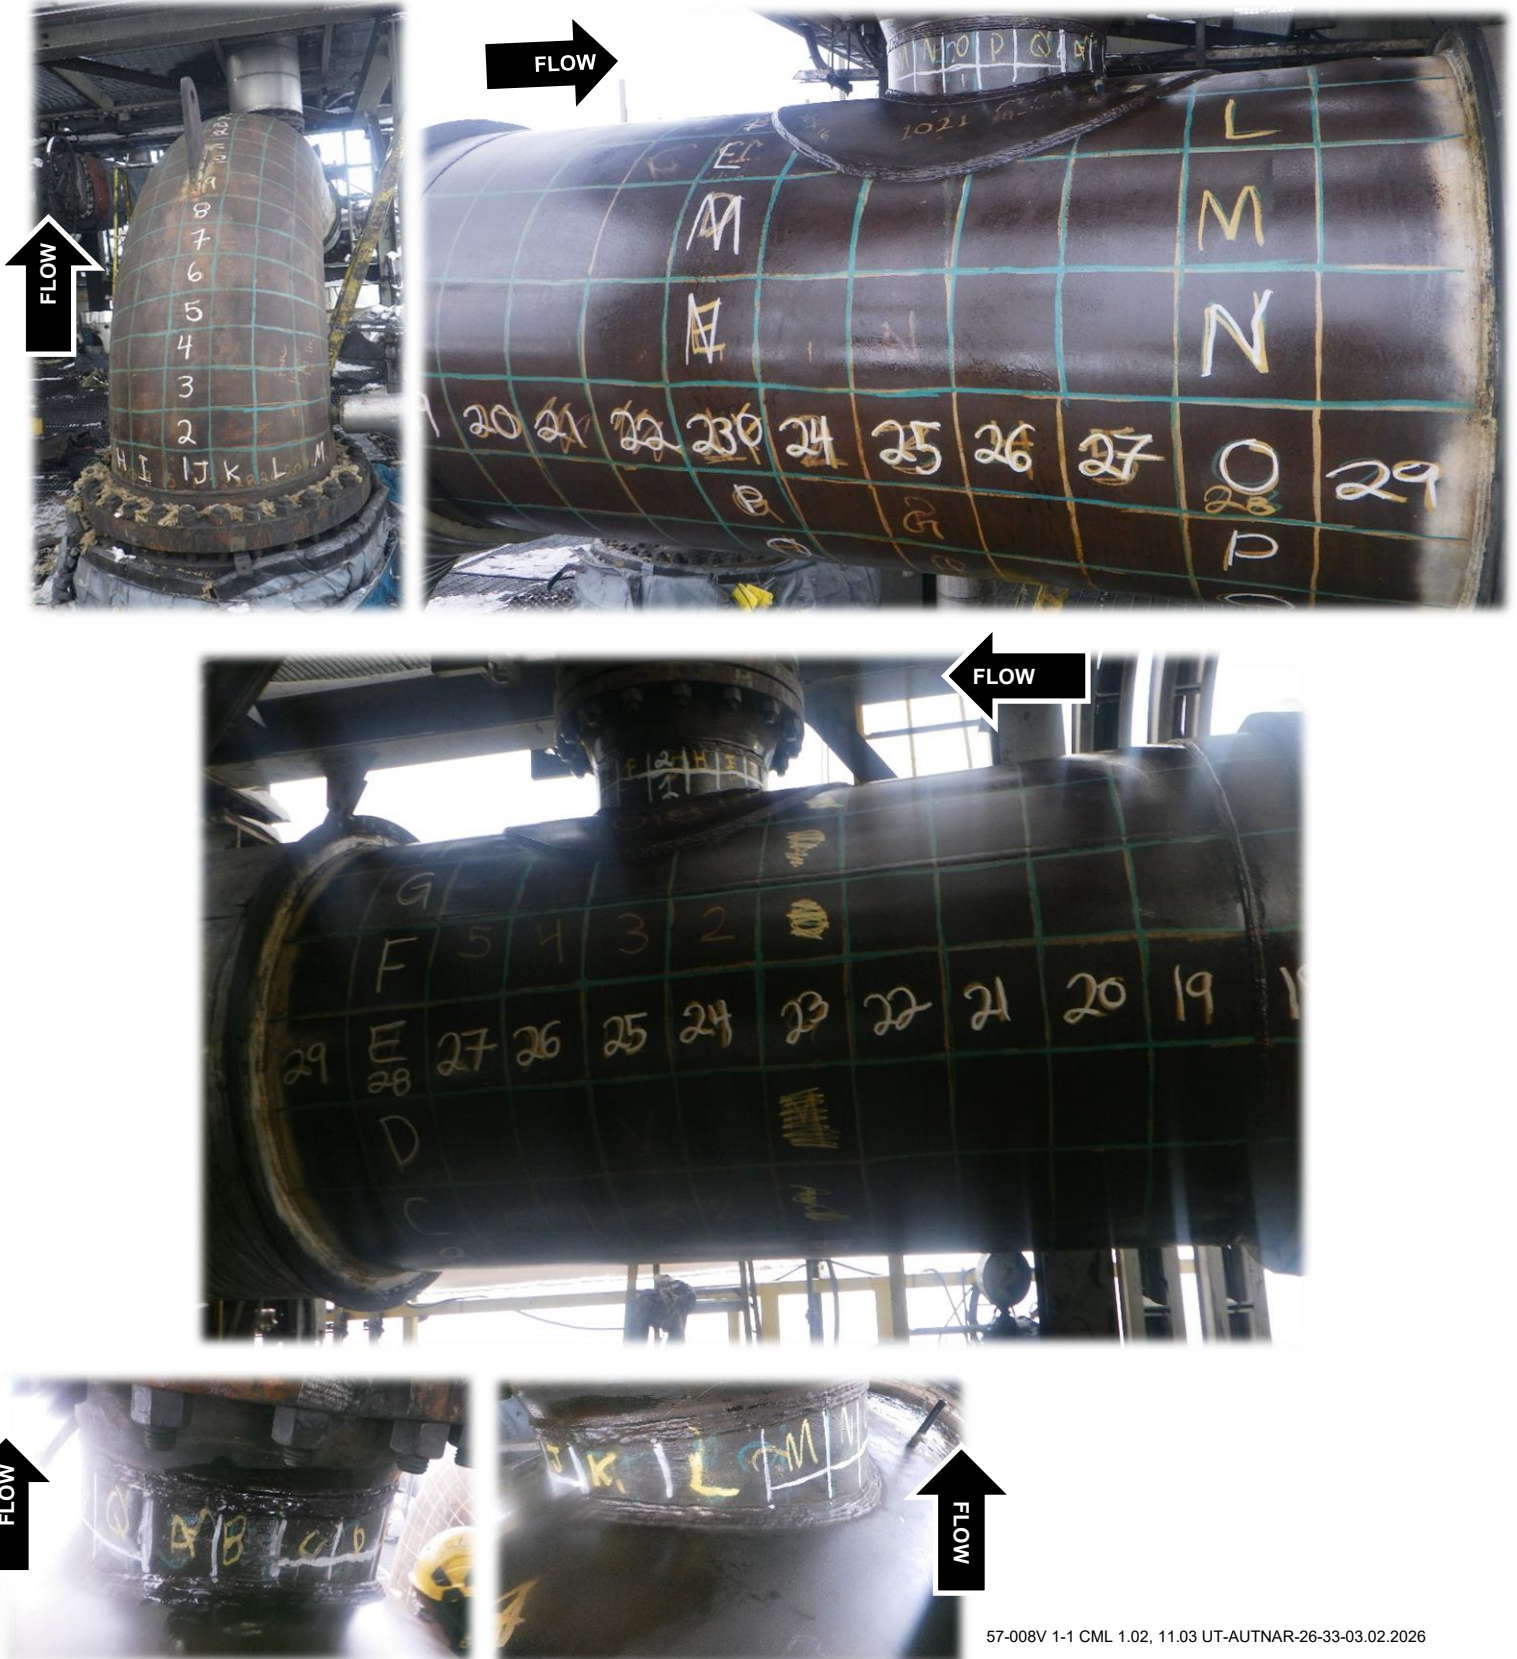
CML 1.02 & 11.03

A **6" x 6"** grid scan was performed on **CML 1.02 & 11.03**. Grid letters "**A to R**" starts at **North** and go **clockwise** with respect to flow. Grid Number "**1-29**" go with flow. See attached grid and photos for reference.

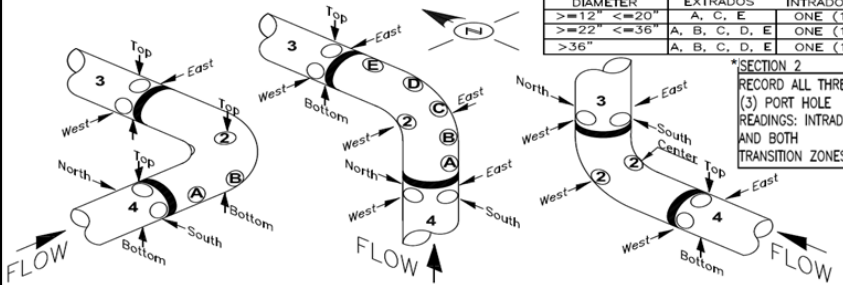
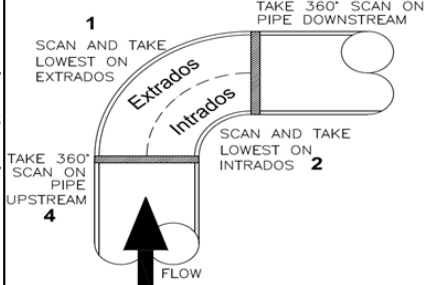
<table><tr> <th rowspan="2">CIRCUIT</th> <th rowspan="2">CML</th> <th rowspan="2">SECTION</th> <th rowspan="2">DIAM.</th> <th colspan="5">PORT HOLES</th> <th colspan="4">FULL SCAN</th> <th rowspan="2">COMMENTS</th> </tr><tr> <td rowspan="4">57-008V 1-1</td> <td rowspan="4">1.02</td> <td>1</td> <td>36"</td> <td></td> <td></td> <td></td> <td></td> <td></td> <td></td> <td></td> <td></td> <td></td> <td></td> <td></td> <td></td> <td></td> <td>"SEE GRID"</td> </tr><tr> <td>2</td> <td>36"</td> <td></td> <td></td> <td></td> <td></td> <td></td> <td></td> <td></td> <td></td> <td></td> <td>0.358</td> <td></td> <td></td> <td></td> <td></td> </tr><tr> <td>3</td> <td>36"</td> <td></td> <td></td> <td></td> <td></td> <td></td> <td></td> <td></td> <td></td> <td></td> <td></td> <td></td> <td>0.374</td> <td></td> <td></td> </tr><tr> <td>4</td> <td>36"</td> <td></td> <td></td> <td></td> <td></td> <td></td> <td></td> <td></td> <td></td> <td></td> <td></td> <td></td> <td></td> <td></td> <td>N/A, FLANGE</td> </tr></table>

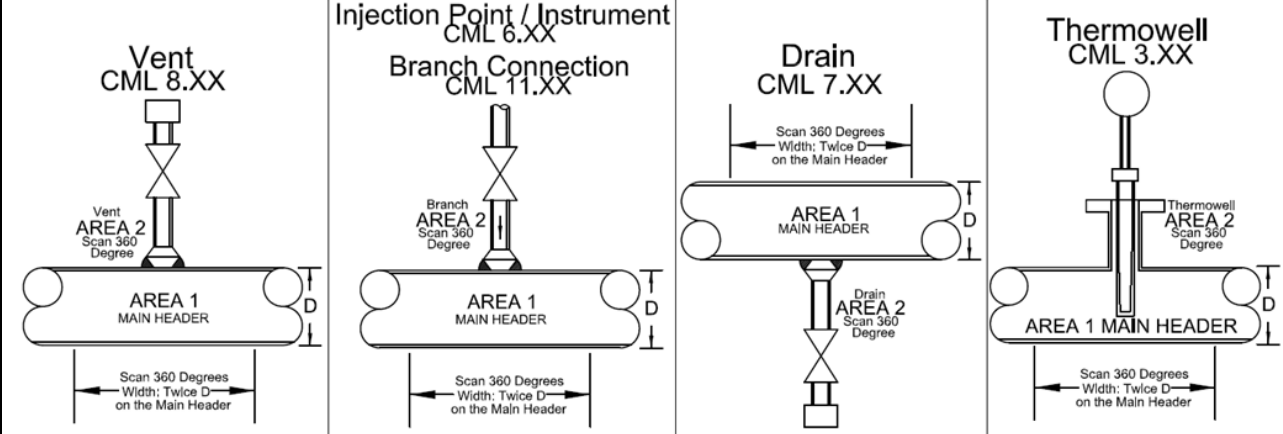
<table><tr> <th>CIRCUIT</th> <th>CML</th> <th>SECTION</th> <th>DIAM.</th> <th>NORTH</th> <th>SOUTH</th> <th>EAST</th> <th>WEST</th> <th>TOP</th> <th>BOTTOM</th> <th>HIGH</th> <th>COMMENTS</th> </tr><tr> <td rowspan="2">57-008V 1-1</td> <td rowspan="2">11.03</td> <td>1</td> <td>36"</td> <td></td> <td></td> <td></td> <td></td> <td></td> <td>0.369</td> <td></td> <td>"SEE GRID"</td> </tr><tr> <td>2</td> <td>16"</td> <td>0.333</td> <td></td> <td></td> <td></td> <td></td> <td></td> <td></td> <td></td> </tr></table>
