Inspection Checklist

Inspection Date: 10-Oct-2023 **Vehicle**

Year: 2023 Make: TOYOTA Model: Sienna Engine: 2GR-FKS

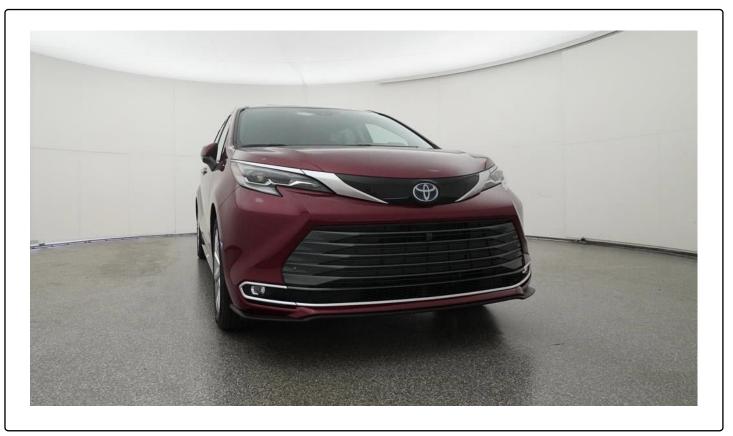
FRONT END OF VEHICLE IS IN GOOD CONDITION WITH MINOR BUMPER SCRATCHES

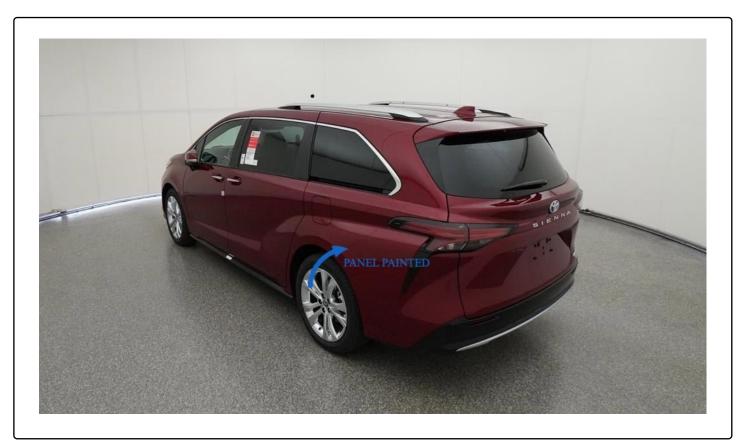
DAMAGE REPORTED TO REAR QUATER PANEL, PAINT READING SHOWING TWO PANELS PAINTED

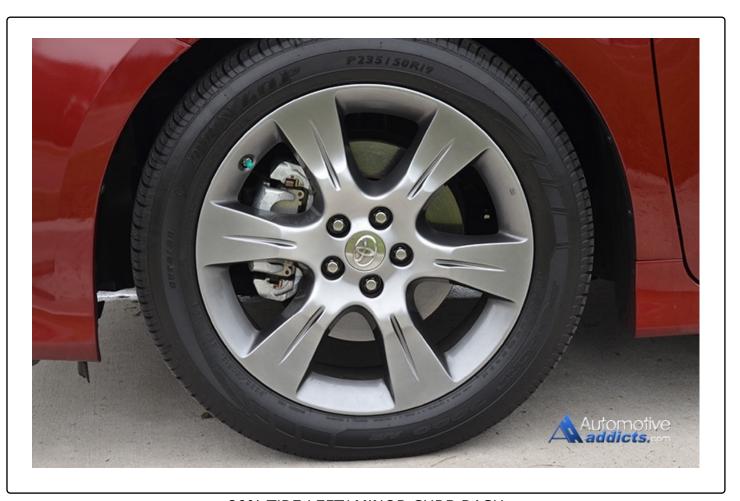
80% TIRE LEFT/ MINOR CURB RASH

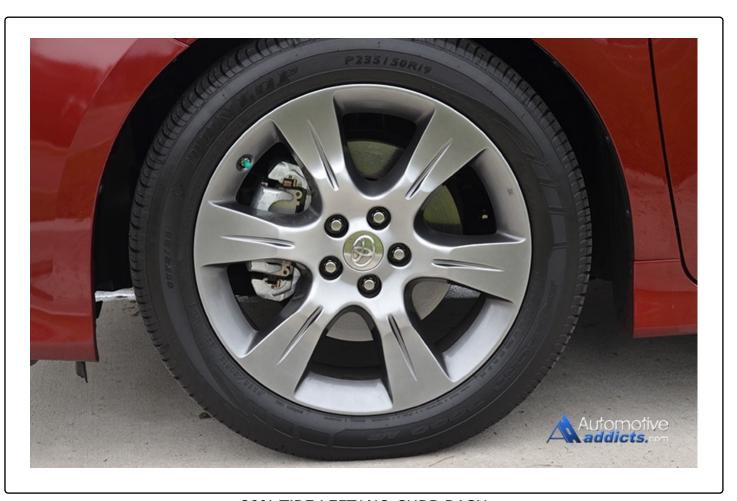
80% TIRE LEFT/ NO CURB RASH

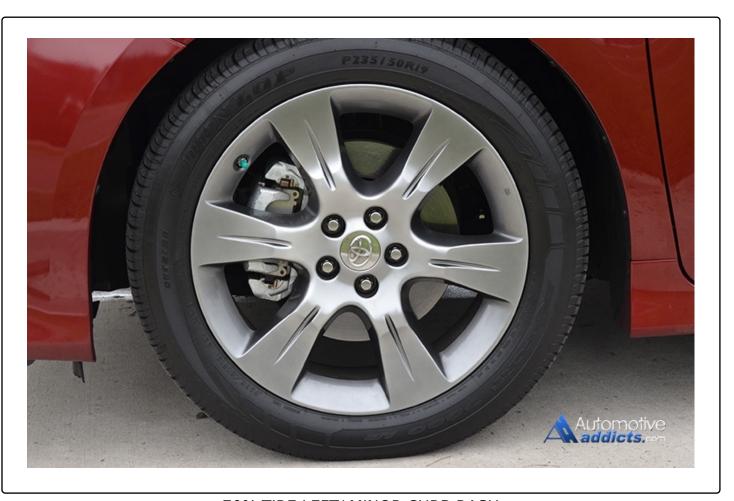
70% TIRE LEFT/ MINOR CURB RASH

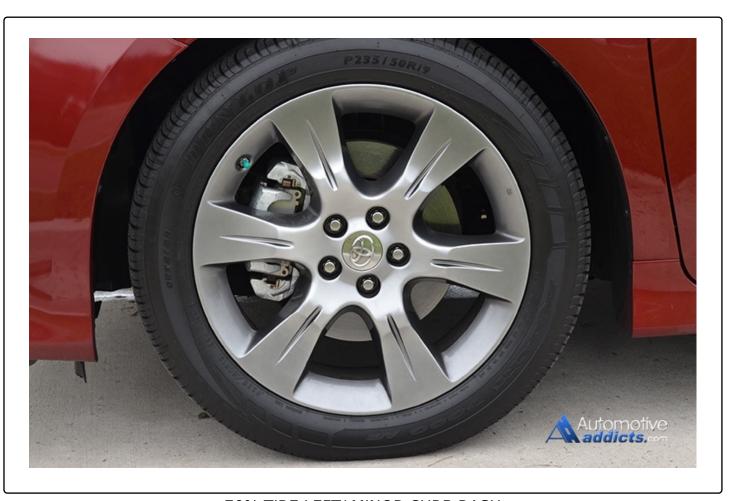
70% TIRE LEFT/ MINOR CURB RASH
