## A320neo family - Engine Interface Unit (EIU) system issues

Reference: 73.25.00023

## LEAP-1A - Engine Stall related to Intermediate Pressure Check Valve (IPCV)

Reference: 36.11.00112

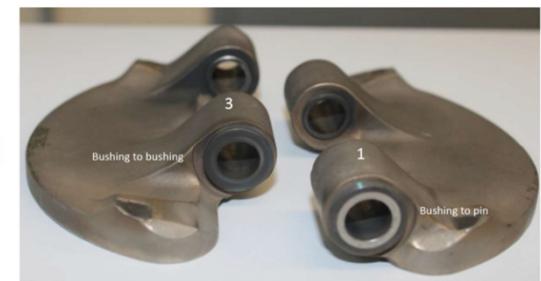
- **9 events of "ENG 1(2) STALL" ECAM Alerts reported during end of climb or beginning of descent (details in the table below)**
- For all events, the affected engine thrust was recovered after the stall
- **7 IPCVs P/N ER8040G01 (Pre MOD) and 2 IPCV P/N ER18000G01 (Post MOD) were found either stuck open (flappers hard to move) during subsequent troubleshooting or damaged beyond allowable limits during engine inspection**

- Bushings migration identified as contributor
- Root cause of bushing migration still under investigation between Airbus, CFM, Safran Nacelles and MRAS
- **Tests performed up to now did not reproduce the bushings migration or flappers stuck open**
- **Further tests on-going**

- VSB BD70CR36-032 and BD70CR36-035 still recommended
- New inspection VSB BD70CR36-049 (to supersede VSB BD70CR36-032) **on-hold, pending investigation findings**

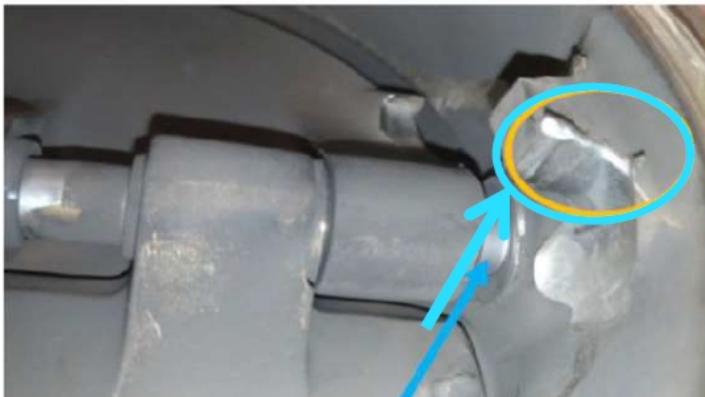
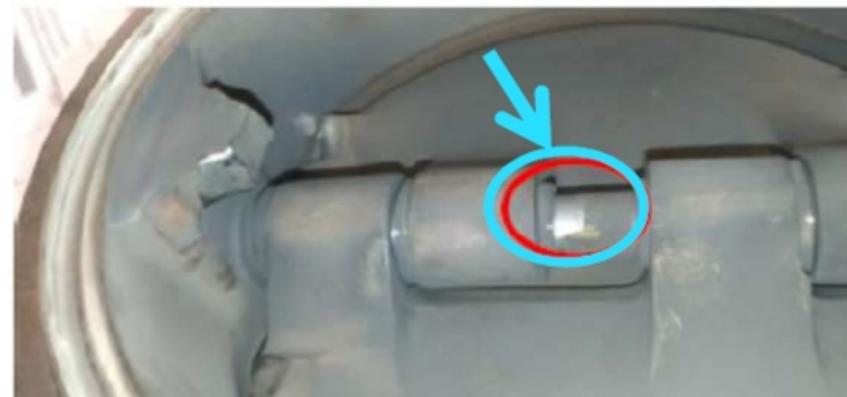
Safran Nacelles investigations showed that those failures were due to a premature wear of internal bushings and door stops deformation. The valves showed signs of wear and deformation beyond acceptable limits.

Safran Nacelles issued VSB BD70CR36-032 in 2018 to inspect the IPCV every C-check in order to identify any premature wear, and replace the valve if necessary.

Therefore, Airbus recommends to perform IPCV inspection per VSB BD70CR36-032 every C-check and in case of findings, replace the valve per VSB BD70CR36-035.

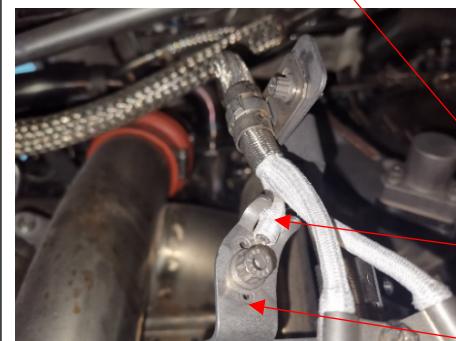
- Operators reported damages on Harness P/N 515175-2 of two types:
  - At the interface with engine support bracket P/N 2609M77G01 (sometimes with reports of broken bracket)
  - At locations where the gap with other engine harnesses is minimal (e.g. Turbine Center Frame harness)
- Some events were found during routine inspection or in shop
- Other events were found following ECAM Alert "ENG 1(2) FIRE LOOP A(B) FAULT" (in case the Harness is disconnected from the ground and the engine experiences a lightning strike)
- No proactive protection of this Harness is allowed (e.g. with fiberglass tape) as it represents a configuration change and has to be covered by a MOD (not currently considered)

Broken support bracket

Harness damaged

Support bracket not damaged

- Dispatch per MMEL 26-12 in case of ECAM Alert "ENG 1(2) FIRE LOOP A(B) FAULT" without troubleshooting
- For Harness P/N 515175-2, Allowable Damage Limits available in AMM Task 71-52-43-210-801-A and repairs in CMM 71-02-02
- If damages are beyond CMM repair limits, one-off repairs can be reviewed by Safran Nacelles on case by case basis
- For the broken support bracket, CFM has to be contacted for dispositions

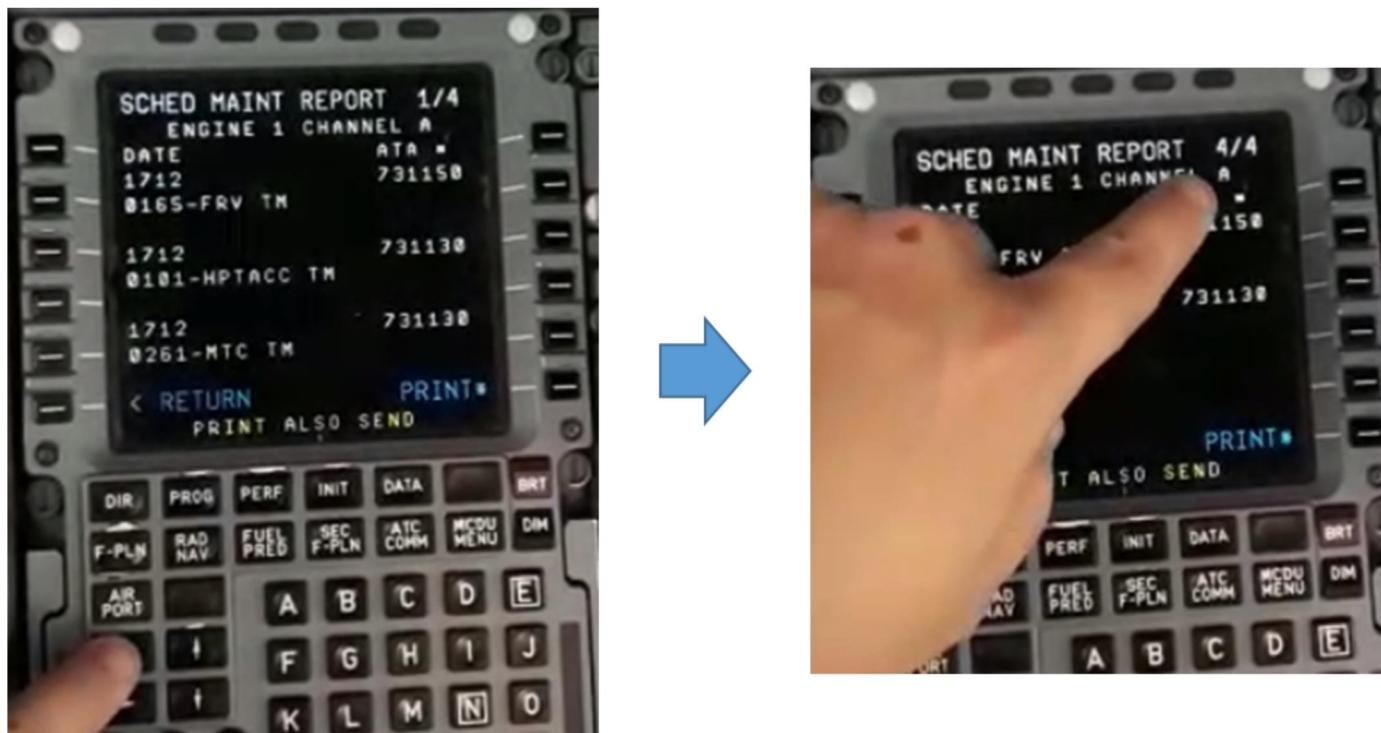
If the operator selects the right arrow to access page 2, the system would remain frozen in page 1 and the message "NO RESPONSE. PRESS RETURN" would be displayed. If, however the Operator selects the left arrow when in page 1, then the page 4 of the SMR would be displayed (see Fig. 1 below).

Figure 1 – Browsing the SMR pages backwards (left arrow)

A workaround will be included in an upcoming update of AMM Task Ref. 73-29-00-740-813-A. Should Operators encounter this condition, Airbus would recommend the following:

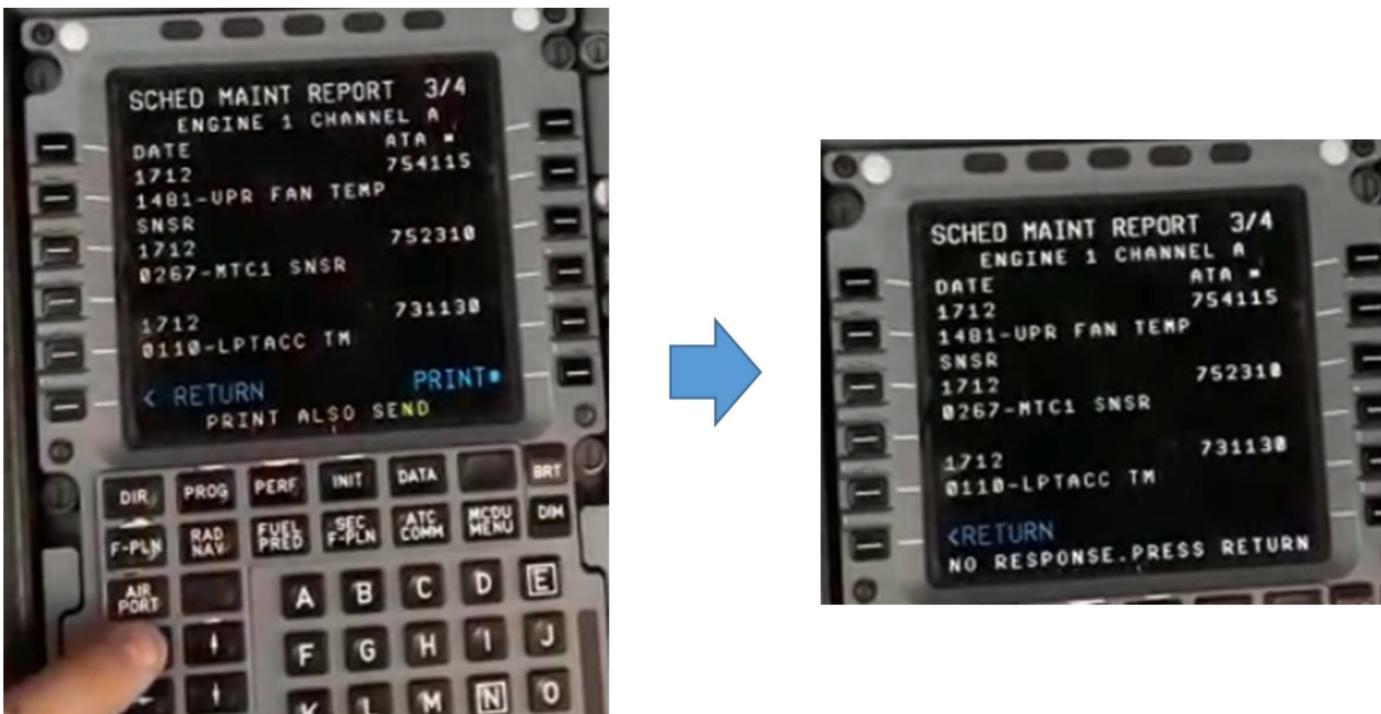
A further selection of the left arrow would gain access to page 3 and yet another selection of the left arrow (to access page 2) would again result in the no response message (page 3 remains displayed – see figure 2 below).

Figure 2 – NO RESPONSE when browsing backwards (left arrow)
