**AIRBUS**

GETTING HANDS-ON EXPERIENCE WITH AERODYNAMIC DETERIORATION

A PERFORMANCE AUDIT VIEW

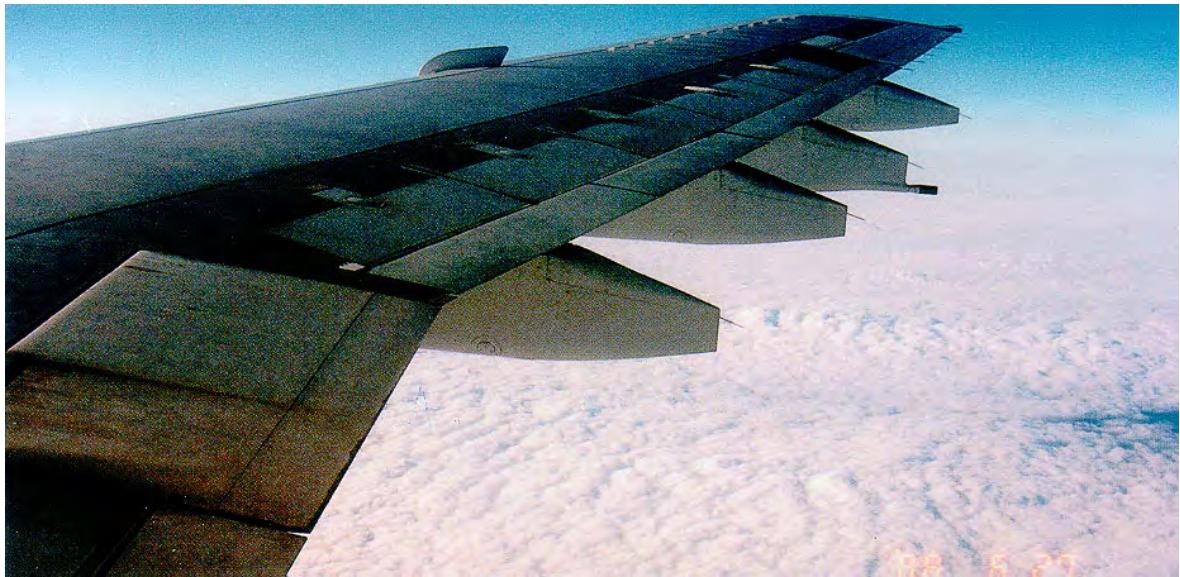
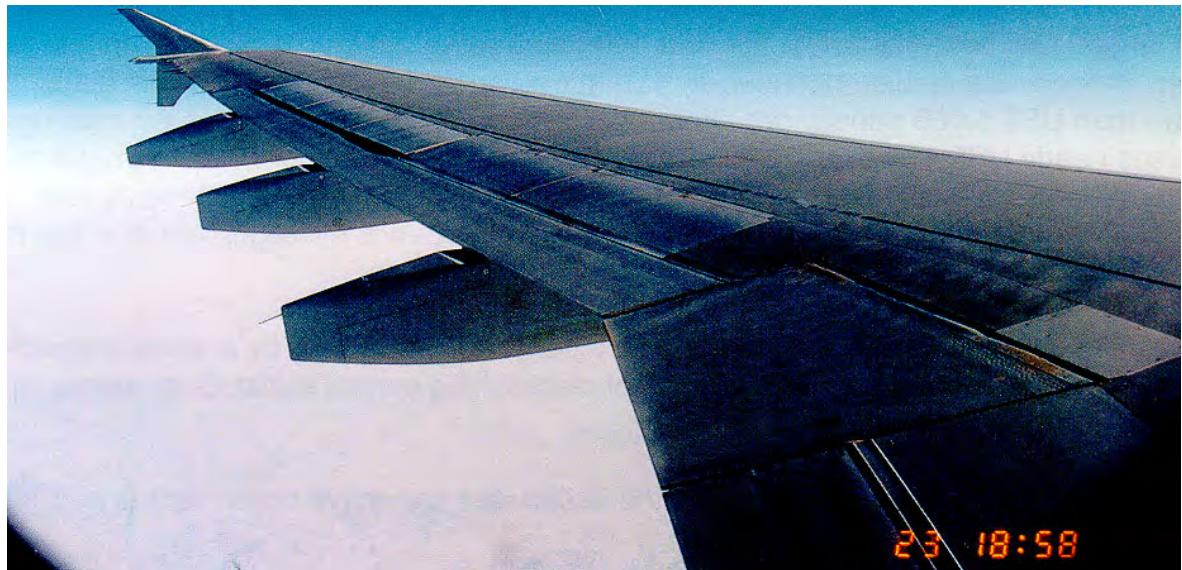
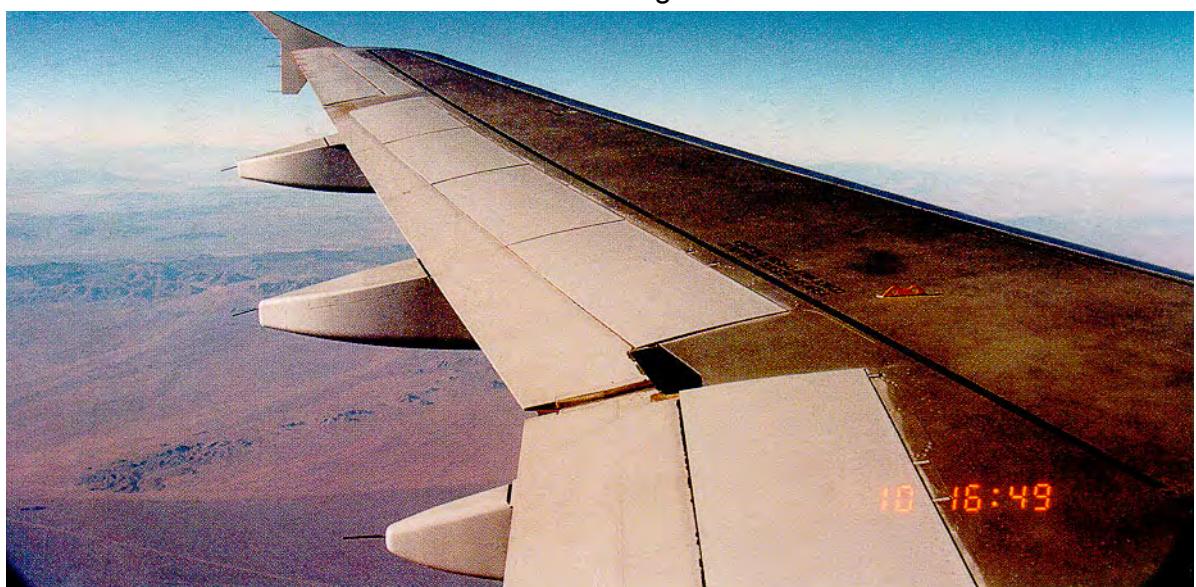
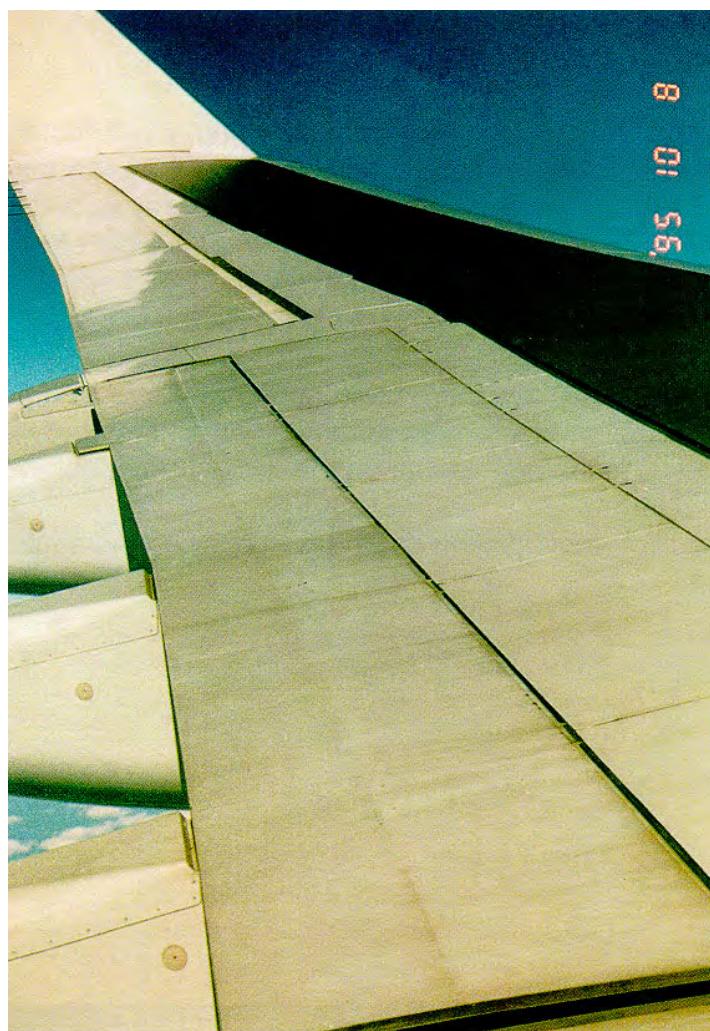
These items correspond to specific control surfaces misrigging. They incur one of the largest fuel penalties, while the cost of the corrective actions, by comparison, is negligible. Indeed, one spoiler extended by 15mm over a 1 metre spanwise length leads to more than US\$ 5,000 penalty per aircraft per year. Similarly, an outboard slat misrigging causes nearly US\$ 11,000 penalty per aircraft per year. Furthermore, flap misrigging - or especially rudder misrigging - can lead to a slightly lower, but still considerable, fuel penalty. Another sensitive item which is generally forgotten is misalignment at a flap track fairing which may cost nearly US\$ 1,000 per aircraft per year.

For a misrigged control surface, the associated corrective action cost is negligible and should indeed be undertaken.

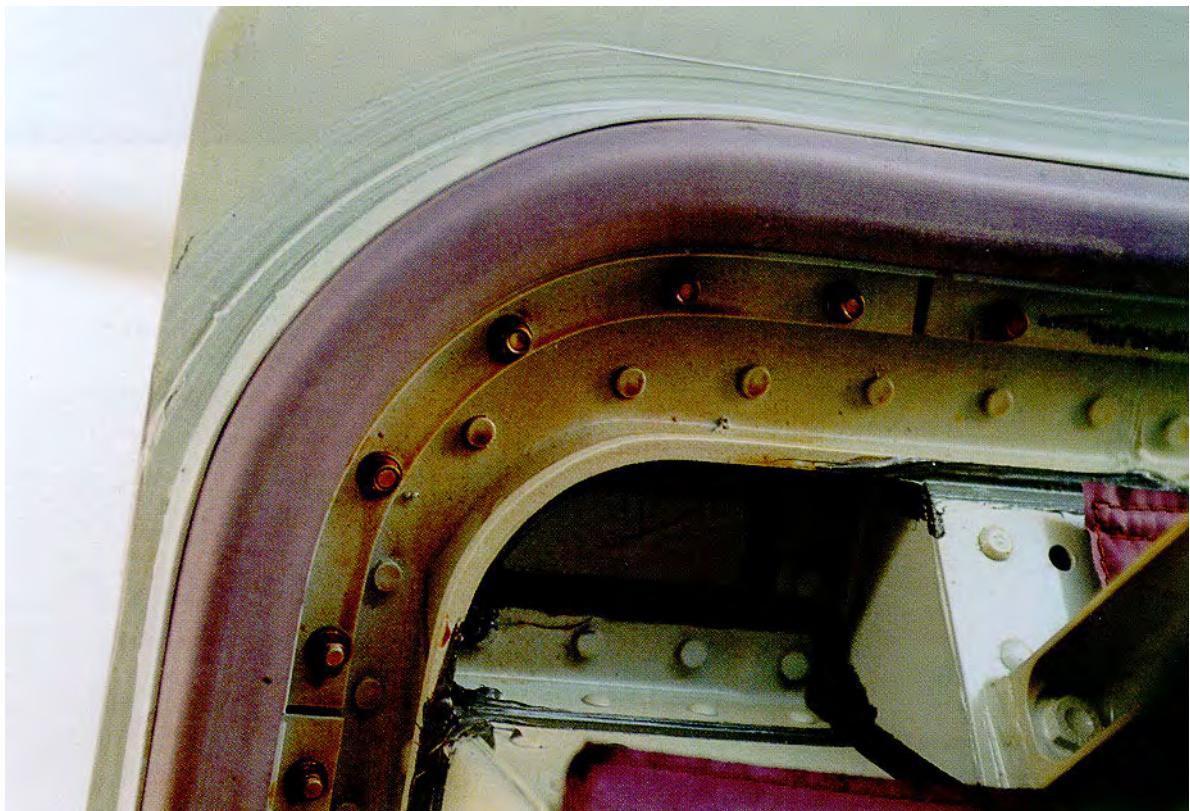
Passenger door seal

2.6.1 Skin roughness

Surface deterioration can lead to significant fuel penalties, especially if the skin is rough or dirty. For a complete aircraft - in the worst case - the penalty can be as high as US\$ 60,000 per aircraft per year. Another serious penalty would certainly be on the airline's commercial image!

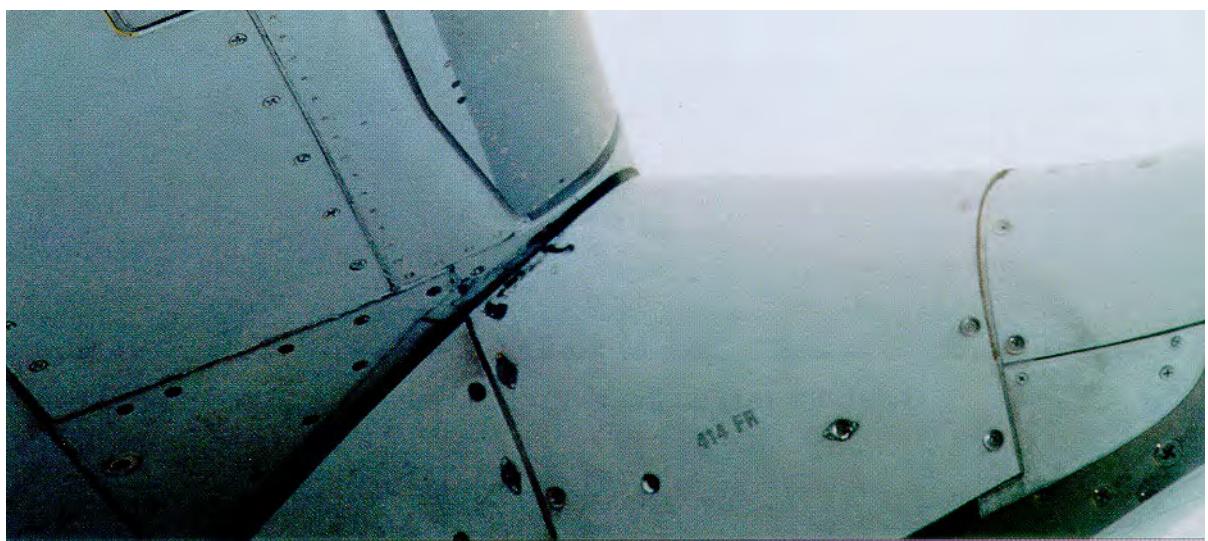
Missing seal on the wing / pylon junction

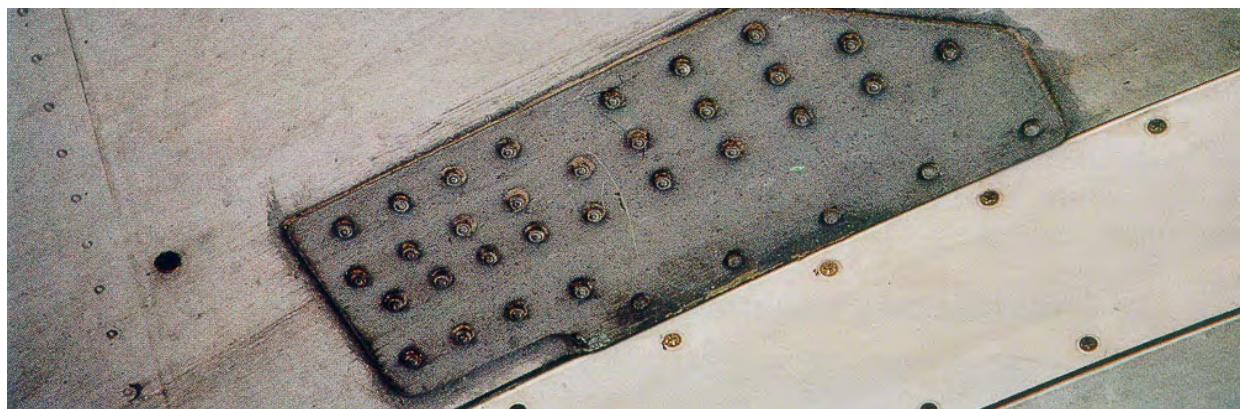
In the same way, external patches induce more drag, especially on the wing upper surface (US\$640). It is normally difficult to replace an external patch by an internal one, but if access has already been gained during an inspection, installing an internal patch could be preferable, since it also has less impact on an airline's commercial image.

External patches on the fuselage

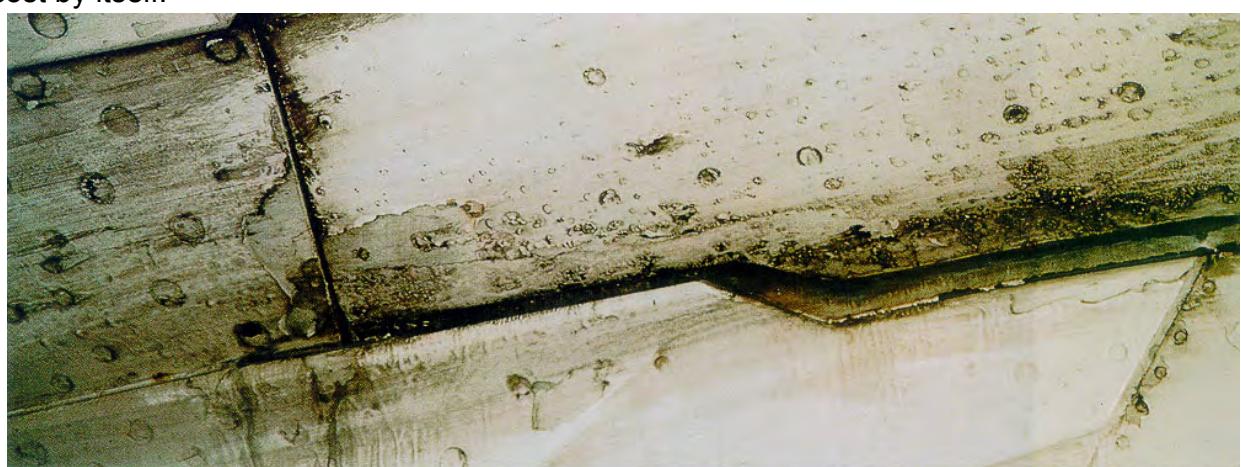
Belly fairing

In order to prevent paint problems, proper preparation has to be carried out before any refresher coat is applied.

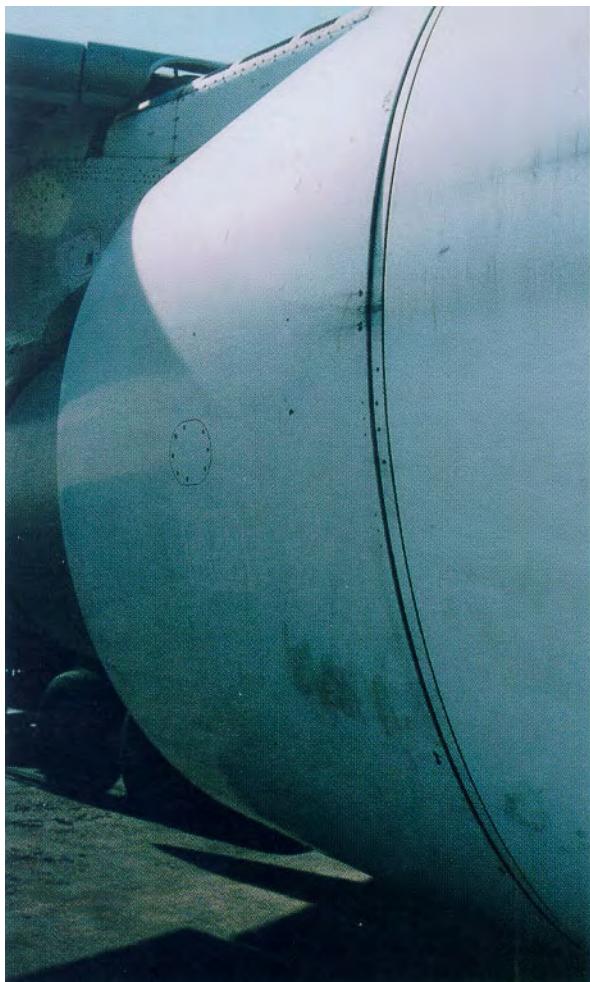
Engine step

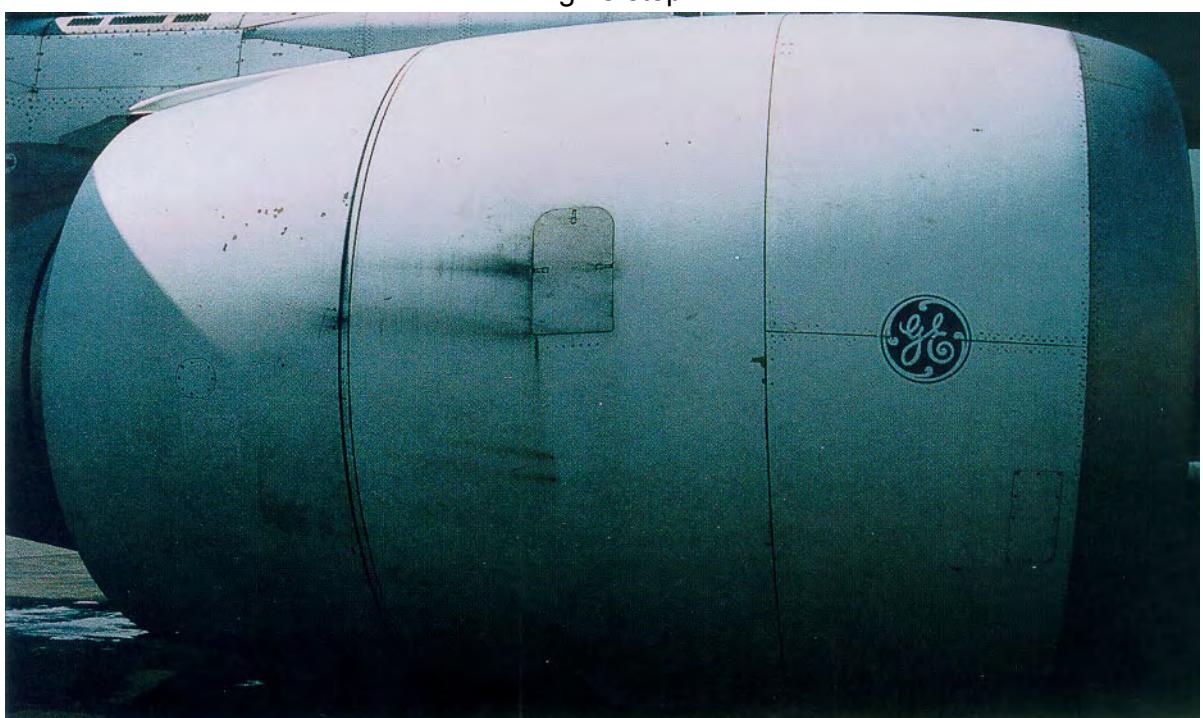
leakage traces

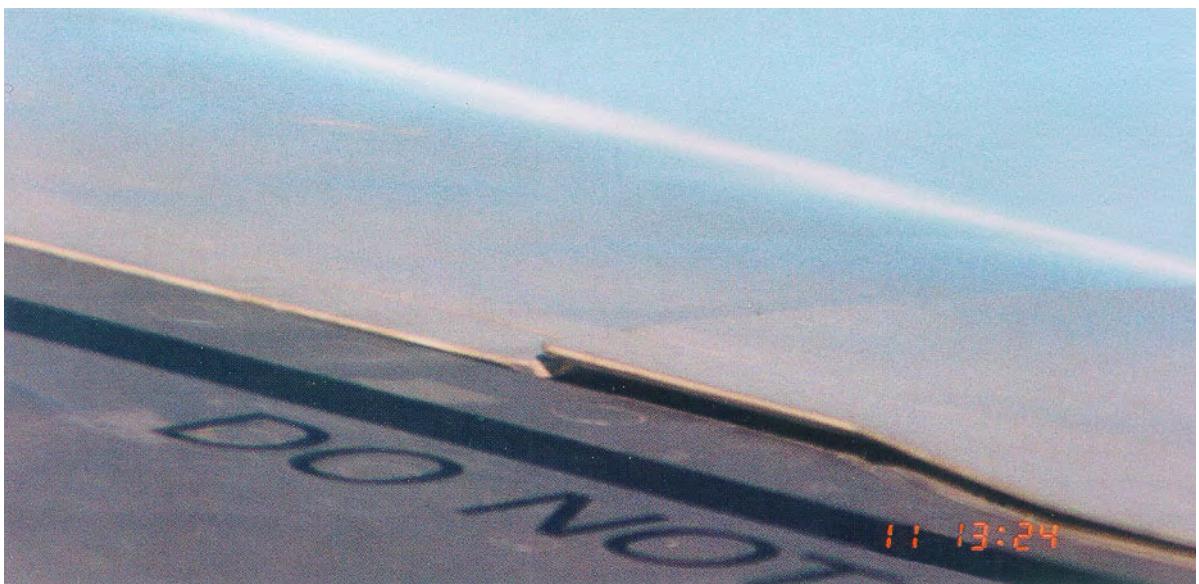
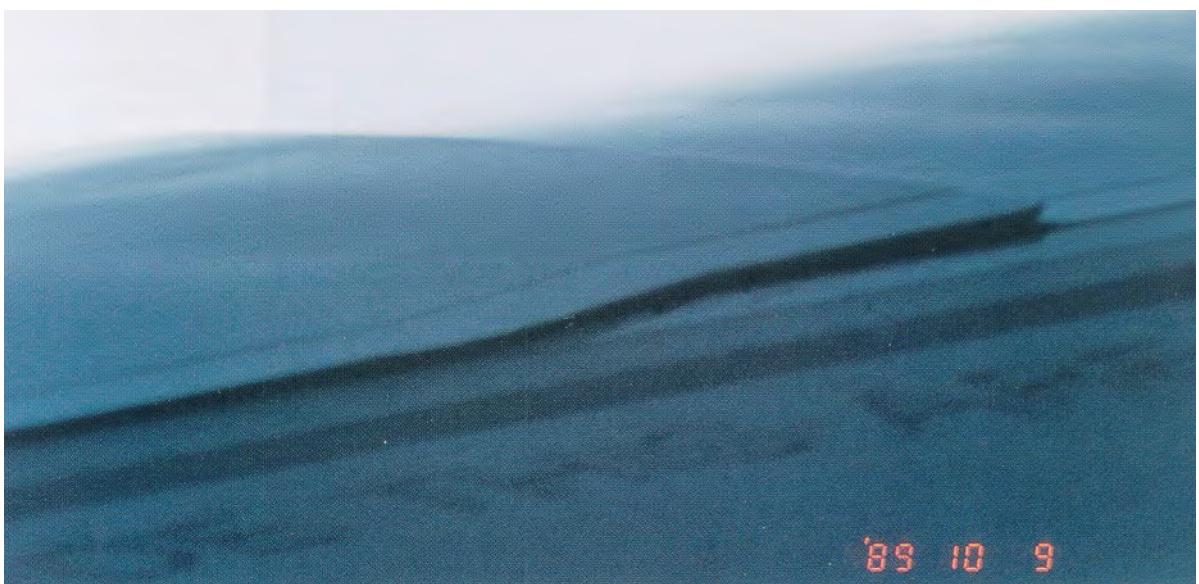
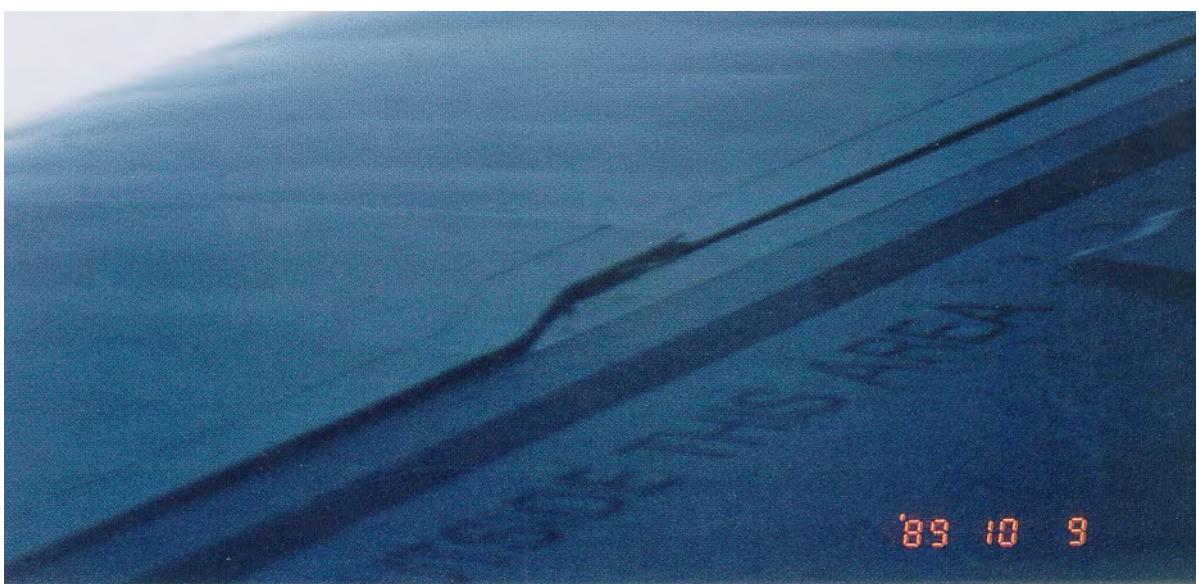
Misrigged slats

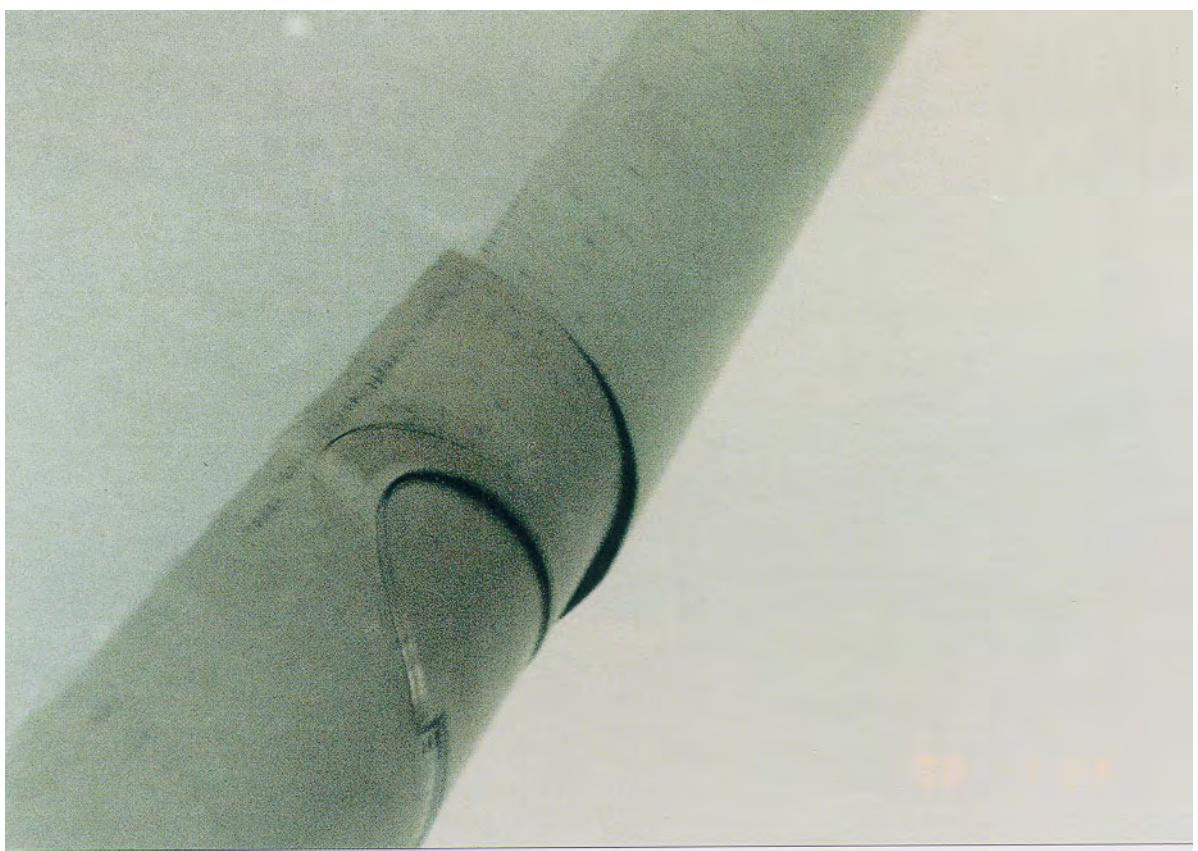
Misrigged slats

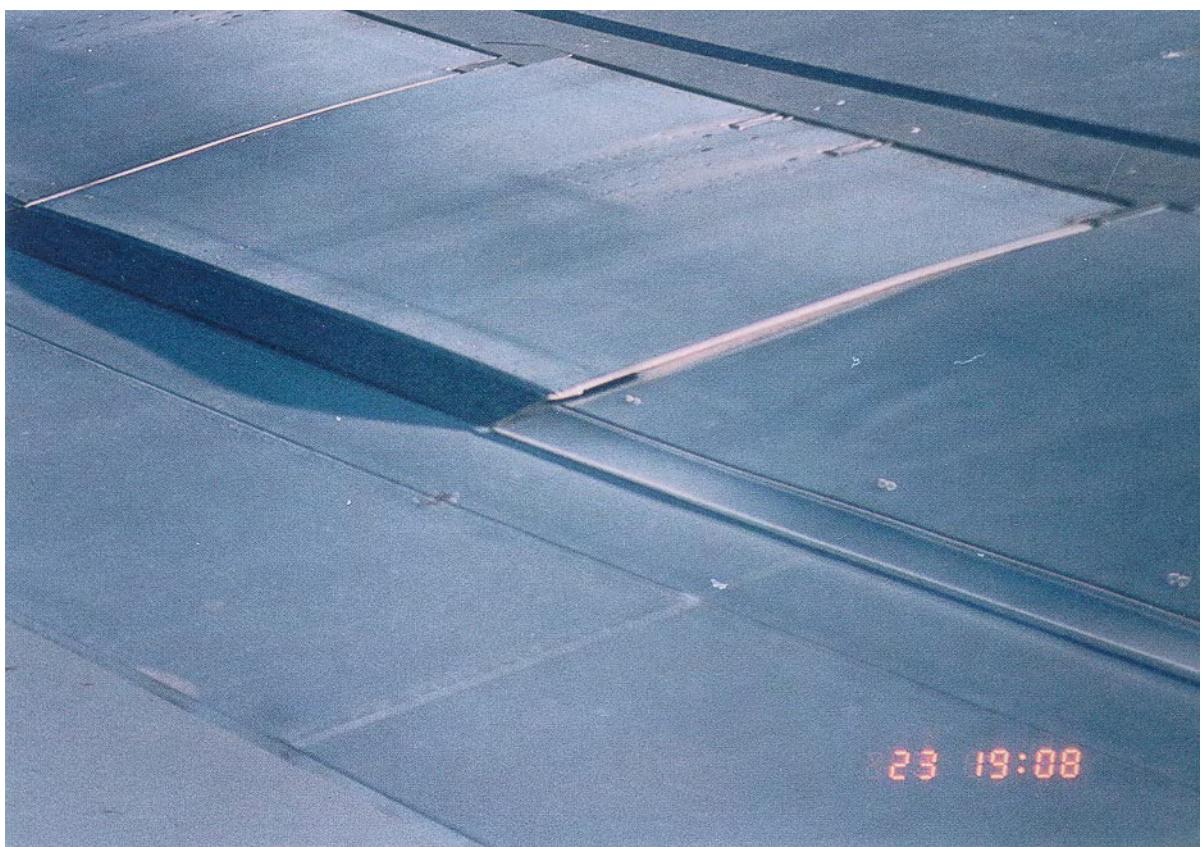
Misrigged spoiler

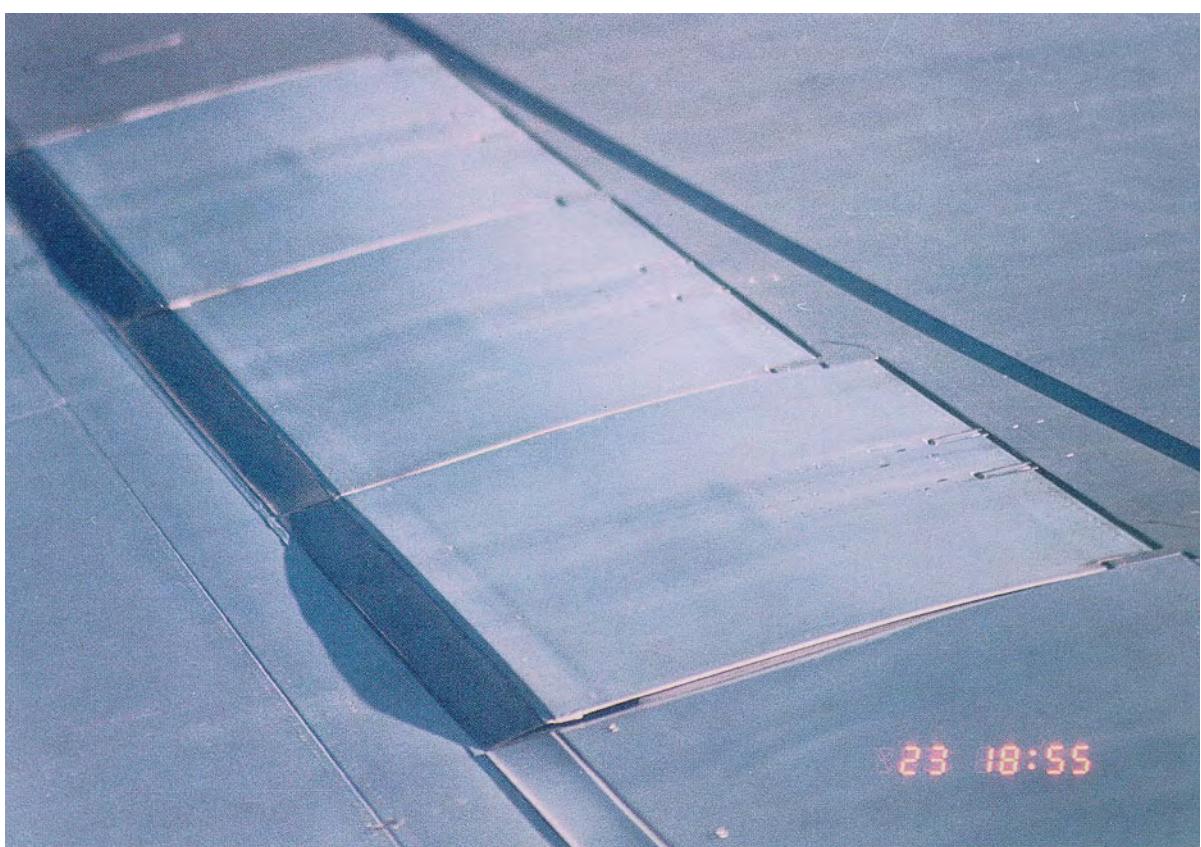
Misrigged spoiler

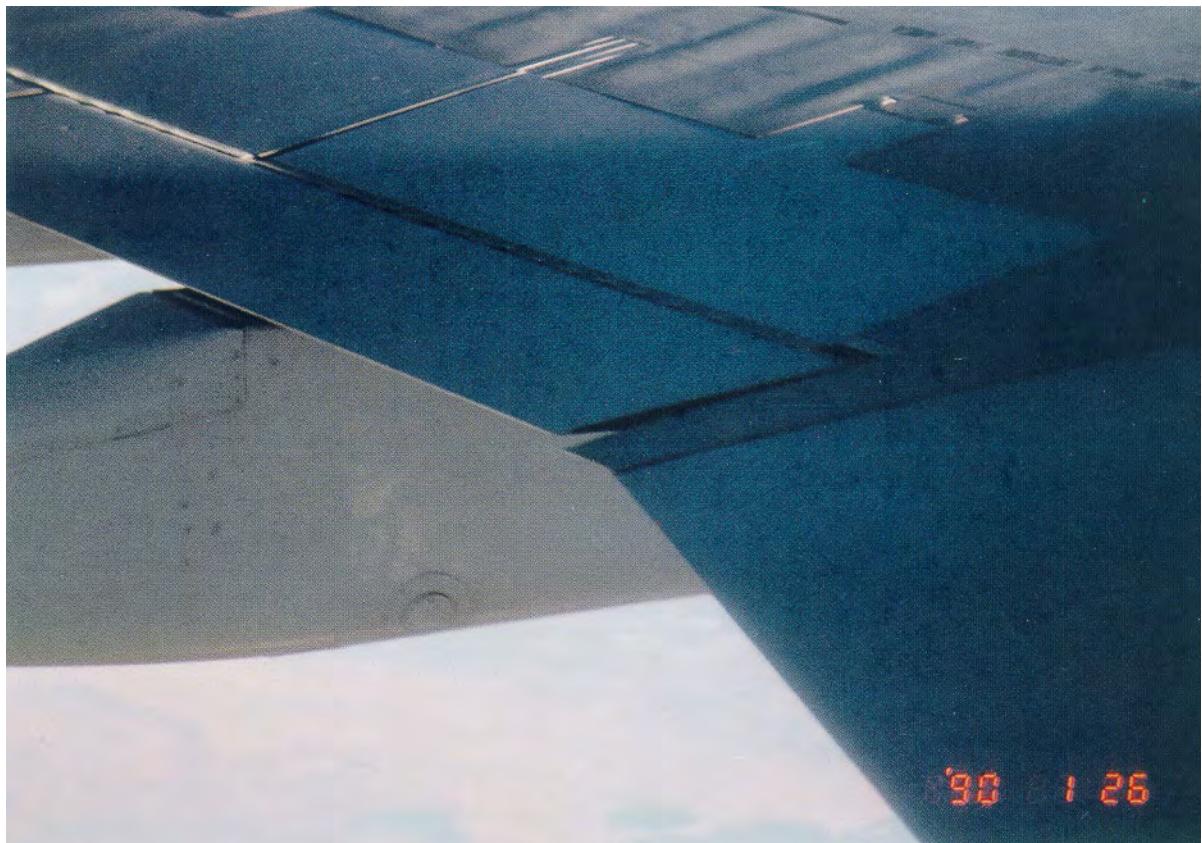
Misrigged flap

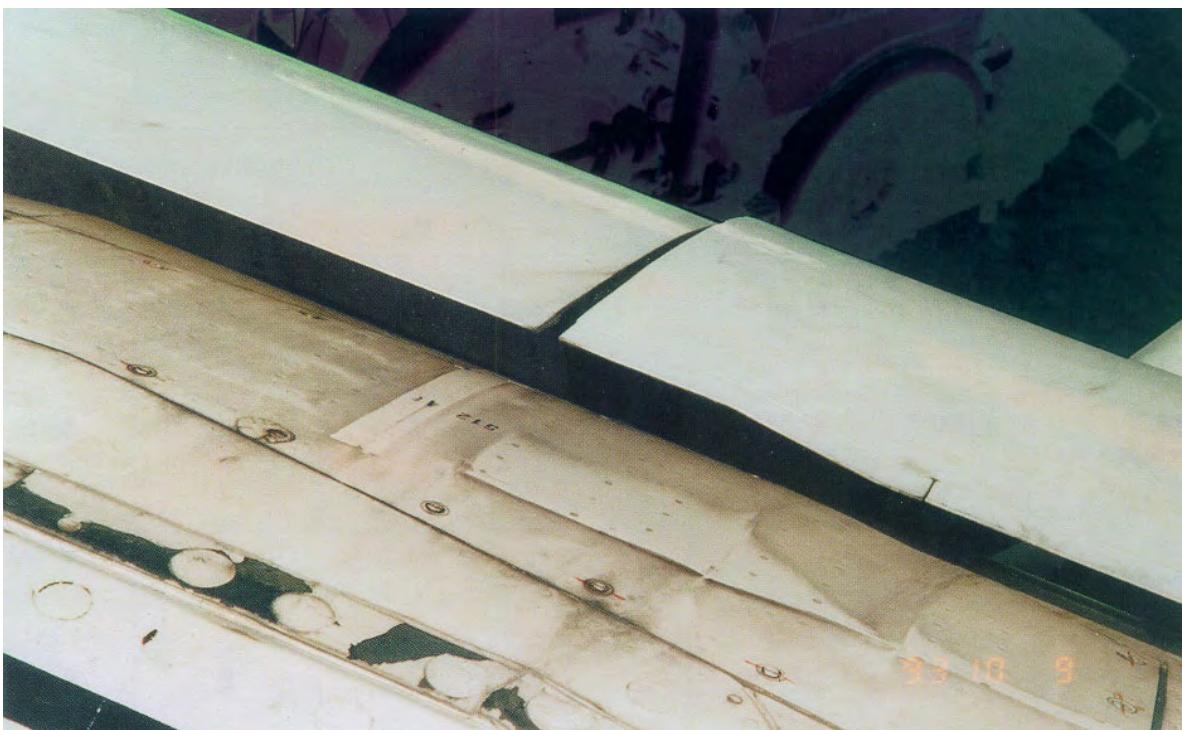
Absence of spanwise slat seal

No traces

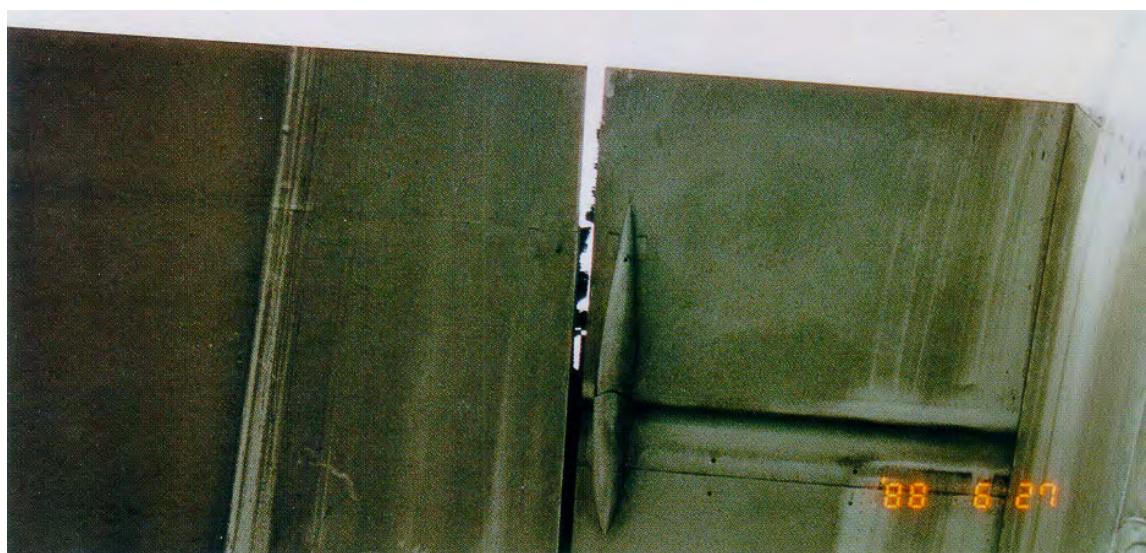
Aileron/flap seal

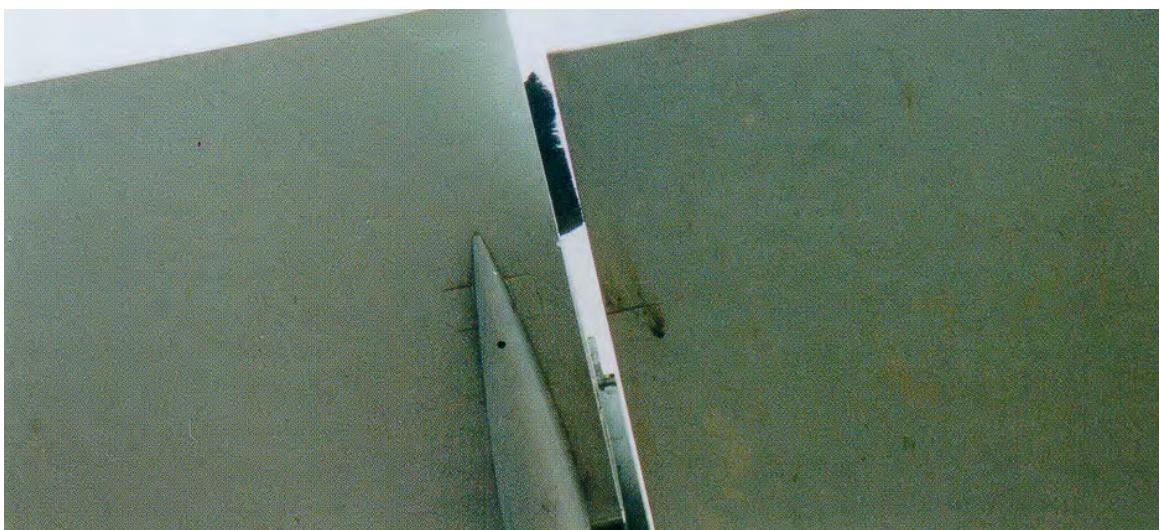
Aileron/flap seal

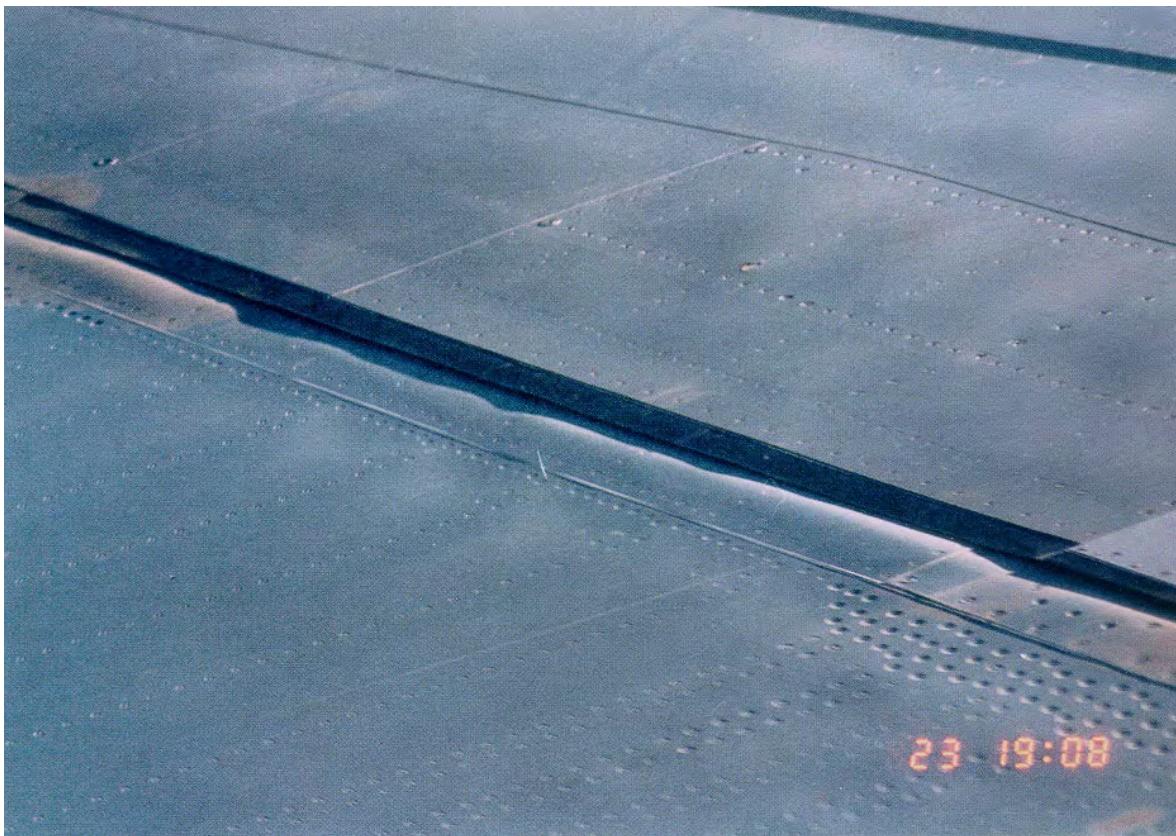
Spanwise aileron seal

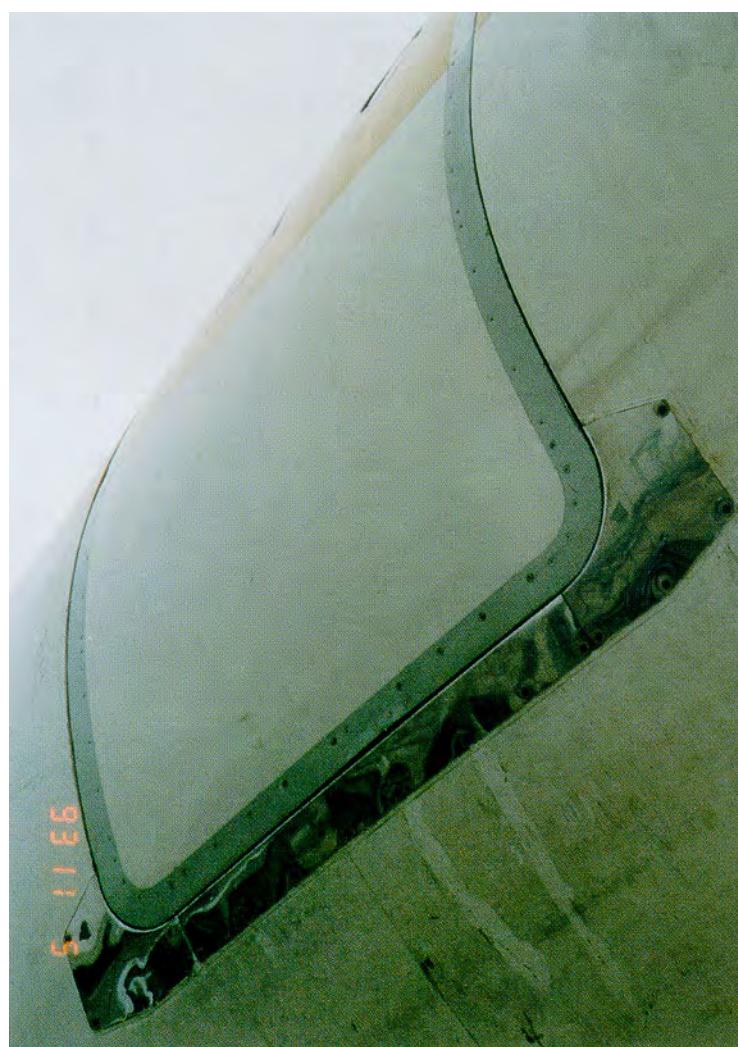
Mismatched passenger doors

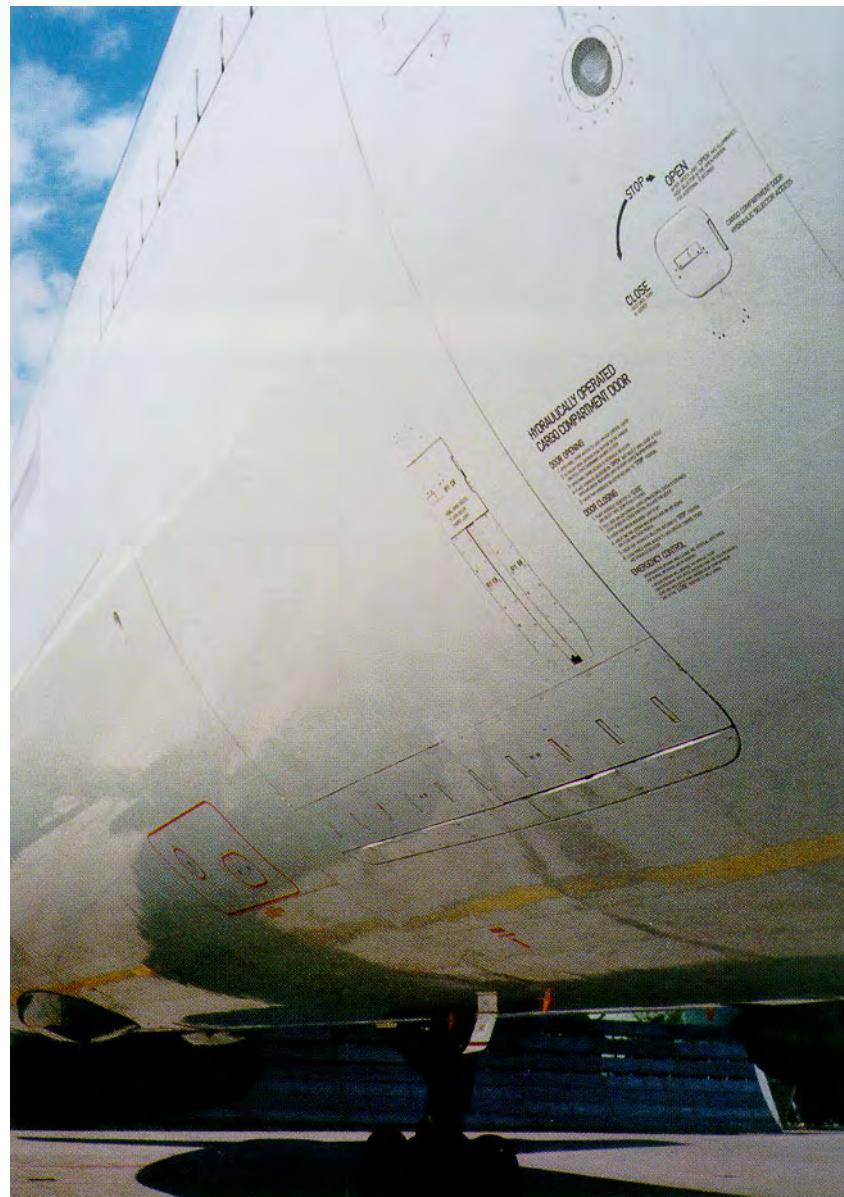
Cargo door

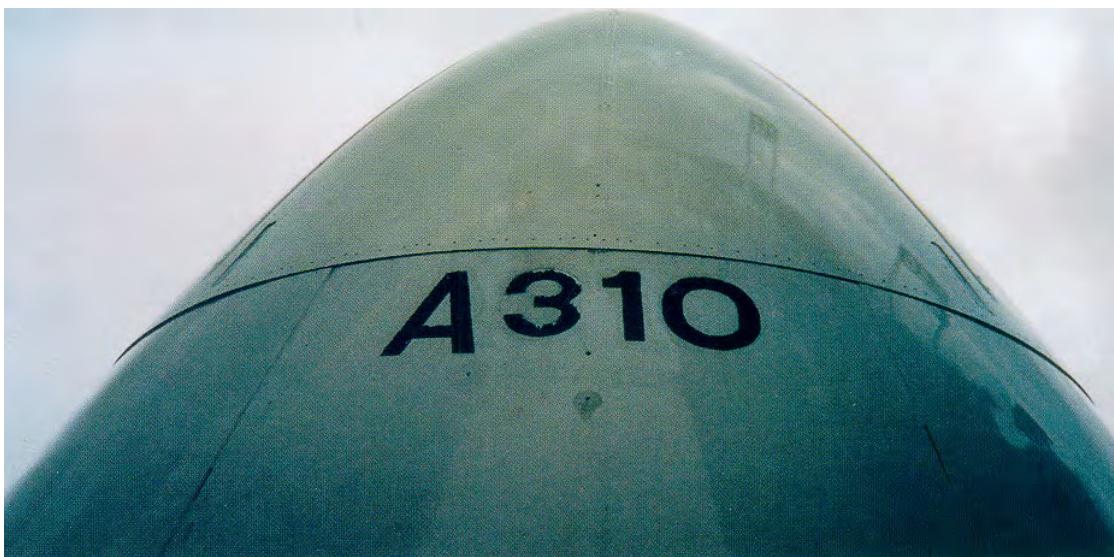
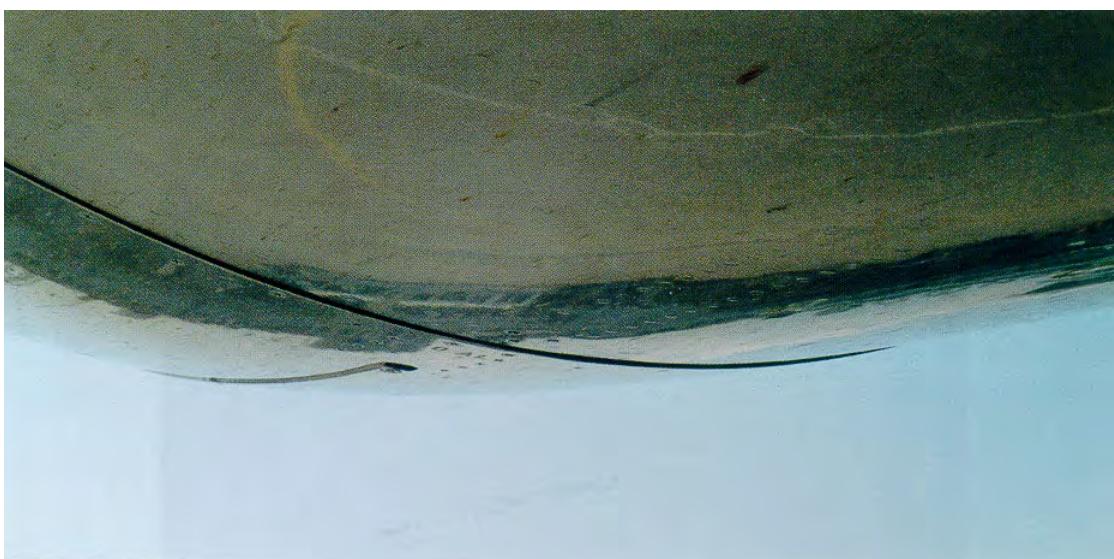
Radome misfit

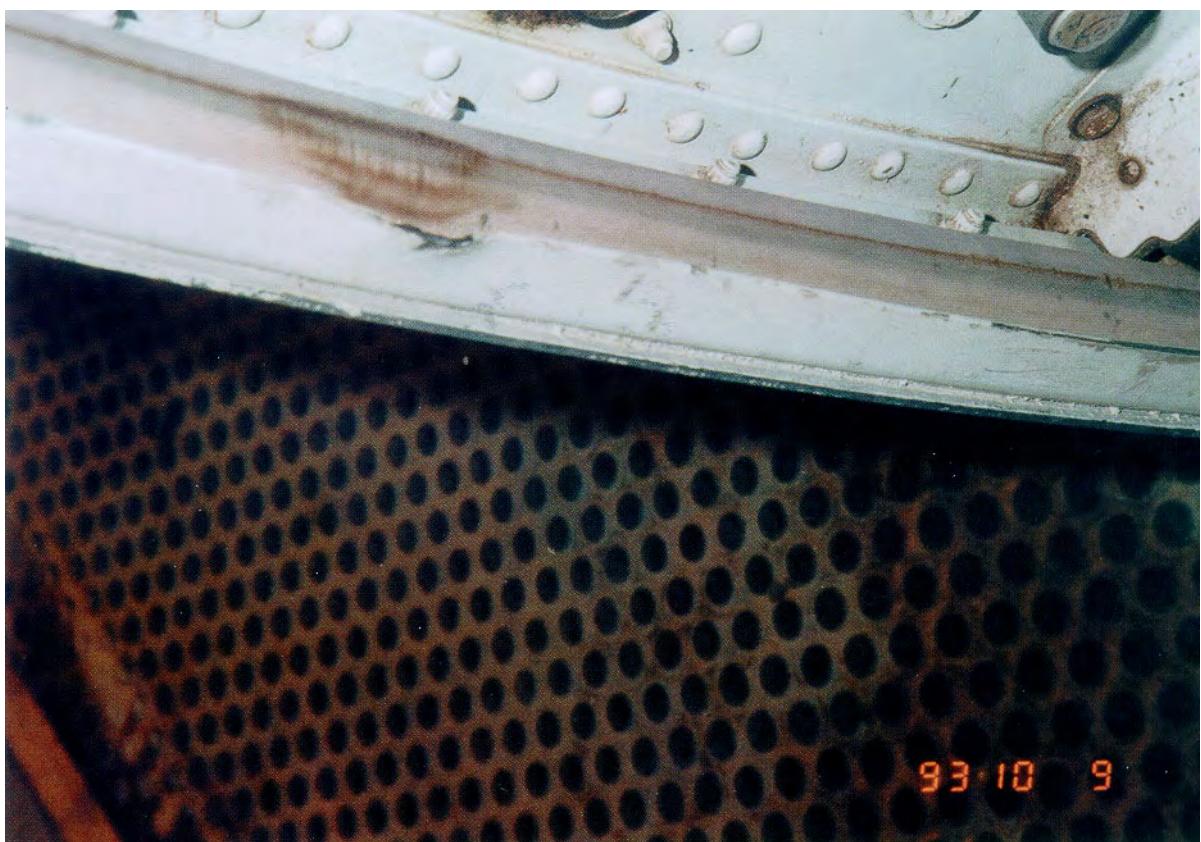
Damaged door

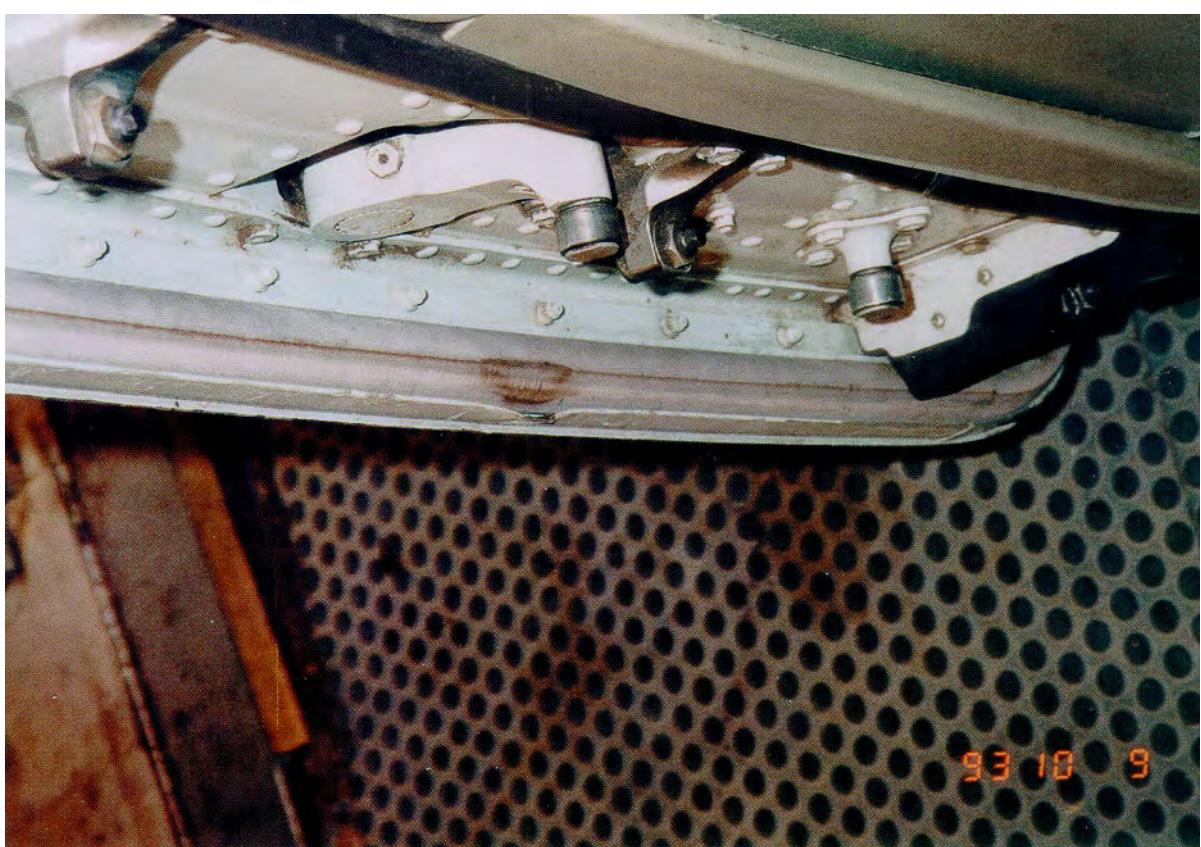
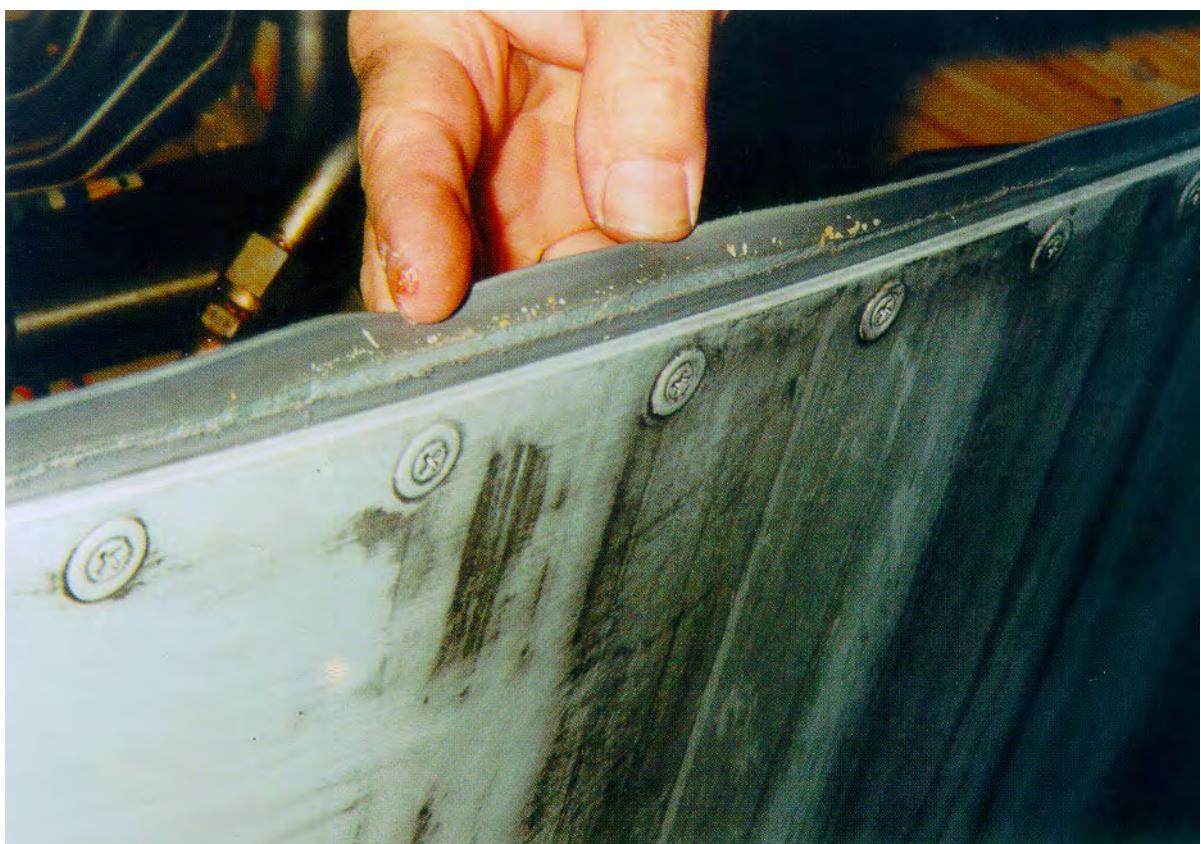
Damaged seal
