**AIRBUS**

GETTING HANDS-ON EXPERIENCE WITH AERODYNAMIC DETERIORATION

A PERFORMANCE AUDIT VIEW

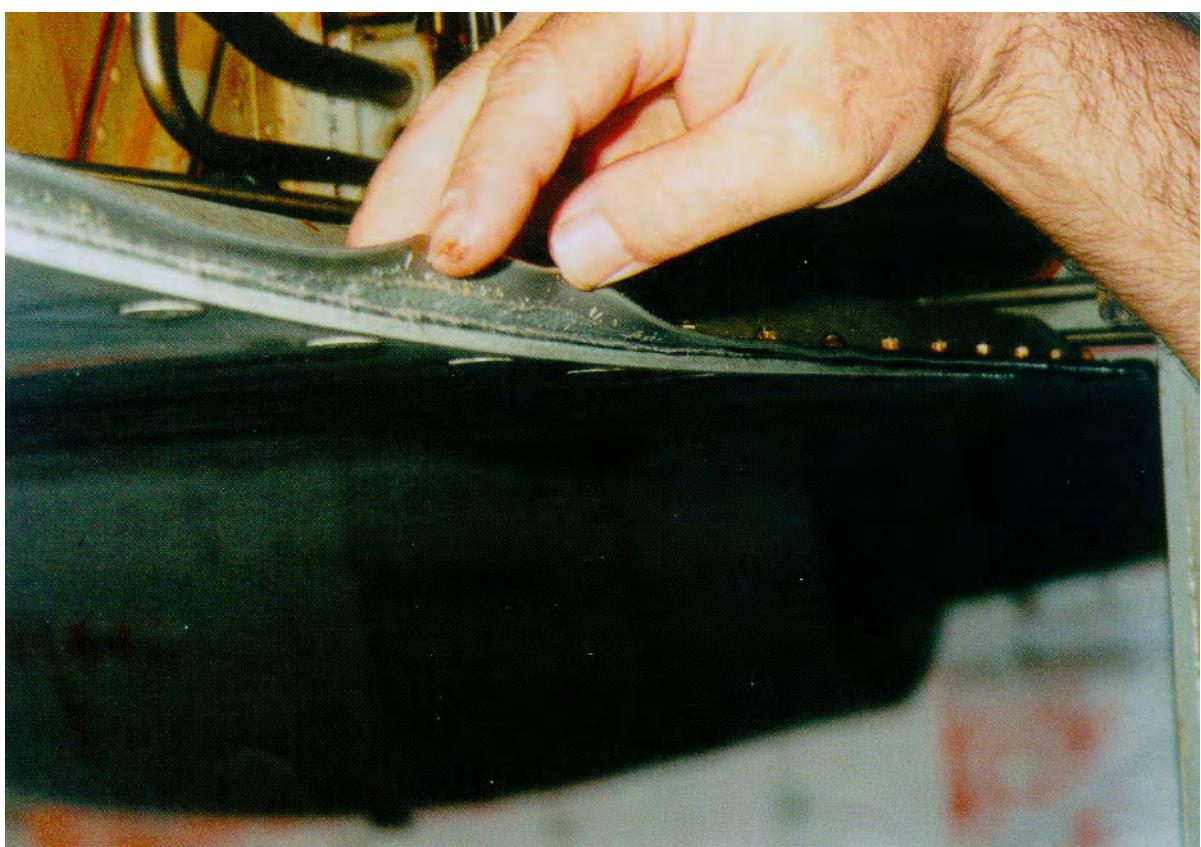
Damaged seals and leakage traces

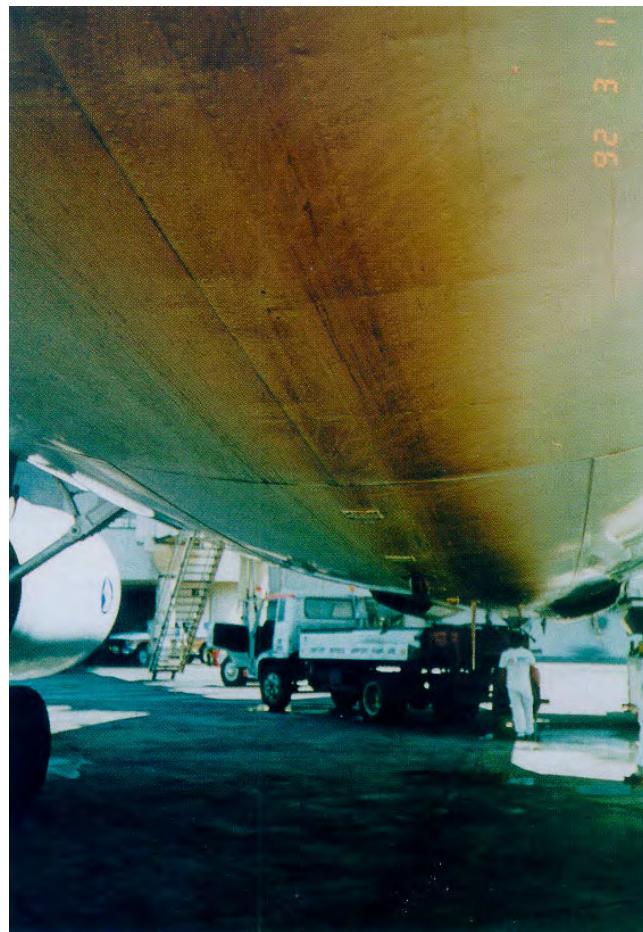
Roughness surface due to skydrol leakage on the belly fairing

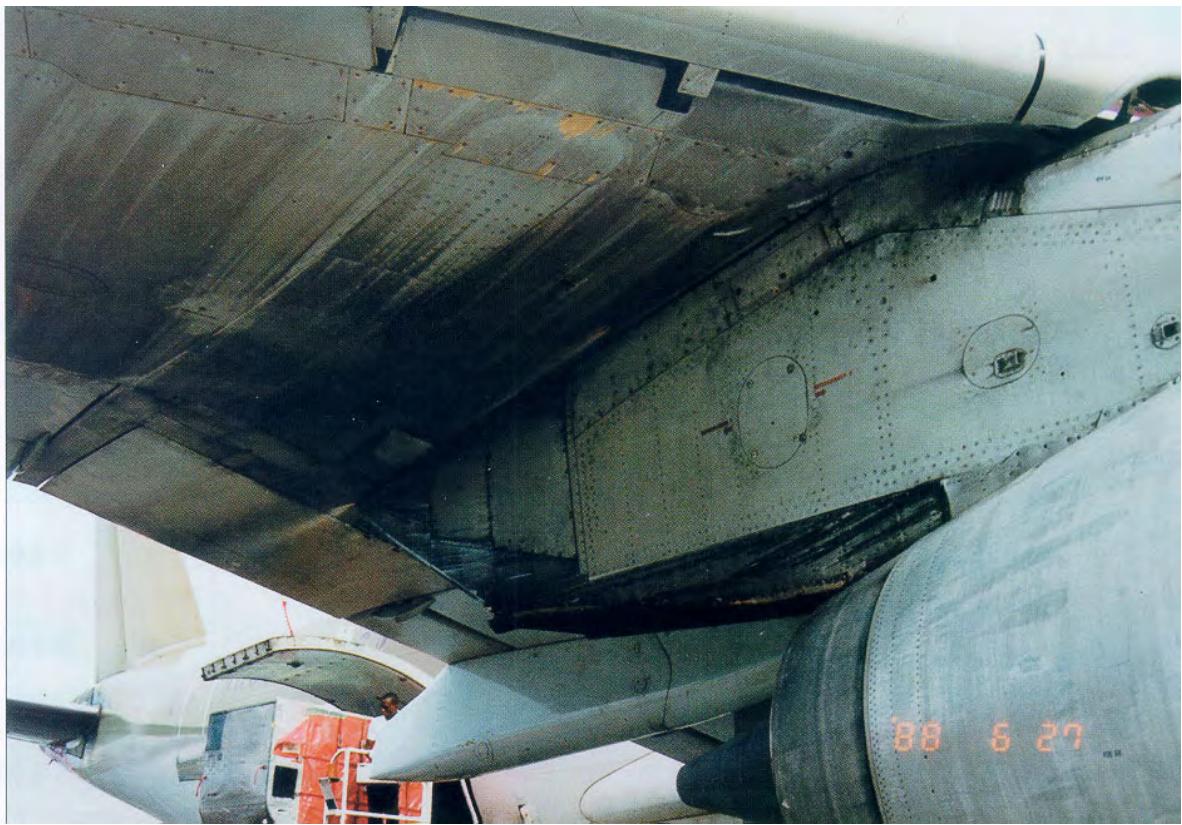
Lower flap track fairing roughness

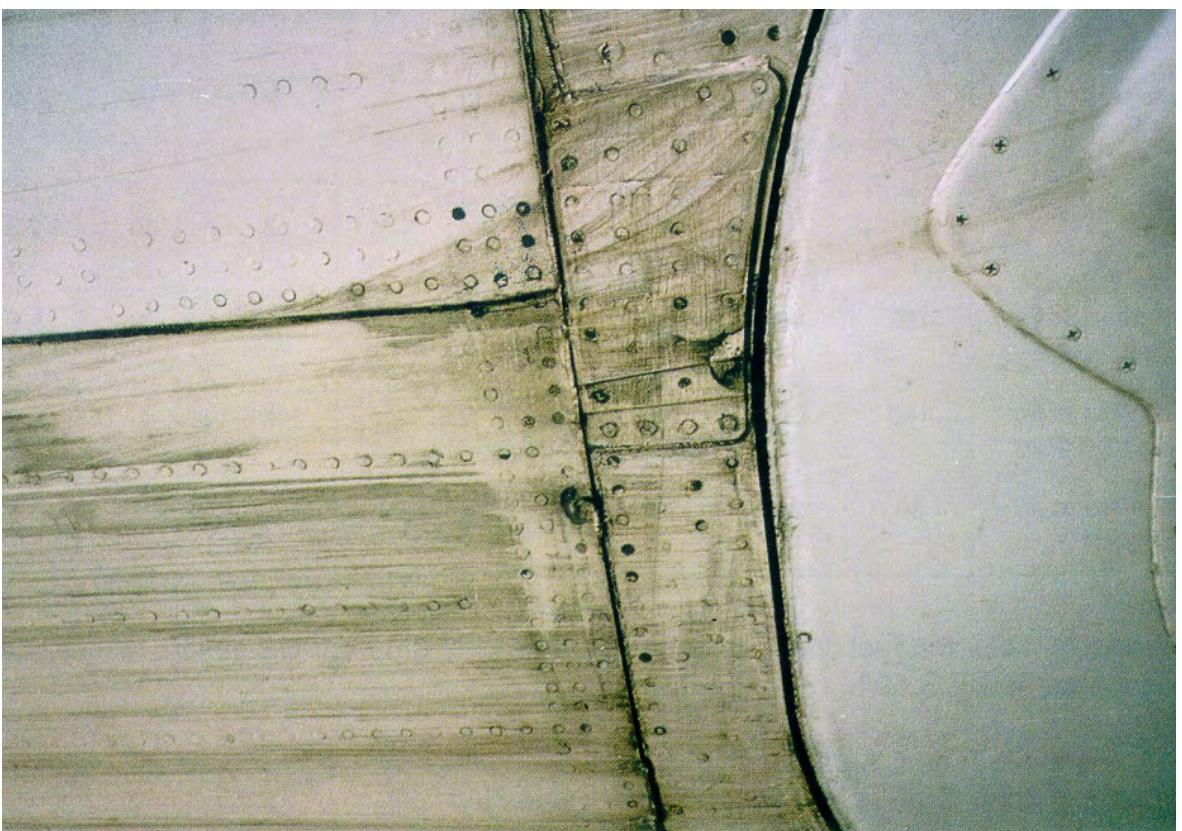
Leakage traces

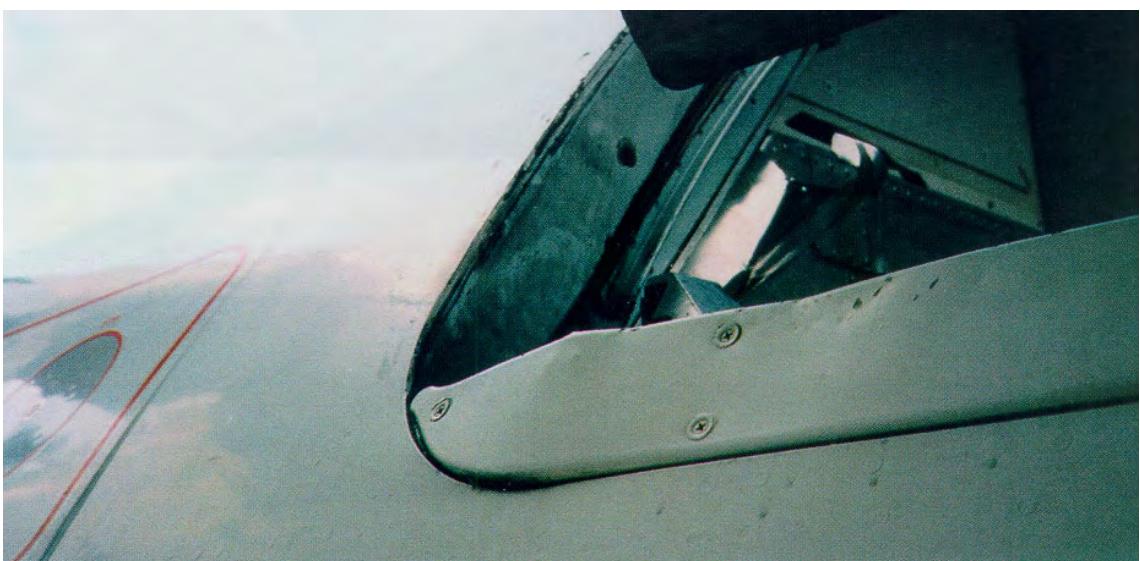
Dented scuff plates

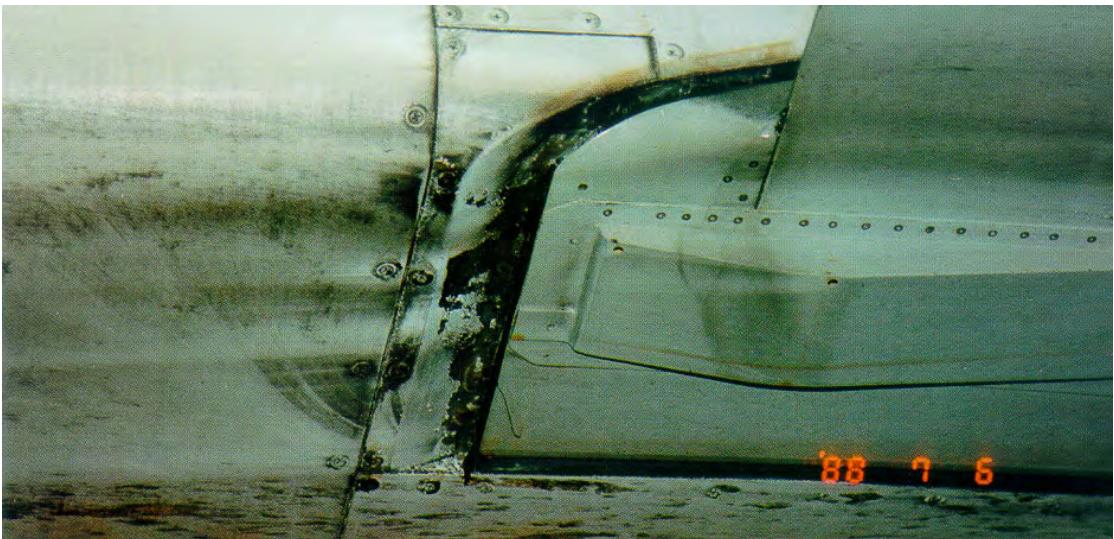
Damaged seal

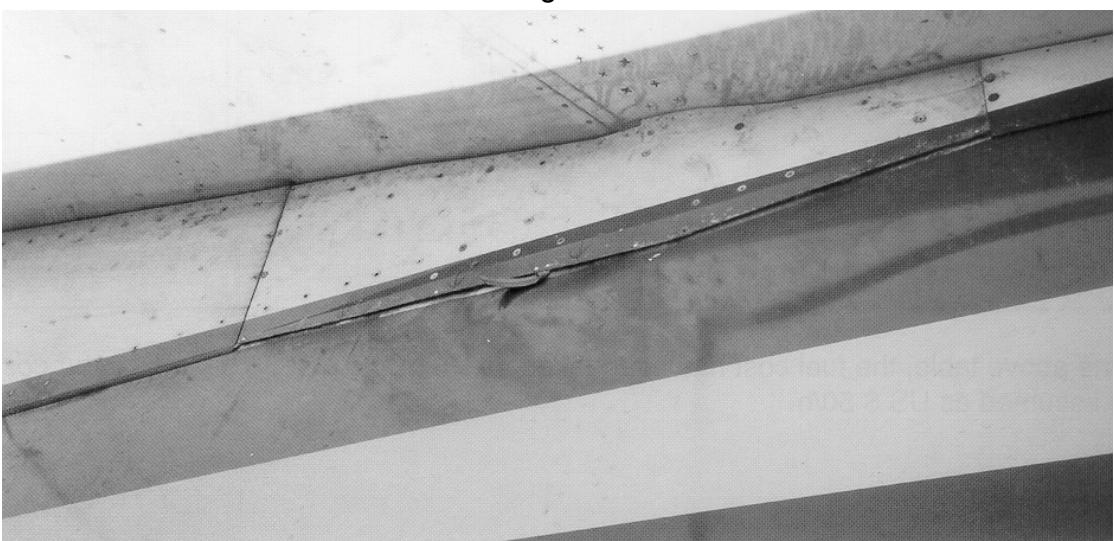
Missing seal

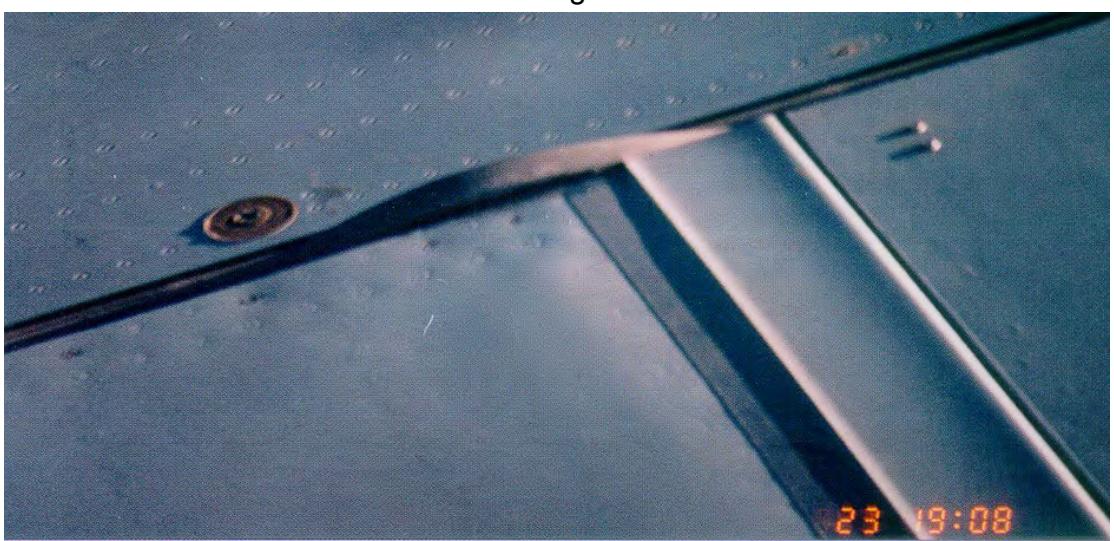
Missing seal

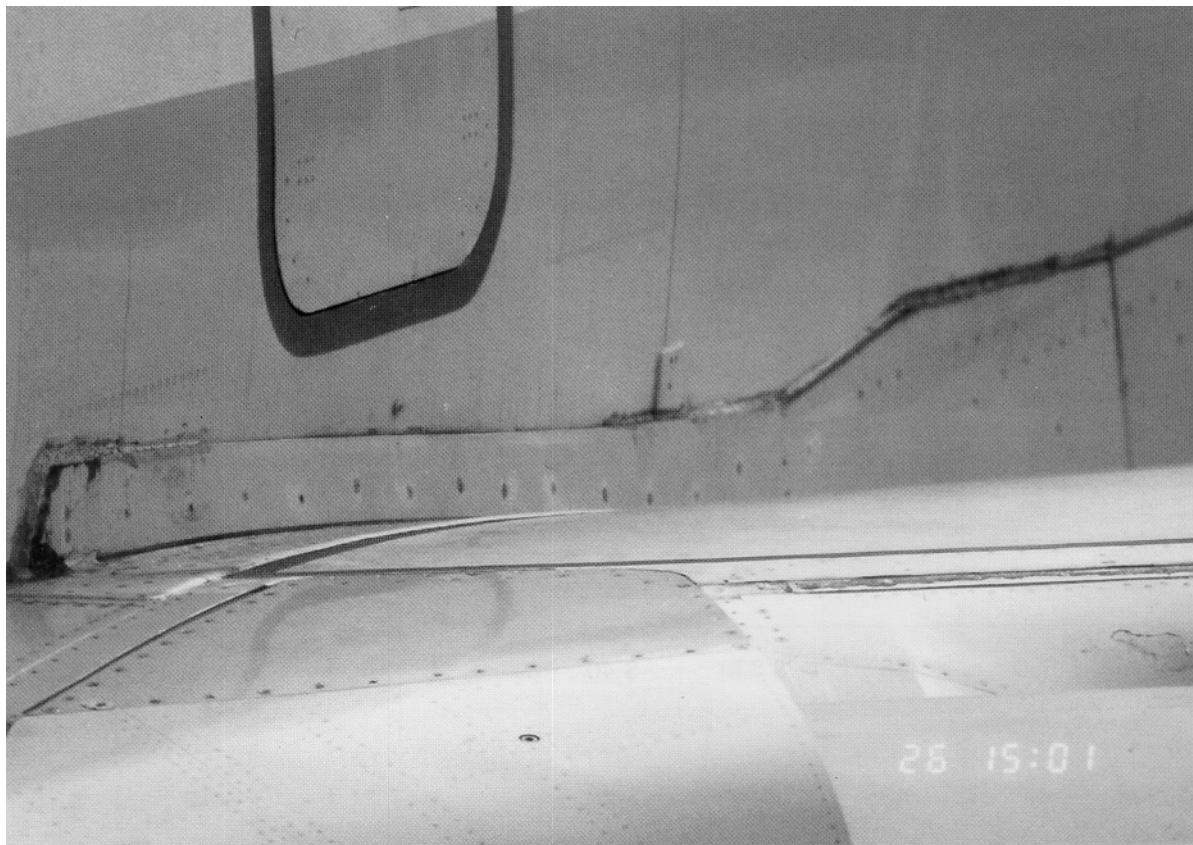
Overfilled belly fairing butt joint gaps

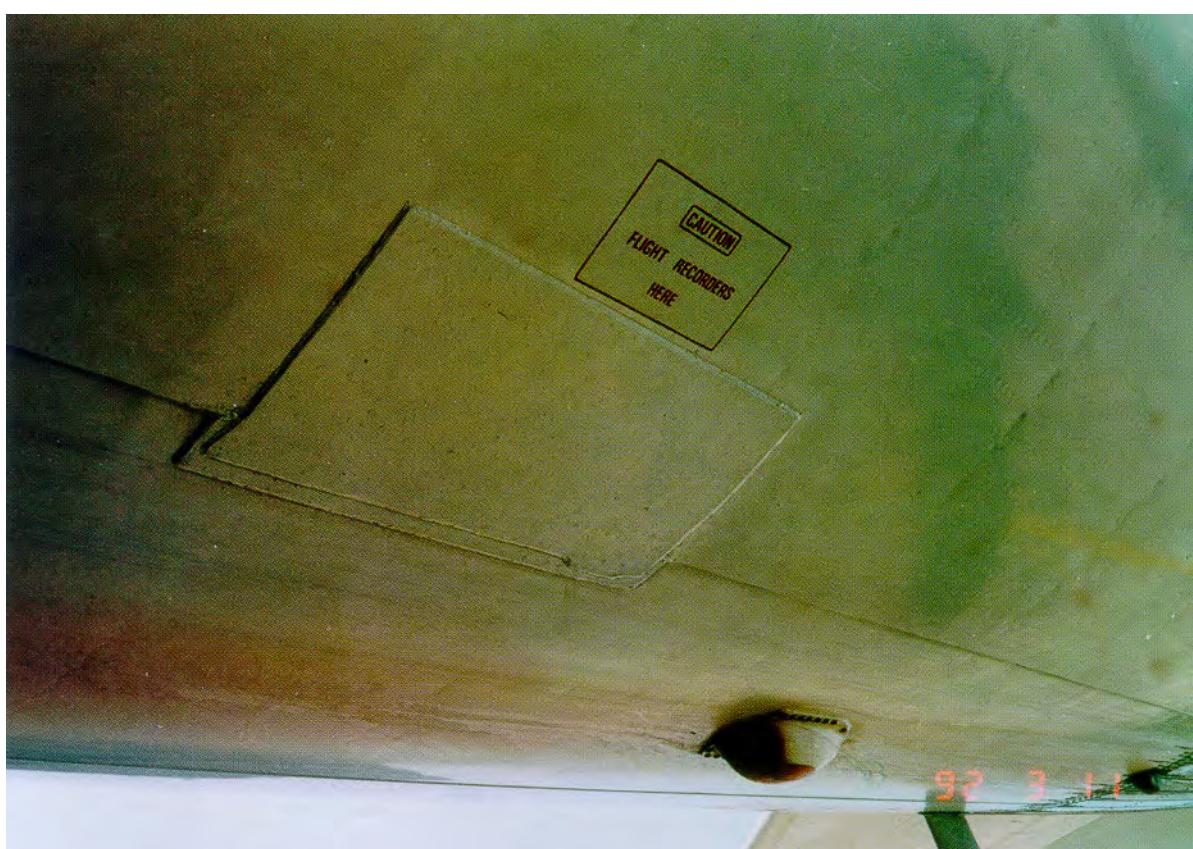
External patches on the fuselage

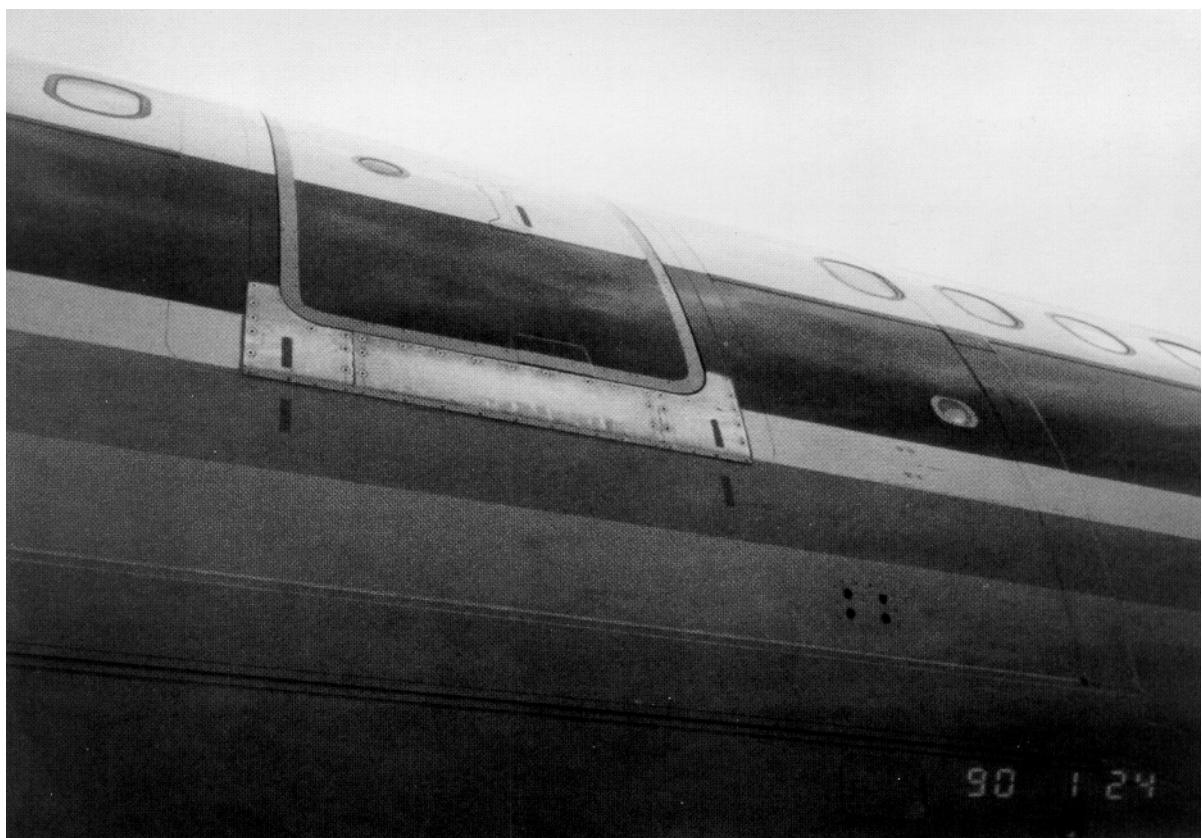
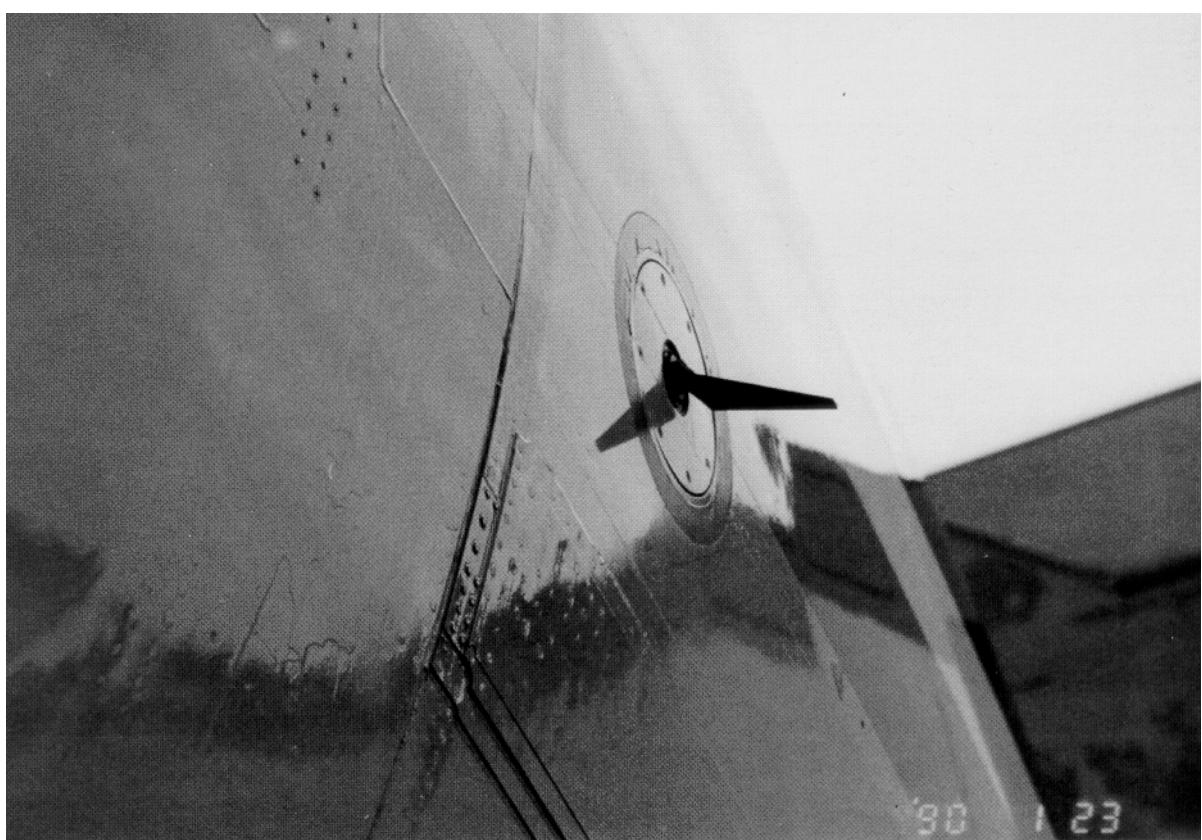
External patches on the fuselage

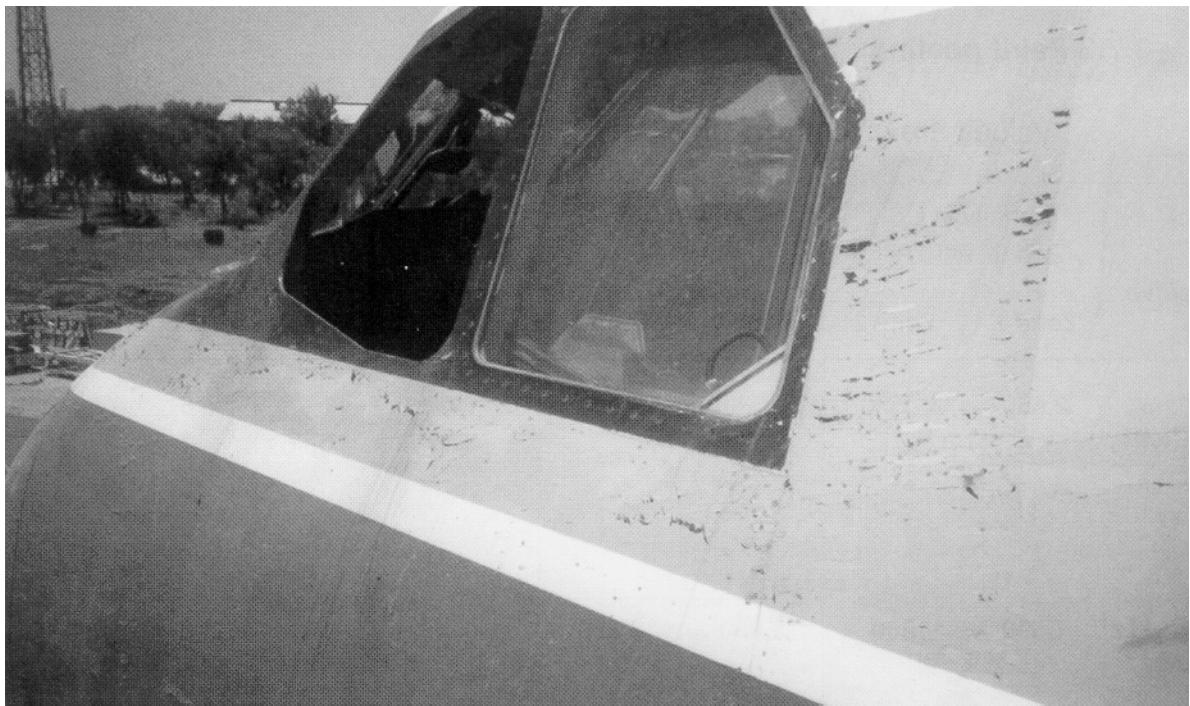
Paint peeling

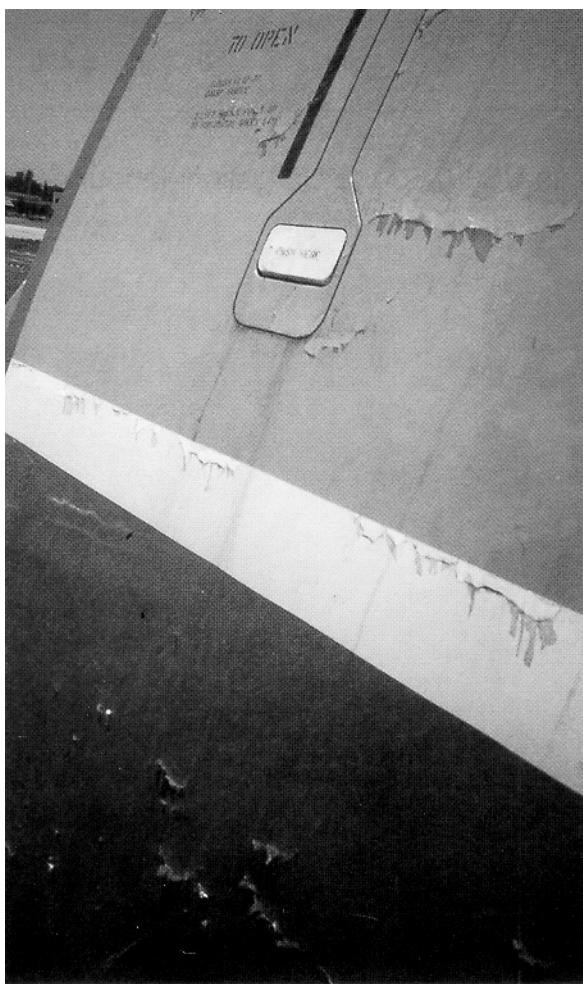
Paint peeling

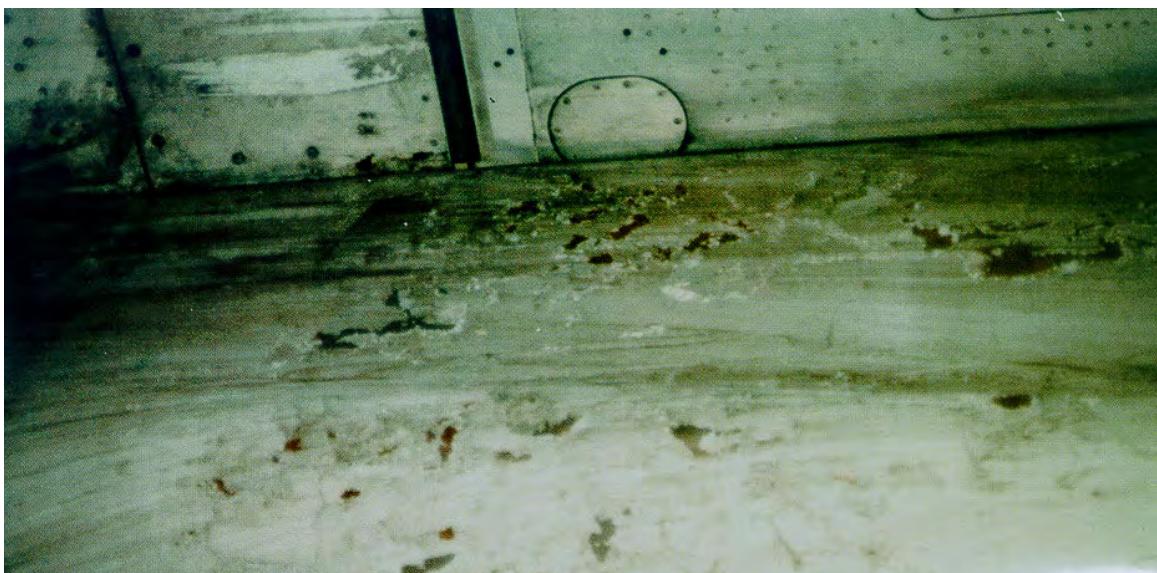
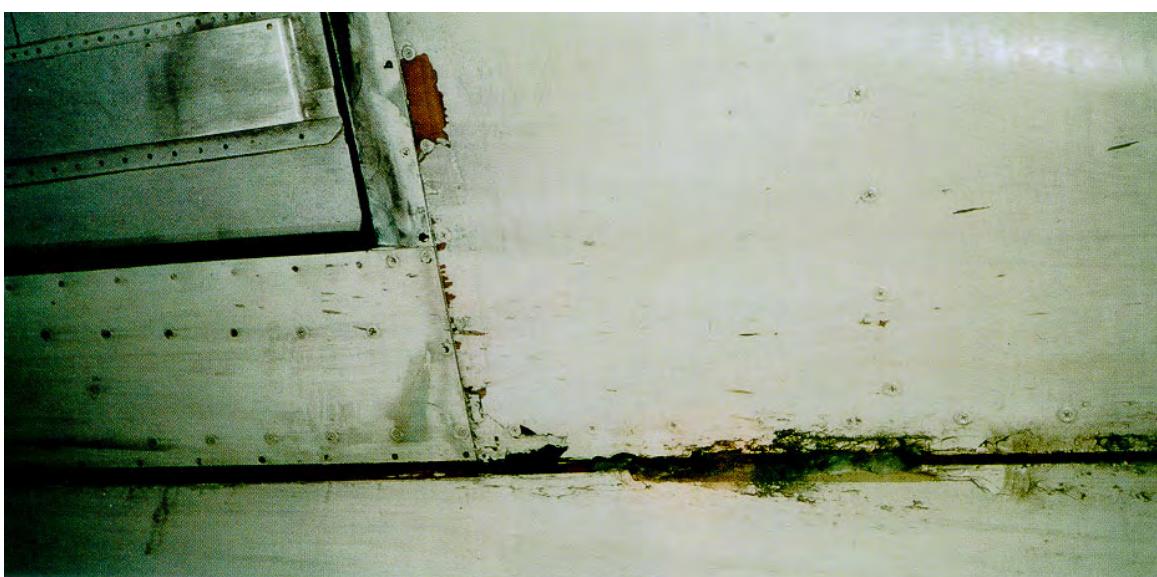
Paint peeling

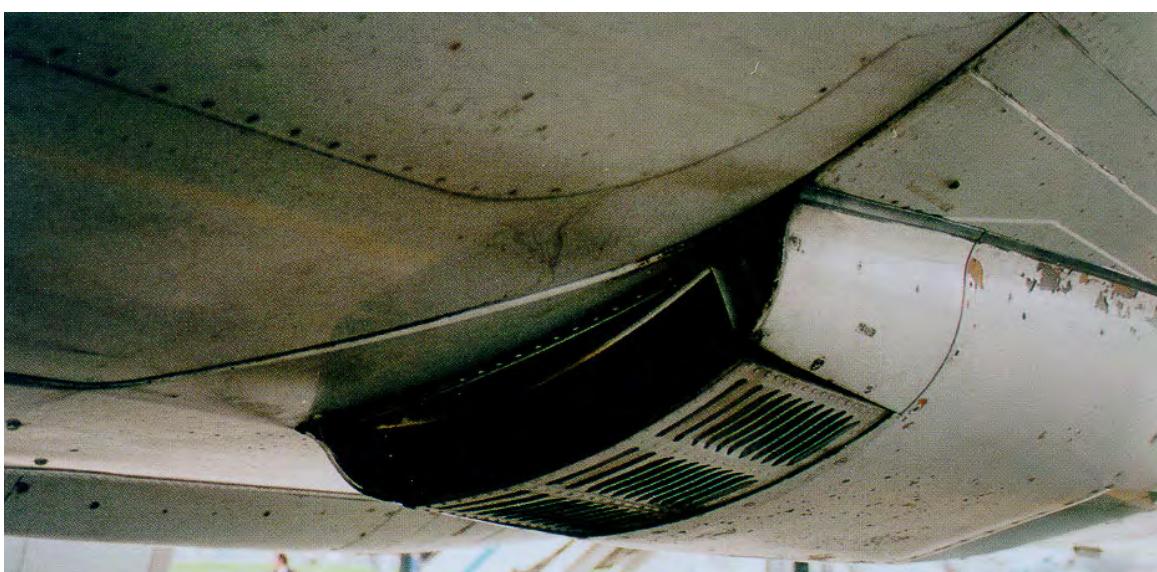
Paint peeling

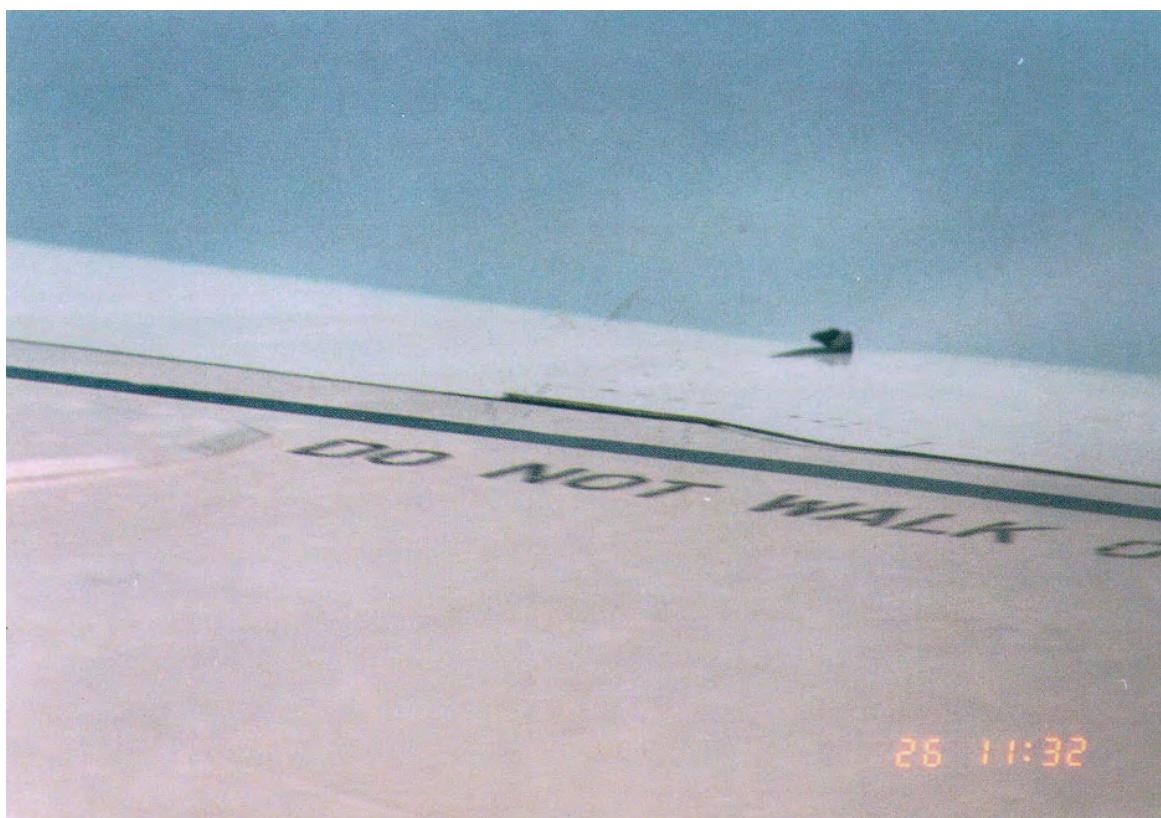
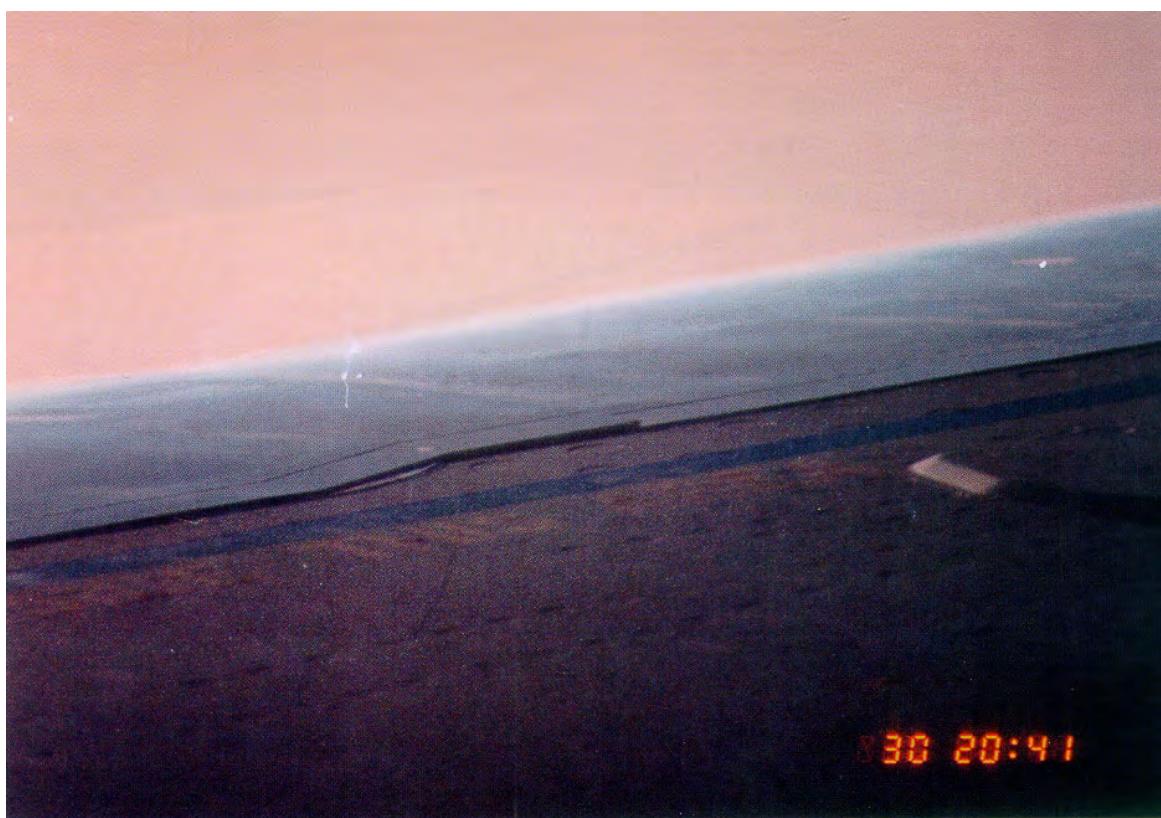
Misrigged slats

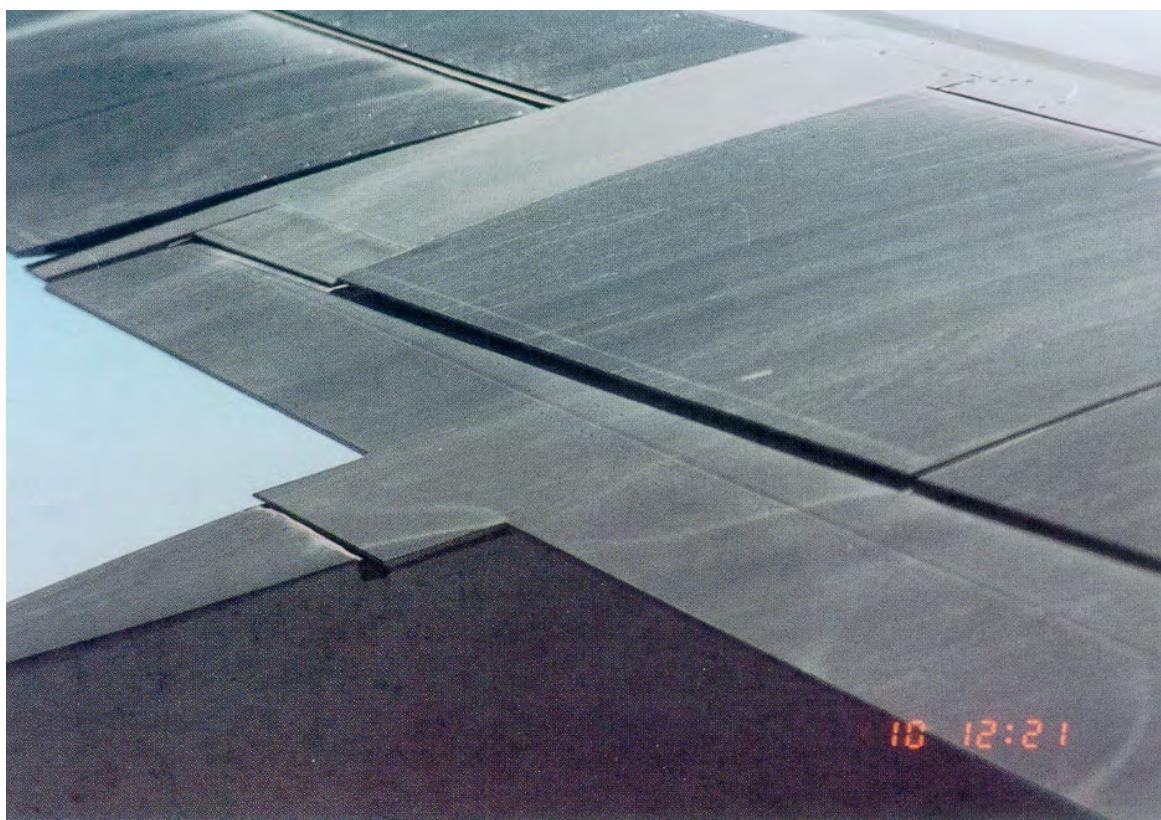
Misrigged spoilers

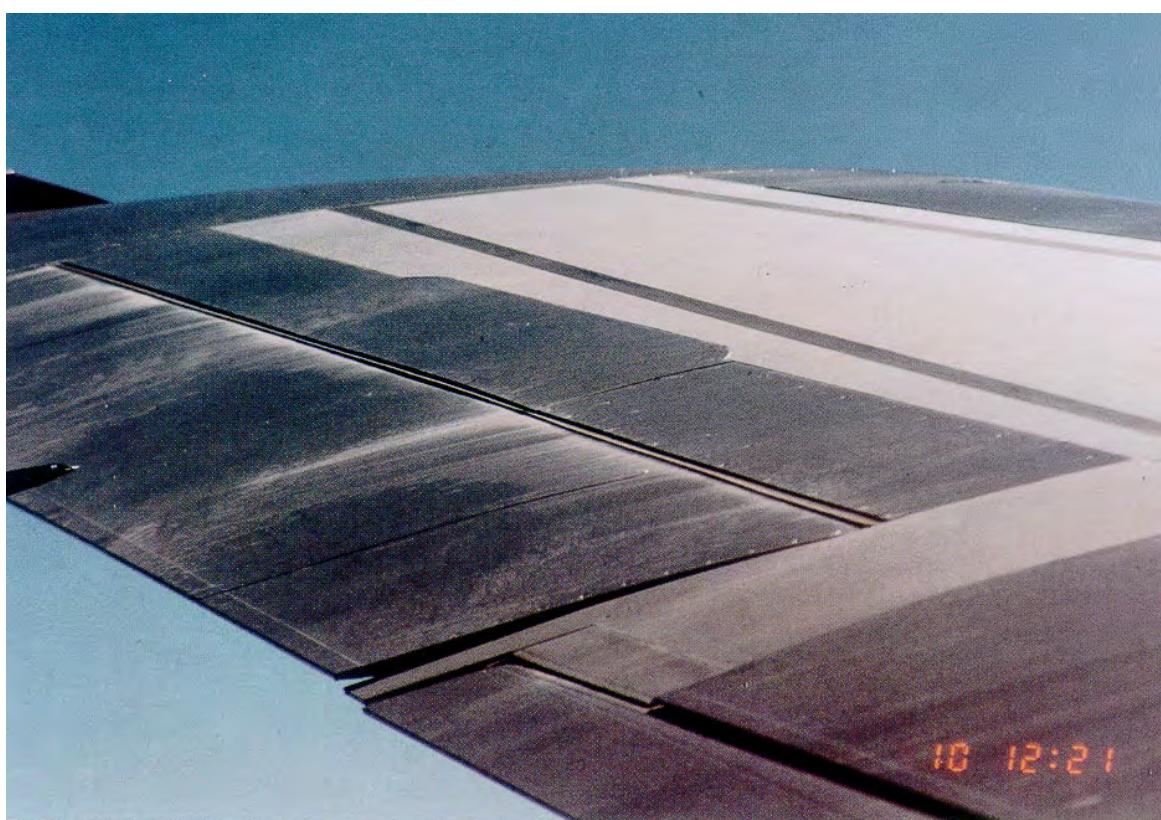
Misrigged spoiler and aileron

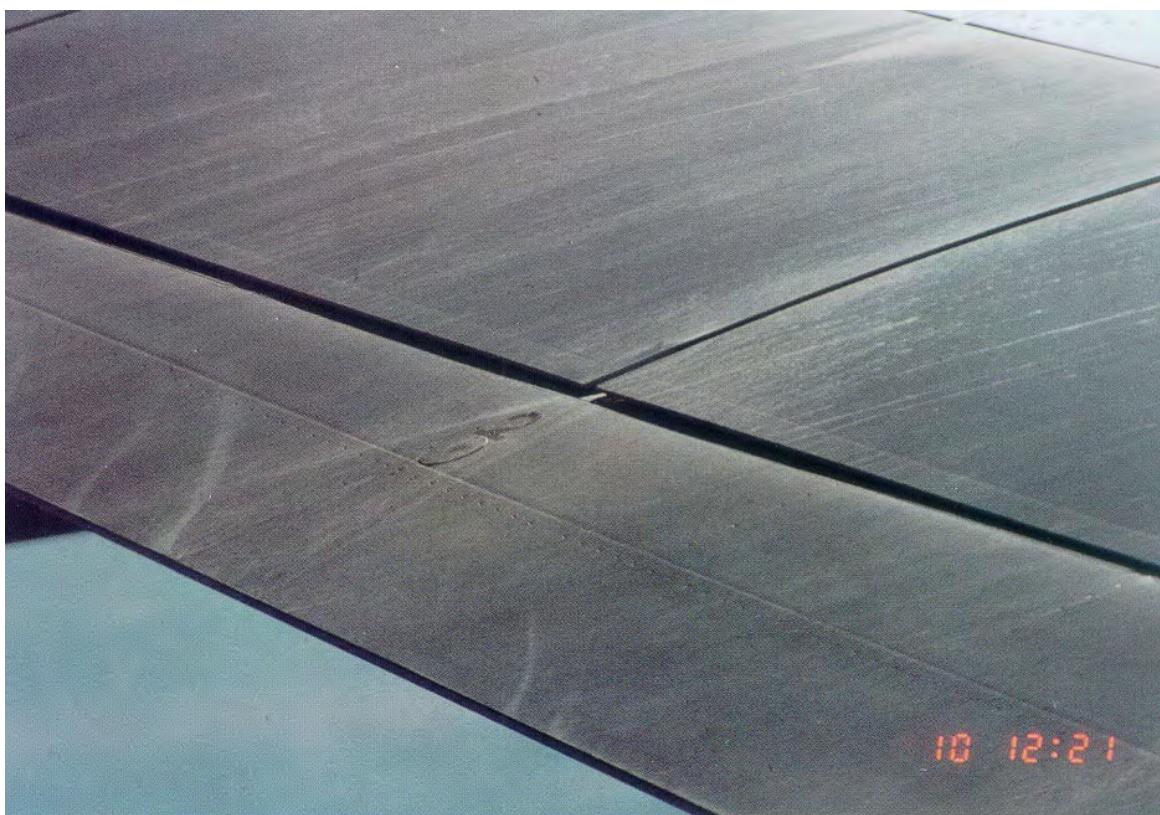
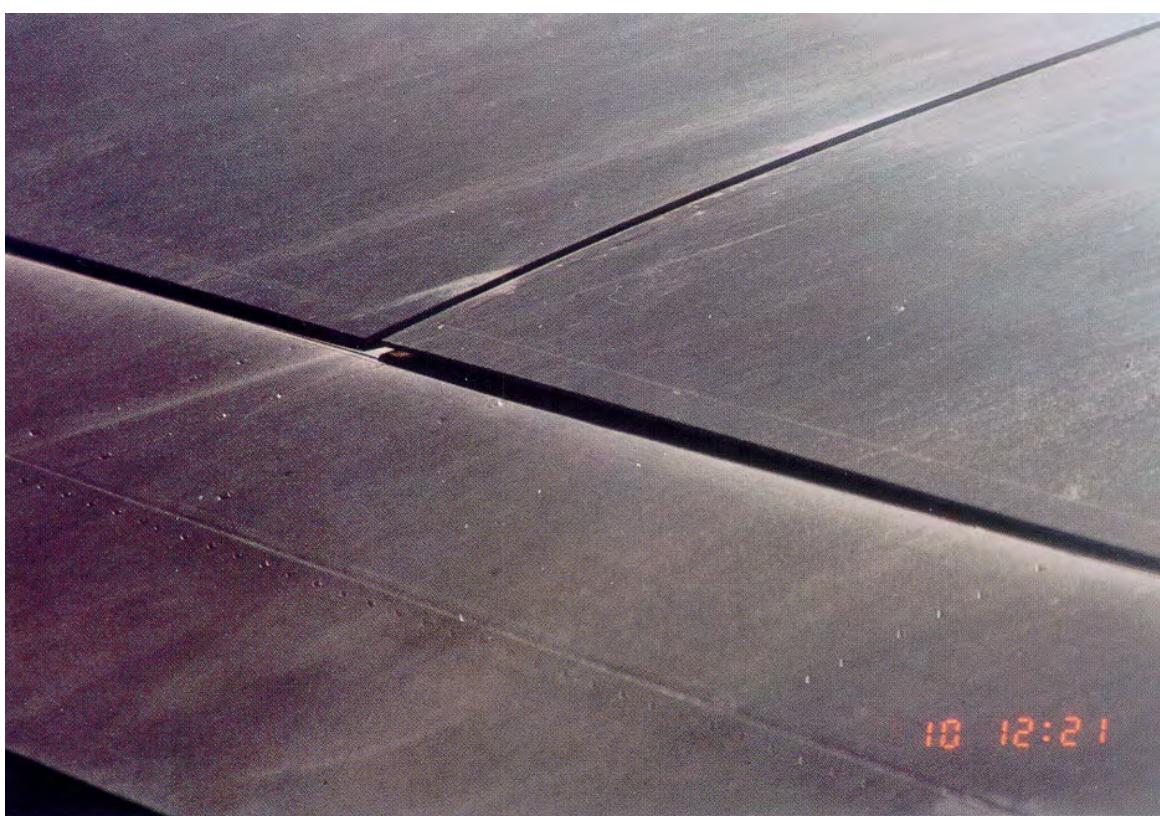
Misrigged spoilers

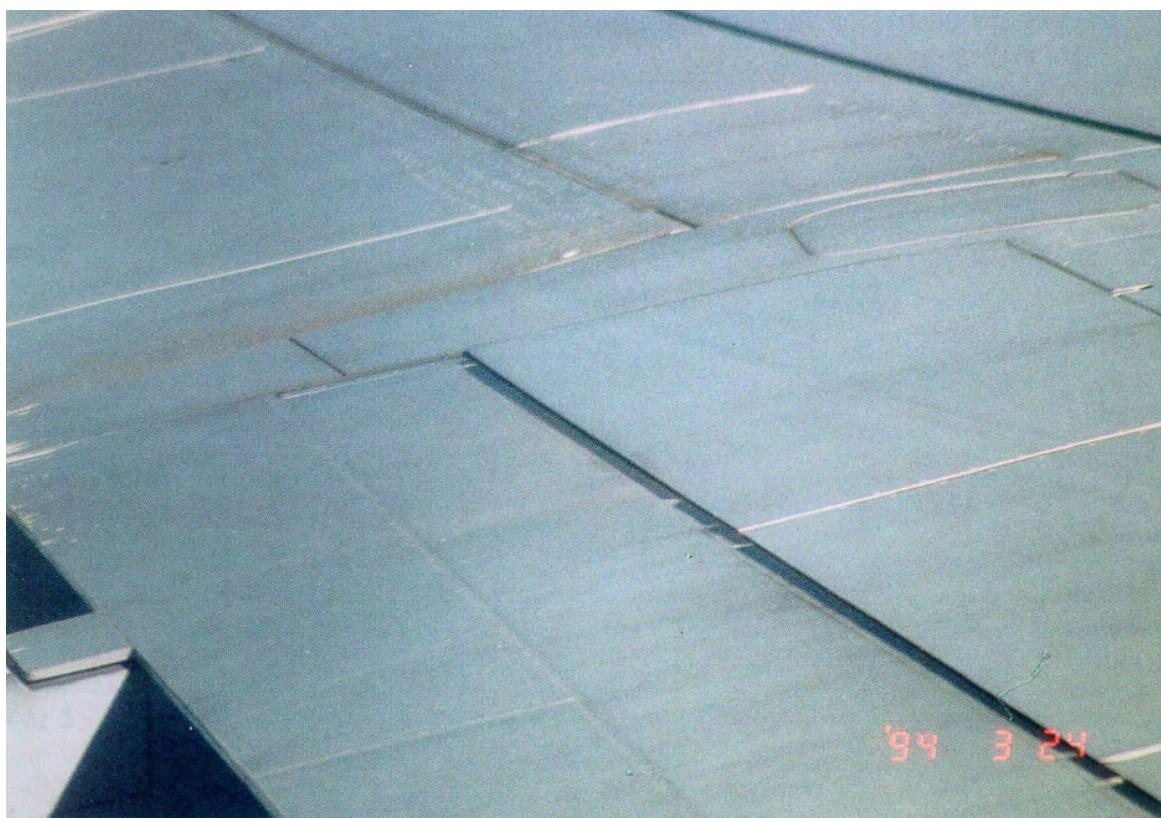
Misrigged spoilers

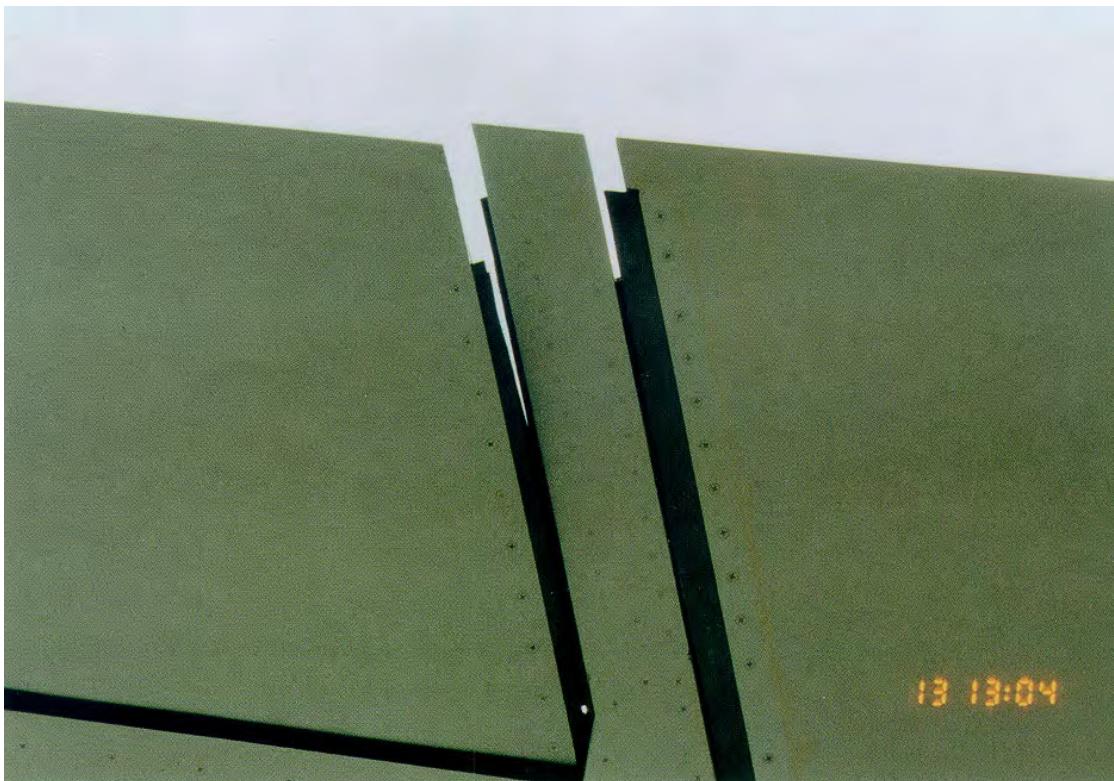
Aileron and flap seals

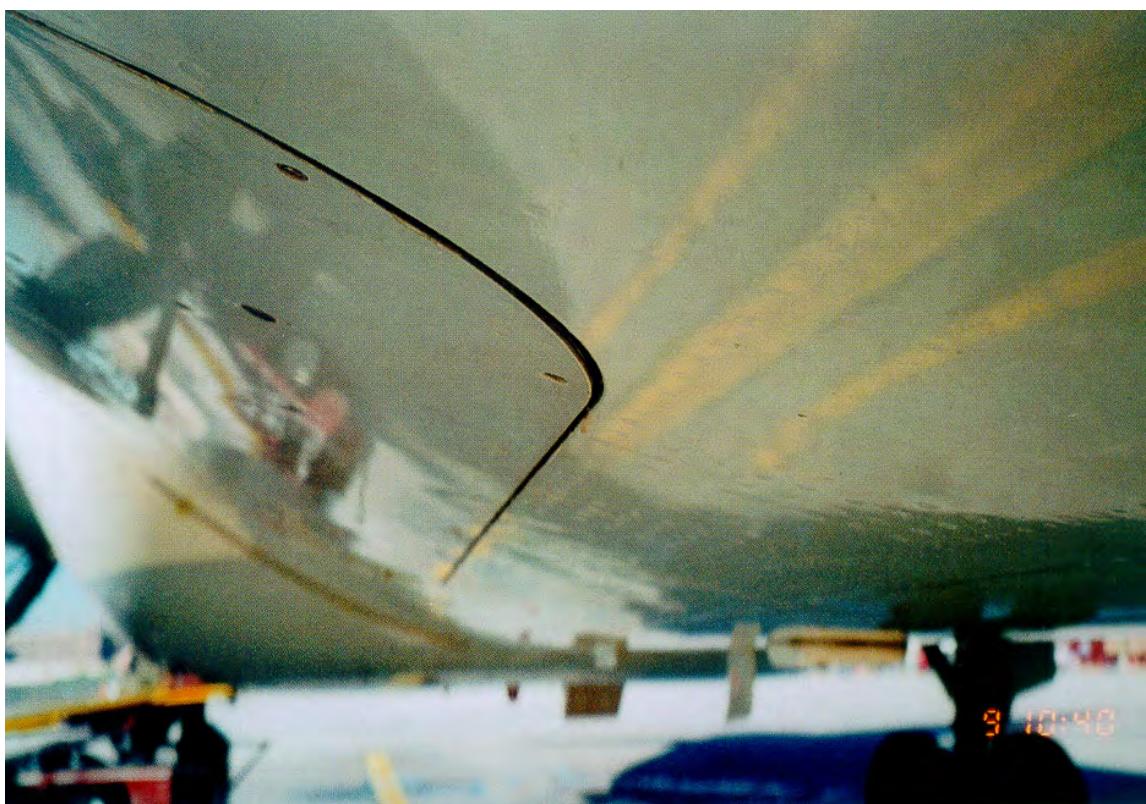
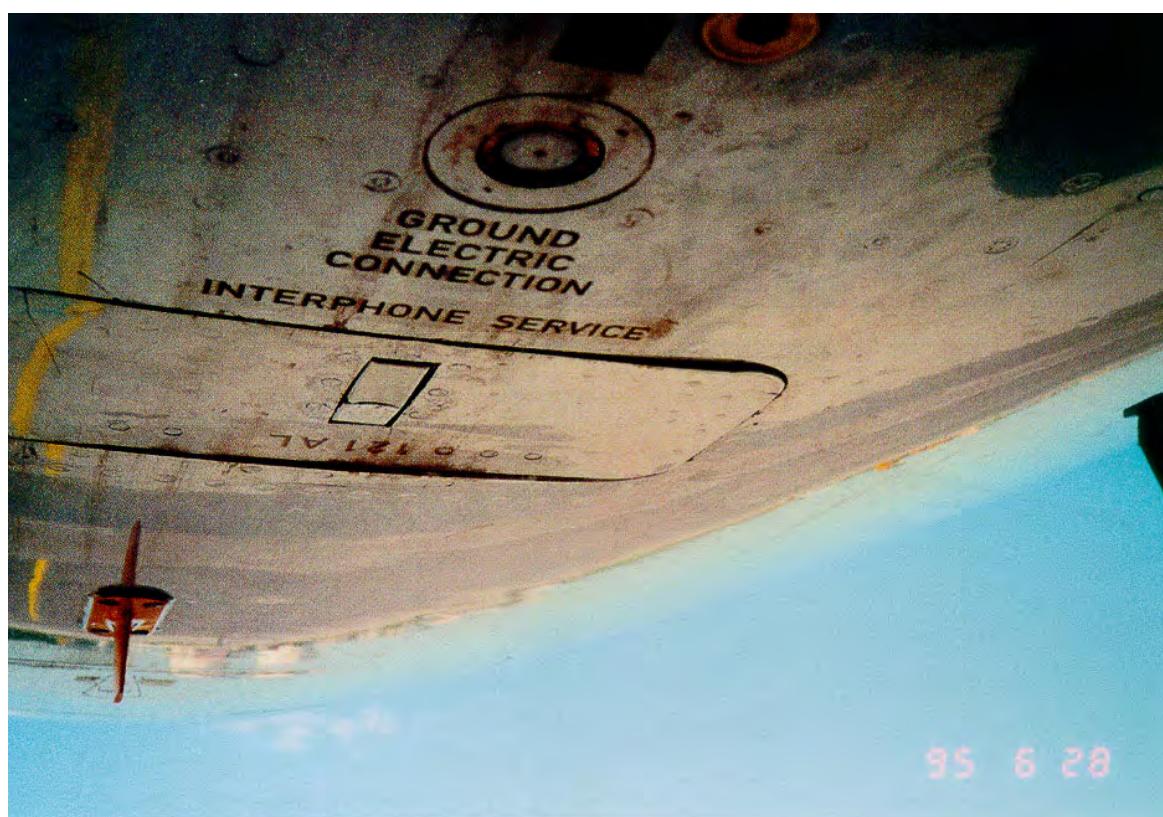
Mismatched access doors
