**AIRBUS**

GETTING HANDS-ON EXPERIENCE WITH AERODYNAMIC DETERIORATION

A PERFORMANCE AUDIT VIEW

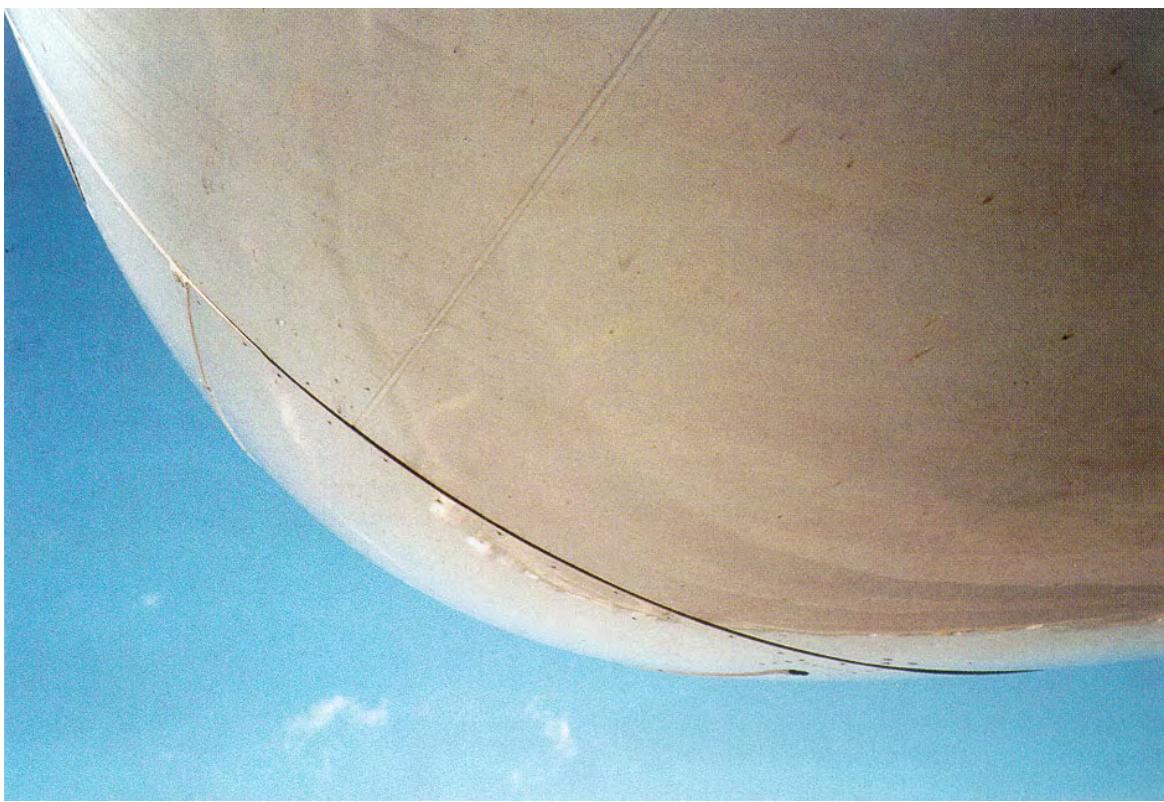
Radome misfit

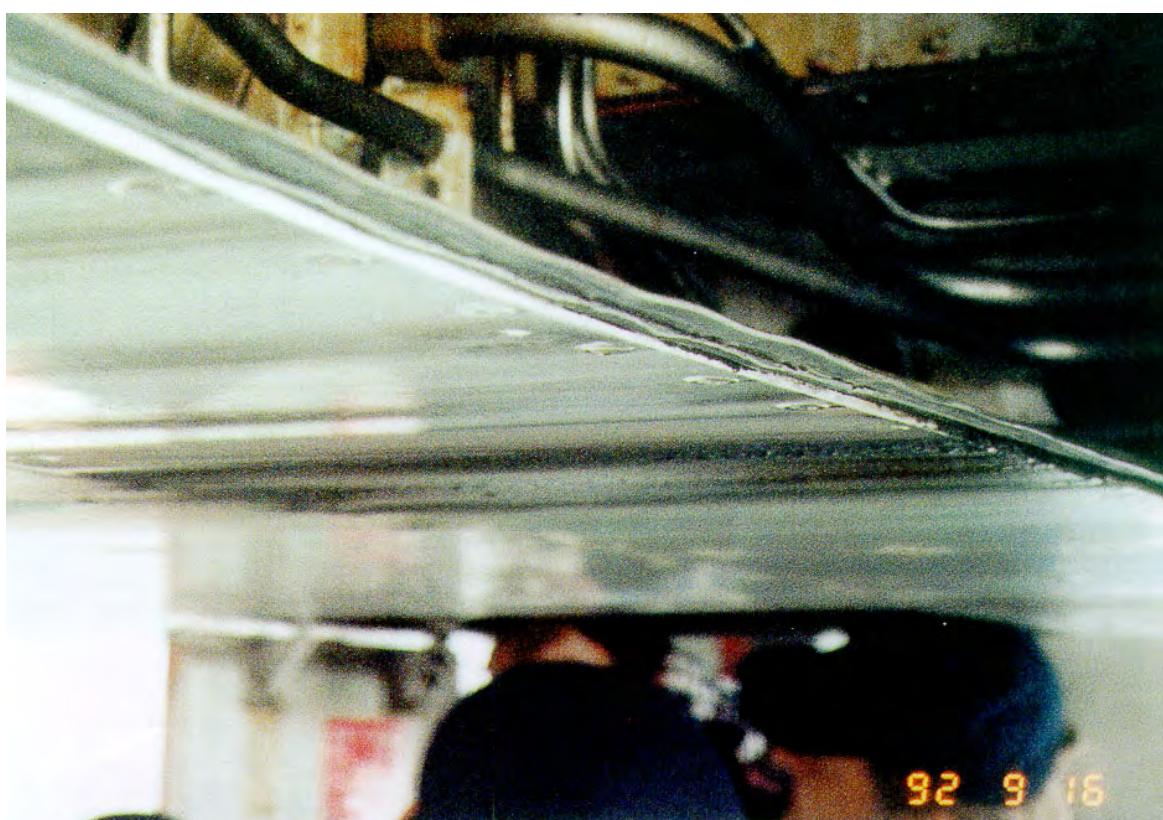
Damaged seal

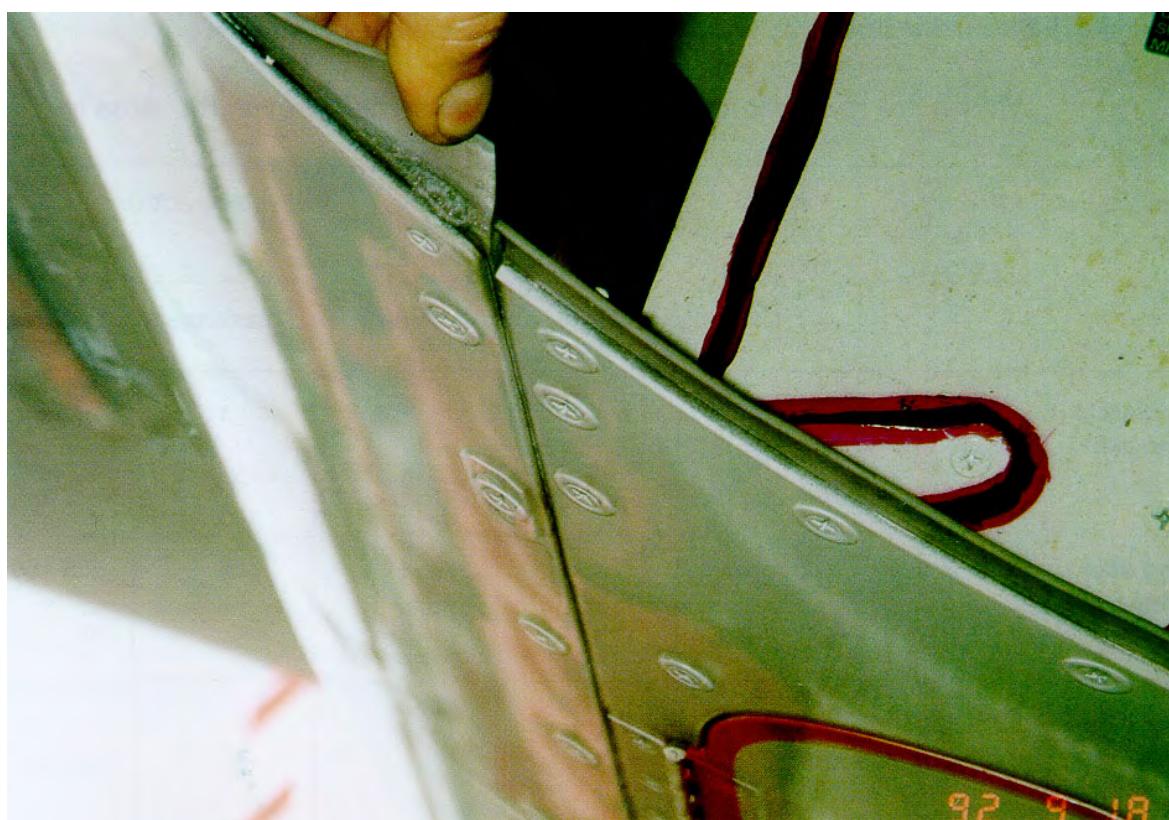
Damaged seal

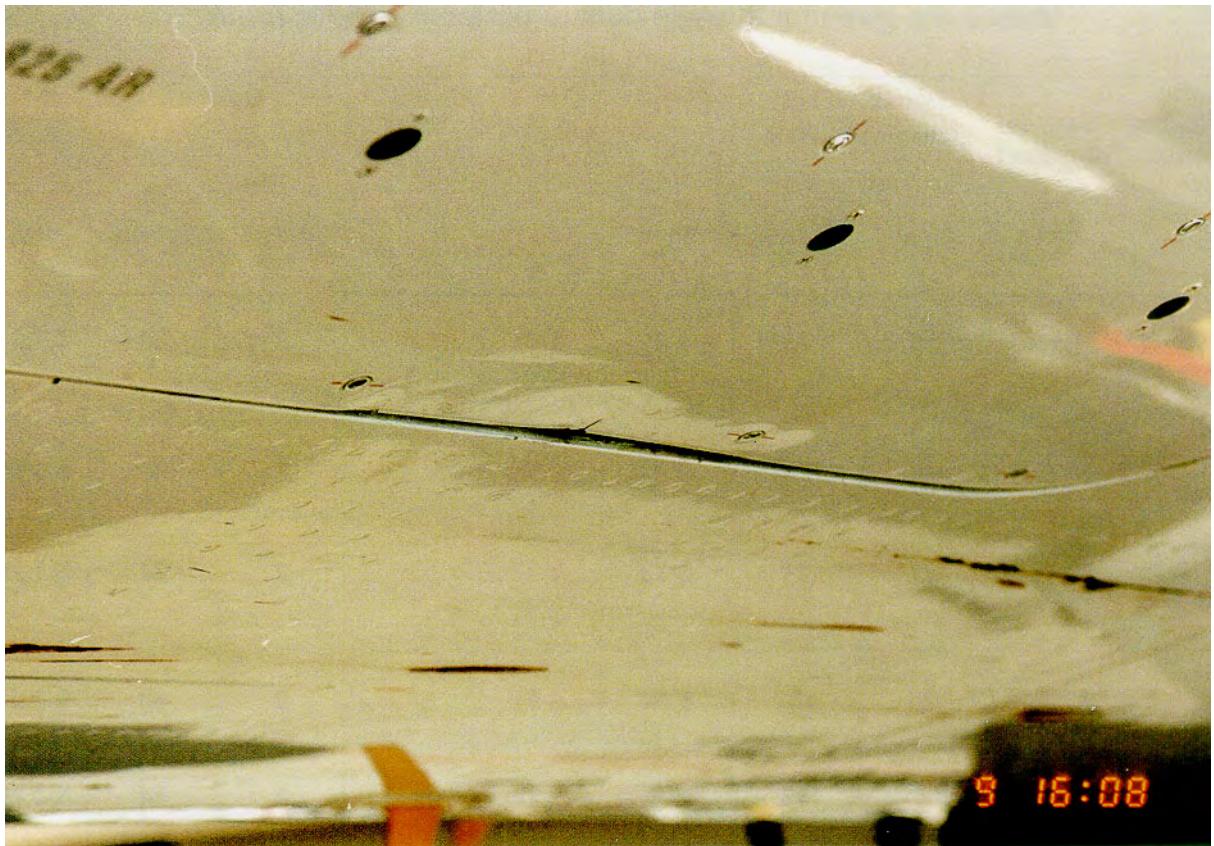
Dented door

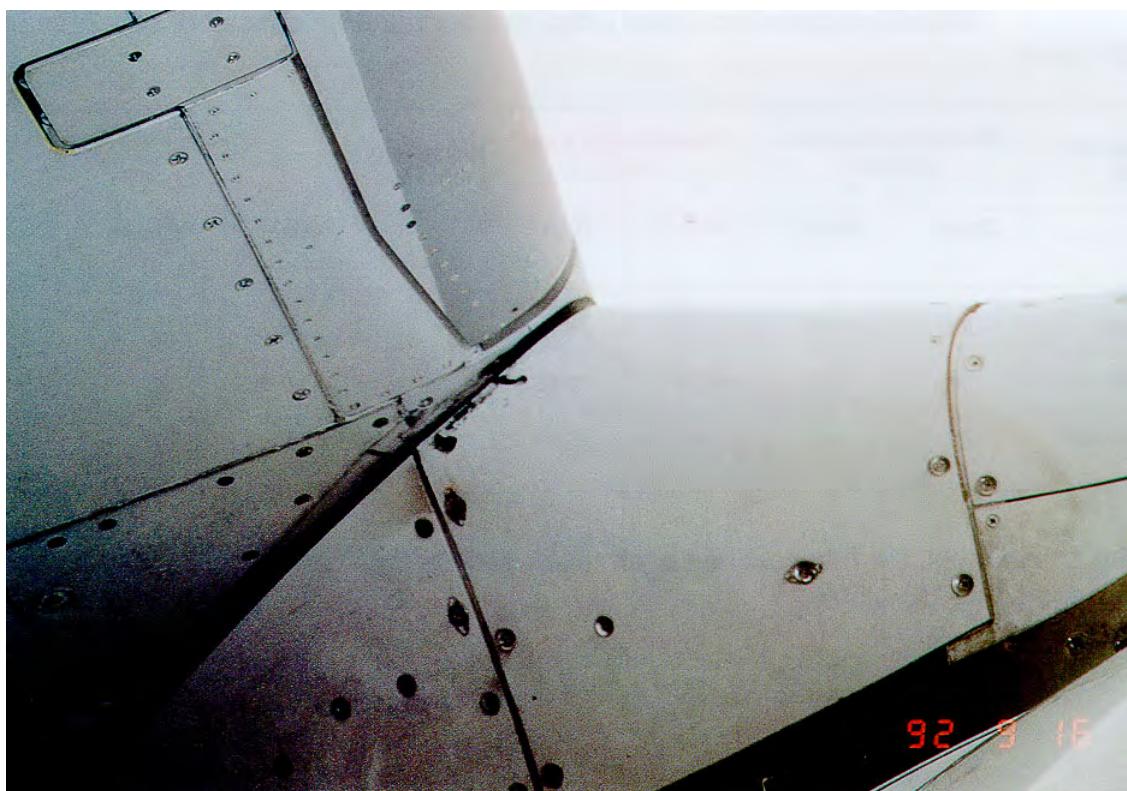
Seal missing

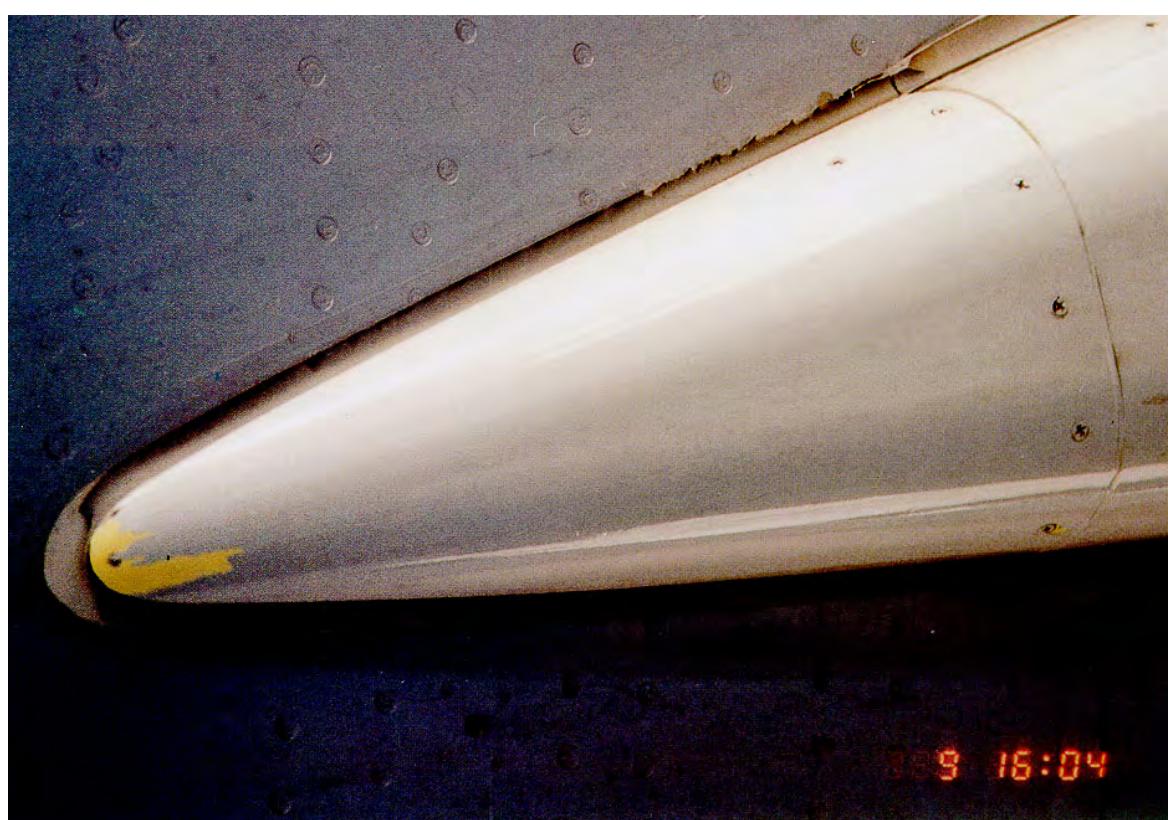
Seal missing

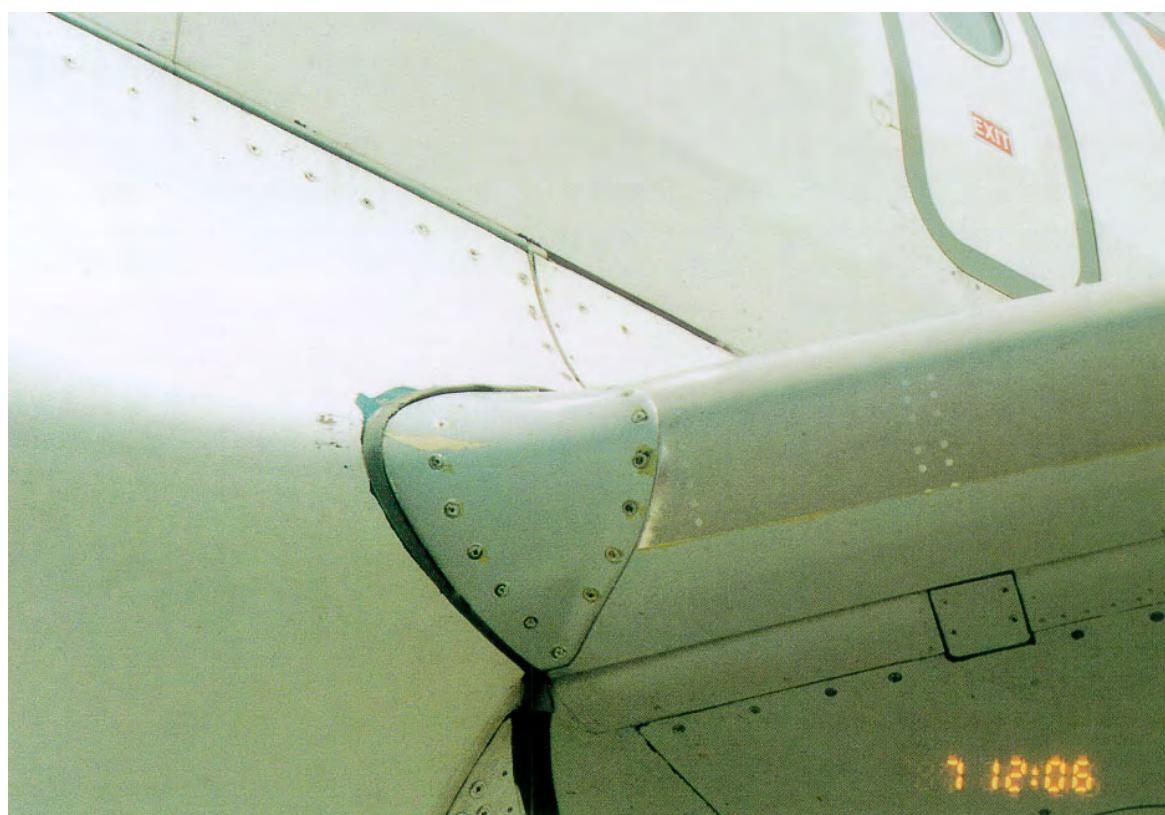
Seal misfit

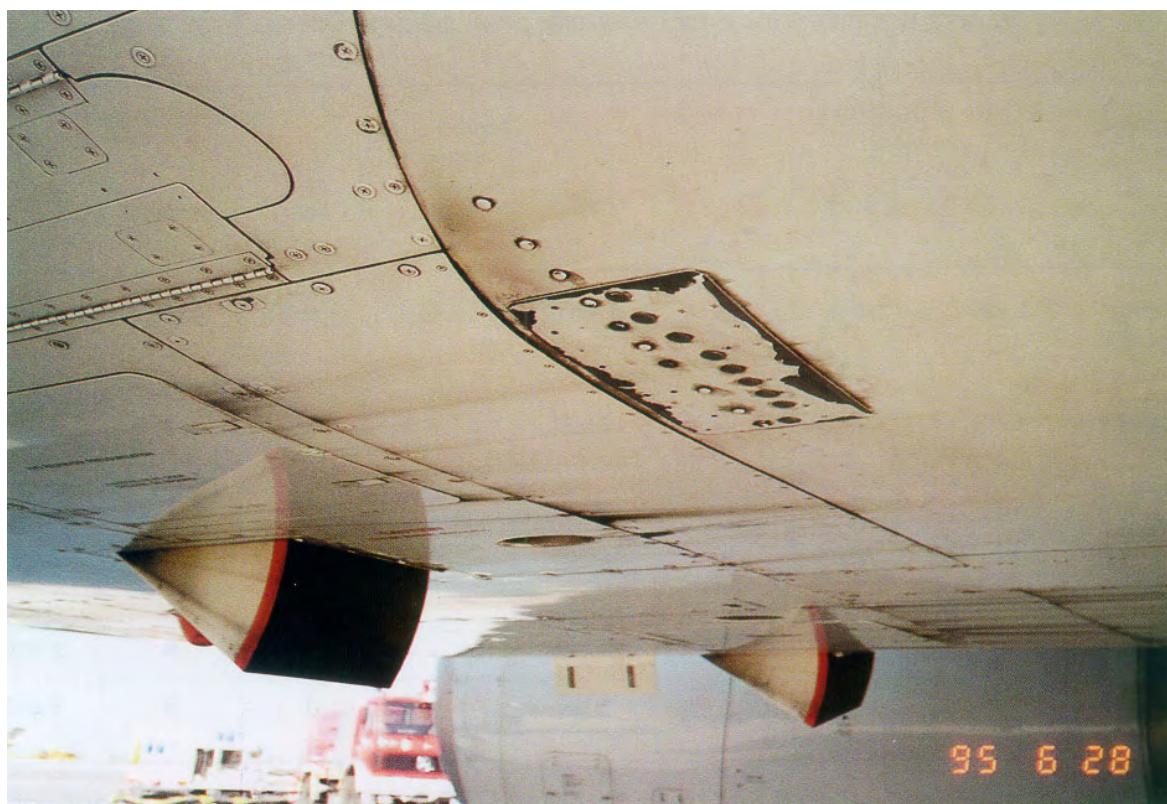
External patches

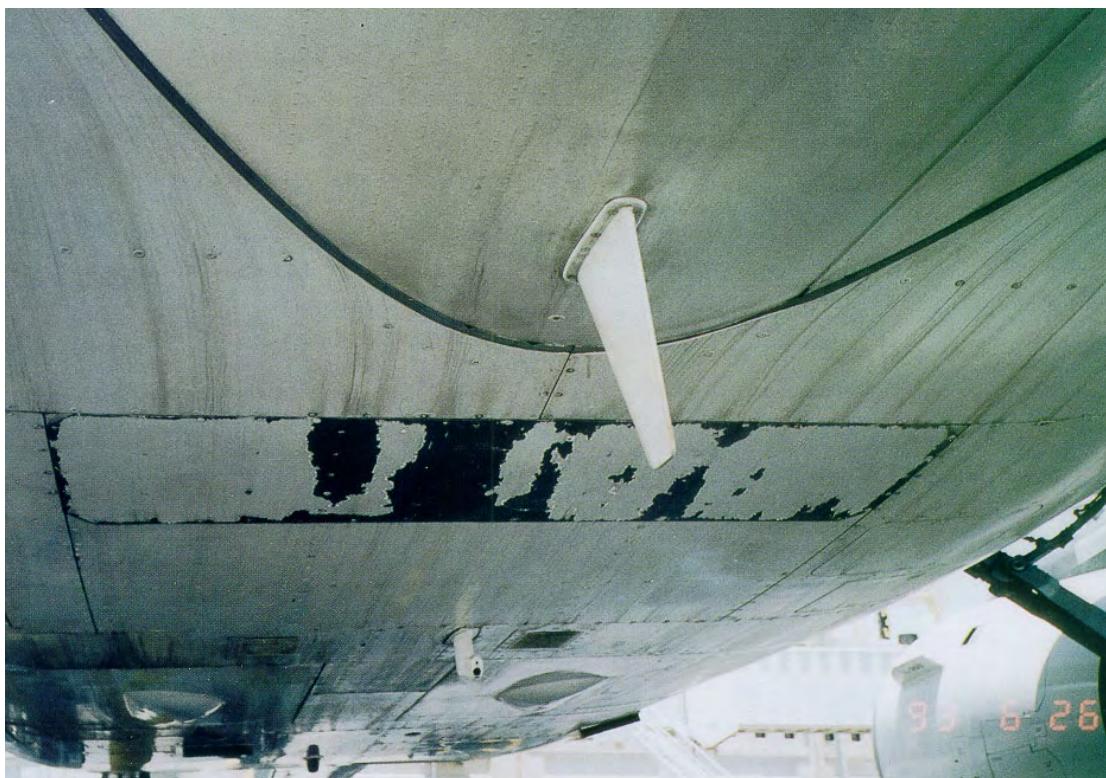
Paint peeling on the
belly fairing

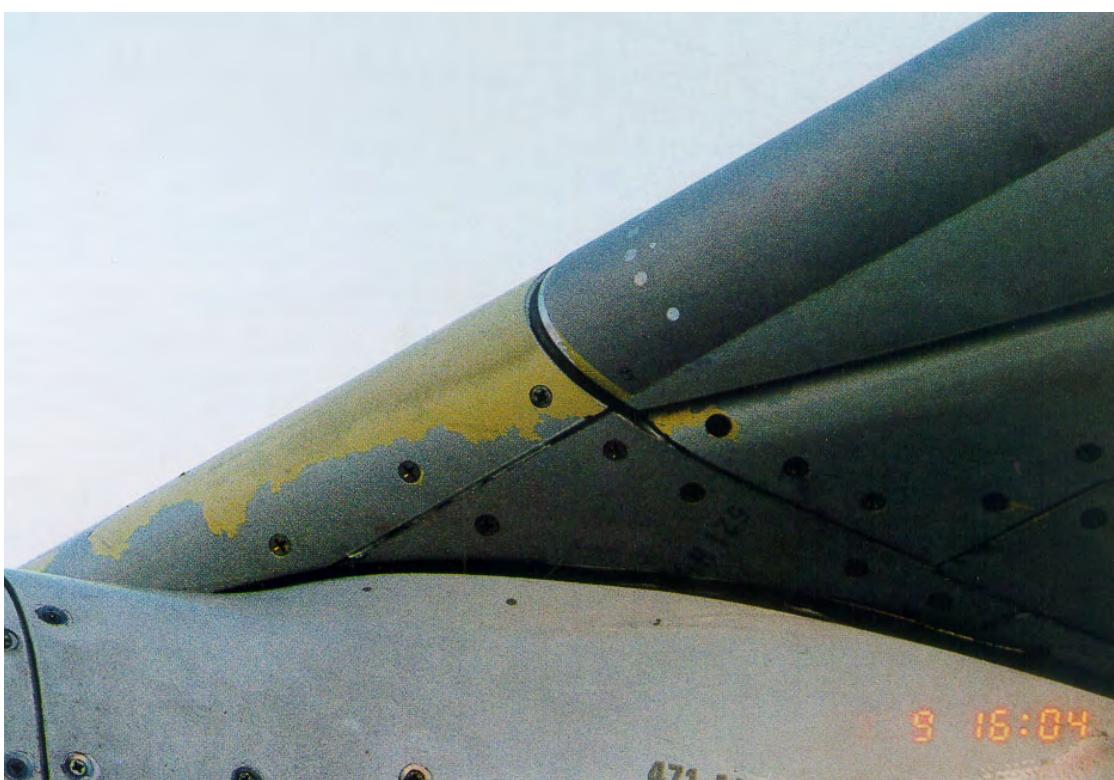
Paint peeling on the slat-leading edge

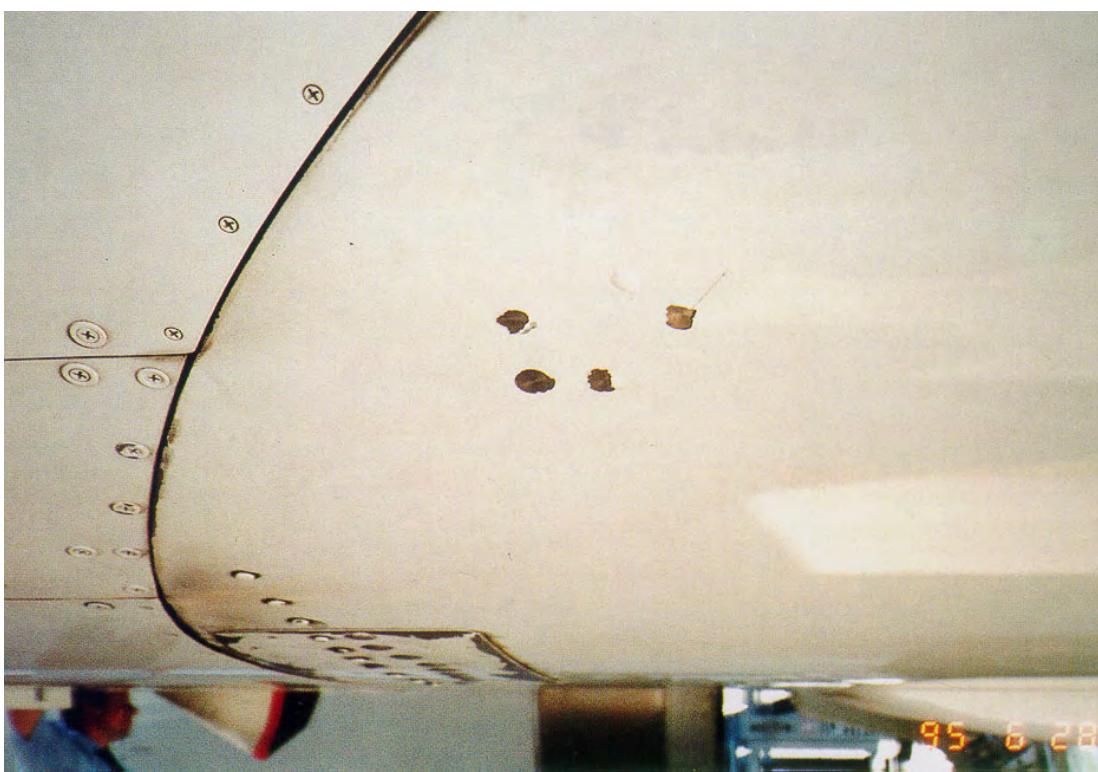
Paint peeling on the belly
fairing

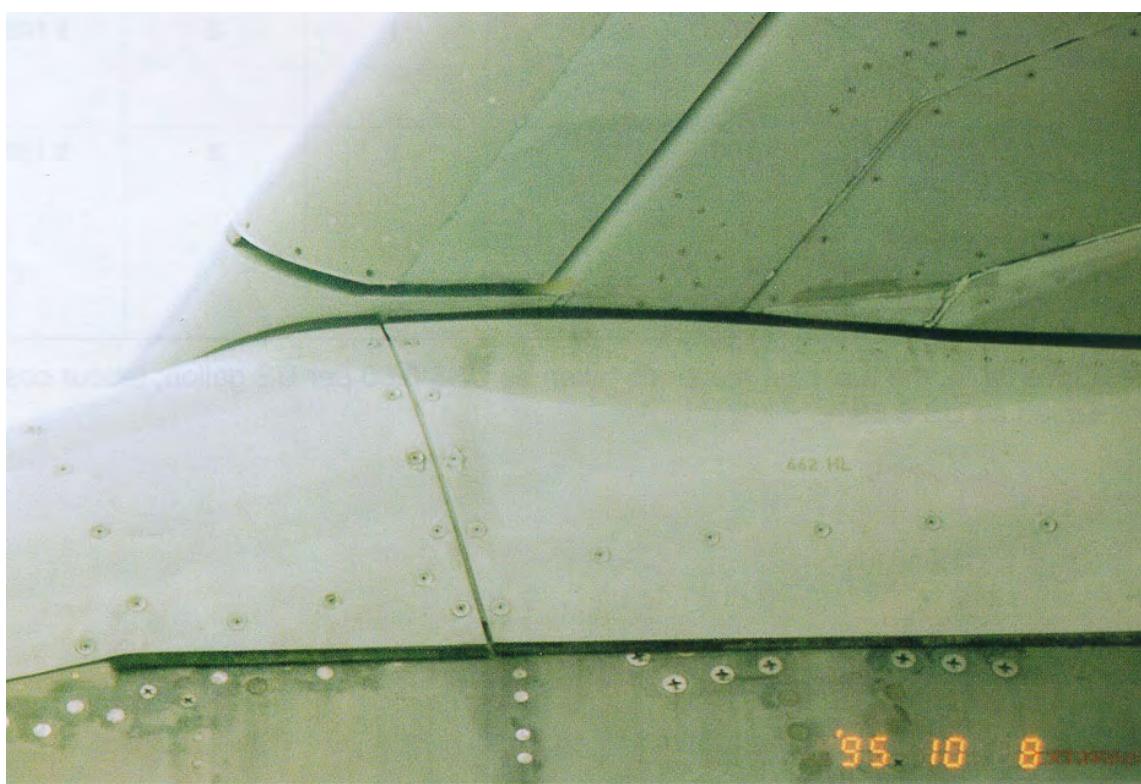
Missing chordwise slat seal

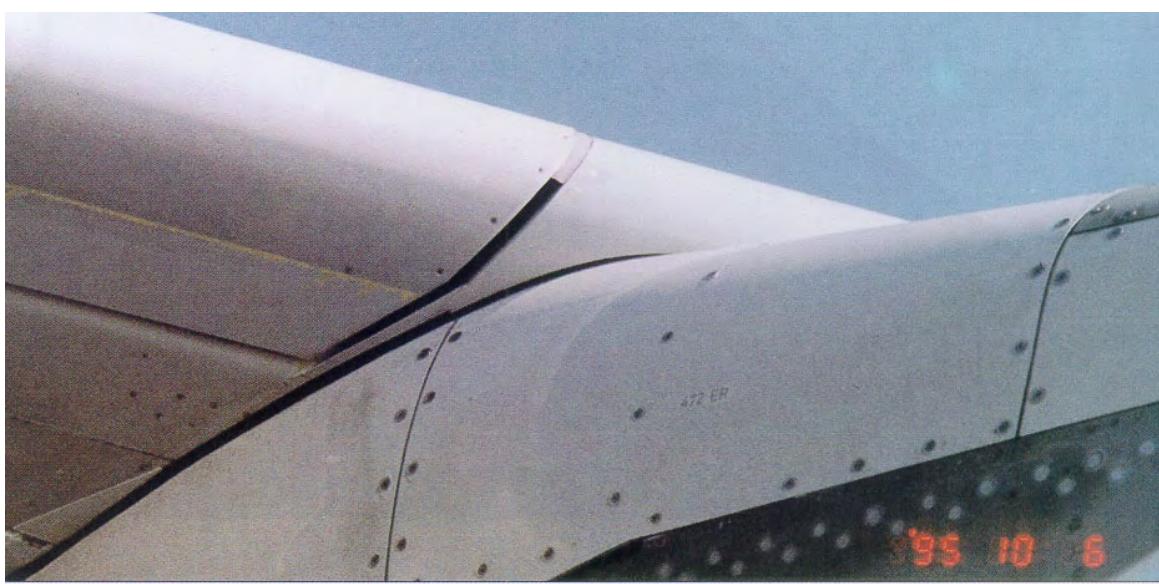
Missing chordwise seal

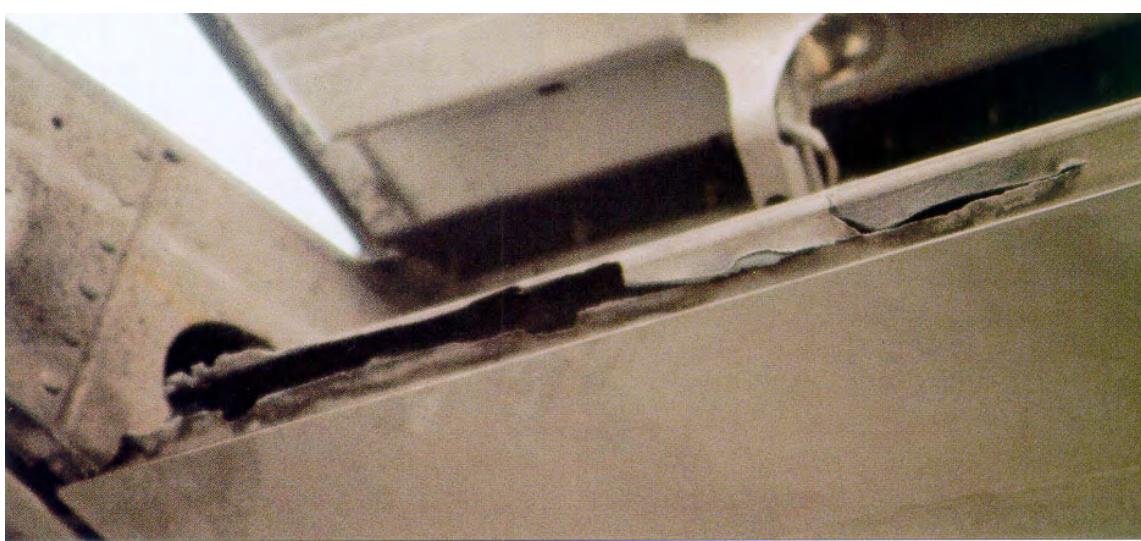
Damaged wing lower-surface-to-flap seals

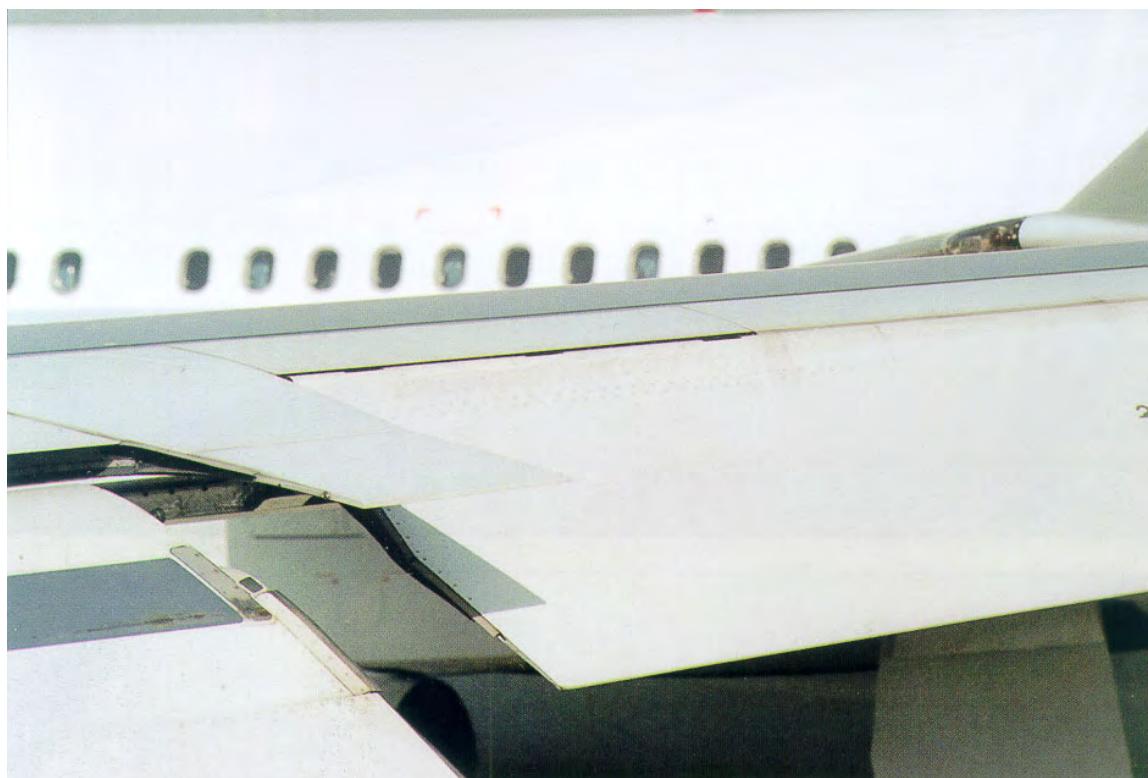
Missing aileron

spanwise seal

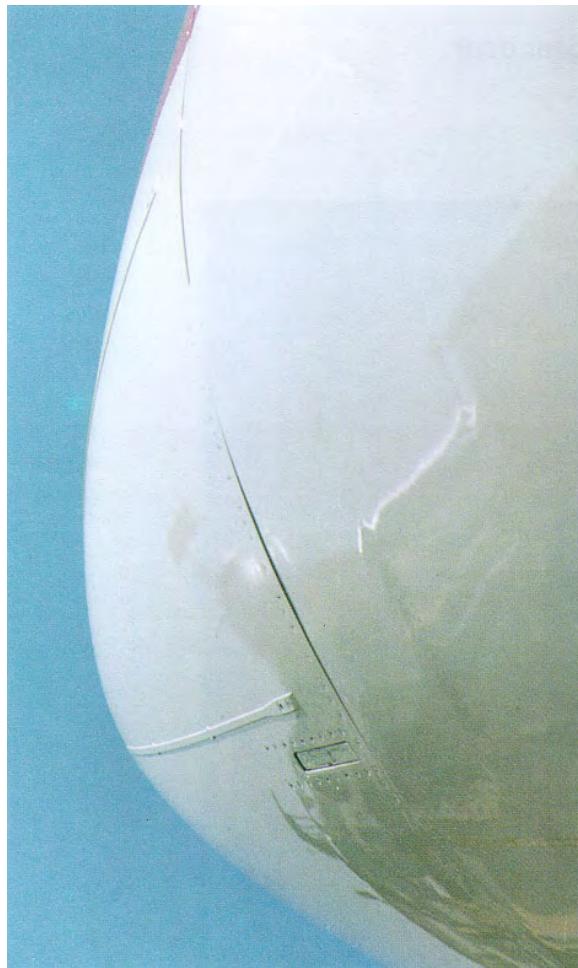
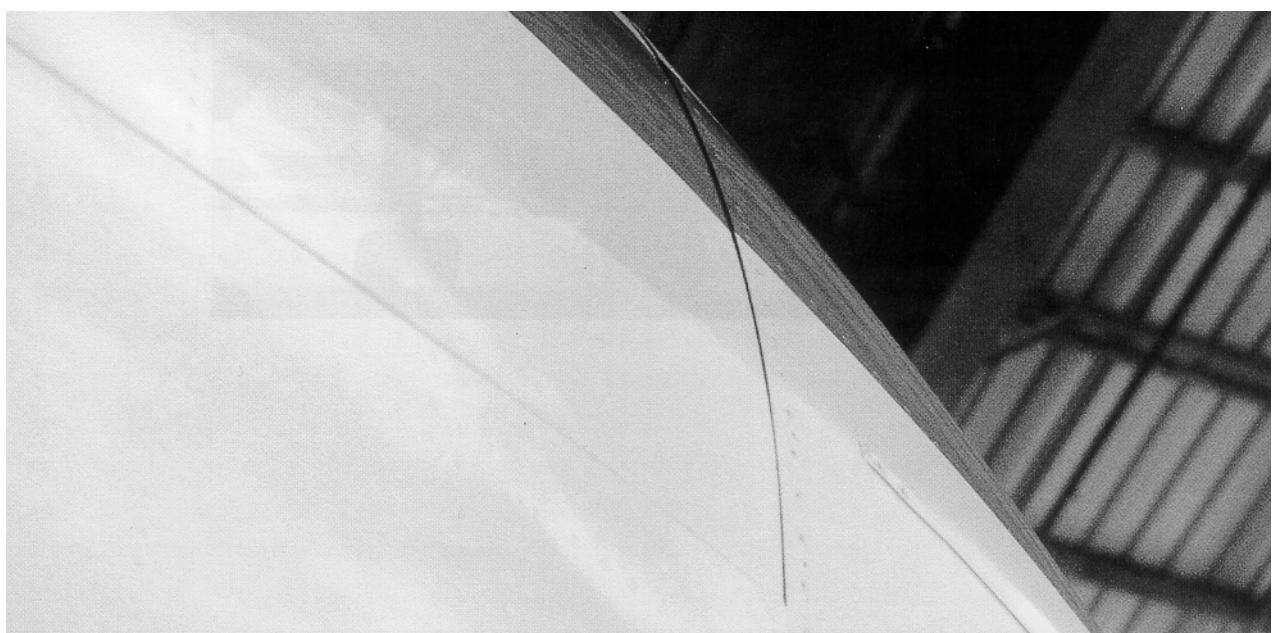
Radome misfit

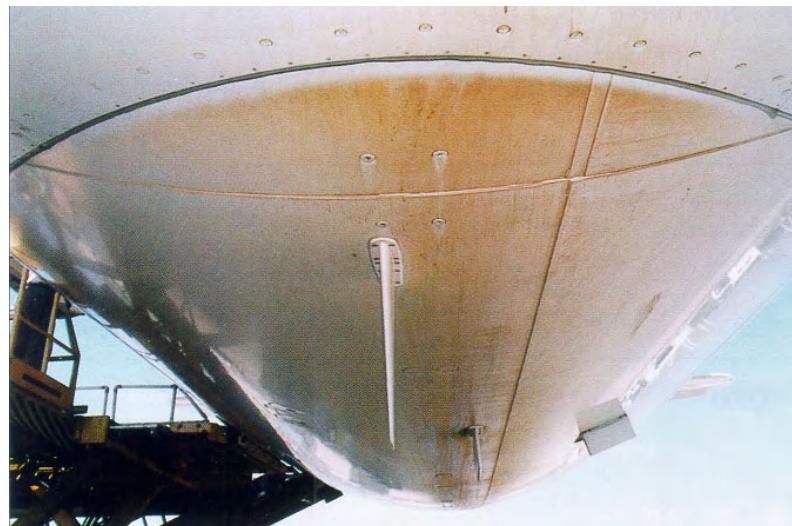
Skin roughness

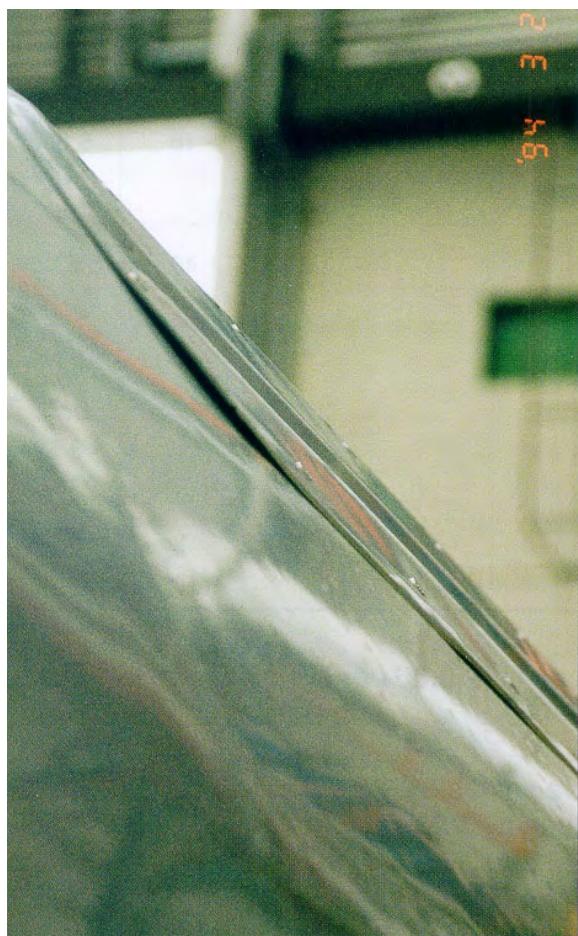
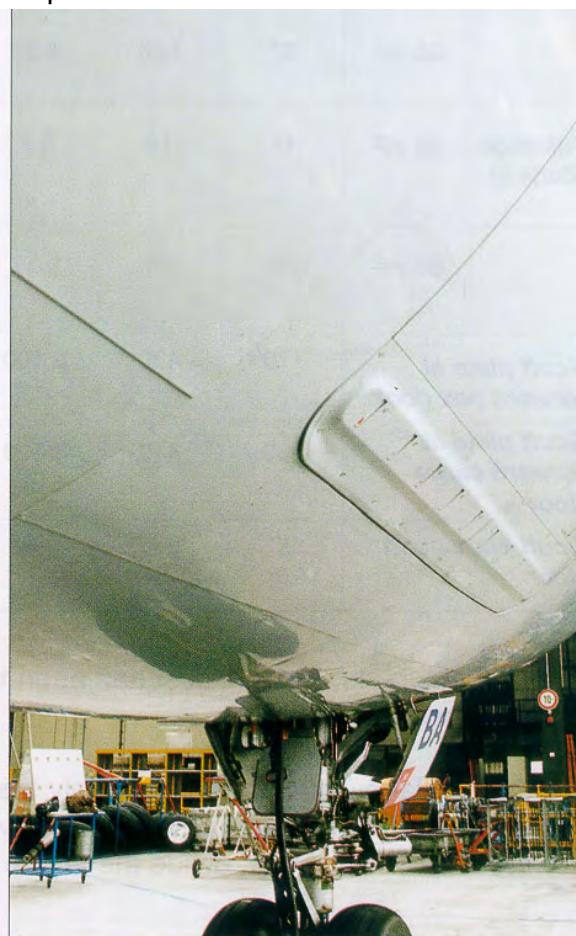
Dented scuff plates

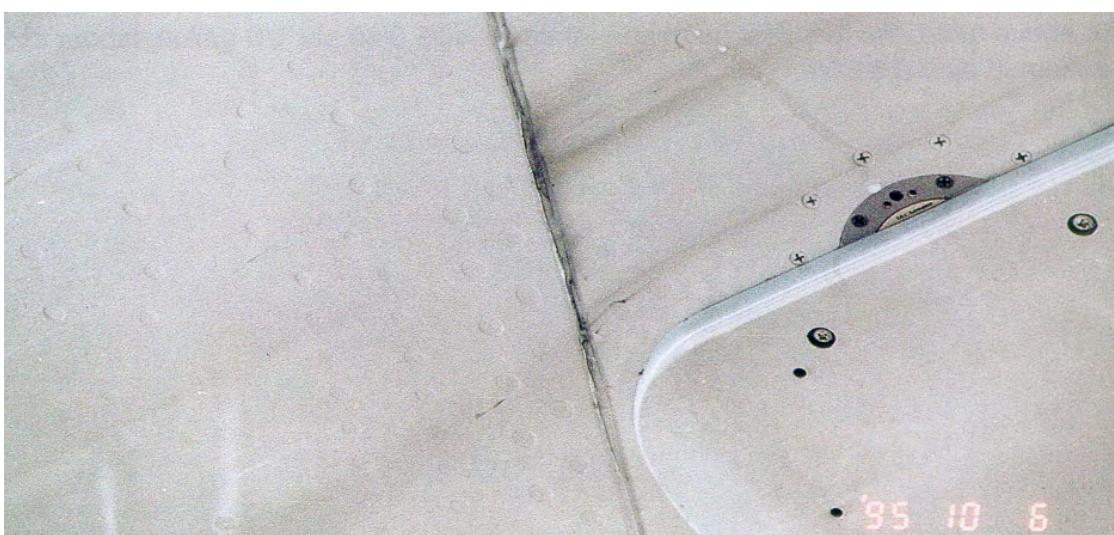
Missing seal

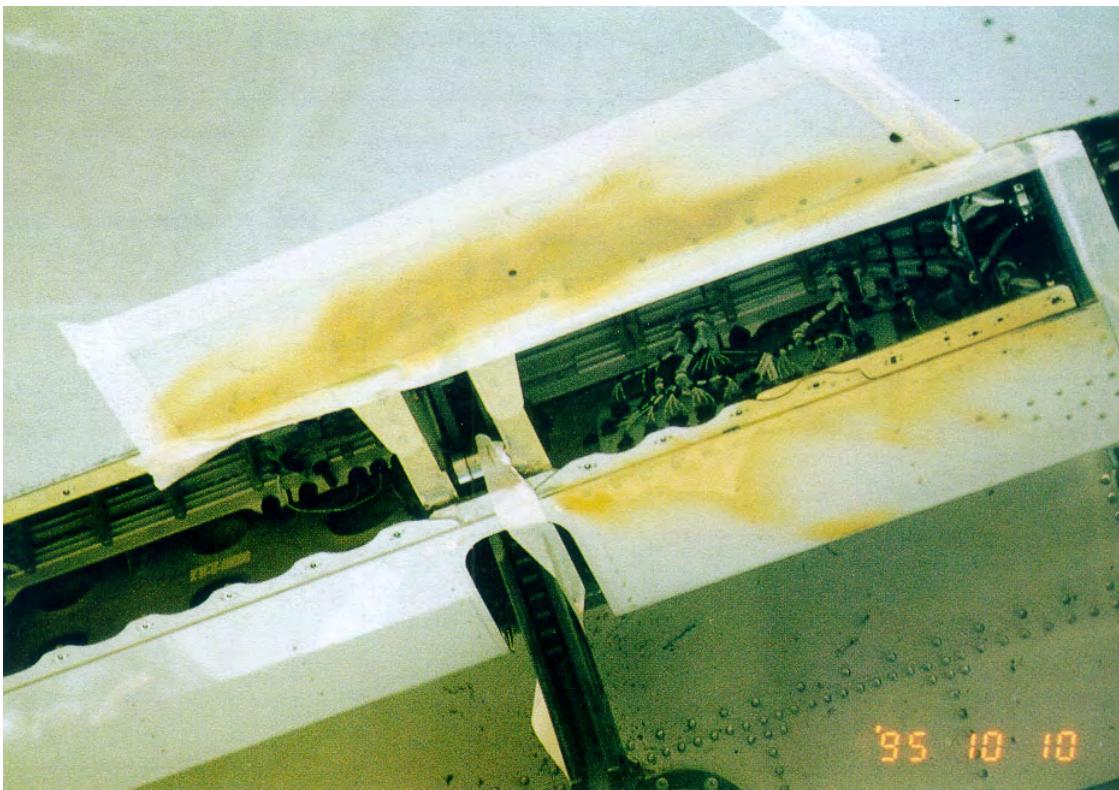
Paint peeling separation

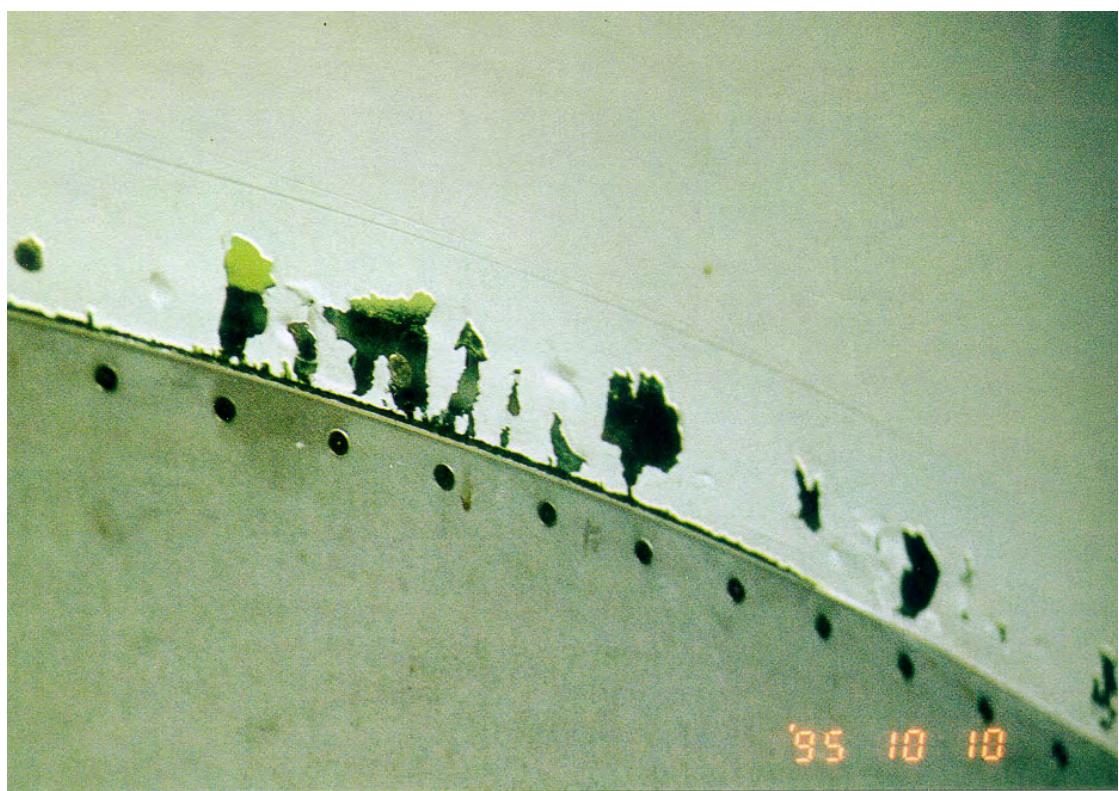
Paint peeling

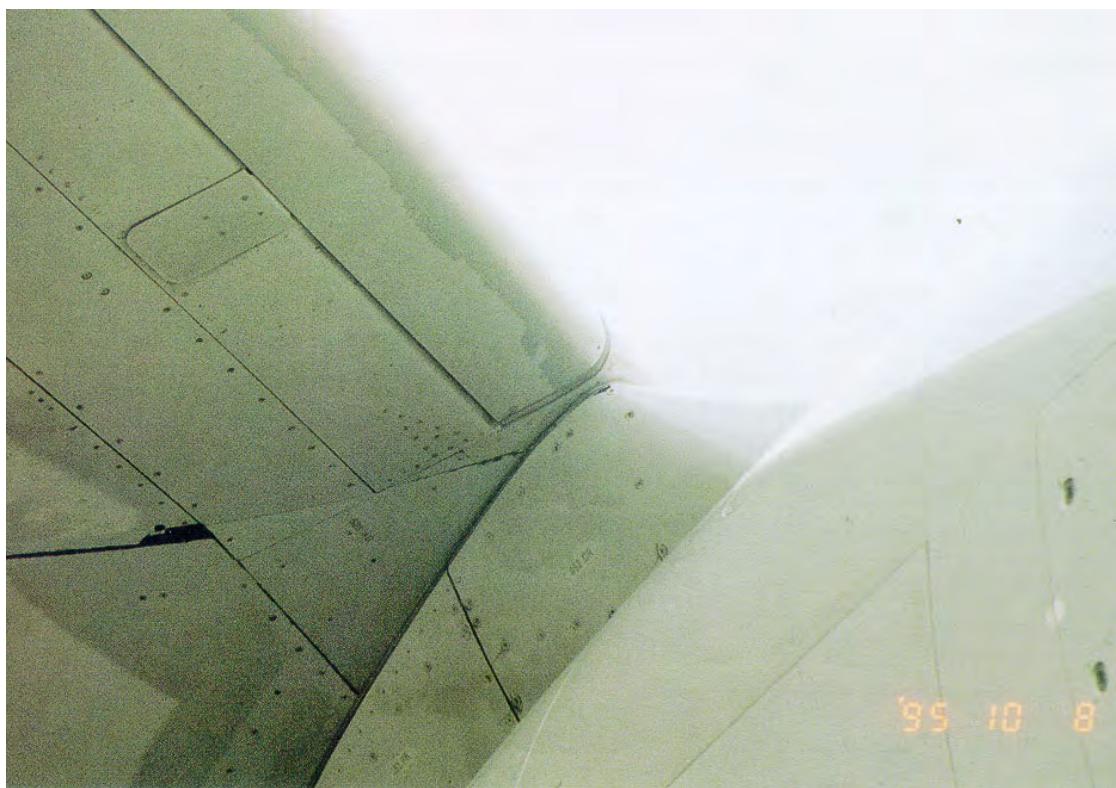
Paint peeling on the slat
leading edge
