Severity: MEDIUM | Risk Score: 53.0/100

| Field | Value |
|---|---|
| Zone ID | 856 |
| Violation Type | UNVERIFIED ZONE |

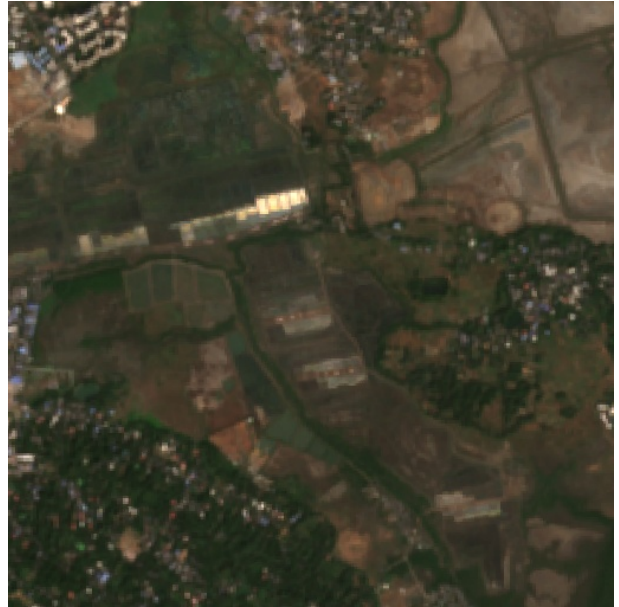
This zone received a MEDIUM score of 53.0/100 because the detected construction covers 0.46 hectares - between 0.2 and 1 hectare. This is a moderate satellite-detected change requiring human verification.

The images below show the flagged location in January 2025 (before) and January 2026 (after). Visible change in land cover - new grey/brown built-up area replacing green or open land - confirms the satellite detection.

January 2026 - After Construction

Land Classification Note: The land classification for this zone could not be verified against available zoning data. The flag is based solely on the magnitude of satellite-detected construction change. Ground verification is required to determine the applicable land use rules.
